**UNITED STATES COAST GUARD**

**INVESTIGATION INTO THE CIRCUMSTANCES  
SURROUNDING THE SINKING OF THE**

# **F/V LADY MARY**

**65 NM SOUTHEAST OF CAPE MAY, NEW JERSEY ON  
MARCH 24, 2009, WITH MULTIPLE LOSS OF LIFE**

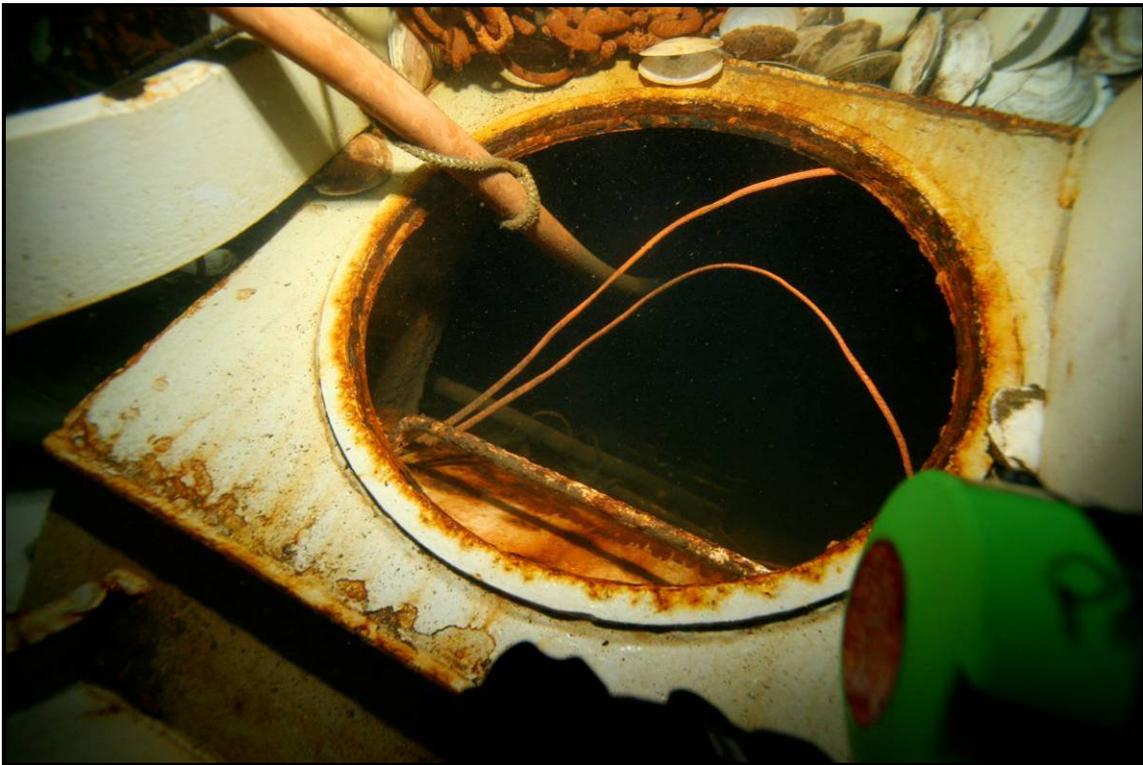
(9) At the aft end of the main deck, right next to the transom, was a circular access hatch leading into the lazarette. The hatch was on the port side of the vessel and was not flush with the main deck; it was raised up on a rectangular access trunk with the aft end higher than the forward end. The Previous Captain testified that the lazarette hatch cover was made of metal, and was like a heavy lid with a handle that would sit on top of the opening. He also testified that the cover was not latched down, but the Survivor testified that it did have a way to be secured. The lazarette hatch cover was missing from the sunken vessel.<sup>187</sup>

**Figure 14: Open lazarette access point located just forward of the transom, port side.**

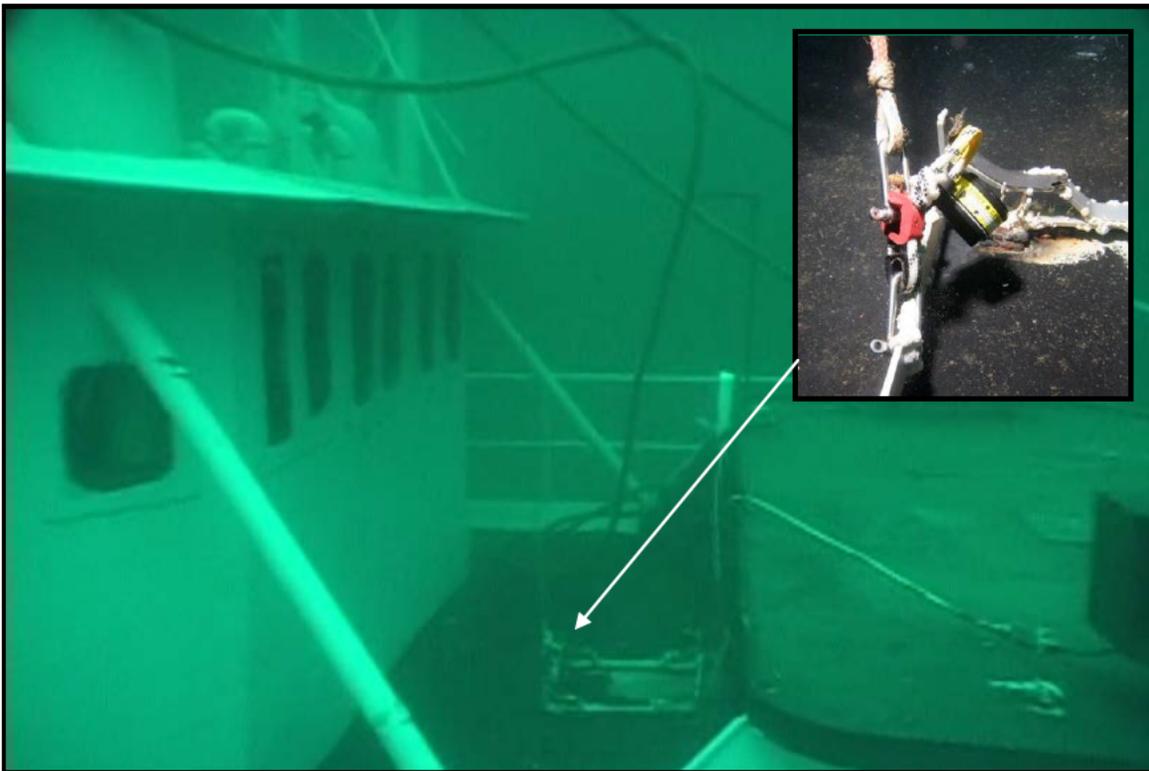
**Figure 21: Empty life raft cradle and HRU.**

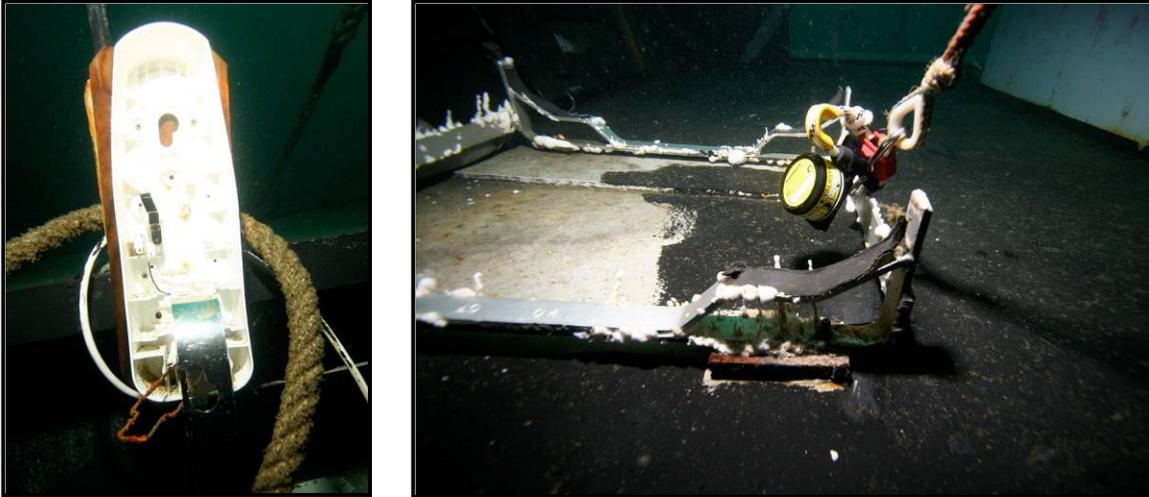
**Figure 35: Empty EPIRB bracket and life raft cradle with hydrostatic release unit**

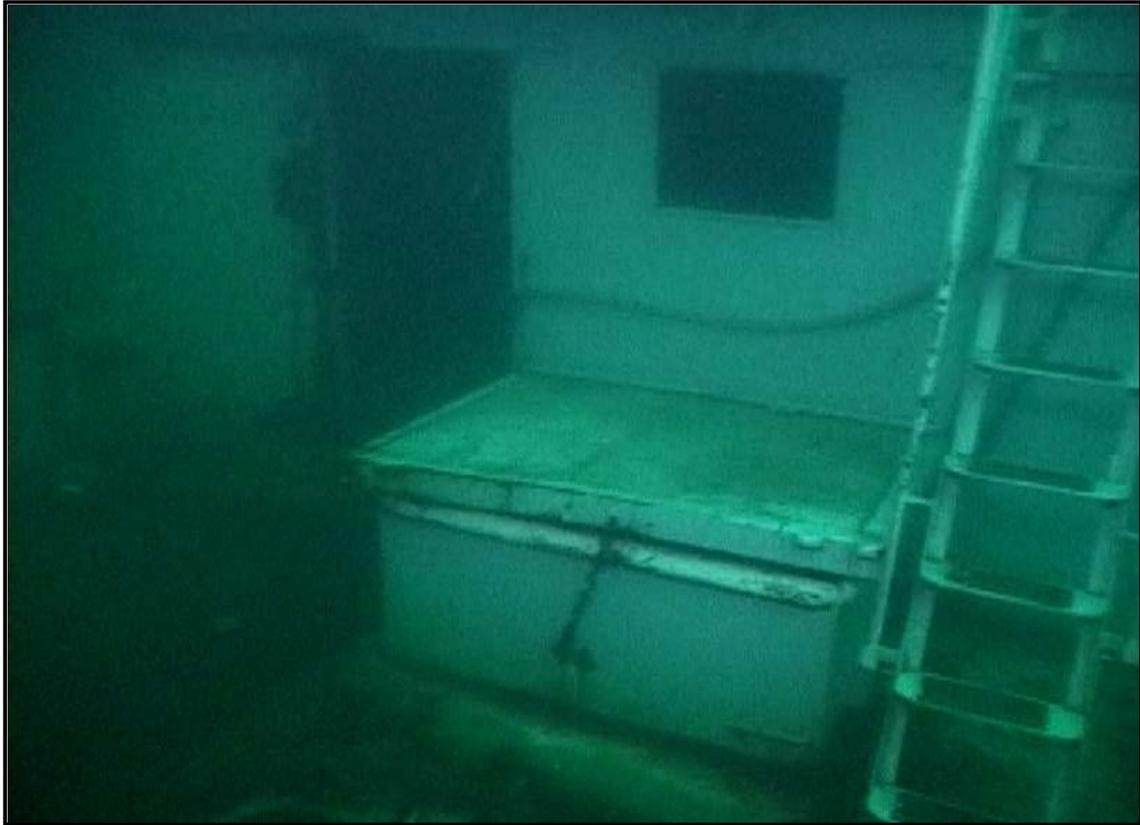
(8) The aft door to the shucking house was missing. The lead commercial diver testified that one of his divers found a survival suit in the shucking house. The survival suit was out of the bag and was located forward of the fish hold hatch near the starboard passageway.<sup>334</sup>

**Figure 40: Fish hold hatch and aft shucking house bulkhead with missing door & air conditioner**

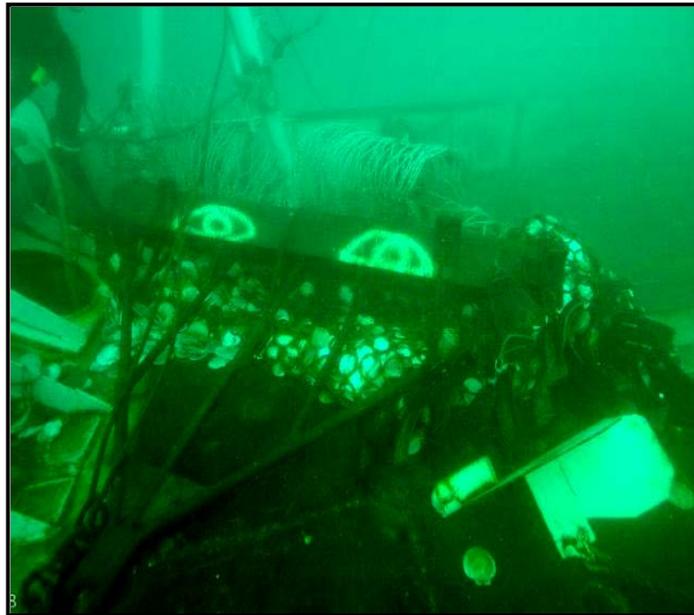
(11) The scallop dredge was found on the main deck, in the aft port corner of the deck. The tongue of the dredge was close to the centerline of the vessel and pointing towards the aft starboard corner of the deck. The dredge net contained scallops, but the cable used to dump the dredge was not attached; it was secured to the port side vertical post. The Shore Manager estimated that the dredge contained 10 or 12 bushels of scallops. The lead commercial diver testified that he did not observe any unusual nicks, scrapes, gouges or paint transfers on the dredge.<sup>337</sup>

**Figure 42: Scallop dredge on aft end of main deck**

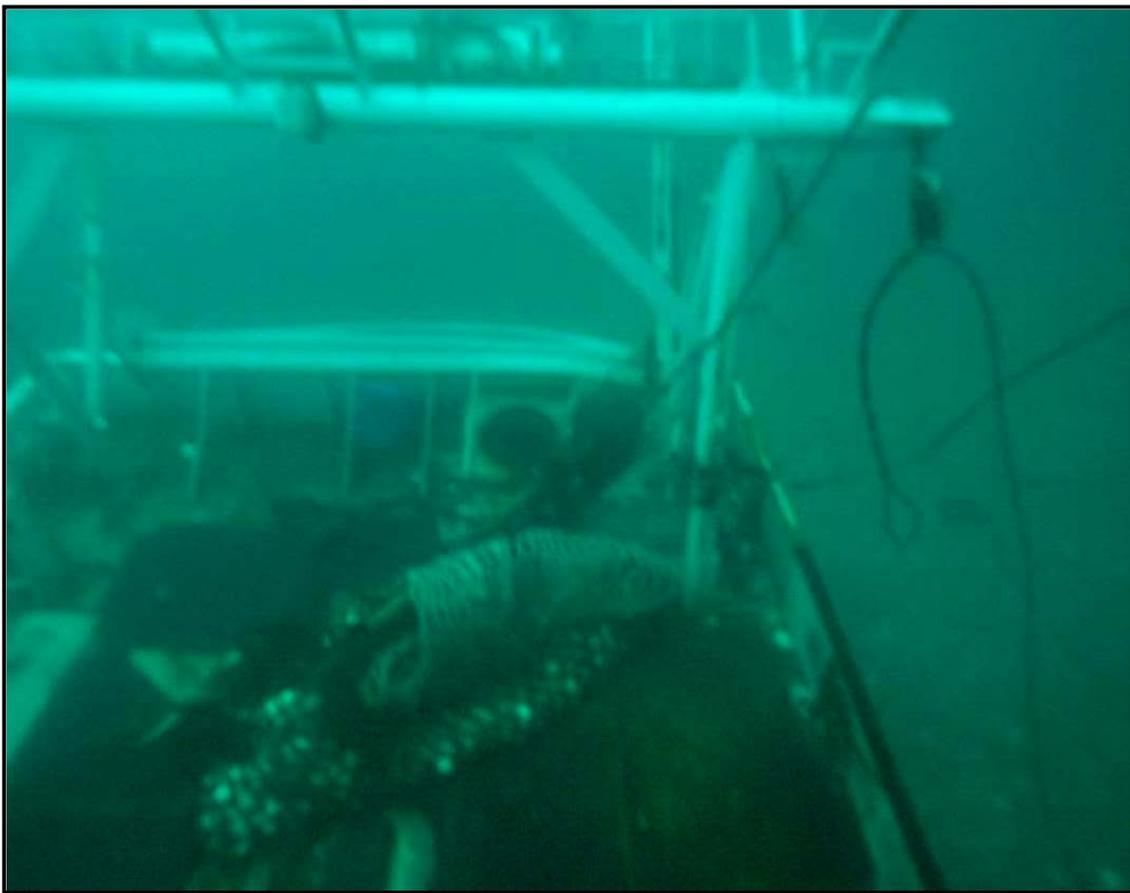
(12) The scallop dredge towing cable was not tight between the port winch drum and the tongue of the dredge. The cable left the winch drum and hung over the side of the LADY MARY just above the ocean floor, and then curved back up to a point right below the port side towing block (but did not run through the block at this point). The towing block was a ten ton block. The cable then looped back down about 6 or 7 feet, to a point almost even with the top of the main deck gunwale, and then ran back up and passed through the block. This 6-7 foot loop was twisted a number of times. After passing through the block, the cable ran up and over the block support and then down to the dredge tongue on the main deck. The lead commercial diver testified that he traced the dredge cable between the drum and the dredge and did not observe damages or unusual marks. The pictures show a few light colored markings on the dredge cable near the twisted section, which appears to be the same color as the block support. In an interview, the Survivor said that the twist in the dredge cable was not uncommon and was usually caused by the dredge spinning during recovery. The Shore Manager testified that in his experience, he had not seen this kind of twist in the dredge cable.<sup>338</sup>

**Figure 15: Main deck showing scallop dredge and cable**

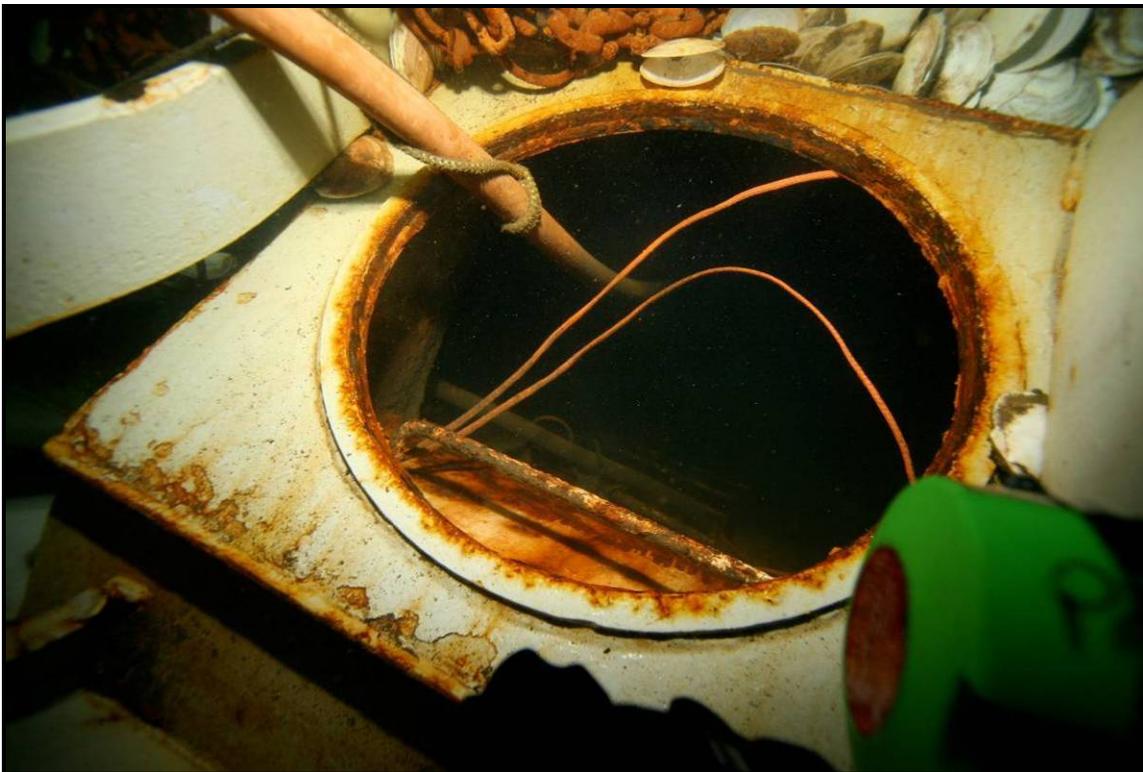
(14) The lazarette was open, and a hose ran from inside of the lazarette, up and aft over the stern ramp. There was a short length (about 2') of orange line tied to the end of the hose which was resting on the stern ramp. The lead commercial diver testified that none of his team members saw what was attached to the other end of the hose inside the lazarette. None of the divers saw the lazarette hatch cover either.<sup>340</sup> The Shore Manager testified that the hose leaving the lazarette was attached to an electric pump that was used for dewatering the space. When the pump was not being used, the hose was stored inside the lazarette, wrapped around the top of the ladder, with the lazarette hatch cover on.<sup>341</sup>

**Figure 44: Open lazarette with hose**

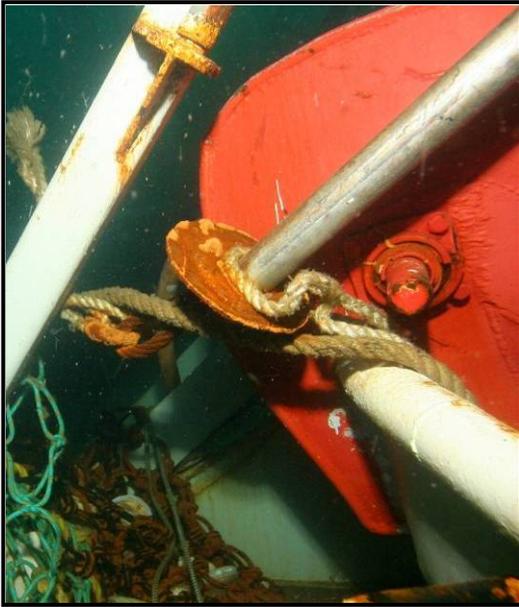
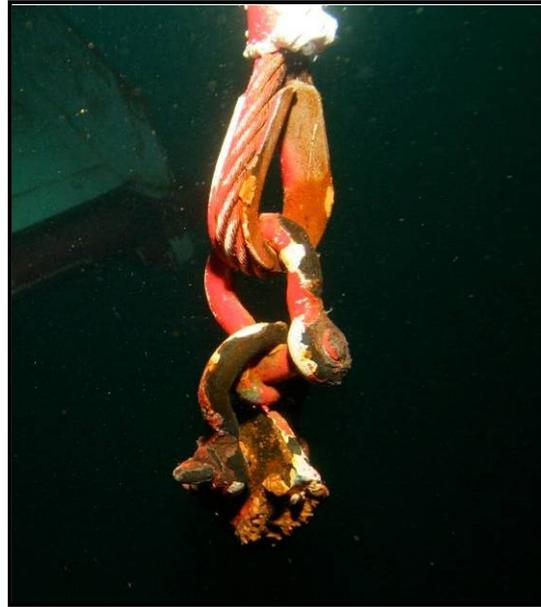
testified that the welded pad eye connecting the stay wire to the stern ramp had never broken before.<sup>342</sup>

**Figure 45: Ends of the port and starboard stay wires**

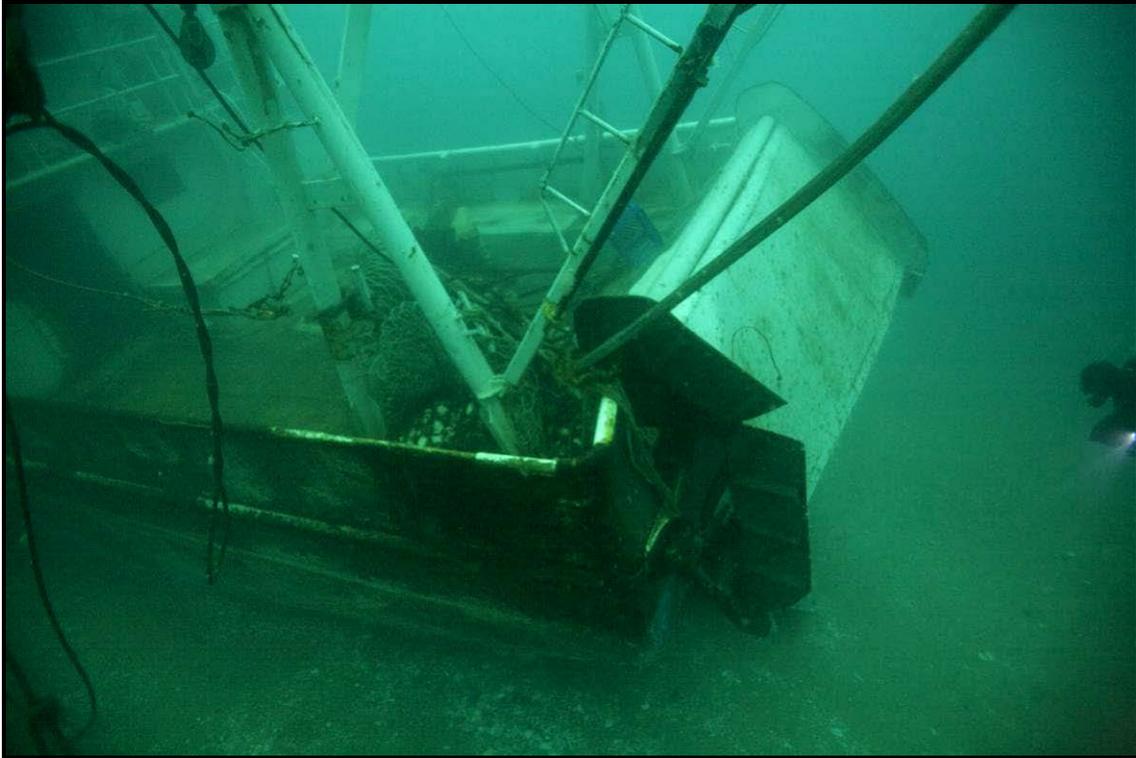
**Figure 18: The damaged stern ramp**

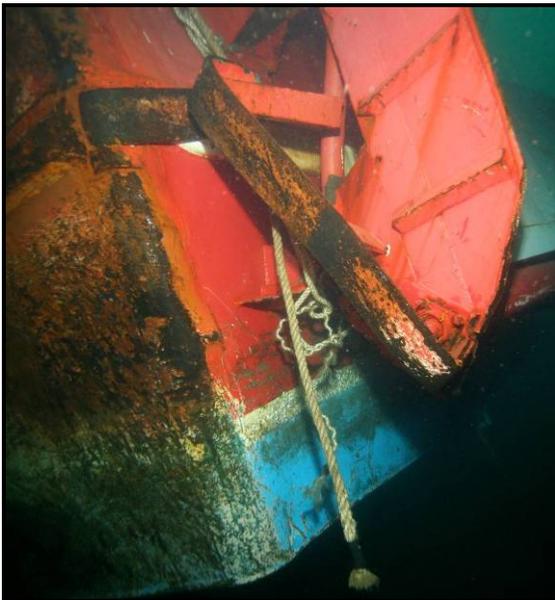
**Figure 19: Close up view of the damaged port quarter**

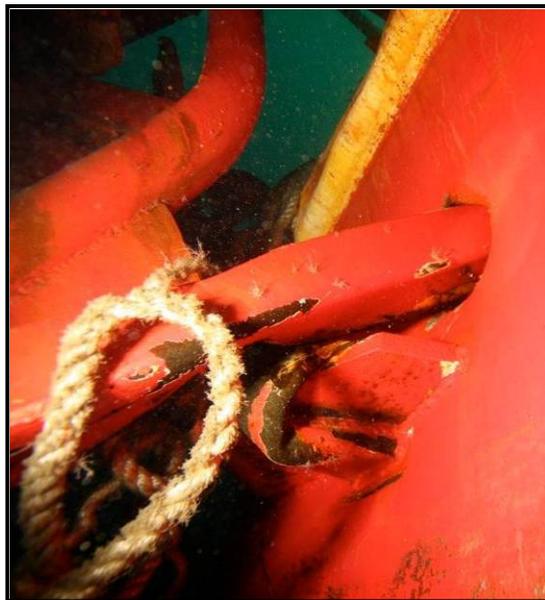
**Figure 20: View looking up from under the ramp to the punctured transom**

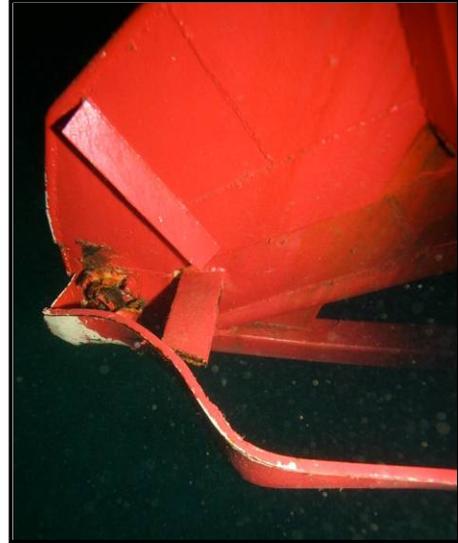
**Figure 22: Starboard side flat bar**

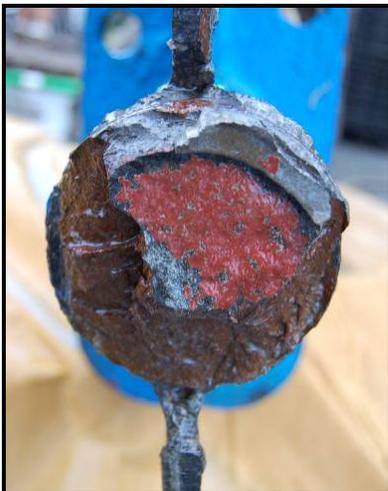
(17) The LADY MARY's rudder was broken off at the rudder stock flange, just below the hull, and the rudder was lying on the ocean floor beneath the vessel's transom. The rudder stock flange was the connection point between the internal rudder stock which ran through the hull into the lazarette, and the external rudder stock which was part of the rudder. The rudder was still connected to the vessel with a chain. The chain ran from a steel tab attached to the aft end of the bottom of the hull on the centerline, to a hole near the top of the trailing edge of the rudder. The Shore Manager testified that the purpose of this chain was to prevent the rudder from turning too far. The rudder was damaged, with bends and breaks in both the rudder body and the supporting stiffeners. The commercial diver testified that he observed red paint on the edge of the rudder. The rudder was recovered by the Navy's MDSU 2, and a detailed rudder analysis is contained in Appendix (e).<sup>344</sup>

**Figure 23: Top of the rudder stock**

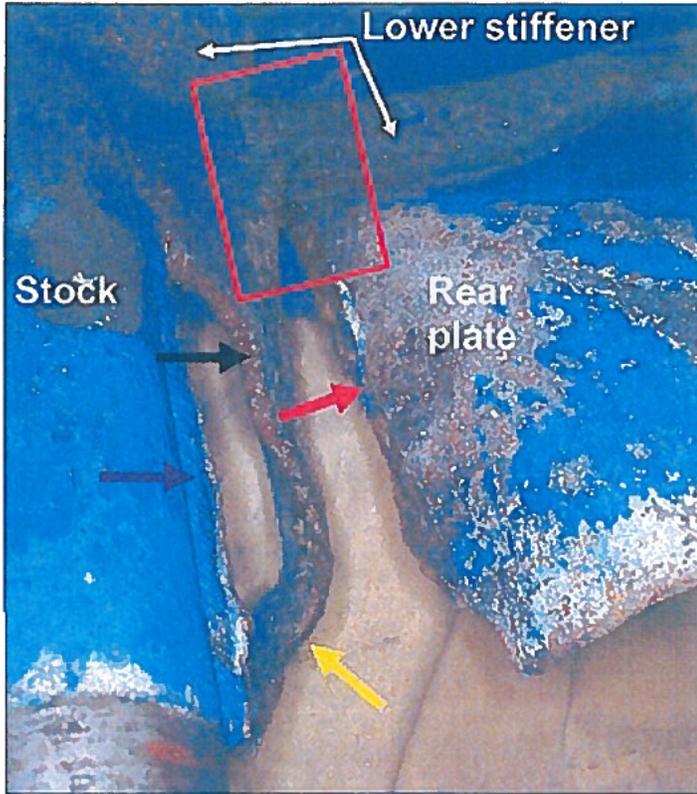
Figure 6. The damage to the rudder below the lower stiffener and contained within the yellow box in Figure 1.

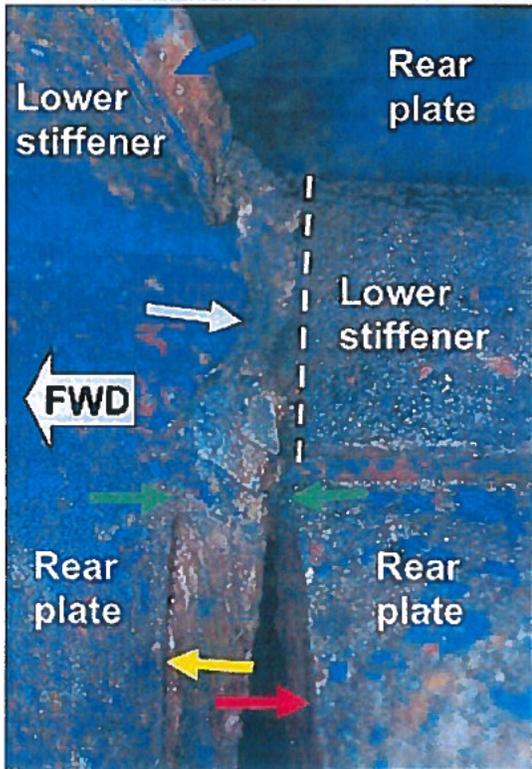
Figure 7. A closer view of the area contained within the red box in Figure 6 above.

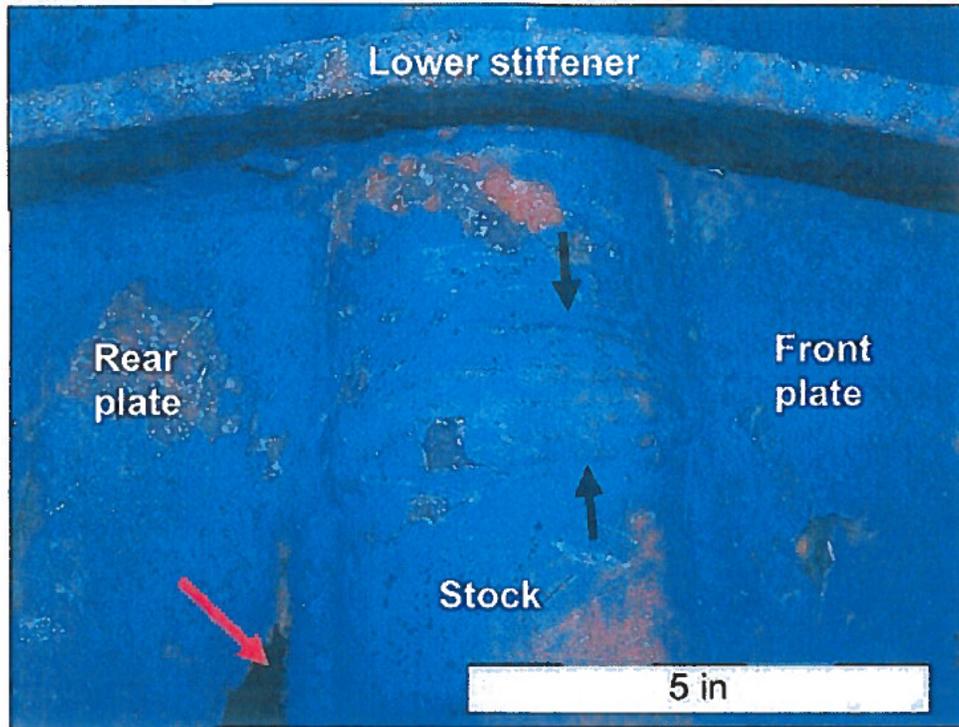
Figure 8. The multi-pass weld observed in the area indicated by the red arrow in Figure 2.

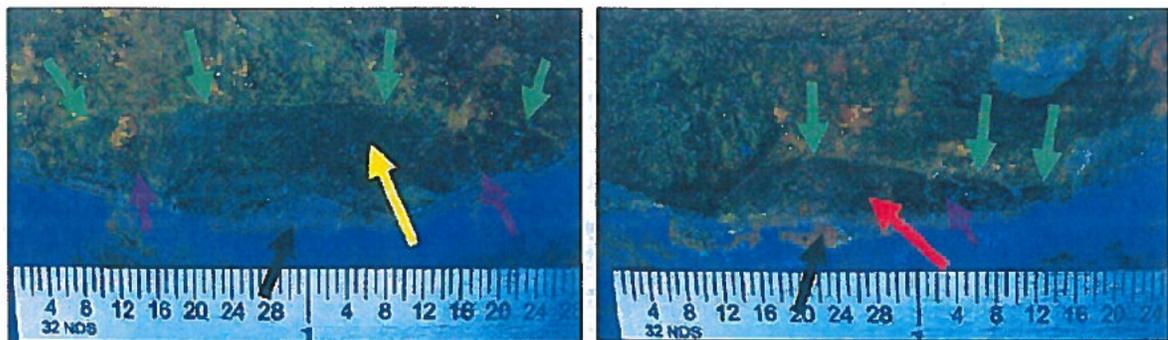
Figure 12. The fracture feature indicated by the yellow arrow in Figure 10 (left) and the fracture feature indicated by the red arrow in Figure 10 (right).

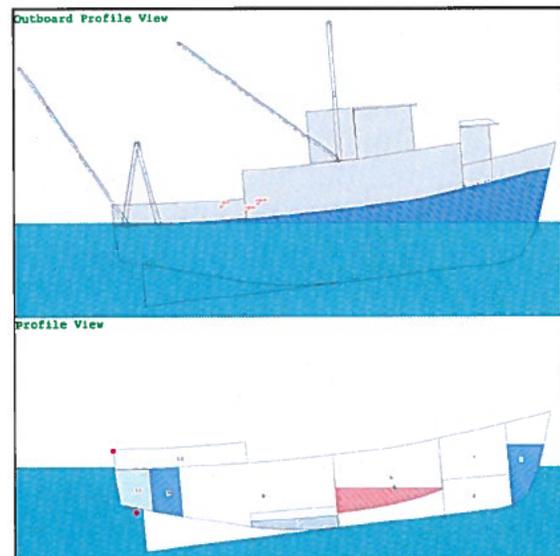
Figure 8: Lazarette Flooded 100% (1-2)

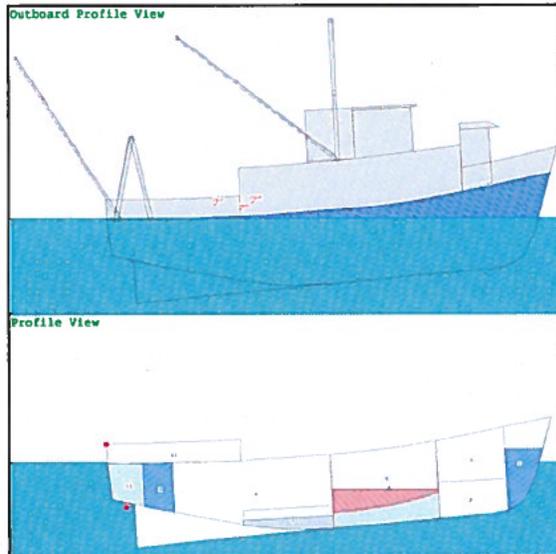
**Figure 9: Lazarette Flooded Progressing to Engine Room (1-3)**

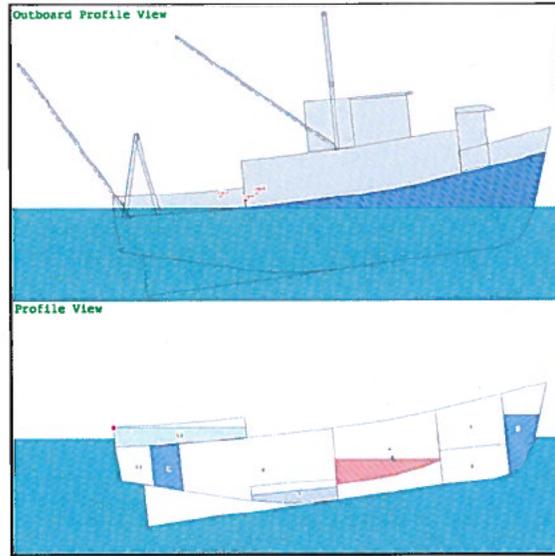
**Figure 12: Aft Deck Full of Green Water (2-2)**

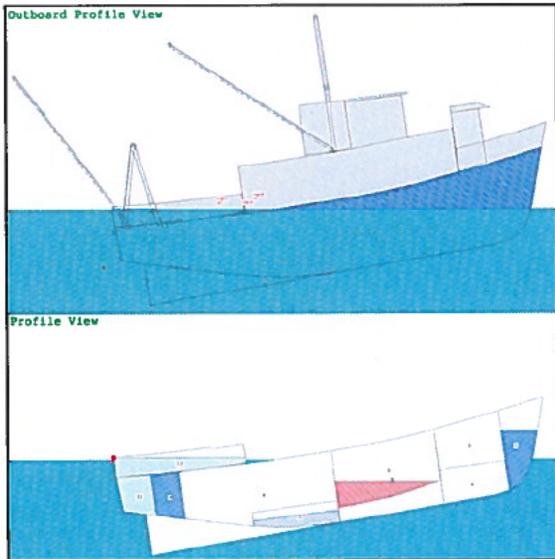
**Figure 13: Aft Deck and Lazarette Flooded**

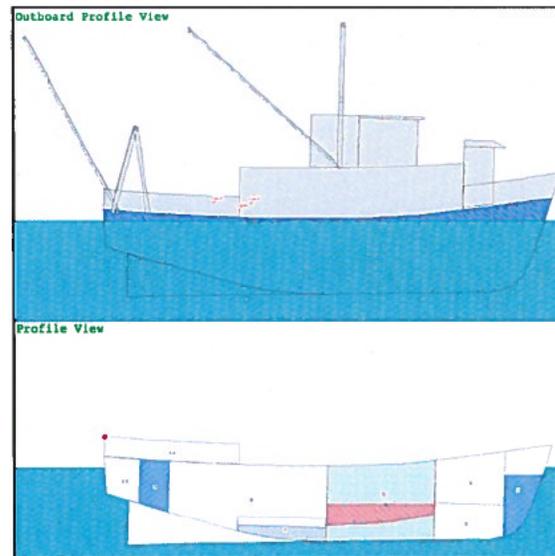
**Figure 15: Engine Room 100% Flooded (3-4)**
