# UNITED STATES COAST GUARD

## ARCTIC ROSE

OFFICIAL NUMBER 931446, IN THE BERING SEA ON  
APRIL 2, 2001, WITH ONE PERSON DECEASED AND  
FOURTEEN PERSONS MISSING AND PRESUMED DEAD

**SINKING OF THE UNINSPECTED FISHING VESSEL ARCTIC ROSE, OFFICIAL  
NUMBER 931446, IN THE BERING SEA ON APRIL 2, 2001, WITH ONE PERSON  
DECEASED AND FOURTEEN PERSONS MISSING AND PRESUMED DEAD**

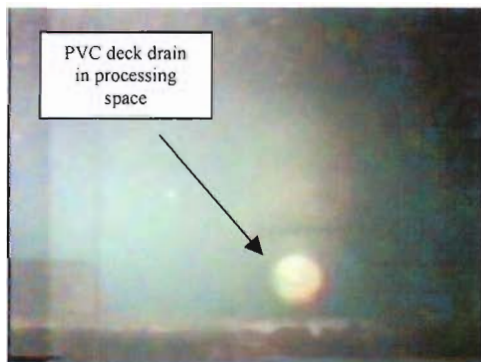
Figure 8  
Photo of PVC deck drain  
cap (2001)

- g. Processing Space Sideshell Openings. There were a total of six sideshell penetrations in the processing space. Four of these openings (2 port and 2 starboard) were approximately 2-3 inches above the deck. These openings were closed by a threaded PVC cap that could be removed (unscrewed) from inside the processing space to allow excess water to drain overboard. Two rectangular shaped openings (1 port and 1 starboard) were overboard discharge chutes to discard by-catch (starboard) and to discharge waste (port) from fish processing.

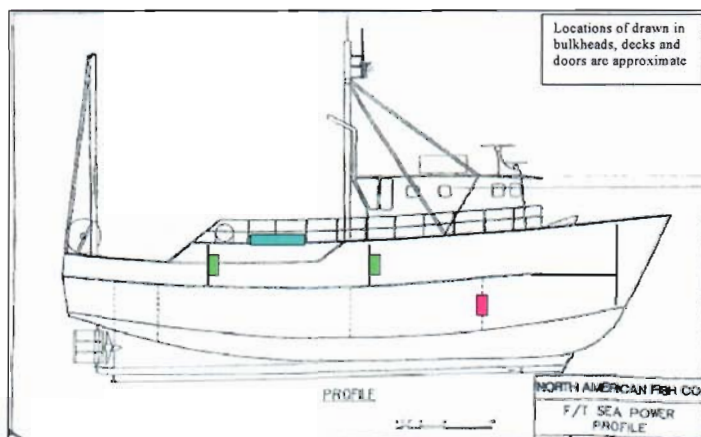
Figure 11  
Drawing showing  
locations of the  
weathertight or watertight  
doors and hatches

- h. Watertight/Weathertight Doors and Hatches. There was a six-dog weathertight door located on the starboard side that opened out to the trawl deck, and a slide hatch located on the aft bulkhead of the processing space. The sliding weathertight chute on the aft bulkhead

facilitated the movement of the catch from the dump box to the processing space. The overhead of the processing space had a weathertight hatch used to offload product. The processing space had six sideshell openings. A small manhole with a raised coaming was located in the top of the deck hatch, which was fitted with a non-watertight or weathertight plywood cover. A weathertight door provided access from the processing space to the mudroom. Access to the engineroom was via a flush deck trunk. A hatch cover was not fitted over the engineroom trunk. There was a watertight door between the engineroom and auxiliary machinery space and a non-watertight hatch between the engineer's stateroom and the auxiliary machinery space. The Jensen Marine Consultants (JMC) issued stability booklet required this watertight door to remain shut at all times except when used for passage. This same book required all openings for scrap and fish chutes in the processing space bulkhead to be kept closed at all times except when used while processing fish.

Action: We concur with the intent of this recommendation. We believe that the fitting of watertight and weathertight doors, required to be closed by a vessel's stability booklet, with alarms and status indicators would improve fishing vessel safety by making masters and crews more aware of the status of their vessel's watertight integrity and alerting them to possible threats of flooding. However, we believe that the development and implementation of a voluntary compliance program rather than attempting to publish regulatory requirements is more appropriate and more likely to be completed faster and with better success. We will consult with the Commercial Fishing Industry Vessel Safety Advisory Committee and work with the industry on the development of appropriate voluntary standards and seek to include the results in an update to Navigation and Vessel Inspection Circular 5-86, *Voluntary Standards for U.S. Uninspected Commercial Fishing Vessels*.

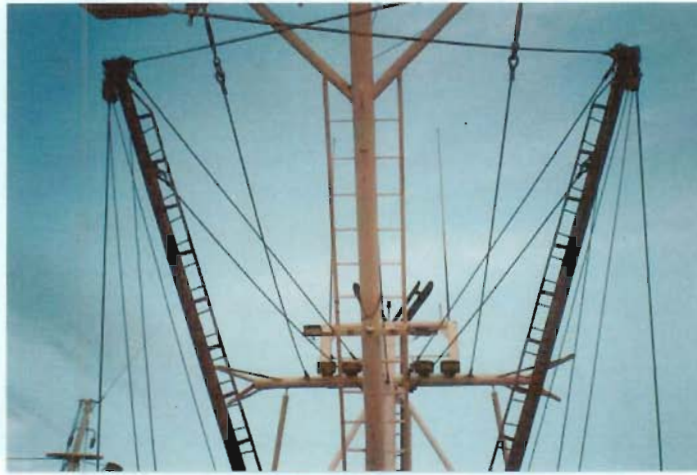
Figure 16  
Photo of "Stability  
Vanes (1995)

The existing stability vanes (see Figure 16), were removed.

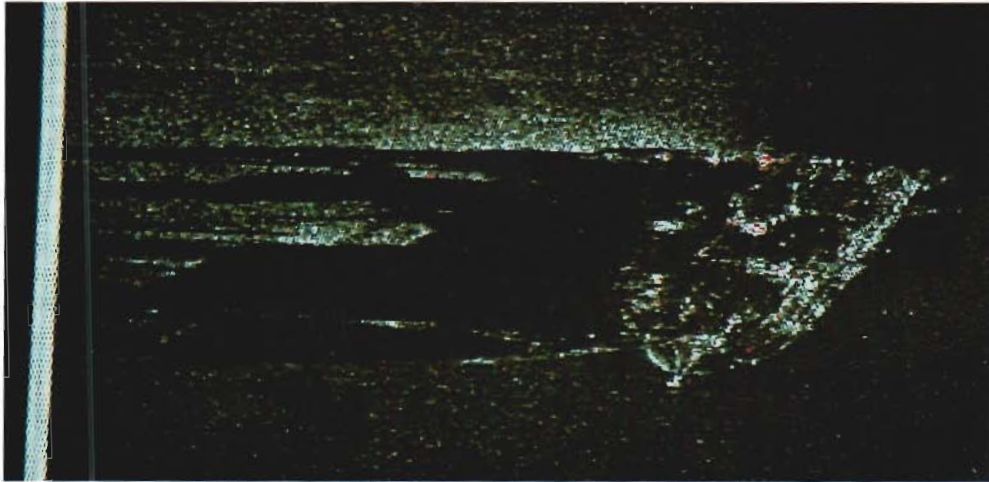
Figure 27  
Picture from side scanning sonar of ARCTIC ROSE (2001)

water. Shortly thereafter, the Board received its first look at the vessel, which was sitting upright on the sea floor in 73 1/3 fathoms, or 428 feet, of water in the location 58° 56.22 minutes North latitude and 175° 53.10 minutes West longitude. The location is approximately 200 miles northwest of St. Paul Island, Alaska. The ROV was maneuvered slowly up the port side of the hull and revealed the name – ARCTIC ROSE. The ROV

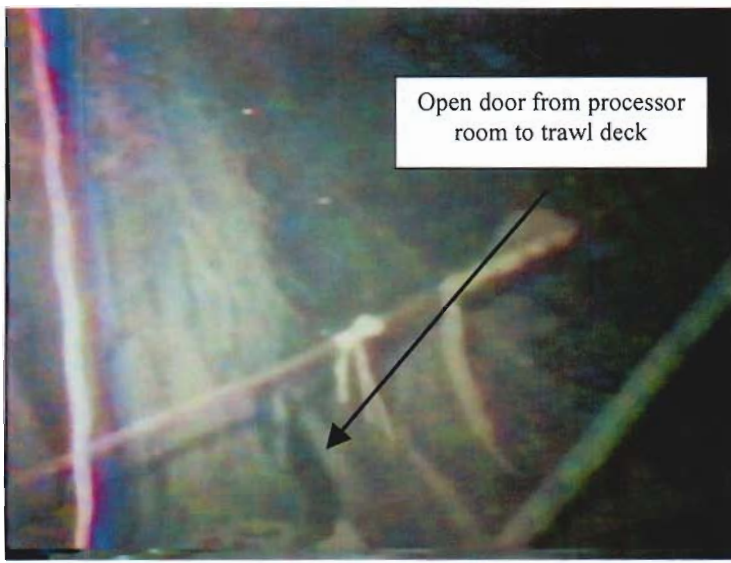
Figure 30  
Photo of open  
weathertight  
door on aft  
bulkhead of  
processing  
space taken  
from ROV  
video (2001)

The information obtained during this expedition also clearly revealed that the vessel was not fishing at the time of the casualty.
