UNITED STATES COAST GUARD

**REPORT OF THE INVESTIGATION
INTO THE
B. No. 255 (O.N. 603622) EXPLOSION, FIRE, AND
DISCHARGE OF OIL APPROX. 3 MILES FROM PORT
ARANSAS, TX WITH TWO CREWMEMBERS
DECEASED OR PRESUMED DECEASED ON
20 OCTOBER 2017**

MISLE ACTIVITY NUMBER: 6291947

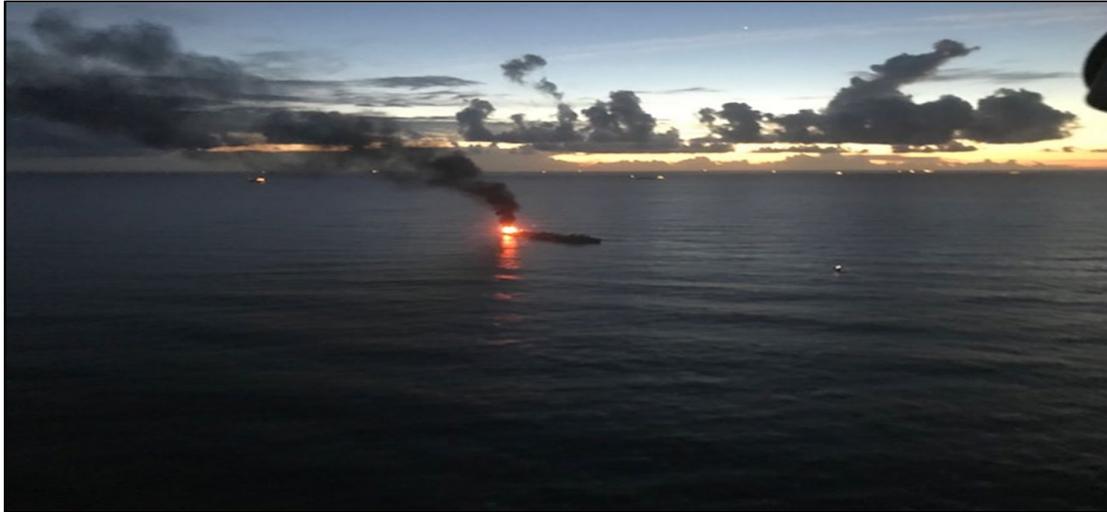
Figure 5: Picture of B. NO. 255 on fire in the Corpus Christi anchorage taken by the U.S. Coast Guard on October 20, 2017. Lights of the other vessels anchored in the area can be seen in the background.

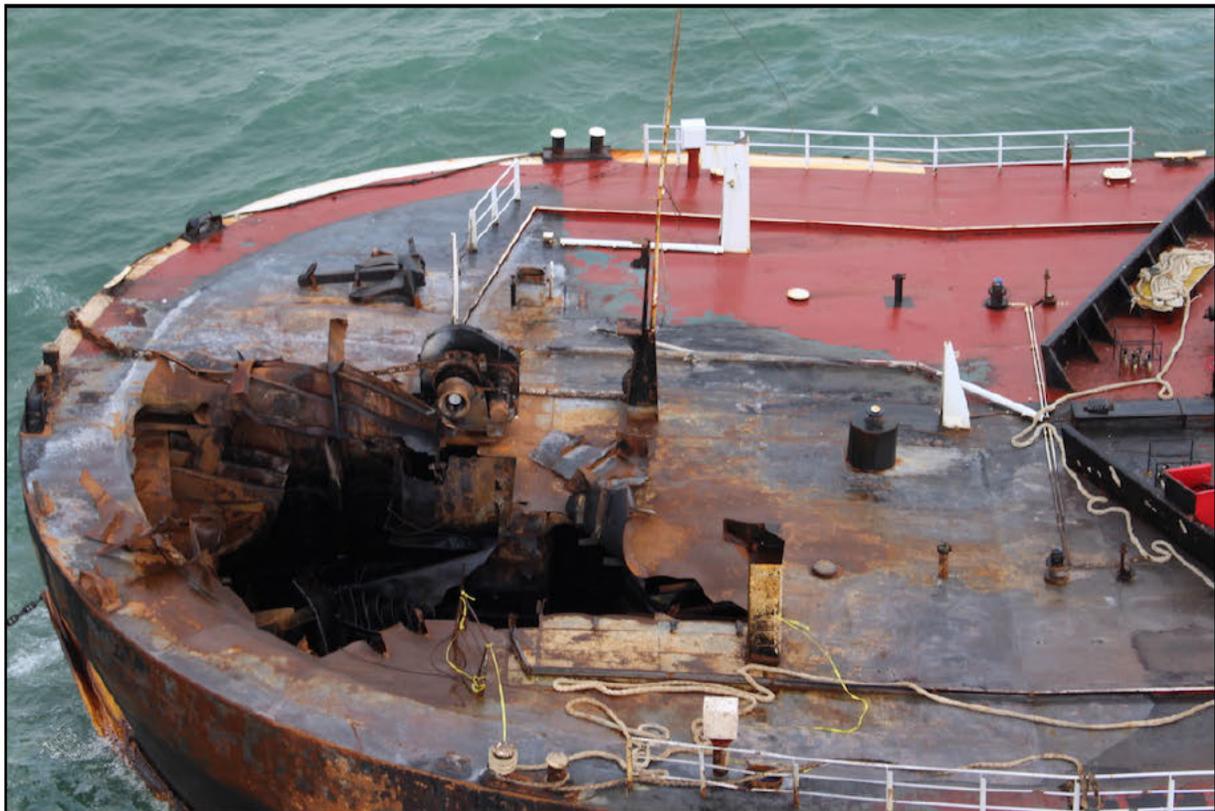
4.1.23. B. NO. 255's forepeak and No. 1 port and starboard cargo tank spaces below deck, and topside bow deck were severely damaged by the explosions.

Figure 7: Overhead view of the explosion damage onboard B. NO. 255 post-explosion. Picture taken by the U.S. Coast Guard on October 22, 2017.

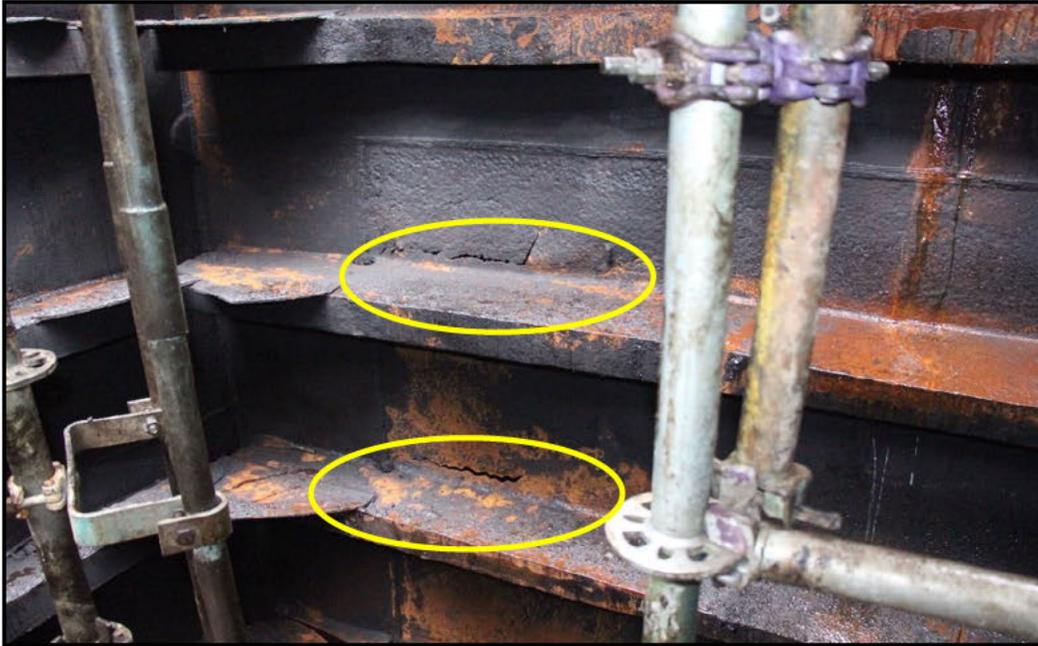
Figure 8: Picture of the number one port cargo tank forward bulkhead as viewed from inside the forward rake looking aft. Circles added to identify cracks. Picture taken by the U.S. Coast Guard on December 6, 2017.

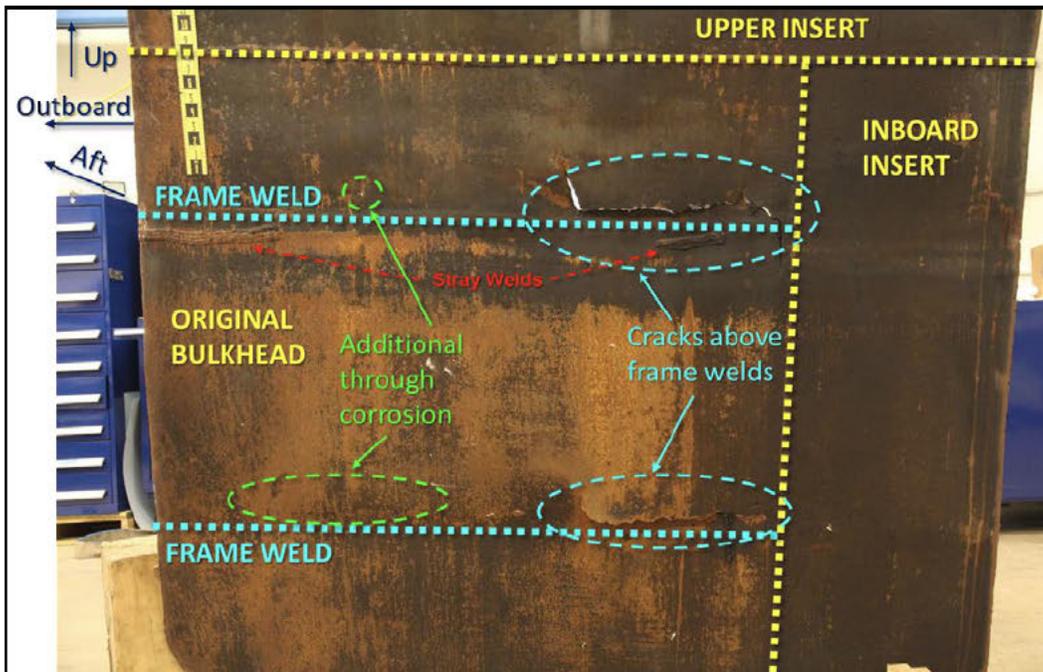
4.3.1.3. The NTSB Materials Laboratory conducted a comprehensive exam of the steel including chemical composition, phase identification, hardness, and micro-indentation testing. The report concluded that of the two cracks identified, the top crack was present prior to the explosion.²⁴ The report also concluded the steel was pitted on the forepeak side of the bulkhead and severe corrosion was present around both cracks consisting of pitting and holes. (See Figure 9)

Figure 9: Removed bulkhead section from B. NO. 255, as viewed from number 1 port cargo tank. (Photo by NTSB)

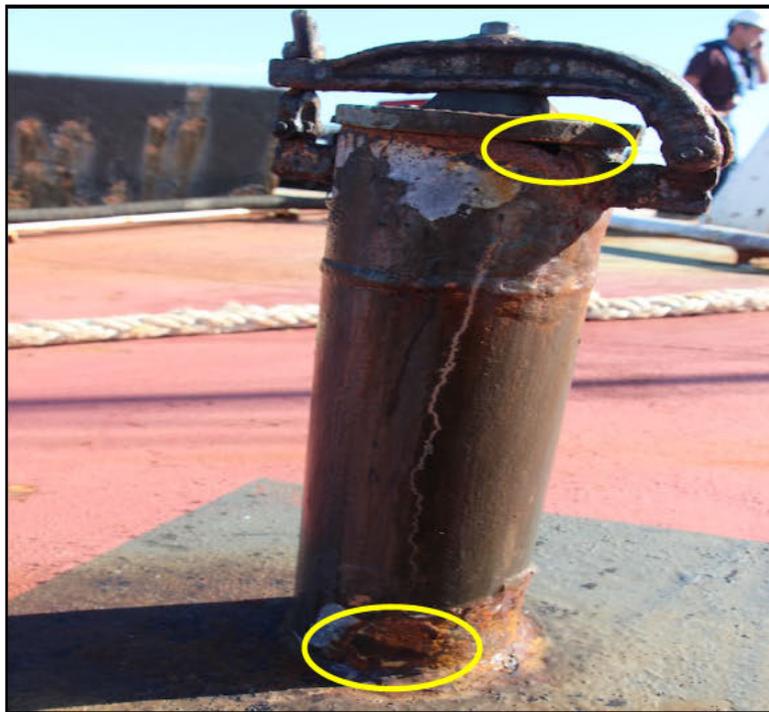
4.3.3. U.S. Coast Guard Investigators discovered significant corrosion at the base and top of the ullage tube for the No. 1 starboard cargo tank. The holes allowed free communication of vapor from the cargo tank to the topside of the barge. The wasted areas were determined to predate the incident. (See Figures 10 and 11)

Figure 10: Picture of the number one starboard cargo tank ullage tube leading directly to the cargo tank on B. NO. 255. Circles added. Picture taken by the U.S. Coast Guard on November 6, 2017.

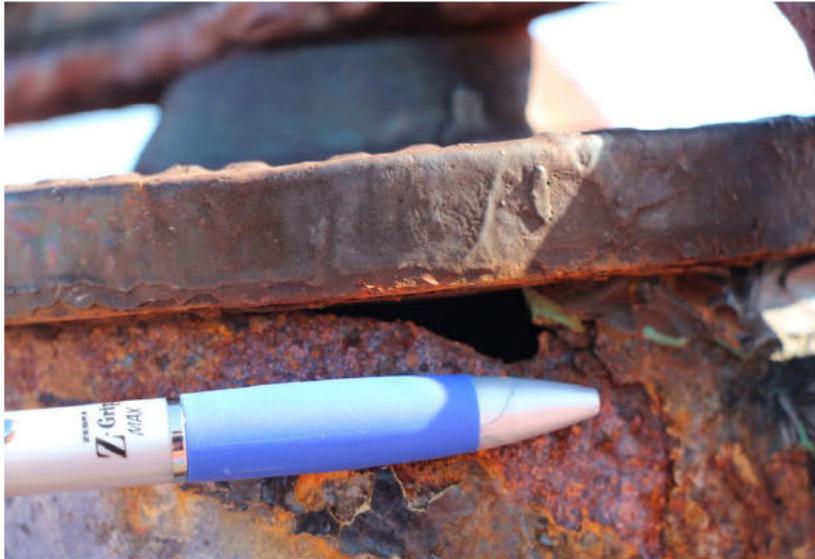
Figure 11: Closer view of the area pictured in Figure 10. Picture taken by the U.S. Coast Guard on November 6, 2017.

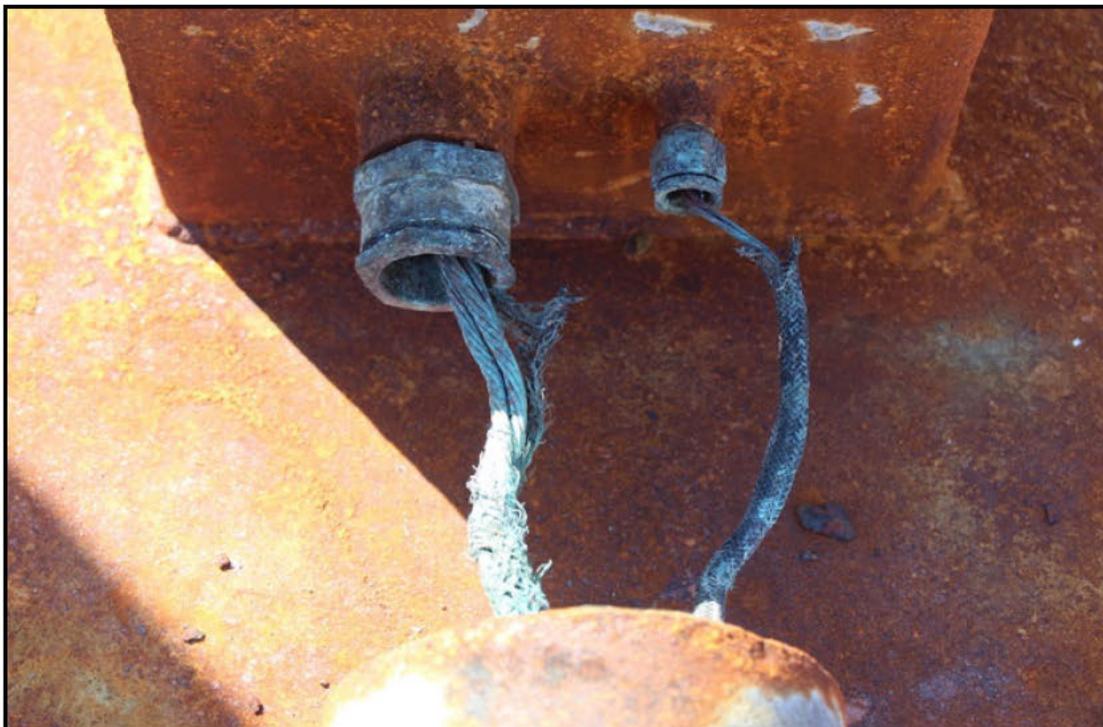
4.3.4. Additionally, U.S. Coast Guard Investigators discovered numerous sections of wasted armored electrical conduit exposing the electrical wire to weather and spindrift. The wasted areas were determined to predate the incident. (See Figures 12 and 13)

4.3.4.1. Exposed wires on a tank barge present a hazardous condition as combustible vapors may ignite.

Figure 12: Deteriorated wiring located in bow area on B. NO. 255. Picture taken by the U.S. Coast Guard on November 6, 2017.

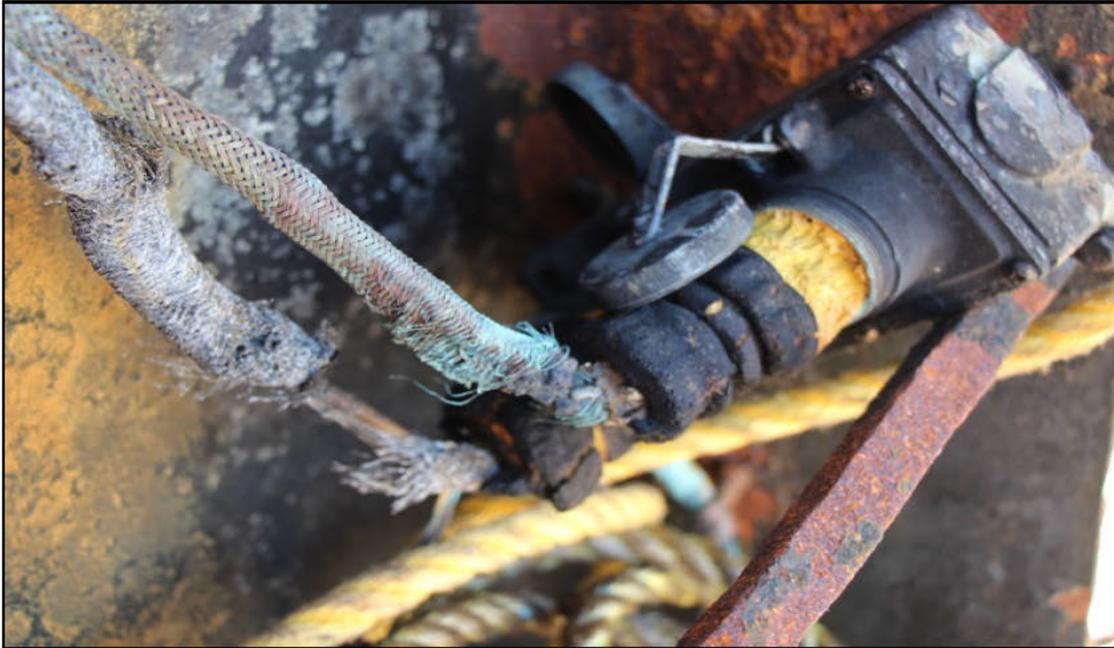
Figure 13: Picture of the outlets for the forward navigation light mast located on the bow area of B. NO. 255. Picture taken by the U.S. Coast Guard on November 6, 2017.

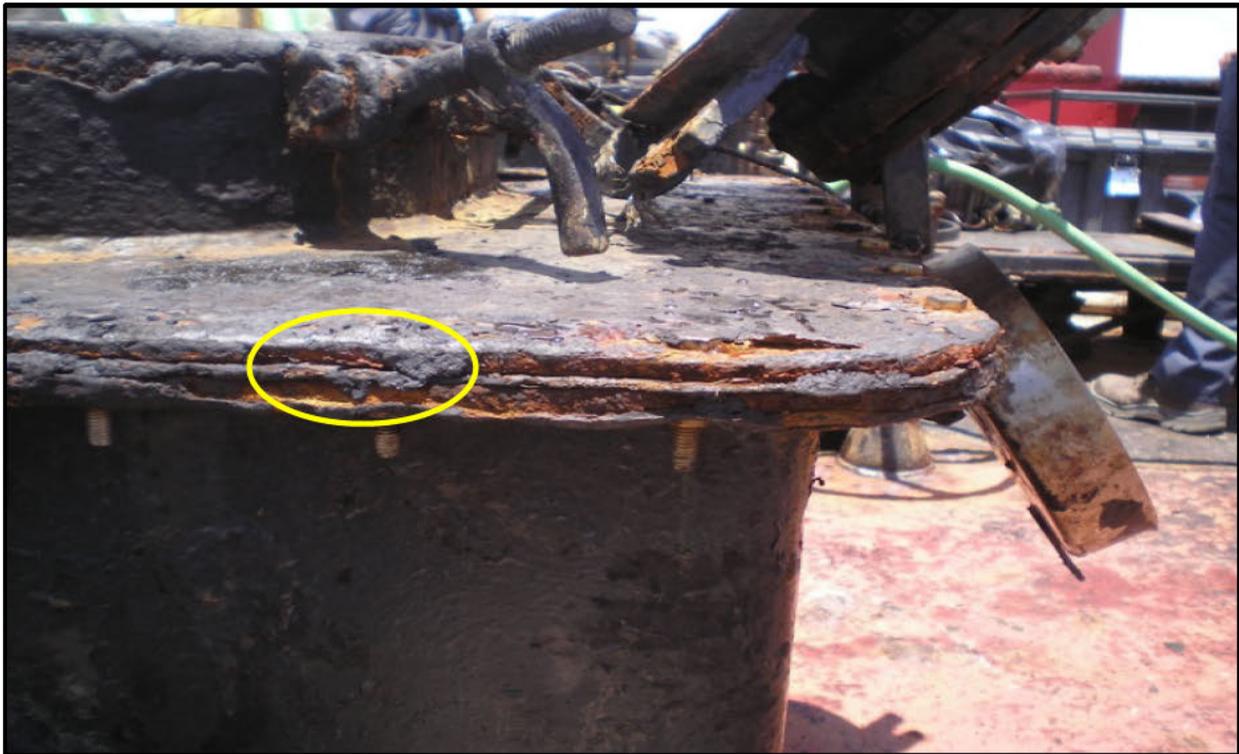
4.3.5. U.S. Coast Guard investigators also discovered extensive corrosion on cargo tank top hatches. The wasted areas were determined to predate the incident. Severe penetrations on the cargo tank hatch lids allowed free communication of vapors from the cargo tank to the topside of the barge.

Figure 14: Picture of wasted cargo tank hatch on B. NO. 255. Circle added. Picture taken by the U.S. Coast Guard in June 2018.

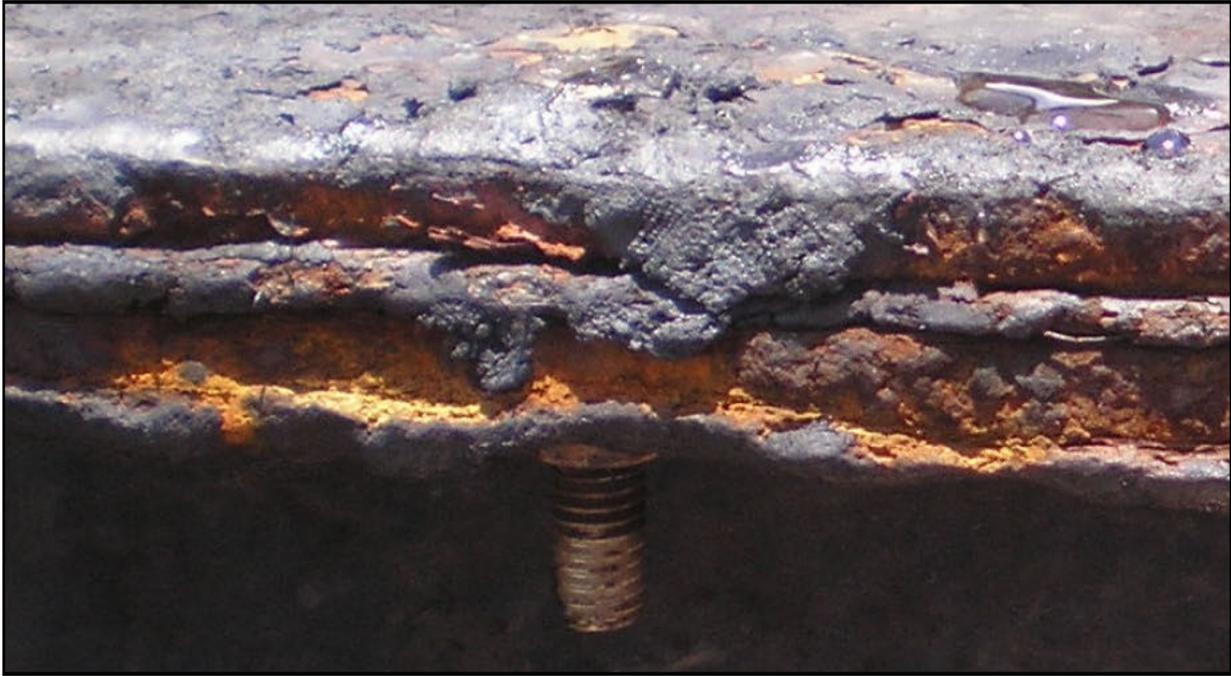
Figure 15: Close up view of the wasted cargo tank hatch in Figure 14. Picture taken by the U.S. Coast Guard in June 2018.

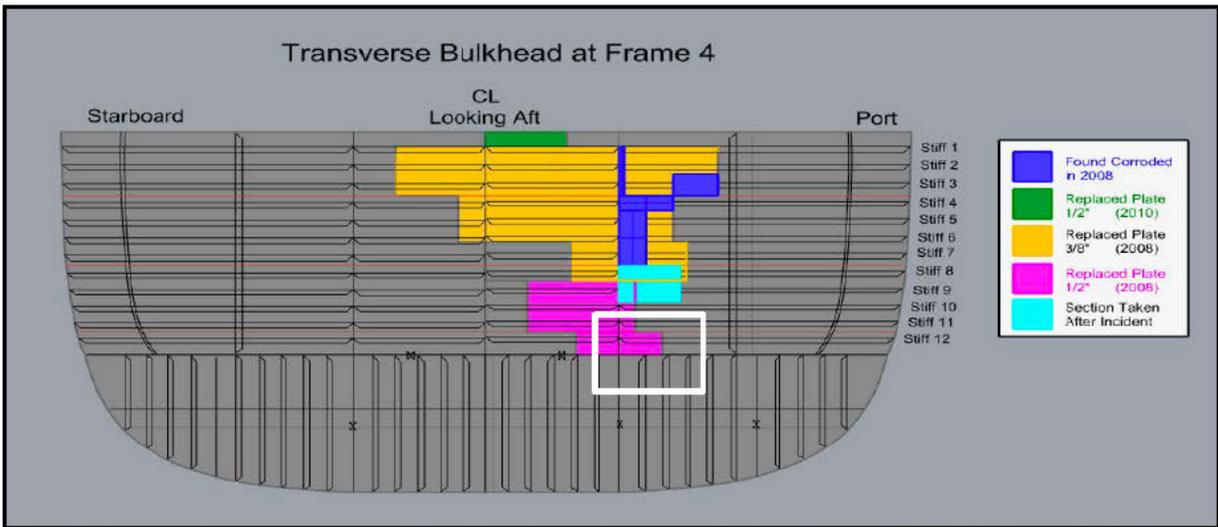
Figure 16: Diagram of repairs to transverse bulkhead forward of number 1 port and starboard cargo tanks. The light blue section is the damaged area analyzed by the NTSB and the U.S. Coast Guard, discussed later in this section. Diagram provided by ABS.

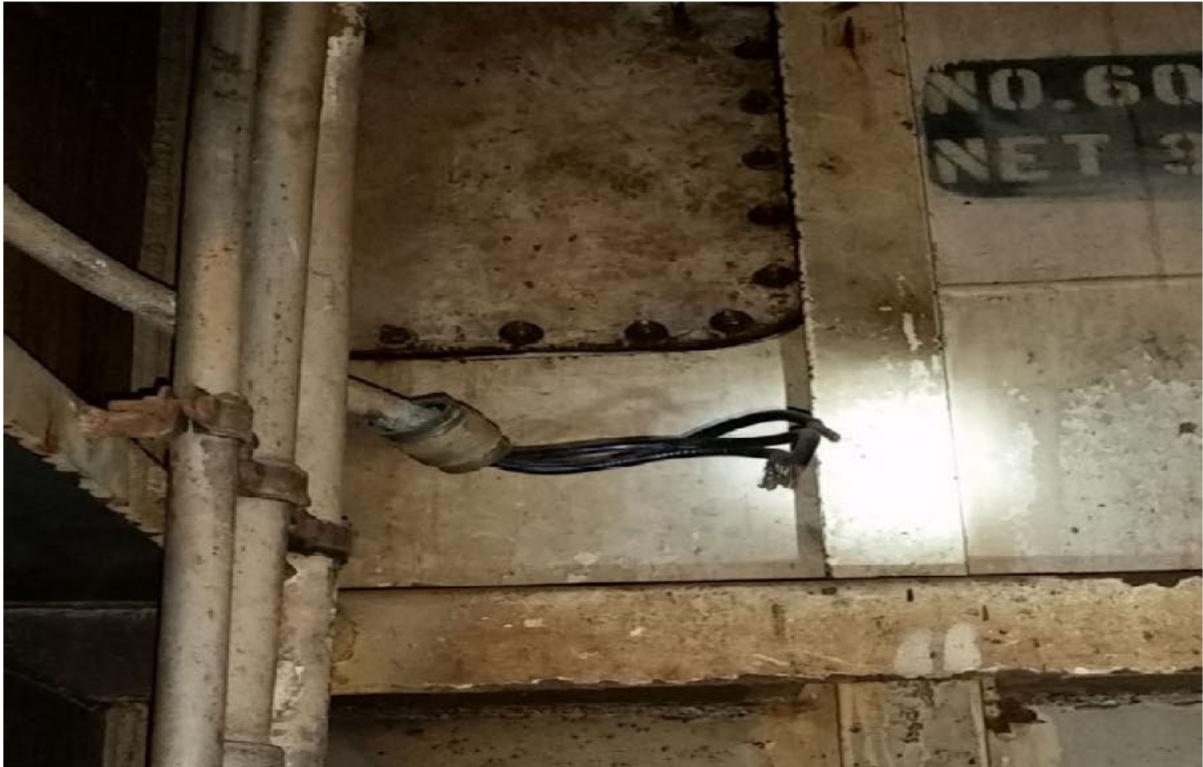
Figure 17: Dead-end wires in forward rake. Picture provided by ABS.

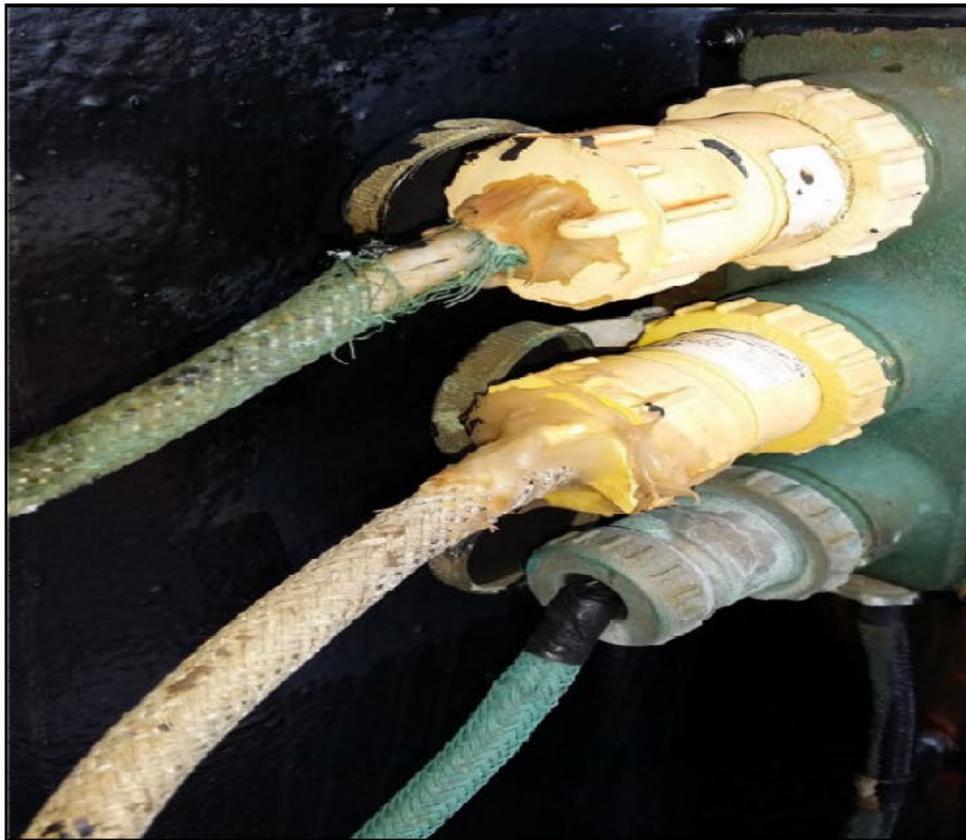
Figure 18: Exposed forward mast plugs located on the forward section of the barge. Picture provided by ABS.
