UNITED STATES COAST GUARD

**REPORT OF THE MARINE BOARD OF INVESTIGATION
INTO THE
STEAM SHIP EL FARO (O.N. 561732)
SINKING AND LOSS OF THE VESSEL
WITH 33 PERSONS MISSING AND PRESUMED DECEASED
NORTHEAST OF ACKLINS AND CROOKED ISLAND,
BAHAMAS
ON OCTOBER 1, 2015**

MISLE ACTIVITY NUMBER: 5735749

September 24, 2017

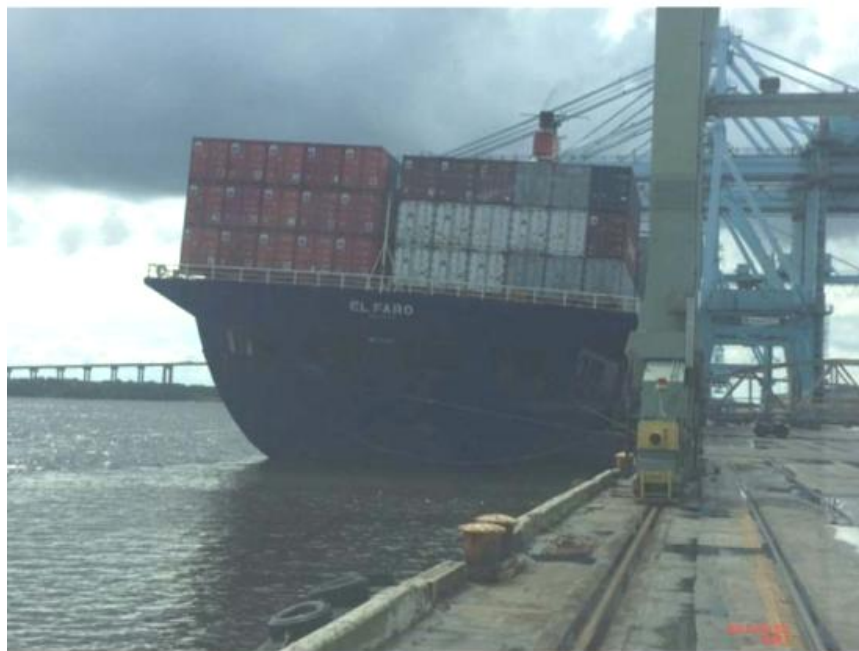
The C/M’s standing orders for loading and unloading operations required that the mates pay attention to any developing list during cargo loading, and to contact the C/M if the list exceeded 2.5 degrees. On the afternoon of September 29, the TMPR Terminal Manager noted a starboard list greater than he had ever observed during loading. As a result, the TMPR Terminal Manager took a photograph of the list and alerted the stevedores to immediately load containers onto the ship’s port side to correct the list. Later analysis of the photograph by a Coast Guard engineer determined the list was approximately four degrees. Based on the Terminal Manager’s alert, the stevedores loaded cargo on the port side and corrected the list before EL FARO sailed.

Figure 3. Photograph taken by TMPR Terminal Manager on September 29, 2015, showing starboard list of approximately 4 degrees during loading operations prior to the final voyage.

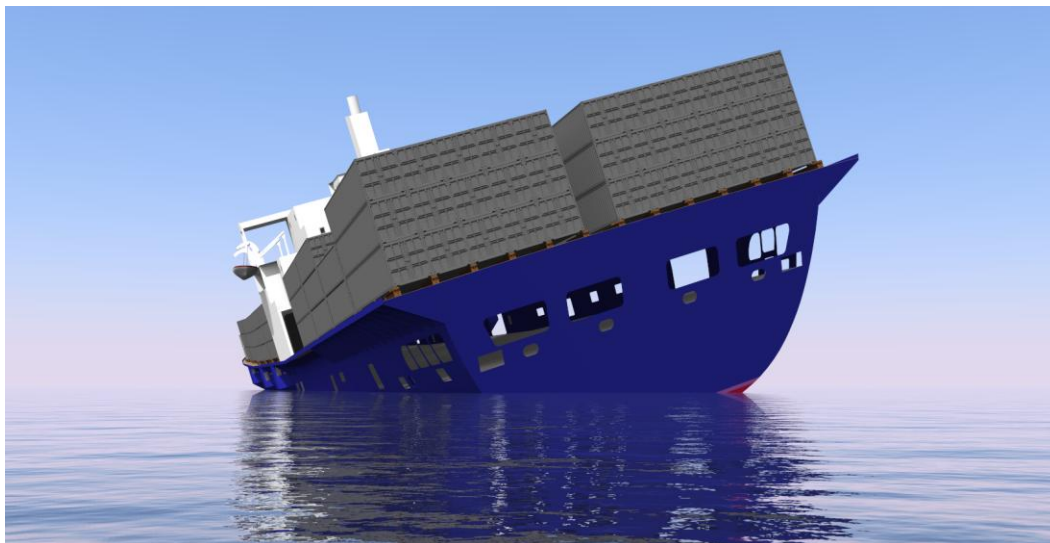
Figure 13. EL FARO computer rendering showing list to port of 18 degrees with departure trim 5.8 feet by the stern due to flooding of Hold 3 estimated at 20% and wind heel. Illustration produced by the USCG Marine Safety Center.

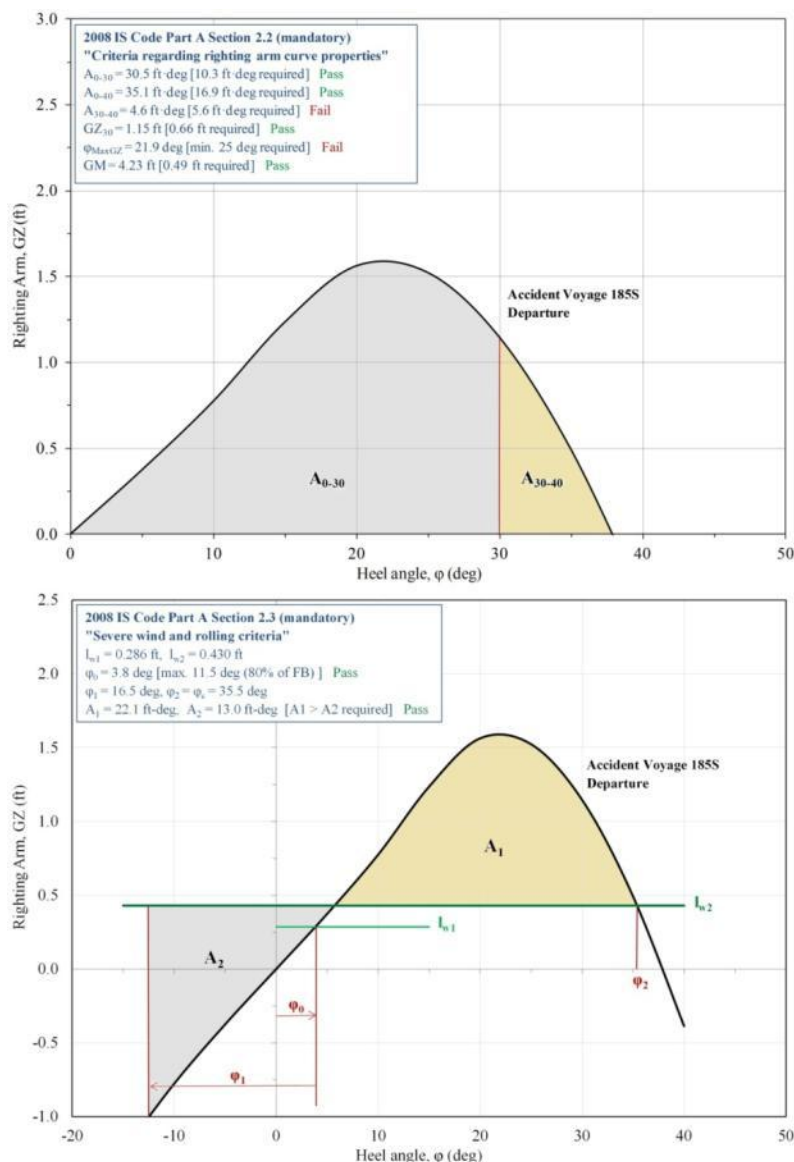
Figure 22. Application of 2008 IS Code righting arm criteria to the accident voyage departure loading condition. (Source: Figure 5-8 of the MSC report)

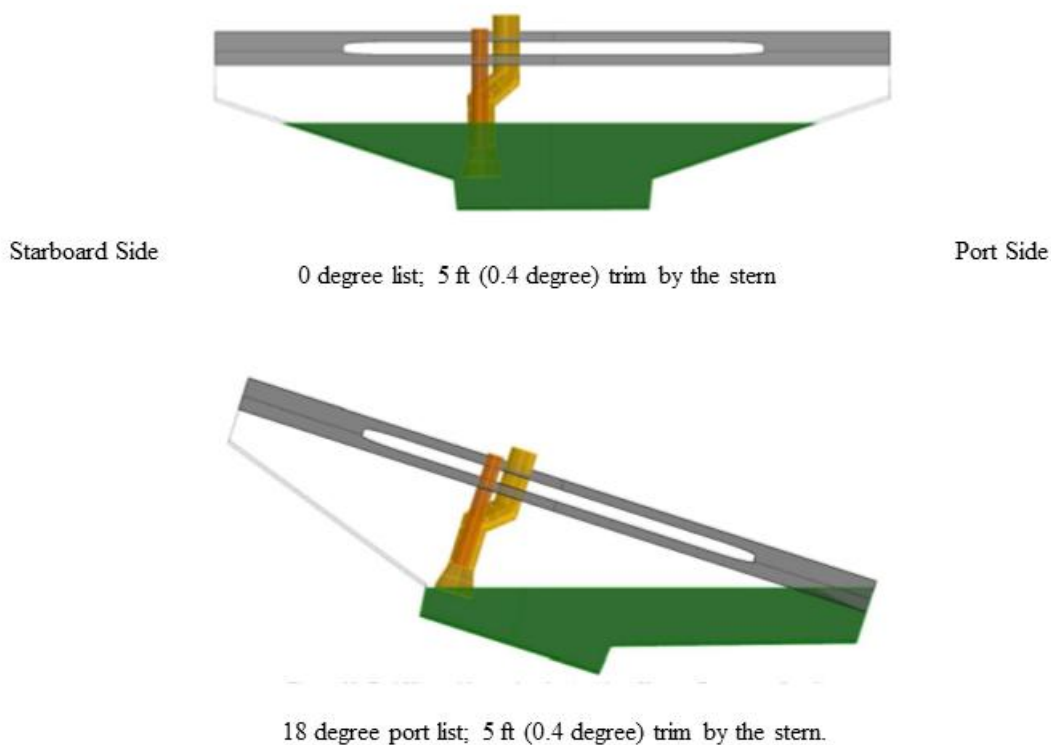
When EL FARO departed Jacksonville, the lube oil level in the sump that served the steam turbines and the main reduction gear was 24.6”. The recommended operating level in the Machinery Operating Manual was 27”, and the approved lube oil sump plan indicated that the operating range was 18”-33”. TOTE had no guidance or policy that required maintaining the recommended 27” operating level.

Figure 26. End views of sump for the accident voyage departure loading condition at 0 degree and 18 degree port list.

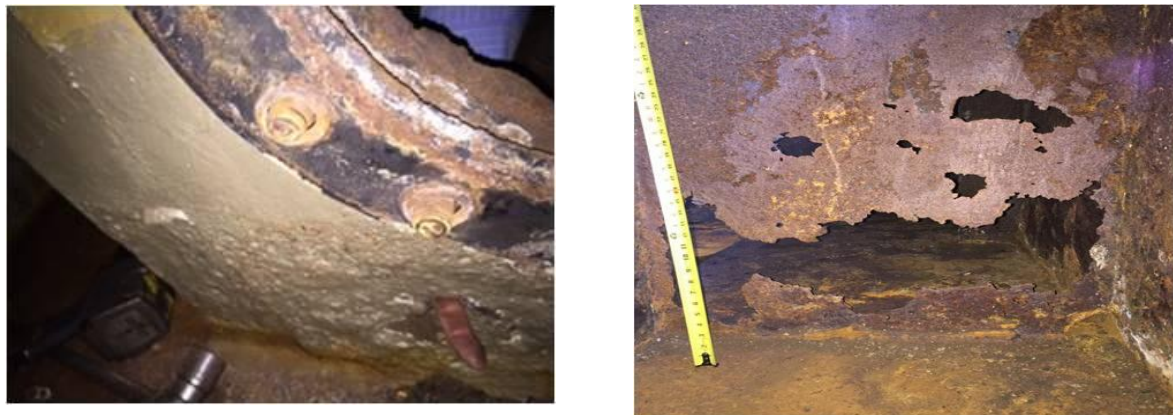
Figure 27. Examples of wastage found within an EL YUNQUE ventilation trunk that were found by Coast Guard Traveling Marine Inspectors during a February 1, 2016, DOC audit of TOTE.

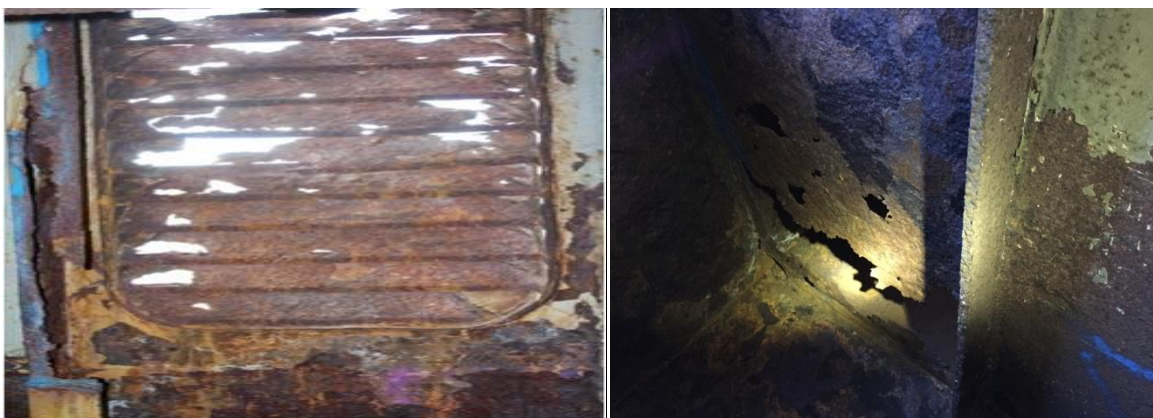
Figure 28. Photographs taken by Coast Guard Traveling Inspectors during an October 2016 visit to EL YUNQUE in Tacoma, WA showing examples of corrosion within the vessel’s exhaust ventilation trunks. (U.S. Coast Guard photographs)

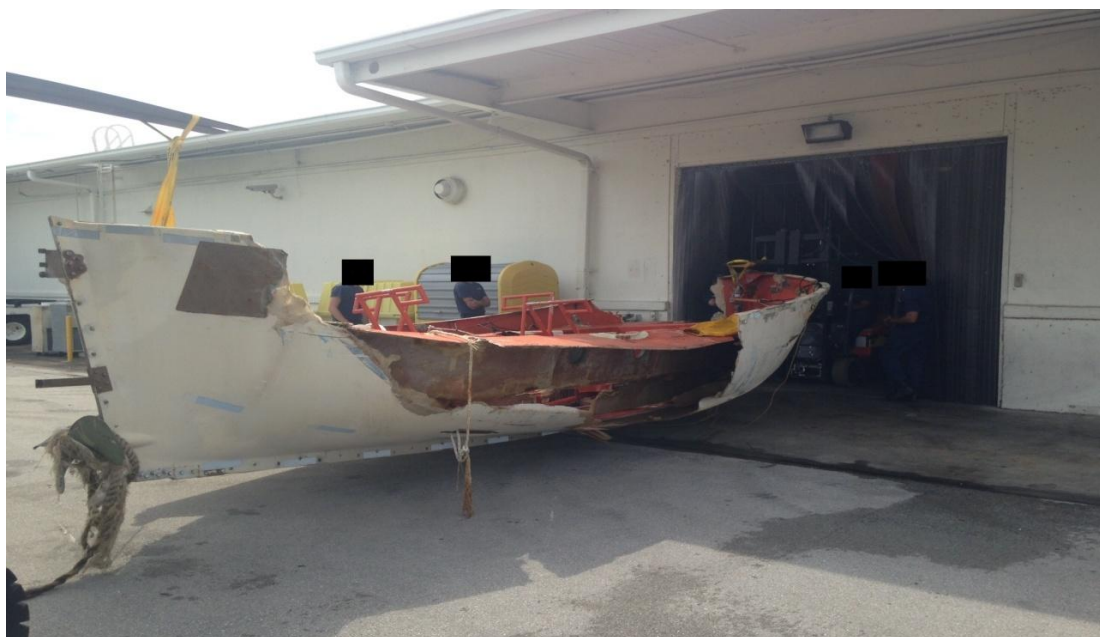
Figure 65. EL FARO Starboard Lifeboat. Heavy damage to the starboard side of the lifeboat is visible. Photo taken at Coast Guard Air Station Miami.

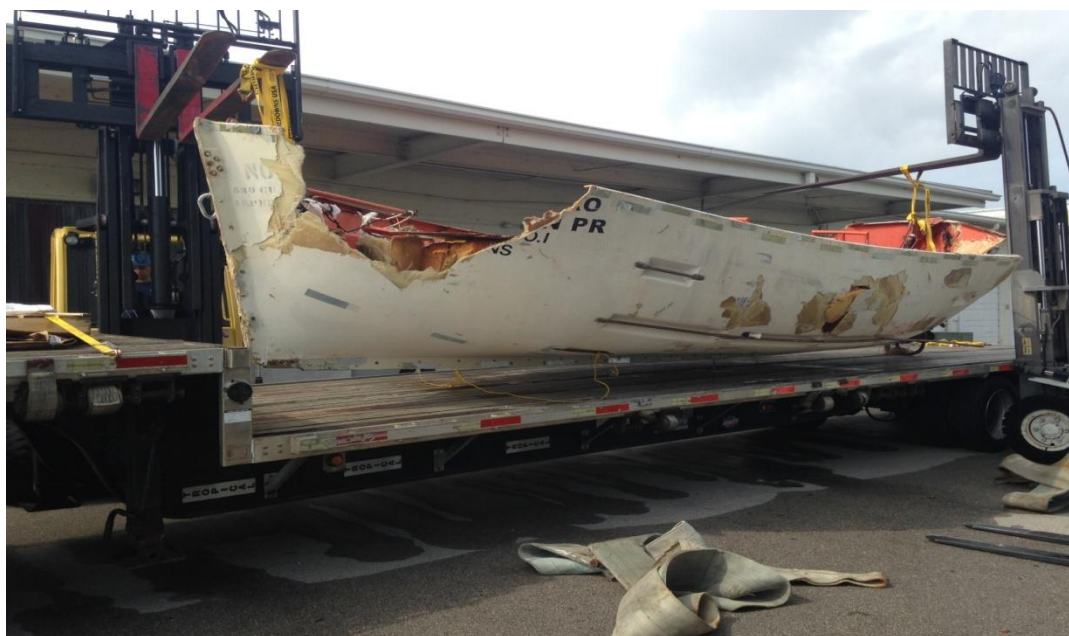
Figure 66. EL FARO Starboard Lifeboat. Damage to the port bow of the lifeboat is visible. Photo taken at Coast Guard Air Station Miami.

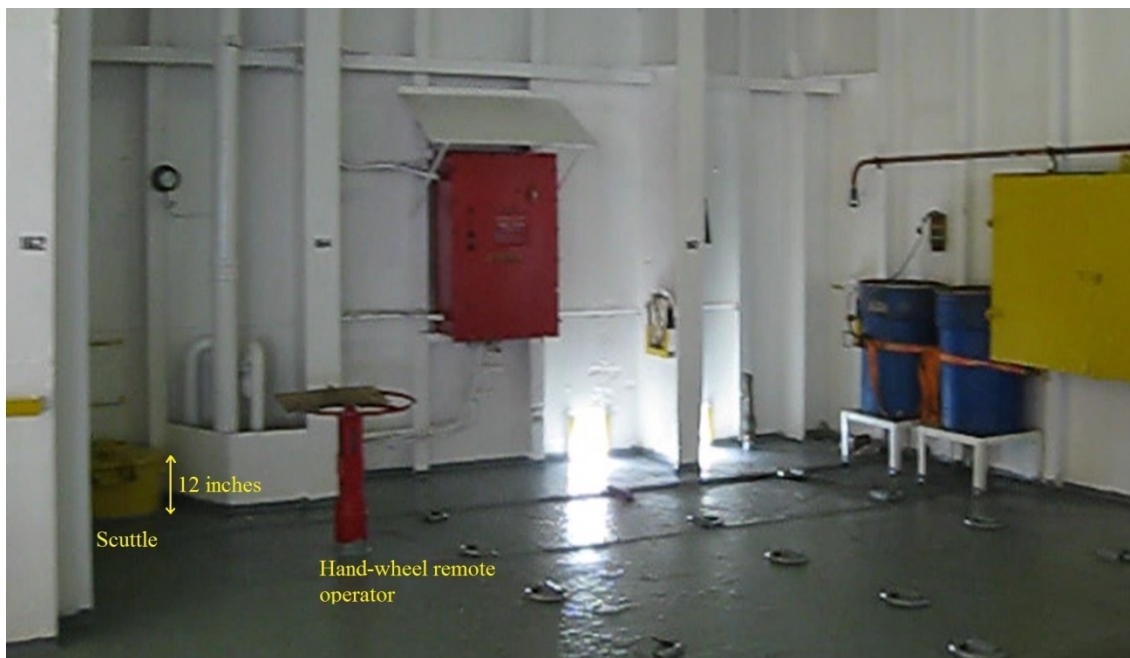
At 5:52 AM, the Master received a call on the house phone informing him that the source of the flooding was an open scuttle. He then turned the ship to port to put the wind on the starboard side and induce a port list. The Master ordered this maneuver to enable the crew to access the partially flooded 2nd deck in order to secure the cargo Hold 3 scuttle on the starboard side. A post-casualty analysis noted that the configuration of the lube oil sump suction valve, which was offset 22” to starboard of centerline, was susceptible to losing suction during a port list.

Figure 6-6: Hold 3 (also called Hold D) starboard personnel access scuttle on the 2nd deck at frame 163. Note that the scuttle opening is 12 inches above the deck. The hand-wheel remote operator for the emergency fire pump sea-chest isolation valve is also shown. Screen capture from video taken aboard EL FARO September 2008 provided by Tote Inc.

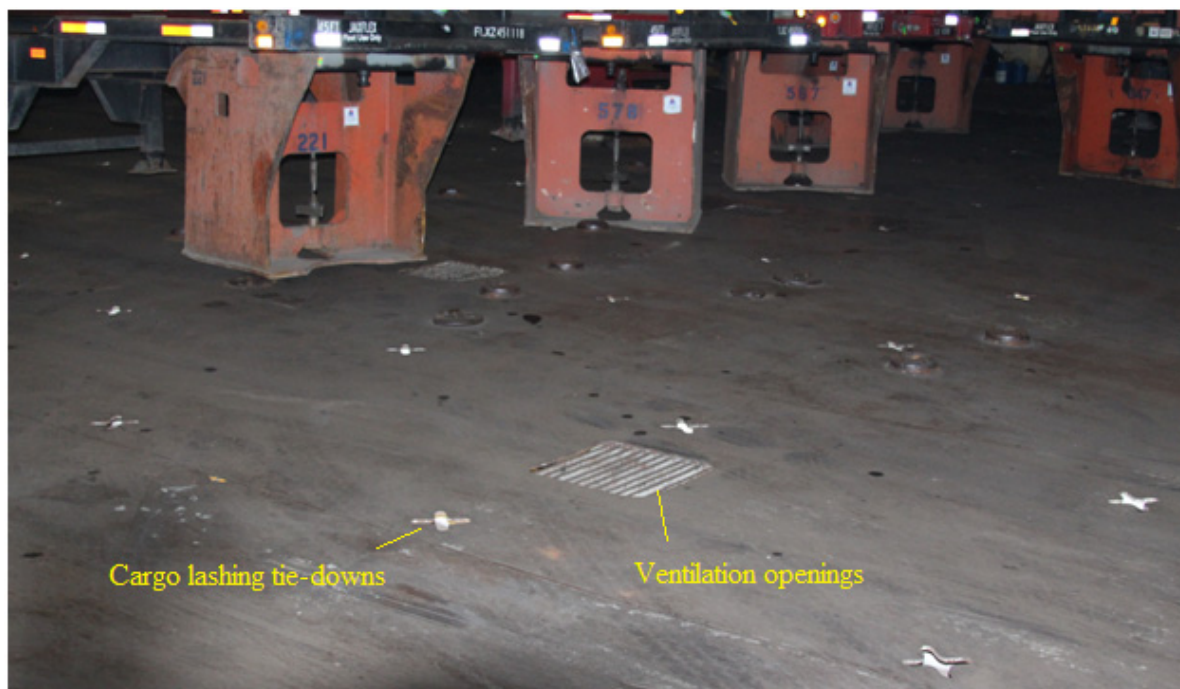
Figure 6-15: Hold 3, 3rd deck, showing non-watertight openings. Photo of sister vessel EL YUNQUE. USCG photo.
