UNITED STATES COAST GUARD

**REPORT OF THE MARINE BOARD OF INVESTIGATION
INTO THE
STEAM SHIP EL FARO (O.N. 561732)
SINKING AND LOSS OF THE VESSEL
WITH 33 PERSONS MISSING AND PRESUMED DECEASED
NORTHEAST OF ACKLINS AND CROOKED ISLAND,
BAHAMAS
ON OCTOBER 1, 2015**

**STEAM SHIP EL FARO (O.N. 561732) SINKING AND LOSS OF THE VESSEL WITH
33 PERSONS MISSING AND PRESUMED DECEASED NORTHEAST OF ACKLINS
AND CROOKED ISLAND, BAHAMAS ON OCTOBER 1, 2015**

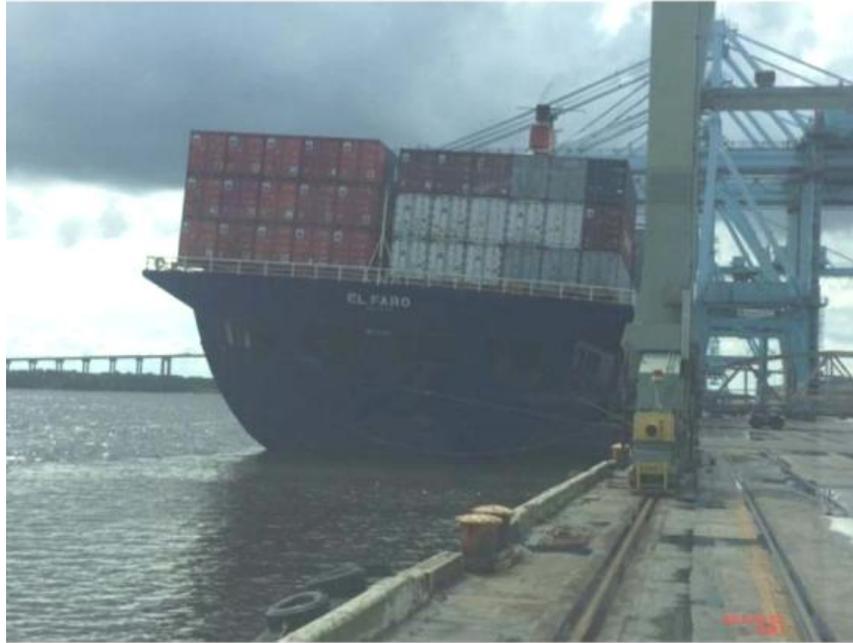
Figure 3. Photograph taken by TMPR Terminal Manager on September 29, 2015, showing starboard list of approximately 4 degrees during loading operations prior to the final voyage.

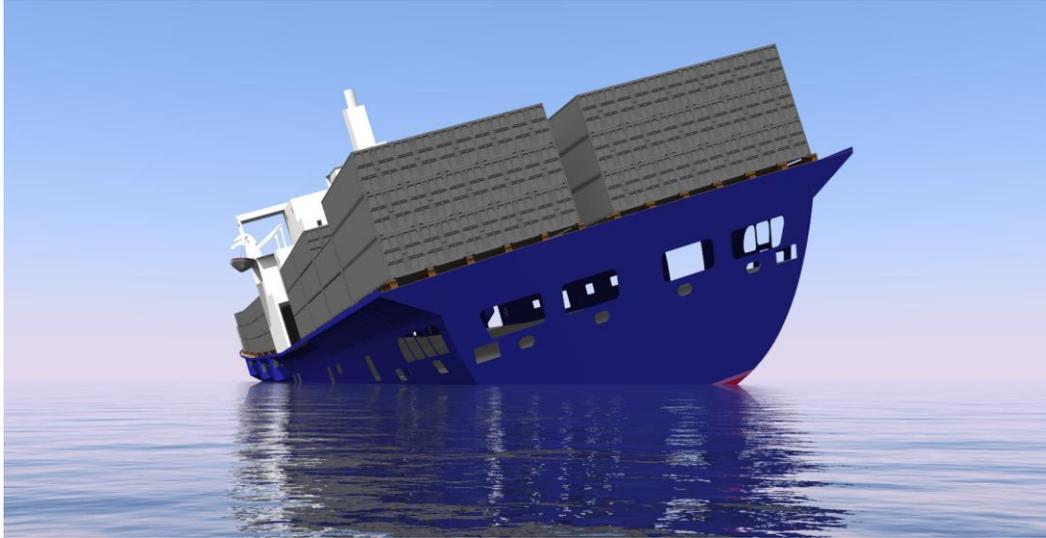
Figure 13. EL FARO computer rendering showing list to port of 18 degrees with departure trim 5.8 feet by the stern due to flooding of Hold 3 estimated at 20% and wind heel. Illustration produced by the USCG Marine Safety Center.

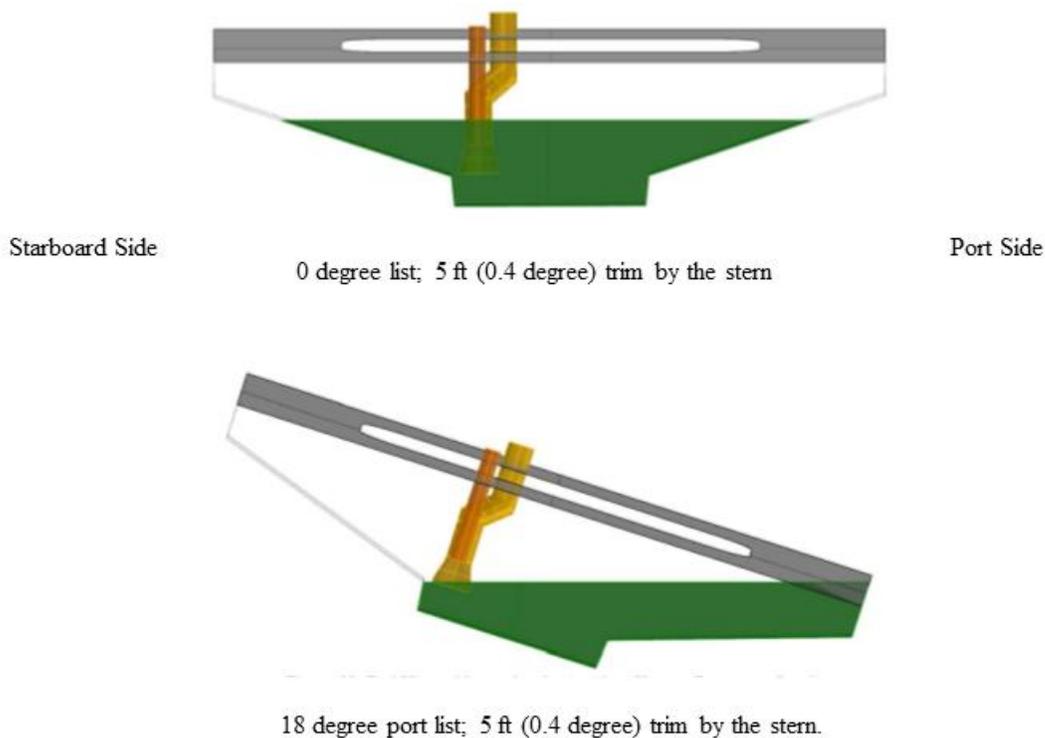
Figure 26. End views of sump for the accident voyage departure loading condition at 0 degree and 18 degree port list.

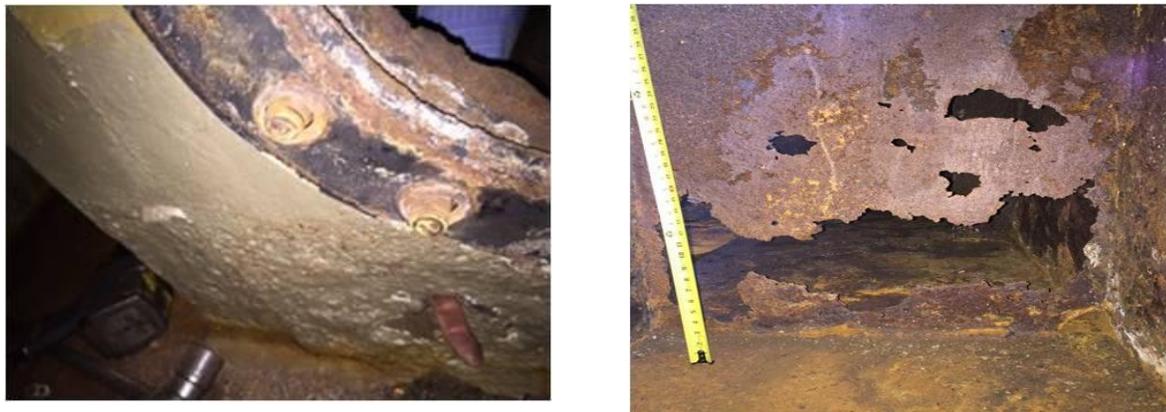
Figure 27. Examples of wastage found within an EL YUNQUE ventilation trunk that were found by Coast Guard Traveling Marine Inspectors during a February 1, 2016, DOC audit of TOTE.

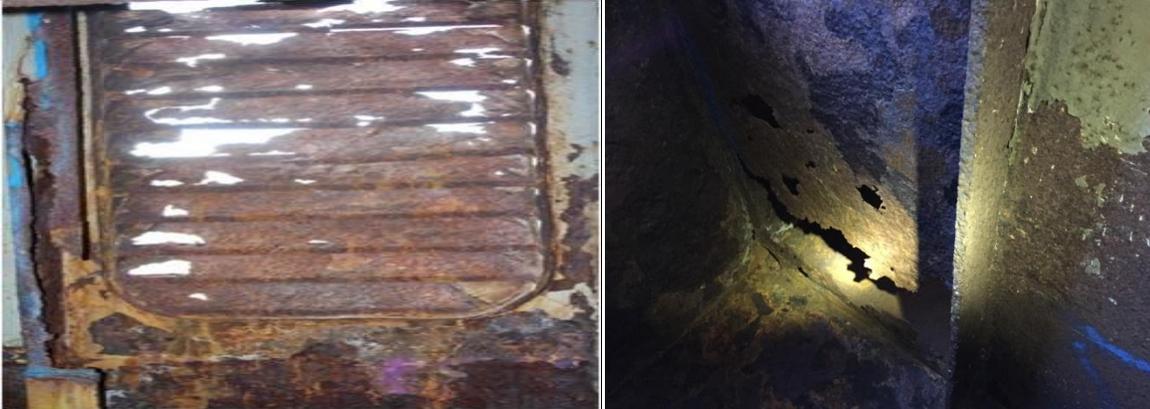
Figure 28. Photographs taken by Coast Guard Traveling Inspectors during an October 2016 visit to EL YUNQUE in Tacoma, WA showing examples of corrosion within the vessel’s exhaust ventilation trunks. (U.S. Coast Guard photographs)

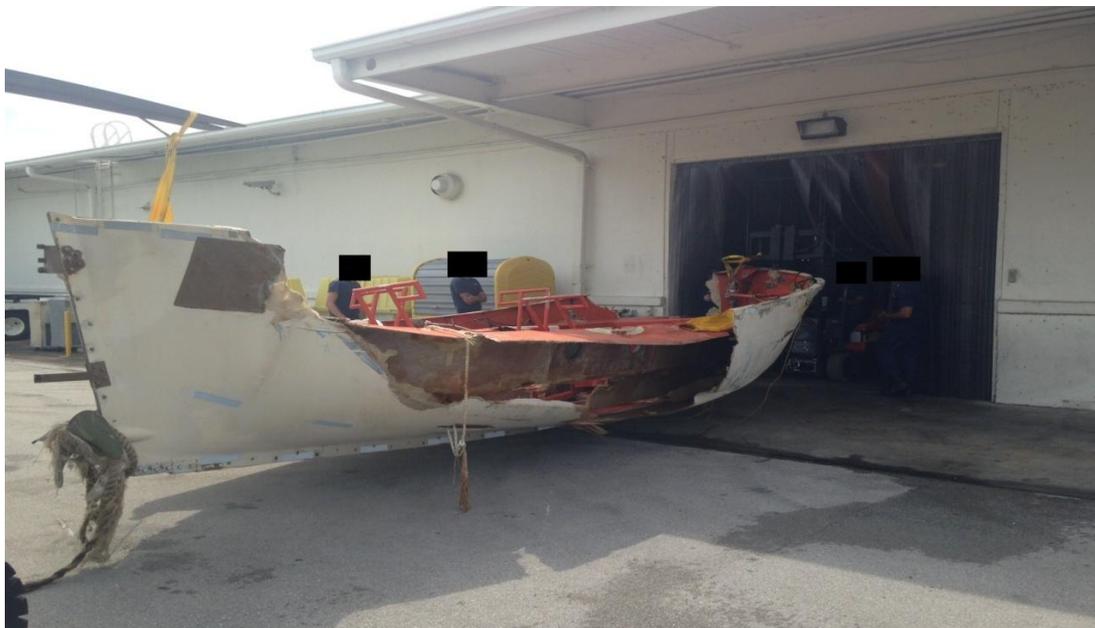
Figure 65. EL FARO Starboard Lifeboat. Heavy damage to the starboard side of the lifeboat is visible. Photo taken at Coast Guard Air Station Miami.

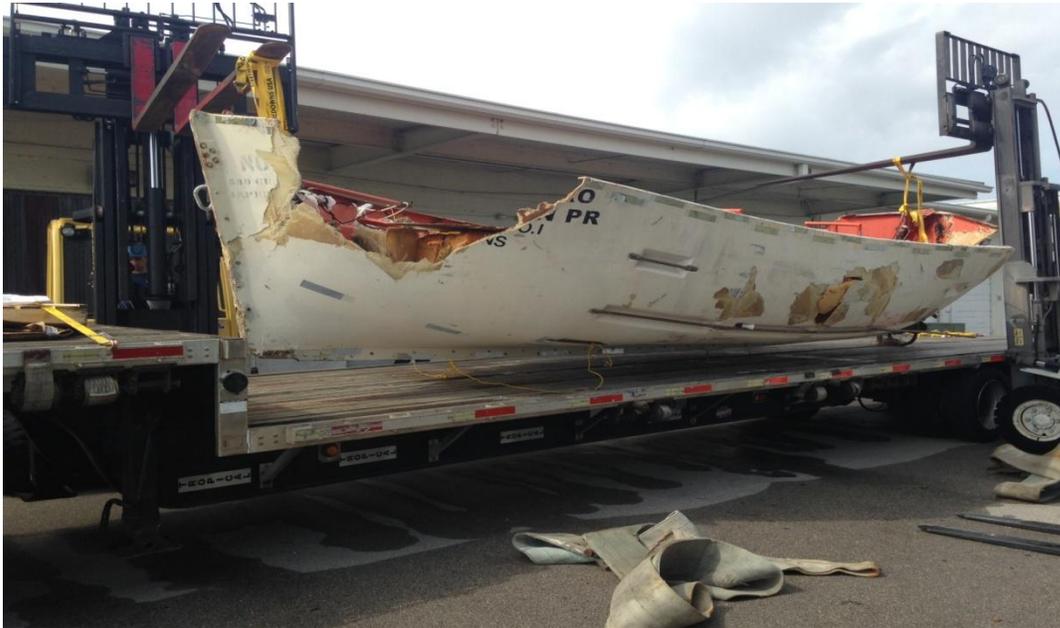
Figure 66. EL FARO Starboard Lifeboat. Damage to the port bow of the lifeboat is visible. Photo taken at Coast Guard Air Station Miami.

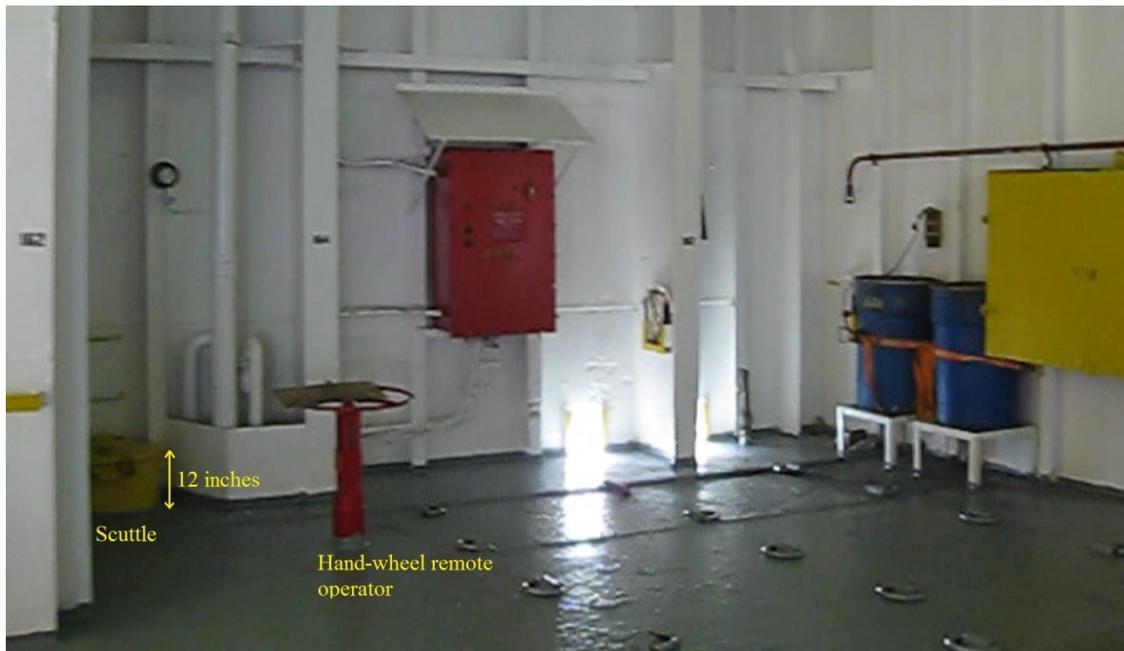
Figure 6-6: Hold 3 (also called Hold D) starboard personnel access scuttle on the 2nd deck at frame 163. Note that the scuttle opening is 12 inches above the deck. The hand-wheel remote operator for the emergency fire pump sea-chest isolation valve is also shown. Screen capture from video taken aboard EL FARO September 2008 provided by Tote Inc.

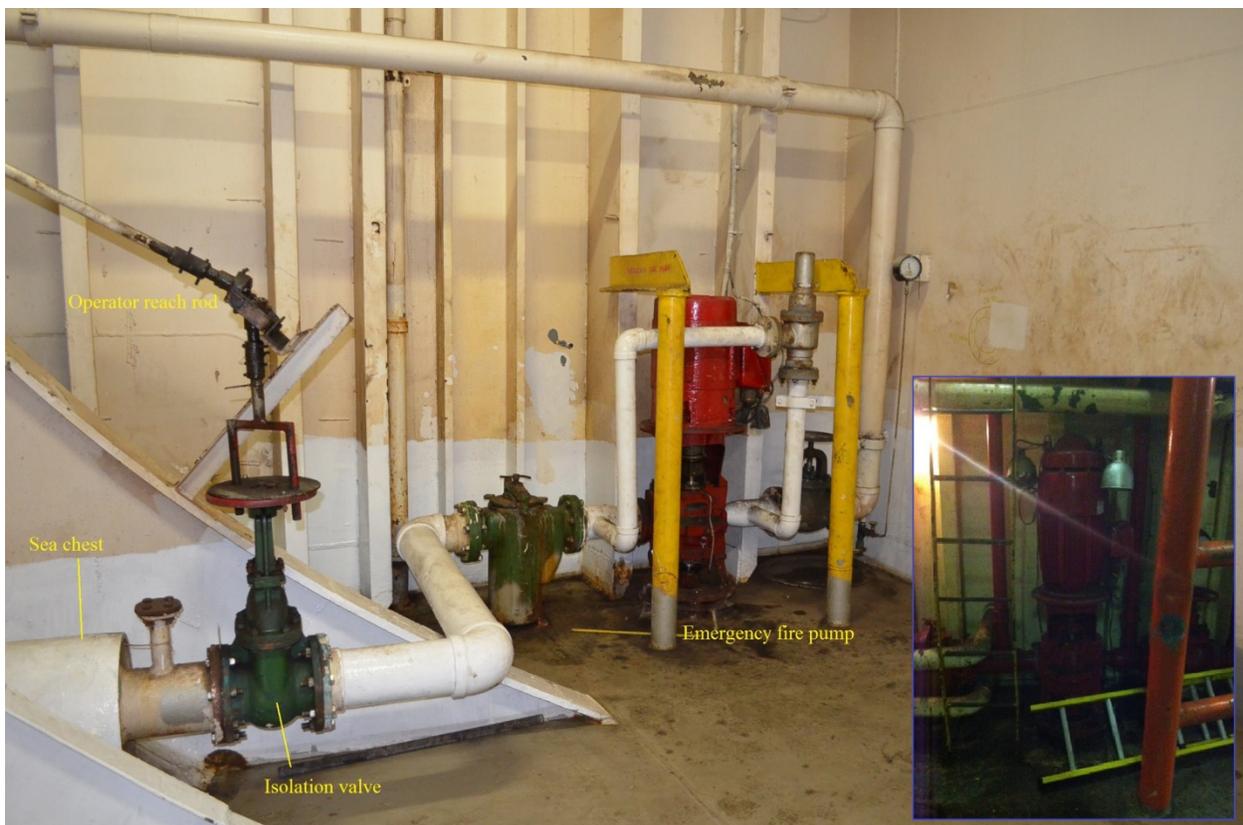
Figure 6-7: Emergency fire pump station in Hold 3, aft starboard 4th deck (tanktop, innerbottom), showing the sea chest, isolation valve, and manual remote operator on sister vessel EL YUNQUE (EL FARO similar but not identical). Inset photo shows part of the arrangement onboard EL FARO. USCG photo with Tote, Inc. photo inset.

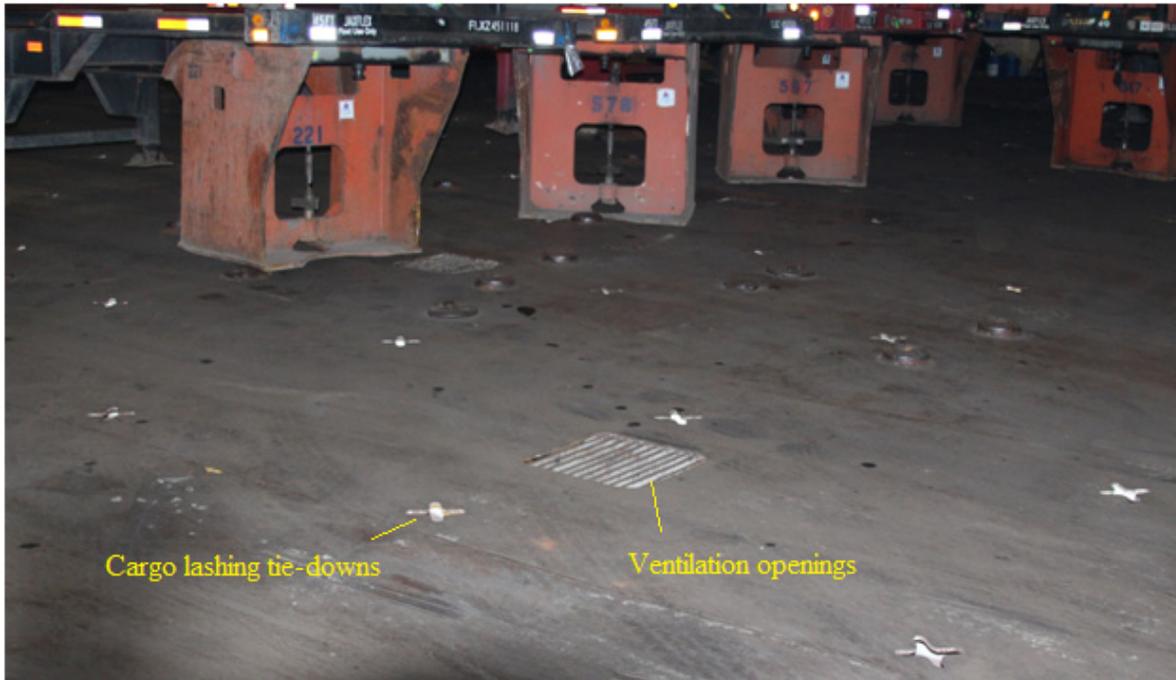
Figure 6-15: Hold 3, 3rd deck, showing non-watertight openings. Photo of sister vessel EL YUNQUE. USCG photo.
