UNITED STATES COAST GUARD

**REPORT OF THE MARINE BOARD OF INVESTIGATION
INTO THE
COMMERCIAL FISHING VESSEL DESTINATION
SINKING AND LOSS OF THE VESSEL
WITH ALL SIX CREWMEMBERS
MISSING AND PRESUMED DECEASED
APPROXIMATELY 4.4 NM NORTHWEST OF
ST. GEORGE ISLAND, ALASKA
ON FEBRUARY 11, 2017**

16732
27 February 2019

**COMMERCIAL FISHING VESSEL DESTINATION (O.N. 632374)
SINKING AND LOSS OF VESSEL
WITH ALL SIX CREWMEMBERS MISSING AND PRESUMED DECEASED
APPROXIMATELY 4.4 NM NORTHWEST OF ST. GEORGE ISLAND, ALASKA ON
FEBRUARY 11, 2017**

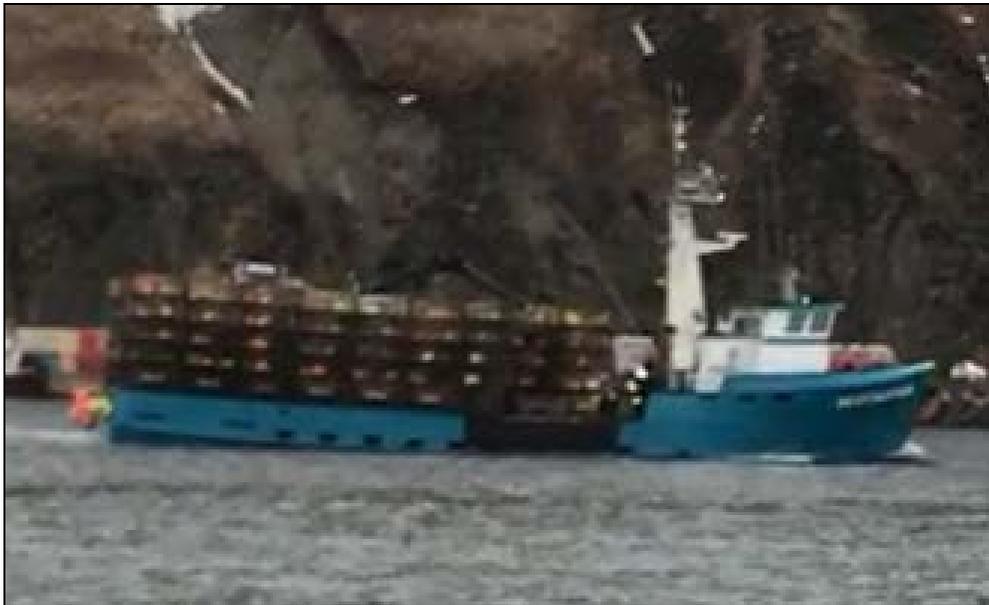
4.1.14. During the DESTINATION’s transit into Dutch Harbor, the crew of the nearby CFV APRIL LANE noticed the vessel’s arrival and proceeded to take a video using a crewmember’s cell phone (see Figure 3). The captain of the APRIL LANE asked his deckhand to take the video because he was “alarmed” about the DESTINATION’s loaded condition given the National Weather Service (NWS) forecasted freezing spray warnings. The captain of the APRIL LANE did not relay or communicate his observation and concerns to the captain of the DESTINATION.

Figure 3. Still image from video taken by a crewmember onboard the APRIL LANE of the DESTINATION’s transit into Dutch Harbor on February 9, 2017, at approximately 1830.

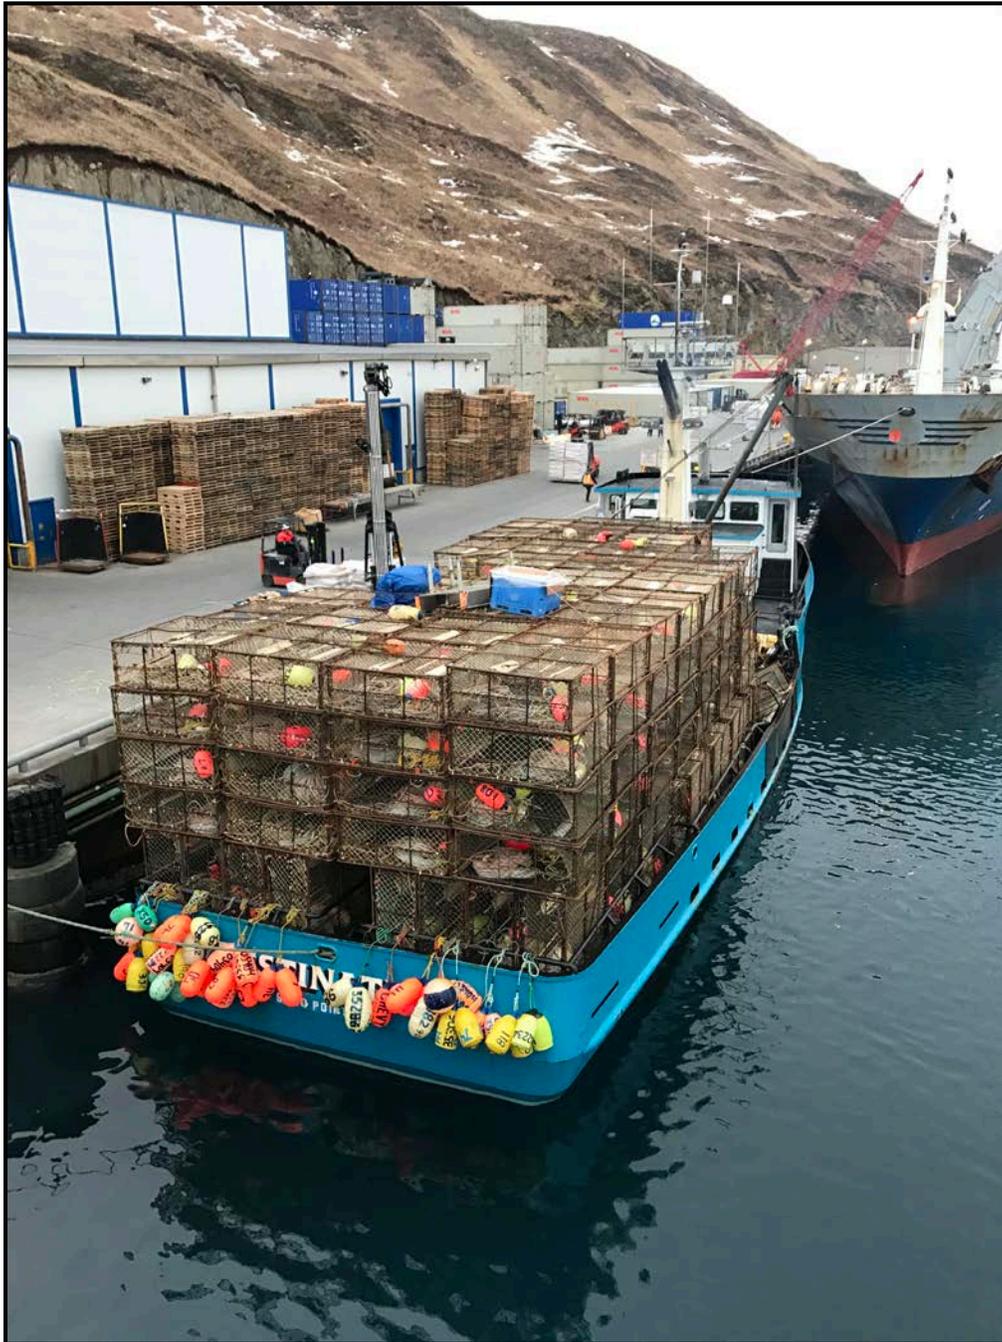
4.1.15. Just prior to the DESTINATION loading the squid bait, a crewmember from the motor vessel OCEAN ROVER, also moored at the Kloosterboer Facility, took two photos of the DESTINATION (see Figures 4 and 5). The crewmember indicated that he took the pictures after he noticed the “enormous” amount of crab pots loaded onboard the DESTINATION.

Figures 4. Photo of the DESTINATION moored at Kloosterboer on February 9, 2017, at approximately 1840.

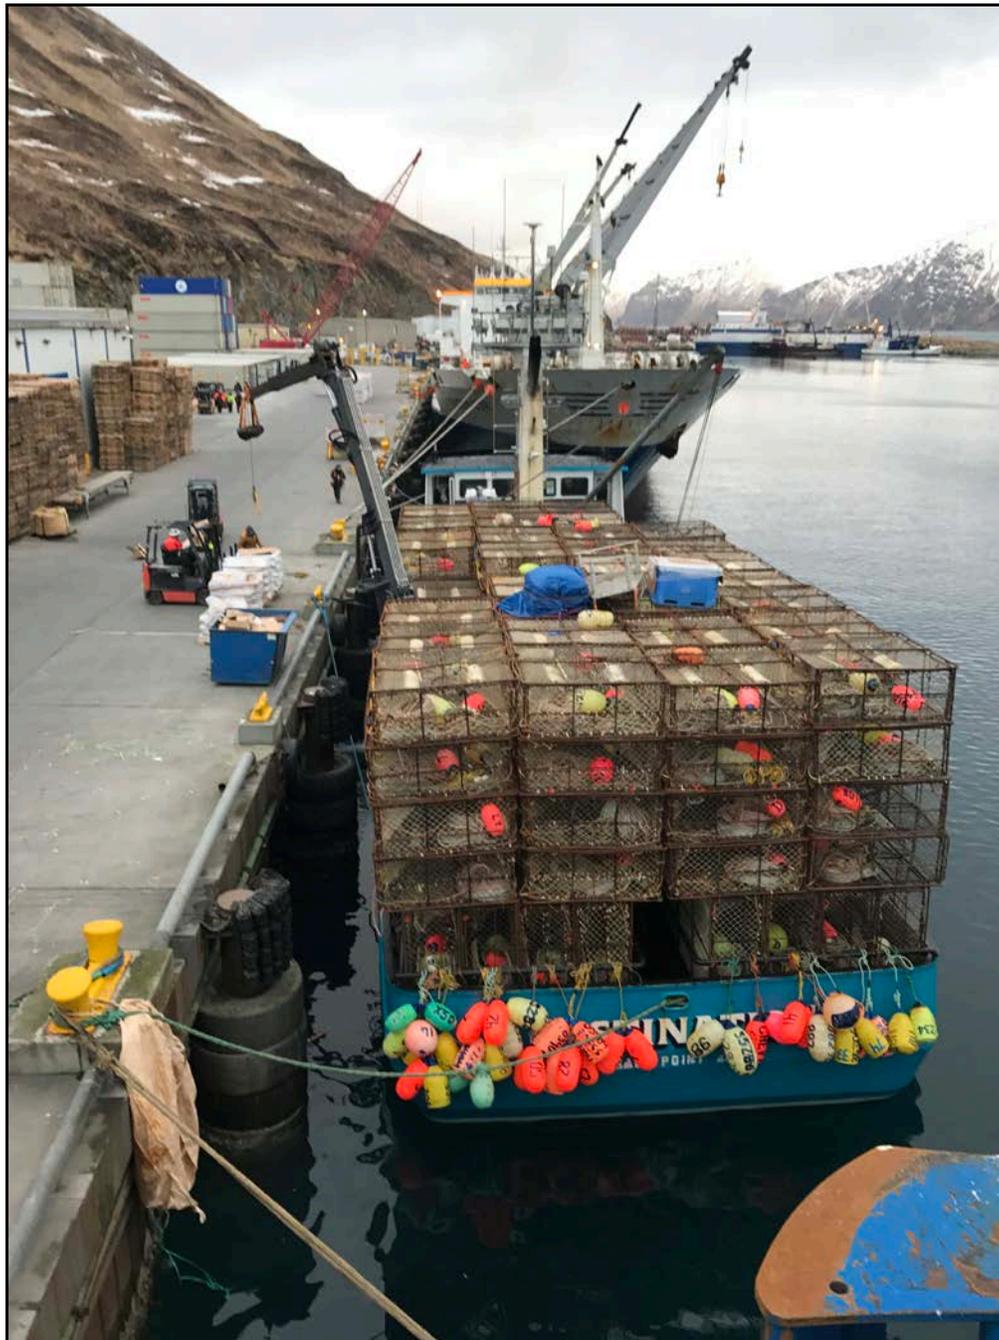
Figures 5. Photo of the DESTINATION moored at Kloosterboer on February 9, 2017, at approximately 1840.

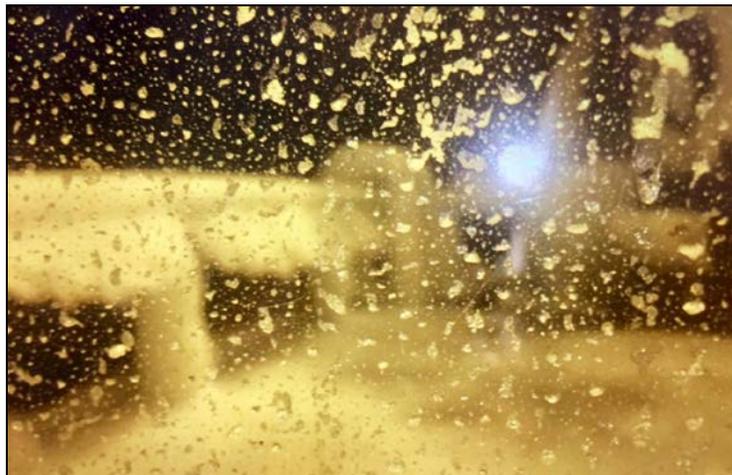
4.3.12. The captain of the BERING ROSE stated when his vessel was operating around St. George Island, it experienced weather “out of the northeast, 35, 40, heavy freezing spray” and 15-foot seas. The vessel had ice accumulations of “over a quarter of an inch per hour.” Figure 24 is a photo taken by a crewmember onboard the BERING ROSE of the ice accumulation on the deck aft of the wheelhouse during the early morning hours of February 11, 2017.

Figure 24. Photo taken by a crewmember onboard the BERING ROSE on the morning of February 11, 2017.

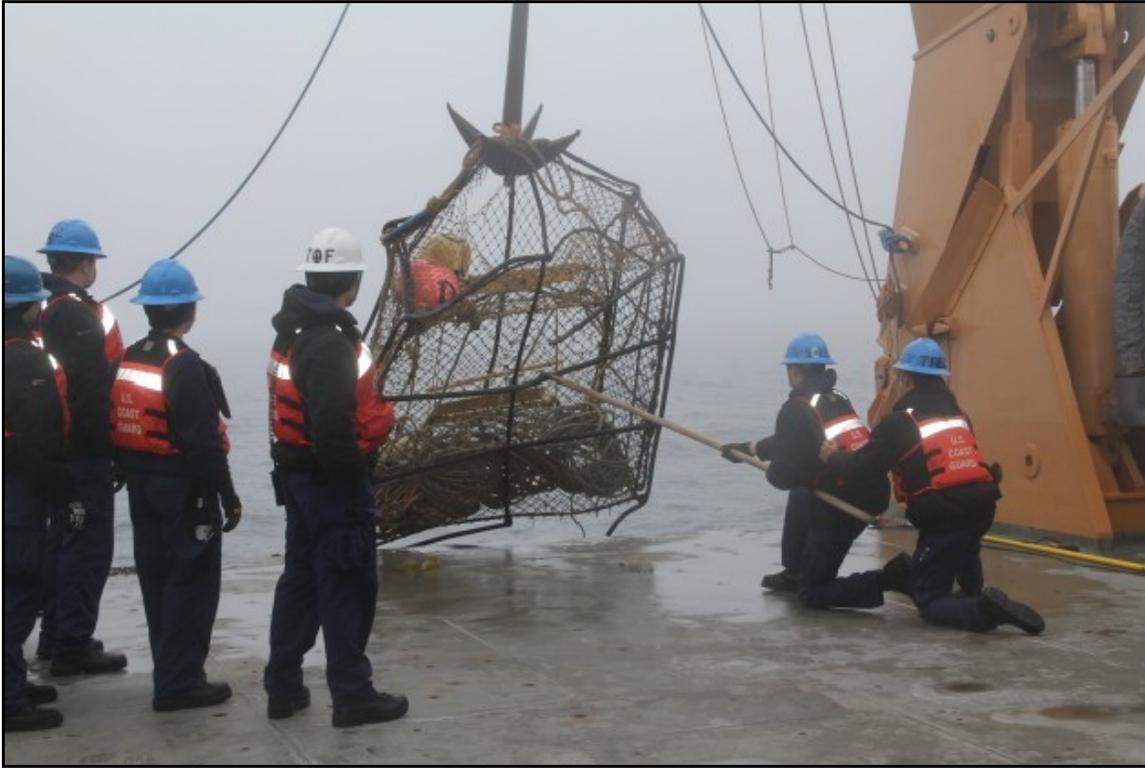
Figure 44. Crewmembers onboard the HEALY recovered a crab pot located near the wreck of the DESTINATION on the sea floor. Photo taken by Coast Guard Public Affairs on July 25, 2017.

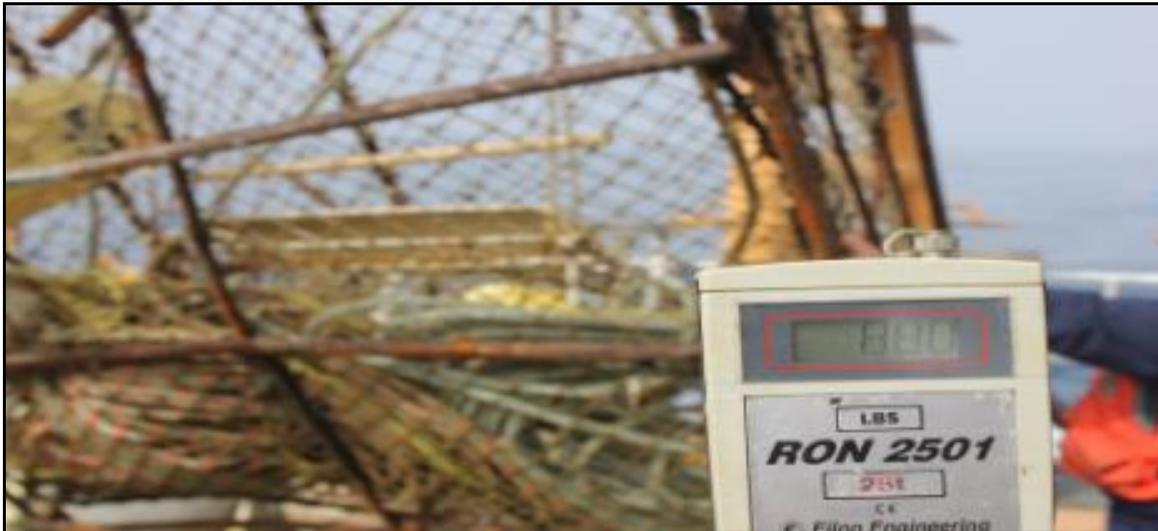
Figure 45. The HEALY weighed the recovered crab pot at 880 pounds with gear. Photo taken by Coast Guard Public Affairs on July 25, 2017.

Recommendation 4: Recommend D13 and D17 CFVEs use direct verification to weigh the vessel's crab pots during dockside safety examinations and SSCs. Examiners should conduct direct verification by actual weight observations of a sample amount of crab pots using a calibrated scale supplied by the Coast Guard. In cases where the weight of the crab pots with its gear is different than the weight used to establish the vessel's stability instructions, the examiner should require the owner to work with a qualified individual to amend the stability instruction's loading tables. This direct verification should help ensure the weight of the crab pots are consistent and in accordance with the weights used to develop the vessel's stability instructions.

Action: I partially concur with this recommendation. While the responsibility for complying with stability requirements lies with vessel operators, spot checks conducted by the Coast Guard may help reduce risks of overloading. Commercial scales that are registered, periodically tested, and decaled through state and industry standards for use in the sale and transport of goods in the aquaculture trades may be used to weigh the crab pots and gear, as well as scales made available by the Coast Guard upon request. I will forward this recommendation to the Commanders of the Thirteenth and Seventeenth Districts for action and direct them to implement a program that spot checks crab pot weights prior to the commencement of crab-fishing seasons.

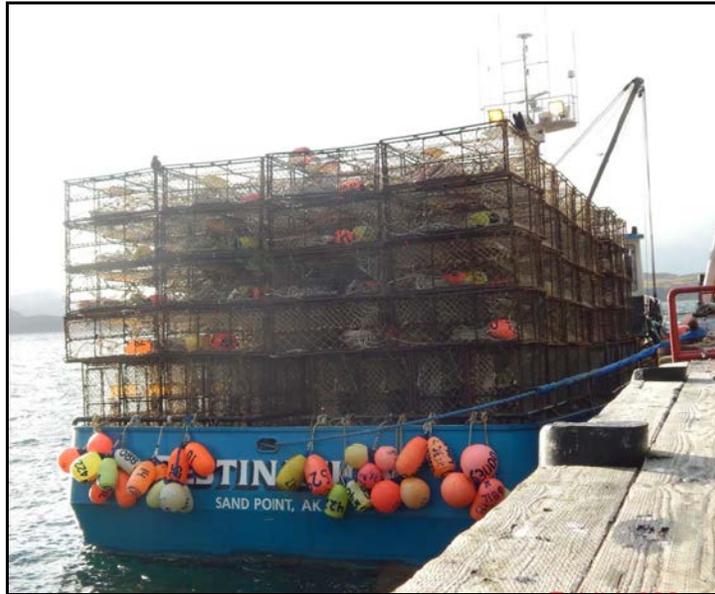
Figure 56. DESTINATION's typical pot loading condition. Undated photo taken and provided by former crewmember.

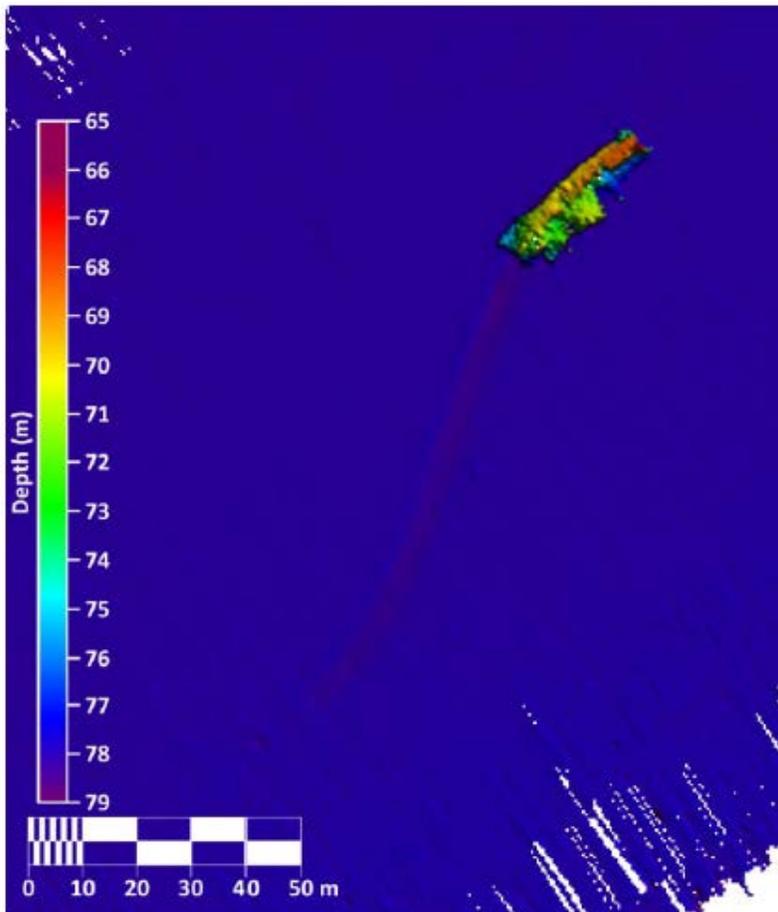
Figure 68. NOAA side-scan sonar imagery of the DESTINATION. Provided by NOAA Ship FAIRWEATHER.

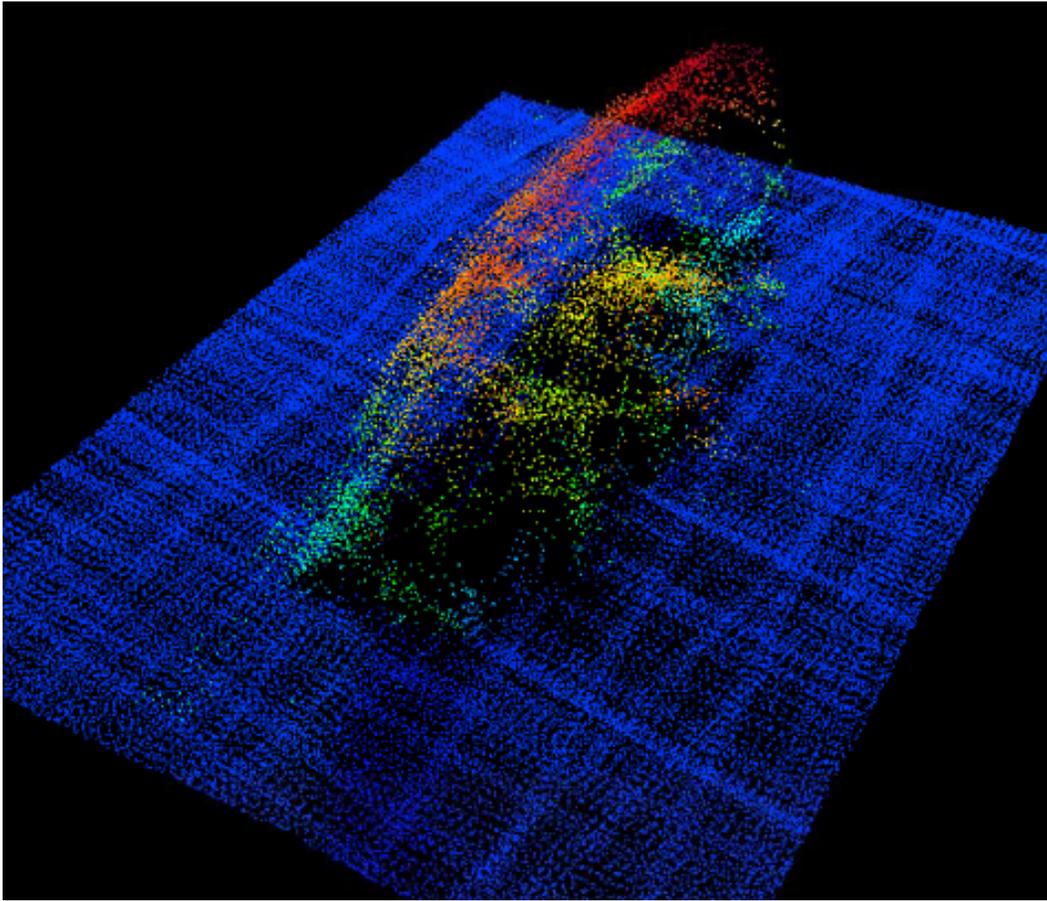
Figure 69. NOAA side-scan sonar imagery of the DESTINATION.
Provided by NOAA Ship FAIRWEATHER.

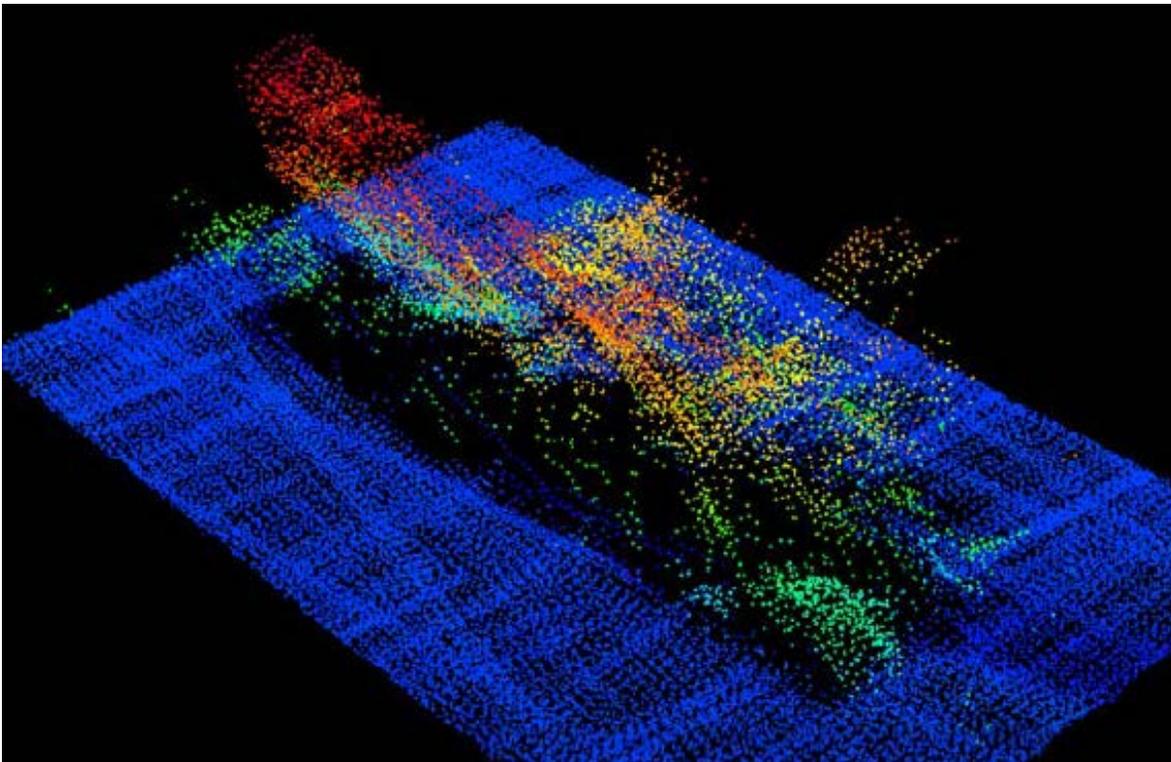
Figure 70. NOAA side-scan sonar imagery of the DESTINATION.
Provided by NOAA Ship FAIRWEATHER.

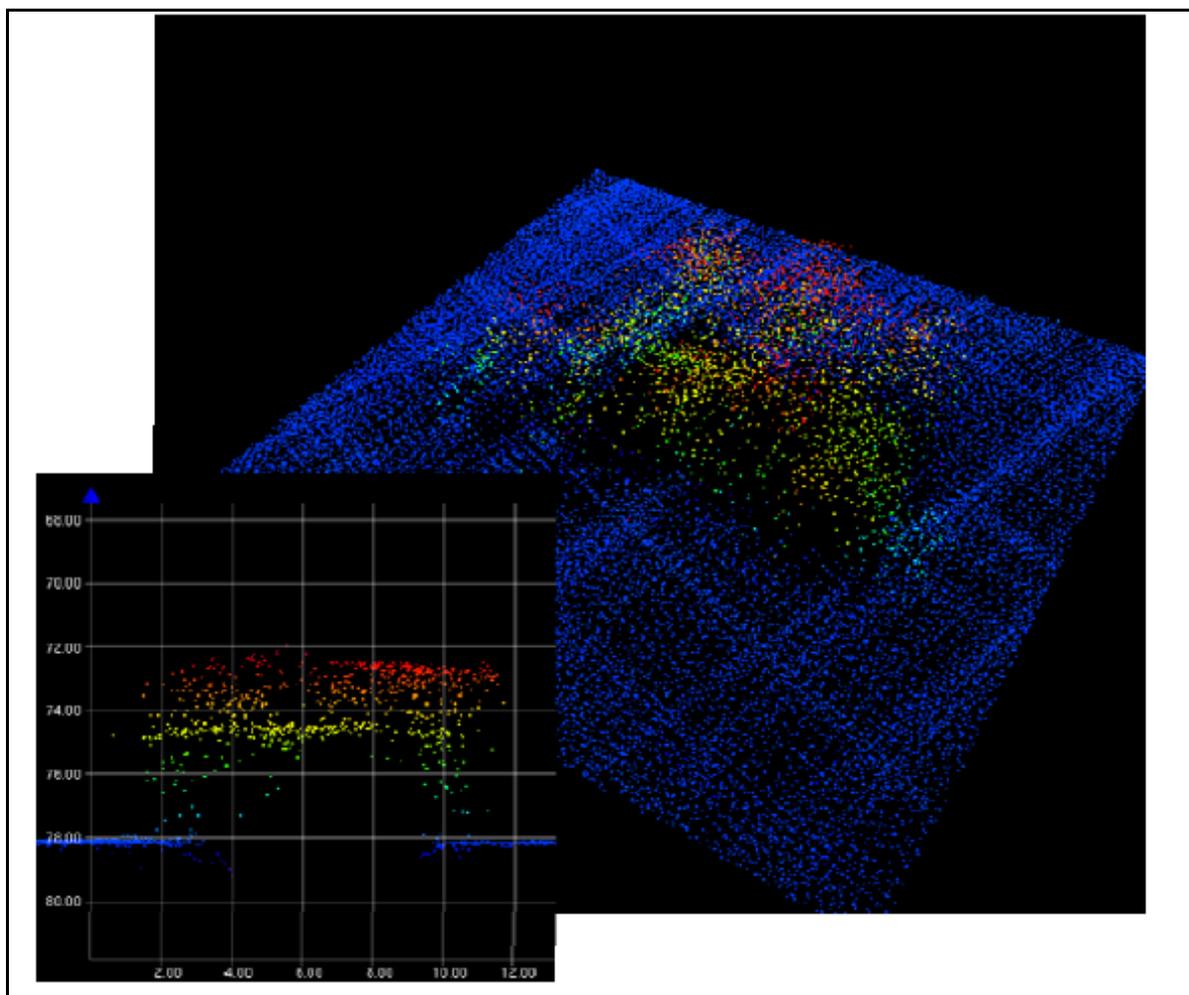
Figure 71. NOAA side-scan sonar imagery of the pots from the deck of the DESTINATION. Provided by NOAA Ship FAIRWEATHER.

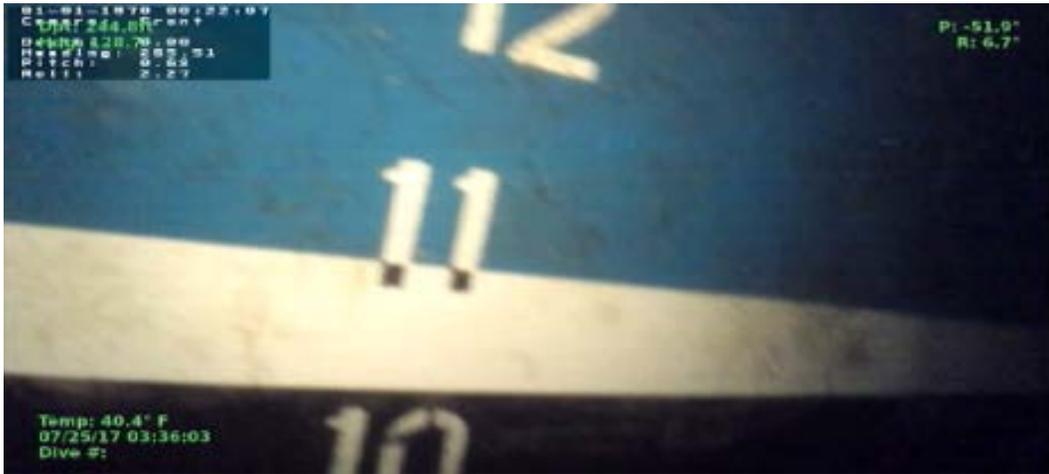
Figure 72. ROV imagery showing the DESTINATION's draft marks.
Photo provided by Coast Guard Dive Locker West.

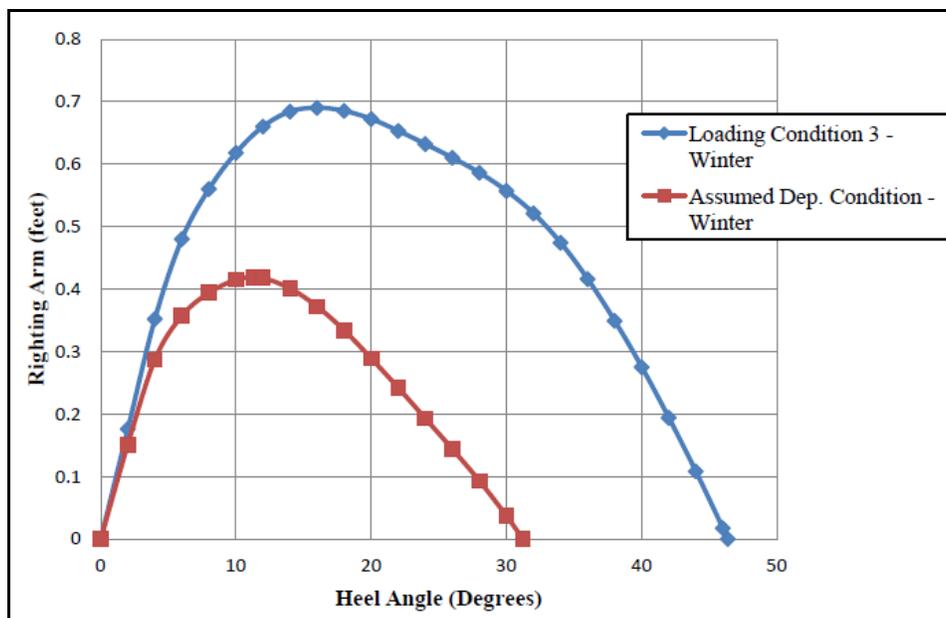
Figure 79. DESTINATION’s righting arm curves - departure condition compared to the stability instructions. Provided by MSC.

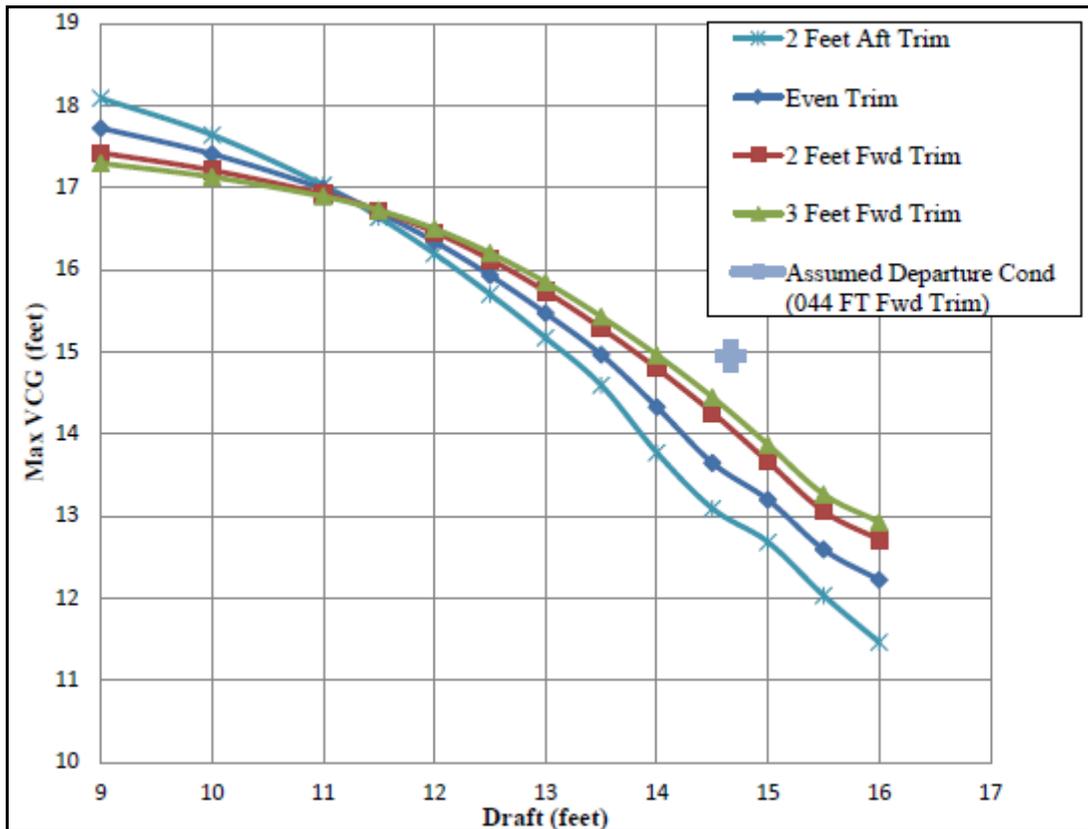
Figure 80. DESTINATION's maximum VCG curves compared to its assumed departure condition. Provided by MSC.

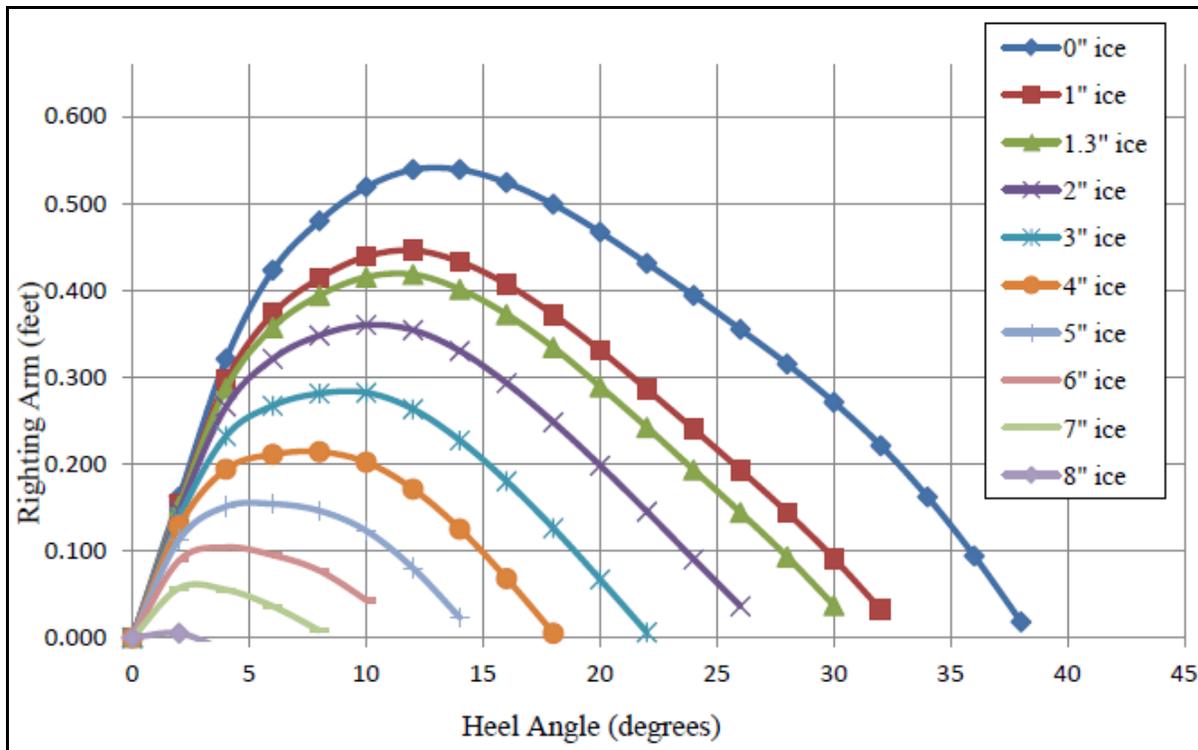
Figure 83. DESTINATION’s righting arm curves for incremental ice loads in departure load conditions from Dutch Harbor. Provided by MSC.

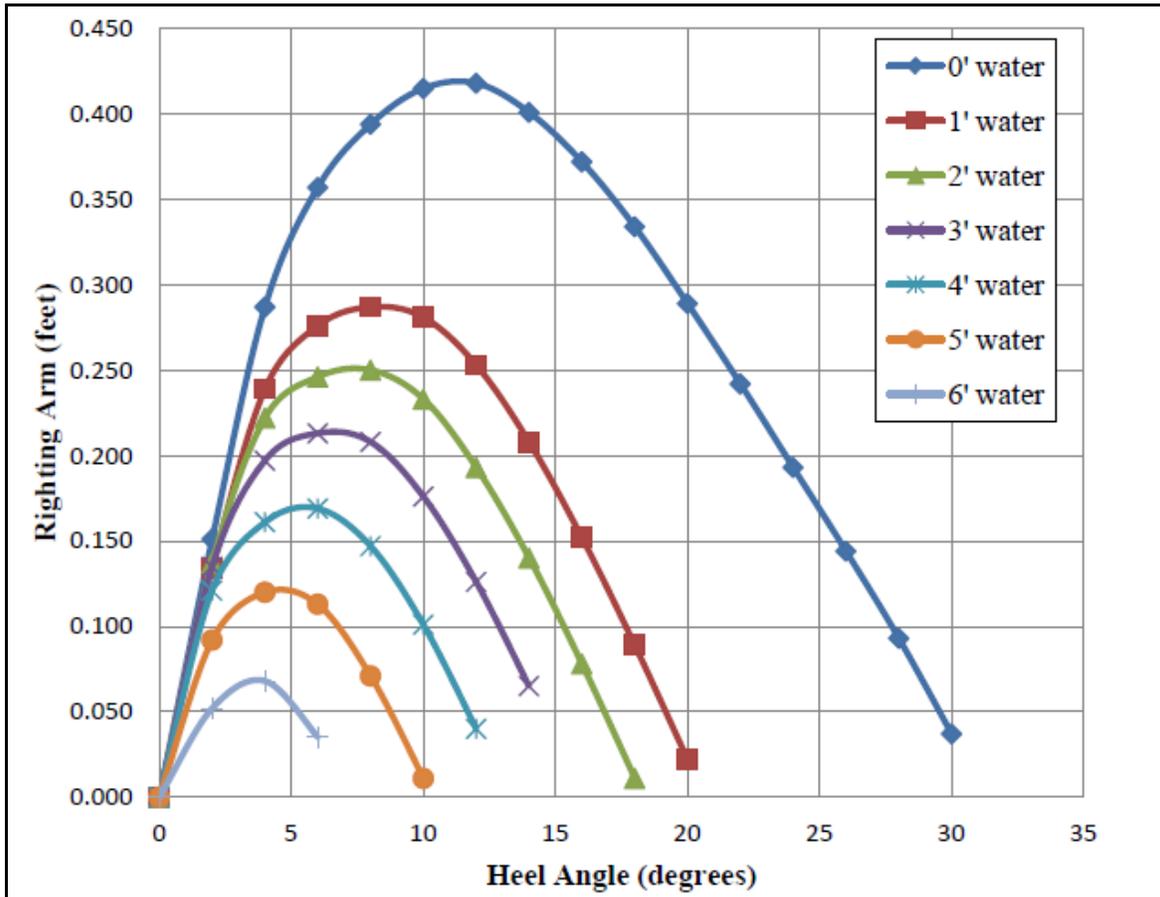
Figure 84. DESTINATION's righting arm curves for incremental filling of number 3 hold in departure load conditions from Dutch Harbor. Provided by MSC.

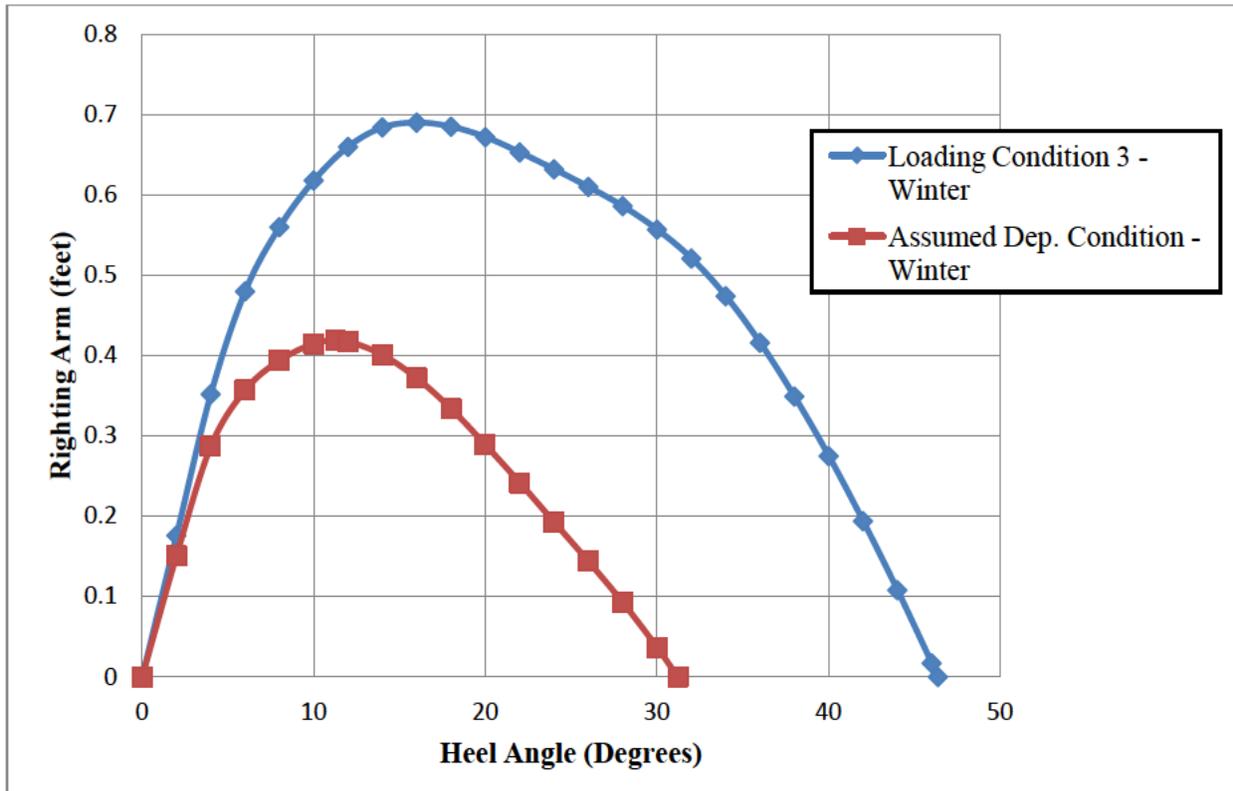
Limit	Required	Attained Condition 3 - Winter	Attained Assumed Dep. Condition
Initial Metacentric Height (GM)	> 0.49 ft	5.02	4.32
Angle of Maximum Righting Arm	> 15°	16.00	11.27
Area up to 40° or Downflood Angle	> 16.9 ft-deg	21.05	8.27
Area between 30° and 40°	> 5.6 ft-deg	4.35	0.02
Area at Max Righting Arm	> 12.92 ft-deg	7.76	3.34

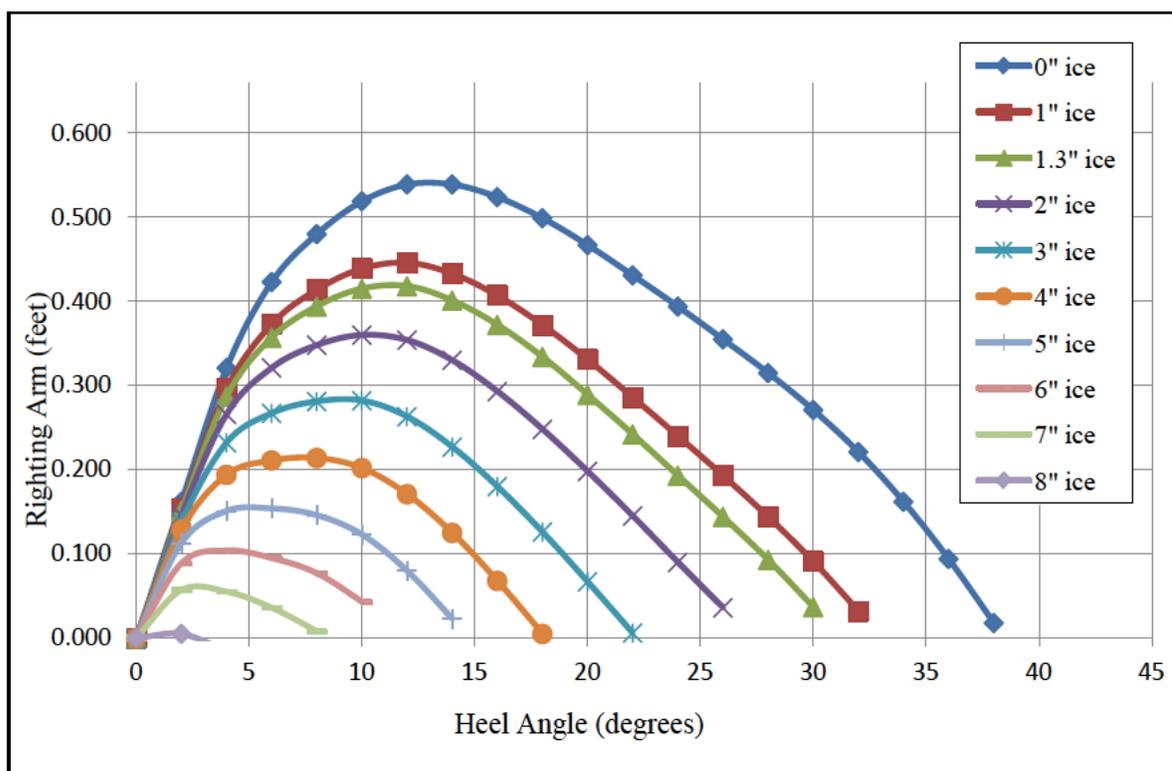
Figure (8): Righting Arm Curves for Incremental Ice Loads

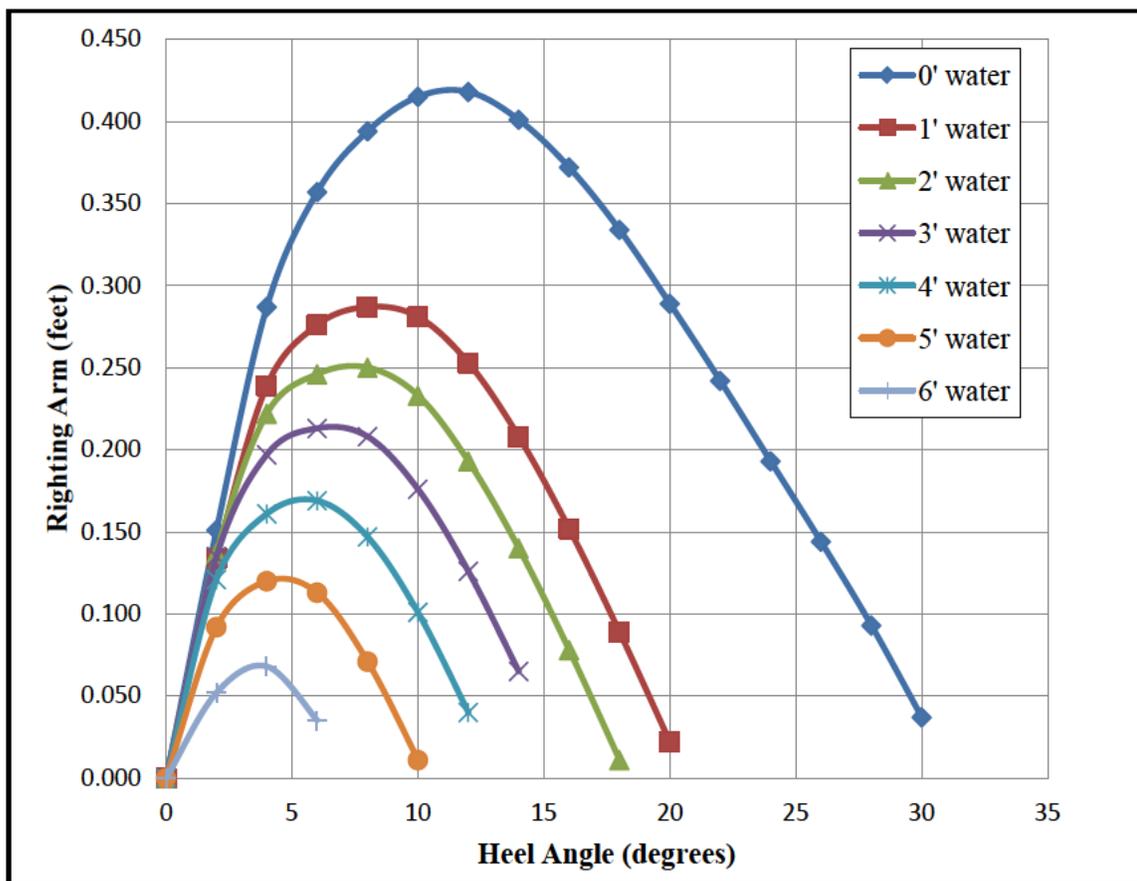
Figure (9): Righting Arm Curves for Incremental Filling of No. 3 RSW Hold
