United States Coast Guard

**Report of the Investigation into the
Circumstances Surrounding the Capsize of
the Liftboat SEACOR POWER (O.N.
1115290) Approximately 7 Nautical Miles
South of Port Fourchon, LA in the Gulf of
Mexico Resulting in the Loss of 13 Lives on
April 13, 2021.**

THE CAPSIZING OF THE COMMERCIAL LIFTBOAT SEACOR POWER (O.N. 1115290) RESULTING IN MULTIPLE LOSSES OF LIFE APPROXIMATELY SEVEN NAUTICAL MILE SOUTH OF PORT FOURCHON, LA IN THE GULF OF MEXICO ON APRIL 13, 2021

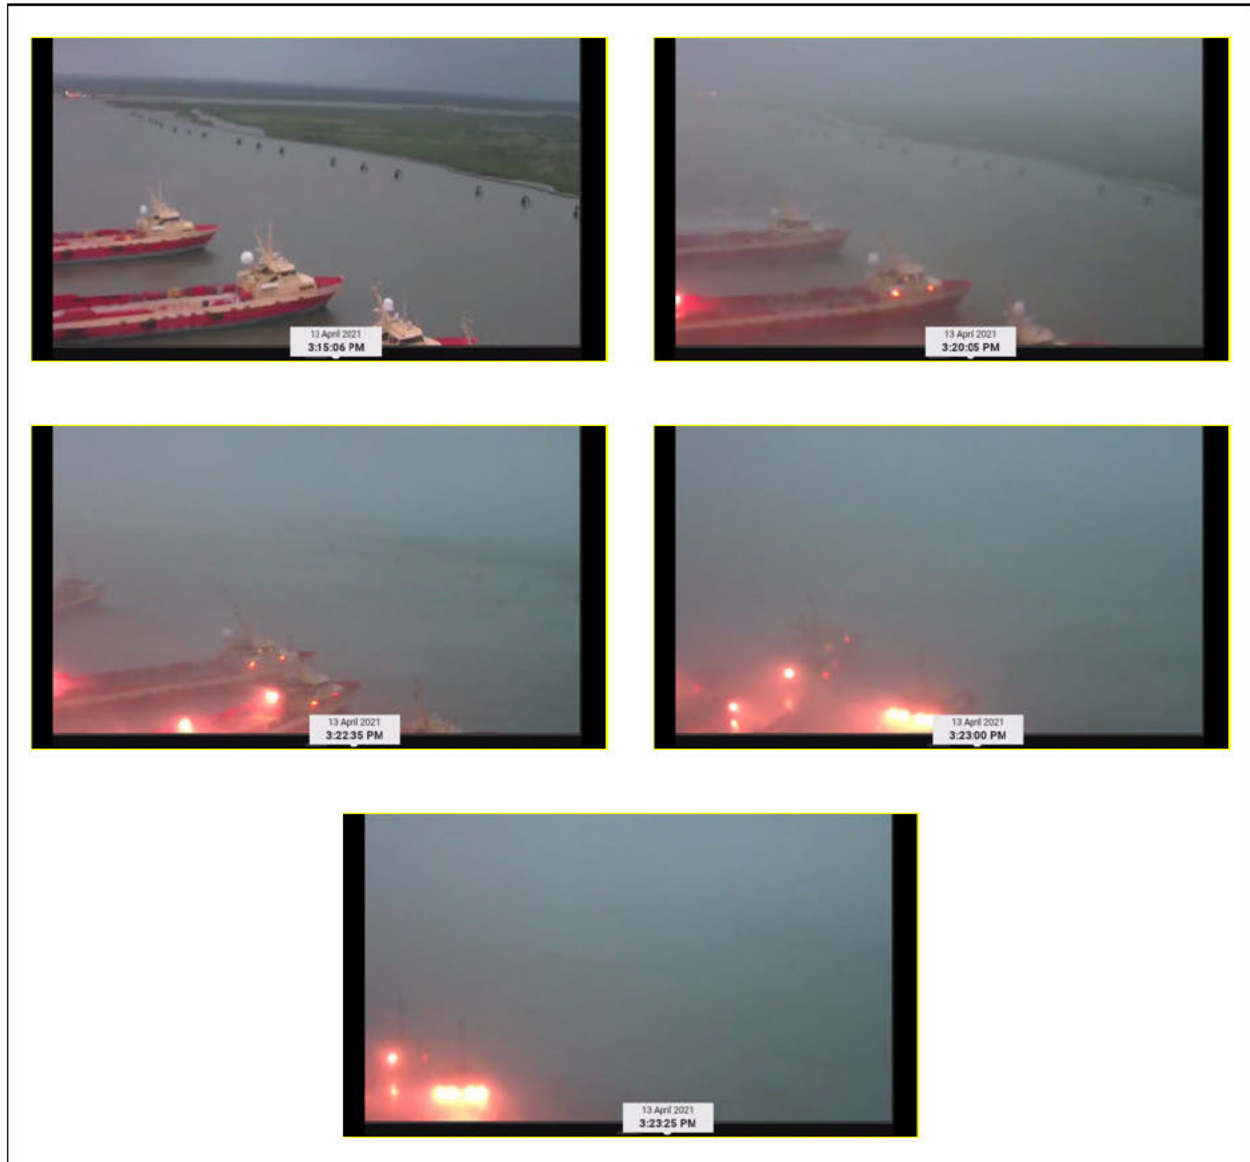
Figure 8: Images from C-Port Drydock Camera

8.1.30. At 1521, C-Port Drydock West camera recorded the arrival of a second, stronger squall.¹⁶ The HOS Port North Yard camera, 100 yards west of C-Port Drydock, also recorded the arrival of the second squall. That camera showed zero visibility at the peak of the squall, and recorded intense winds for 108 minutes, or 1 hour and 48 minutes.¹⁷ At 1522, the second squall reached the camera at the Baroid Dock in Bayou Lafourche, 1.5 miles south of C-Port Drydock. The squall was moving south, toward SEACOR POWER.¹⁸

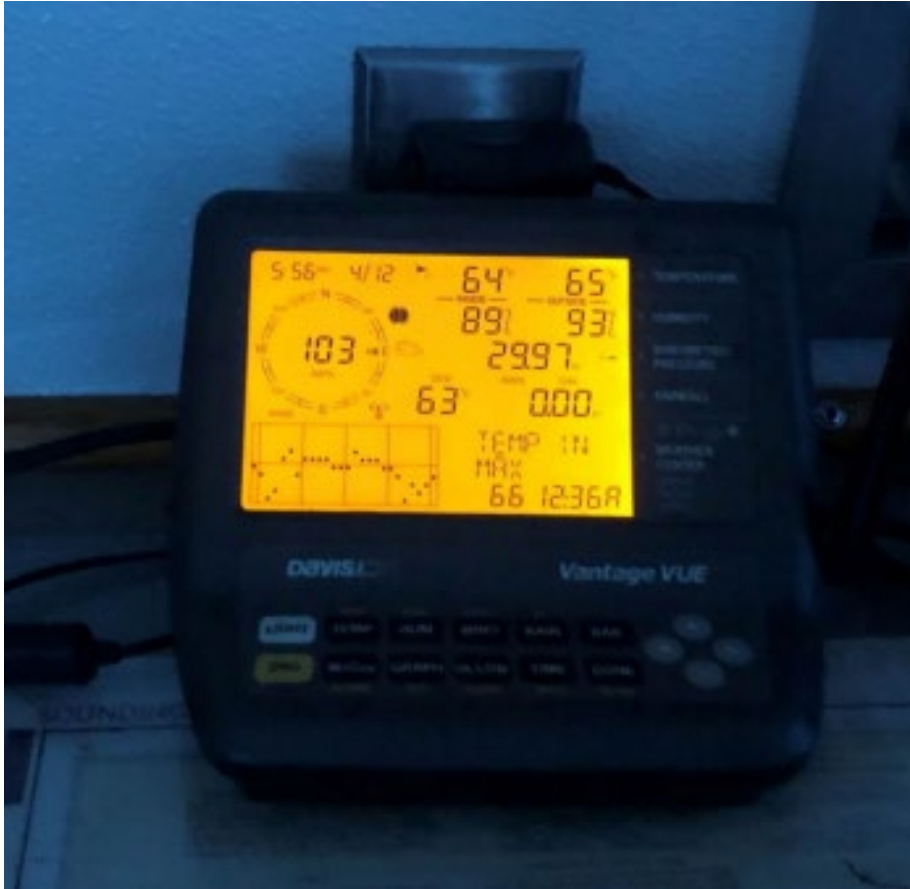
Figure 12: Liftboat VANESSA Anemometer displaying 103mph winds at 1537

- 8.1.38. At 1537, the Liftboat VANESSA Master observed a wind speed of 103 mph. Approximately 3 minutes later he observed a 113 mph wind gust.²² The vessel was located 4.5 nautical miles west-northwest of SEACOR POWER.²³

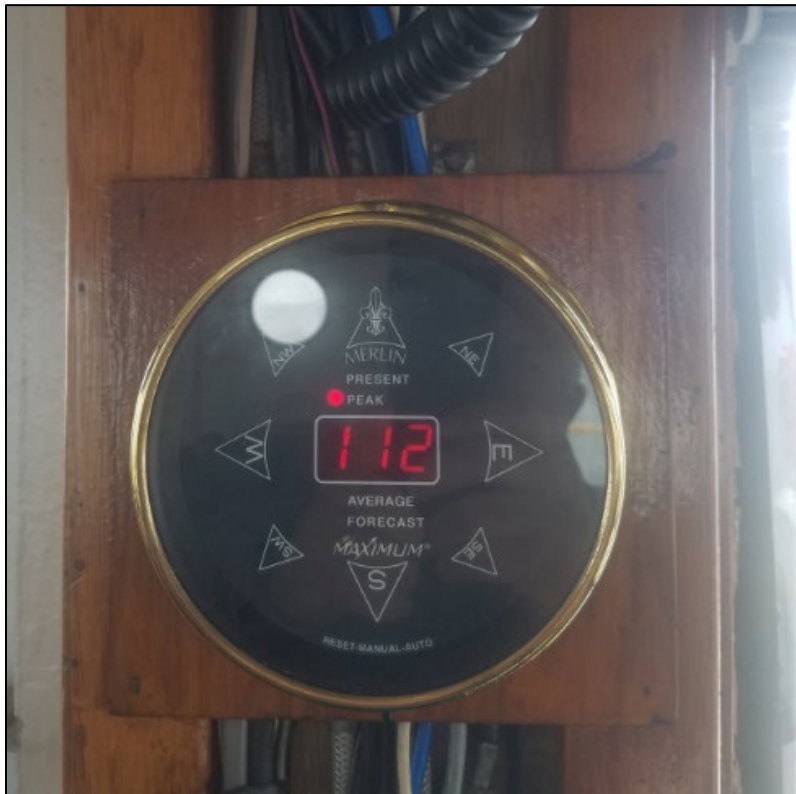
Figure 16: Liftboat ROCKFISH anemometer reading of 112 knots on April 13, 2021 (Exhibit 144)

- 8.1.53. During the hearing the Master of Liftboat ROCKFISH reported that his anemometer measured a wind gust of 112 mph on the date of the incident. The Master did not know what time this gust occurred, but provided a photo of the anemometer reading.³⁰ He stated that if he had known that type of weather was coming, he would have waited to move his vessel that day. He also stated that if he had moved the ROCKFISH 15 minutes later, then his vessel would have capsized as well.

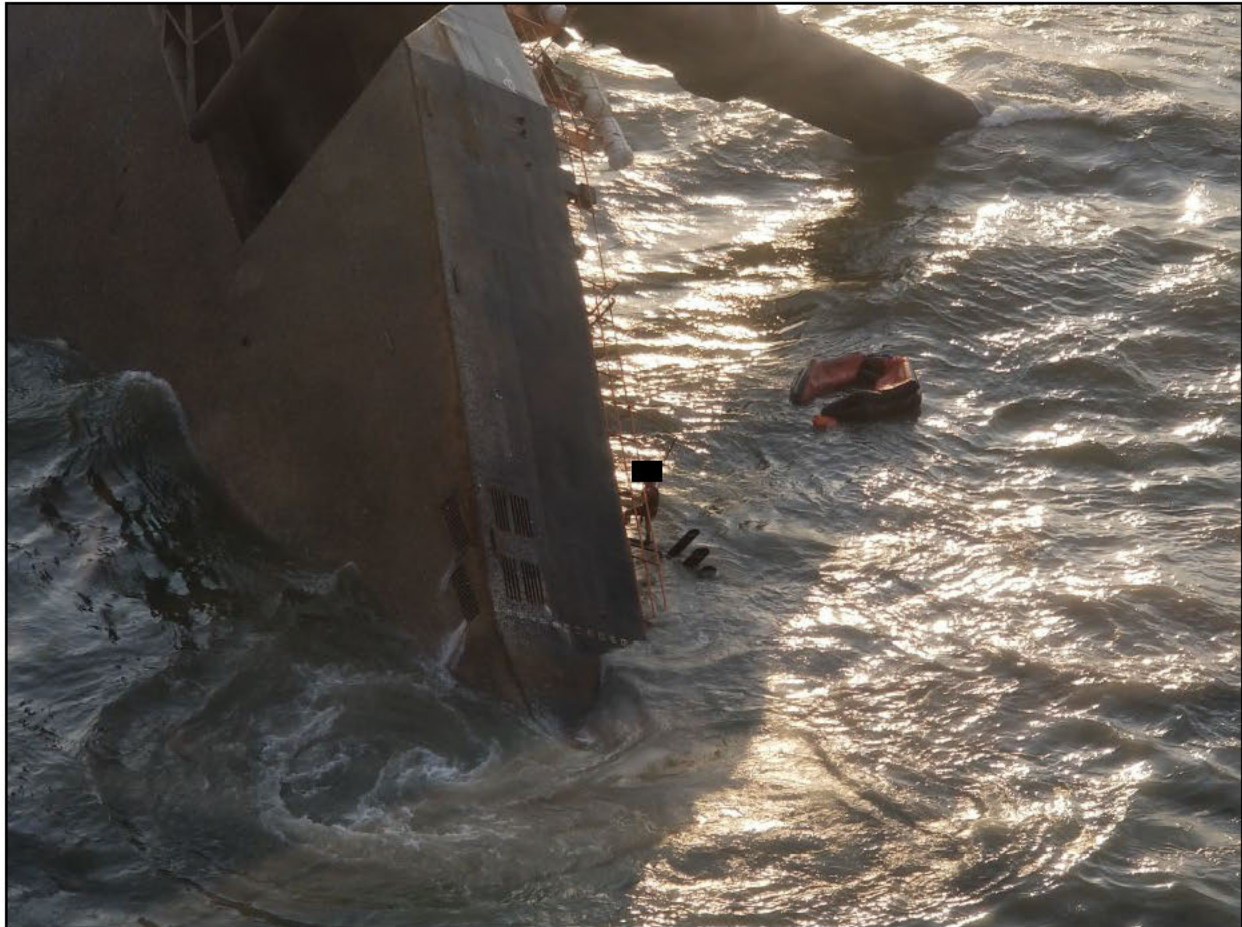
Figure 19: Bristow Helicopters Rescue Swimmer on the hull of SEACOR POWER on April 14, 2021

lowered their rescue swimmer into the water at 0723,⁸⁵ and the rescue swimmer searched for survivors on the SEACOR POWER and in the liferaft. He did not find any survivors or any signs of life visually or as a response to banging on the hull. At 0745, the helicopter recovered the rescue swimmer,⁸⁶ conducted a search pattern, and returned to Galliano at 0833.⁸⁷

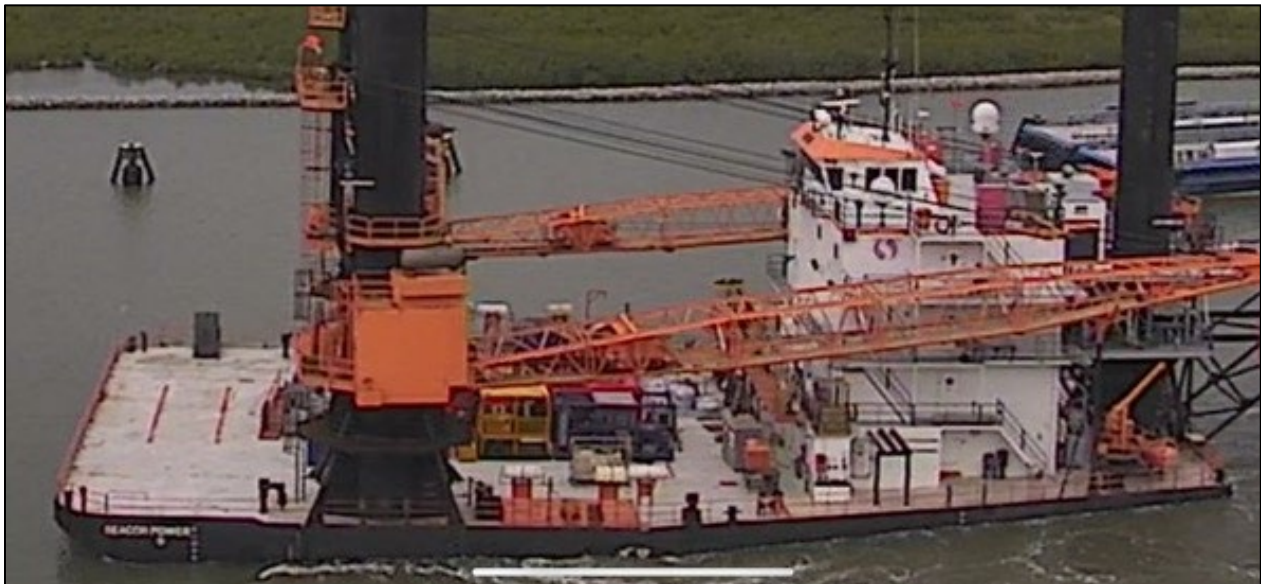
Figure 28: SEACOR POWER Departing Port Fourchon on April 13, 2021

- 8.4.23. Cameras in Port Fourchon recorded SEACOR POWER's departure on April 13, 2021. SEACOR POWER's observed draft was 9.25 feet at the Plimsol mark (the waterline was at the bottom of the ring). SEACOR POWER had approximately 2.5 feet of aft trim as observed using the number of forward and aft draft marks visible on the port side. Heel angle could not be observed from camera angles.¹³¹

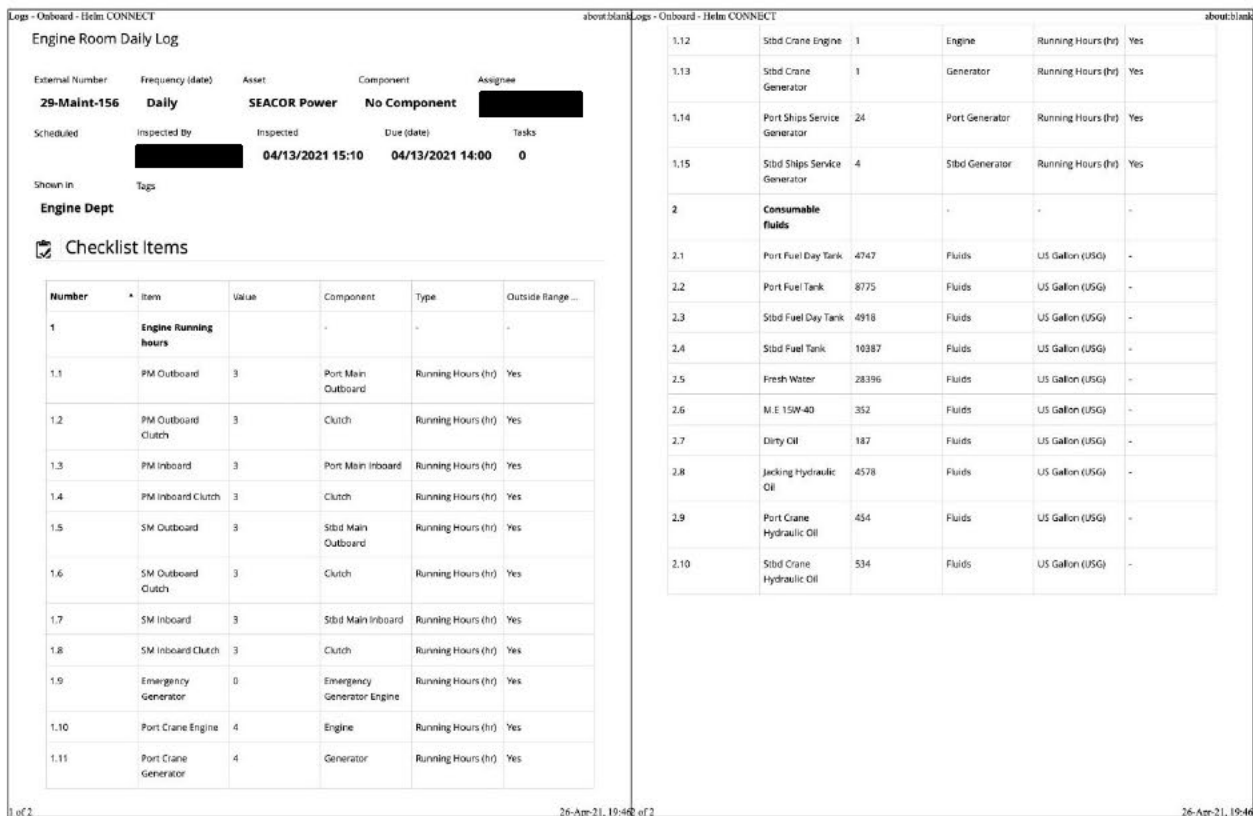
Figure 29: HelmConnect tank loading information at 1510 on April 13, 2021 (Exhibit 86)

8.4.26. The consumable tank loading aboard SEACOR POWER was reported by the onboard HelmConnect system at 1510, just prior to casualty.¹³³ This tank loading is shown in the following figure.

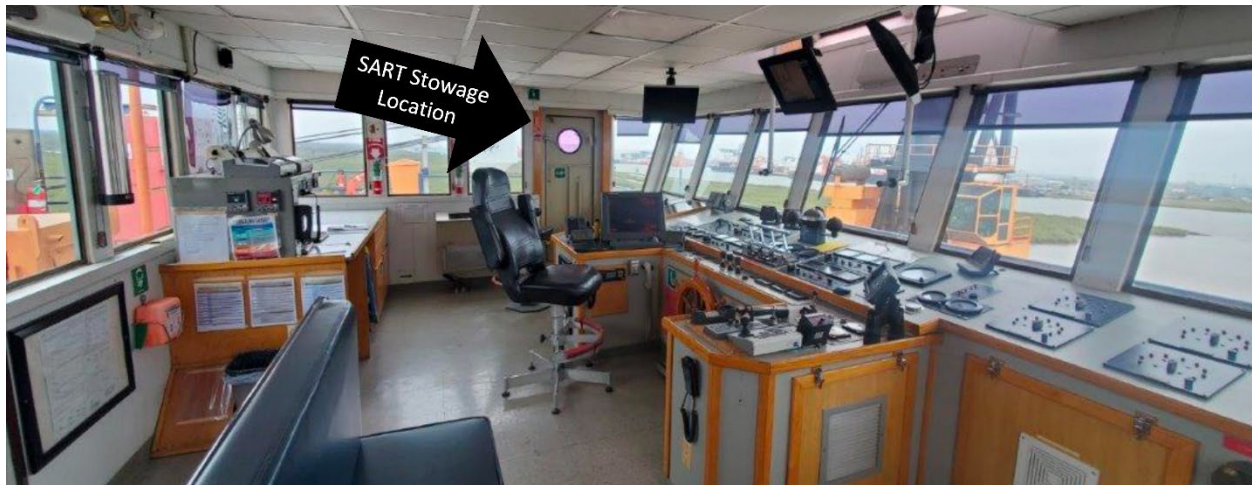
Figure 48: SART stowage location in wheelhouse

- 8.9.7. There were two radar SARTs stored on SEACOR POWER's bridge, located on the aft side of the port and starboard wheelhouse doors.²³⁶ The SARTs were manufactured by Jotron.²³⁷ The First Mate stated that the SARTs were recently replaced. He also stated that there were no SART poles on SEACOR POWER.

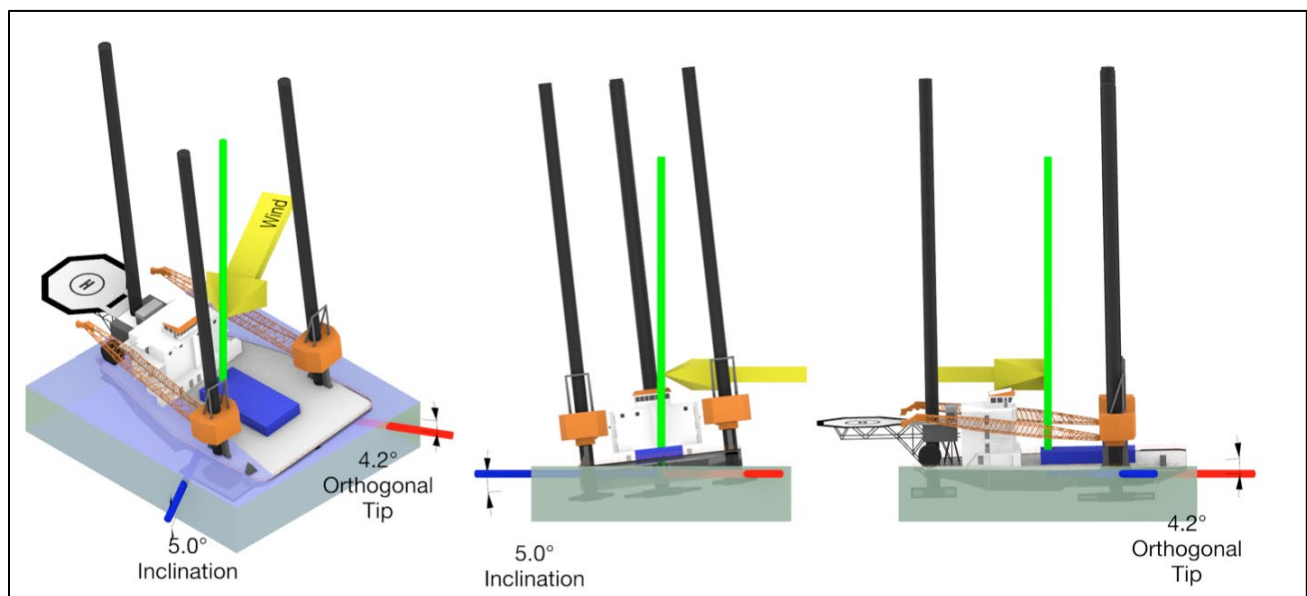
Figure 52: Sketch of SEACOR POWER inclined 5° in still-water from wind at 240° relative (Exhibit 246)

- 9.1.16. Immediately prior to the capsizing, the First Mate observed a 5 degree list. At that angle, part of SEACOR POWER's main deck would be submerged, as noted in the figure below. If any doors or vents on the starboard side of the main deck were open, this would have caused downflooding. There was no evidence to indicate that downflooding was a causal factor in the capsizing.
