# MARINE CASUALTY REPORT

## ALEUTIAN ENTERPRISE

Flooding, capsizing, and sinking in the Bering  
Sea on March 22, 1990, with nine persons  
missing and presumed dead

U.S. COAST GUARD  
MARINE BOARD OF INVESTIGATION REPORT

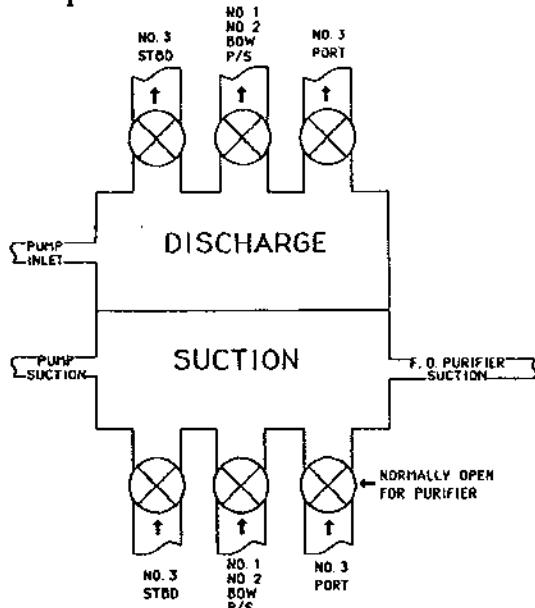
Figure 5

k. Fuel Oil Manifold Figure (5) is a sketch of the fuel oil transfer manifold as described by the assistant engineer. Transferring fuel from No. 3 port to No. 3 starboard fuel oil tanks required opening the No. 3 starboard discharge valve since the No. 3 port suction valve was normally open. The assistant engineer testified that this was a simple task.

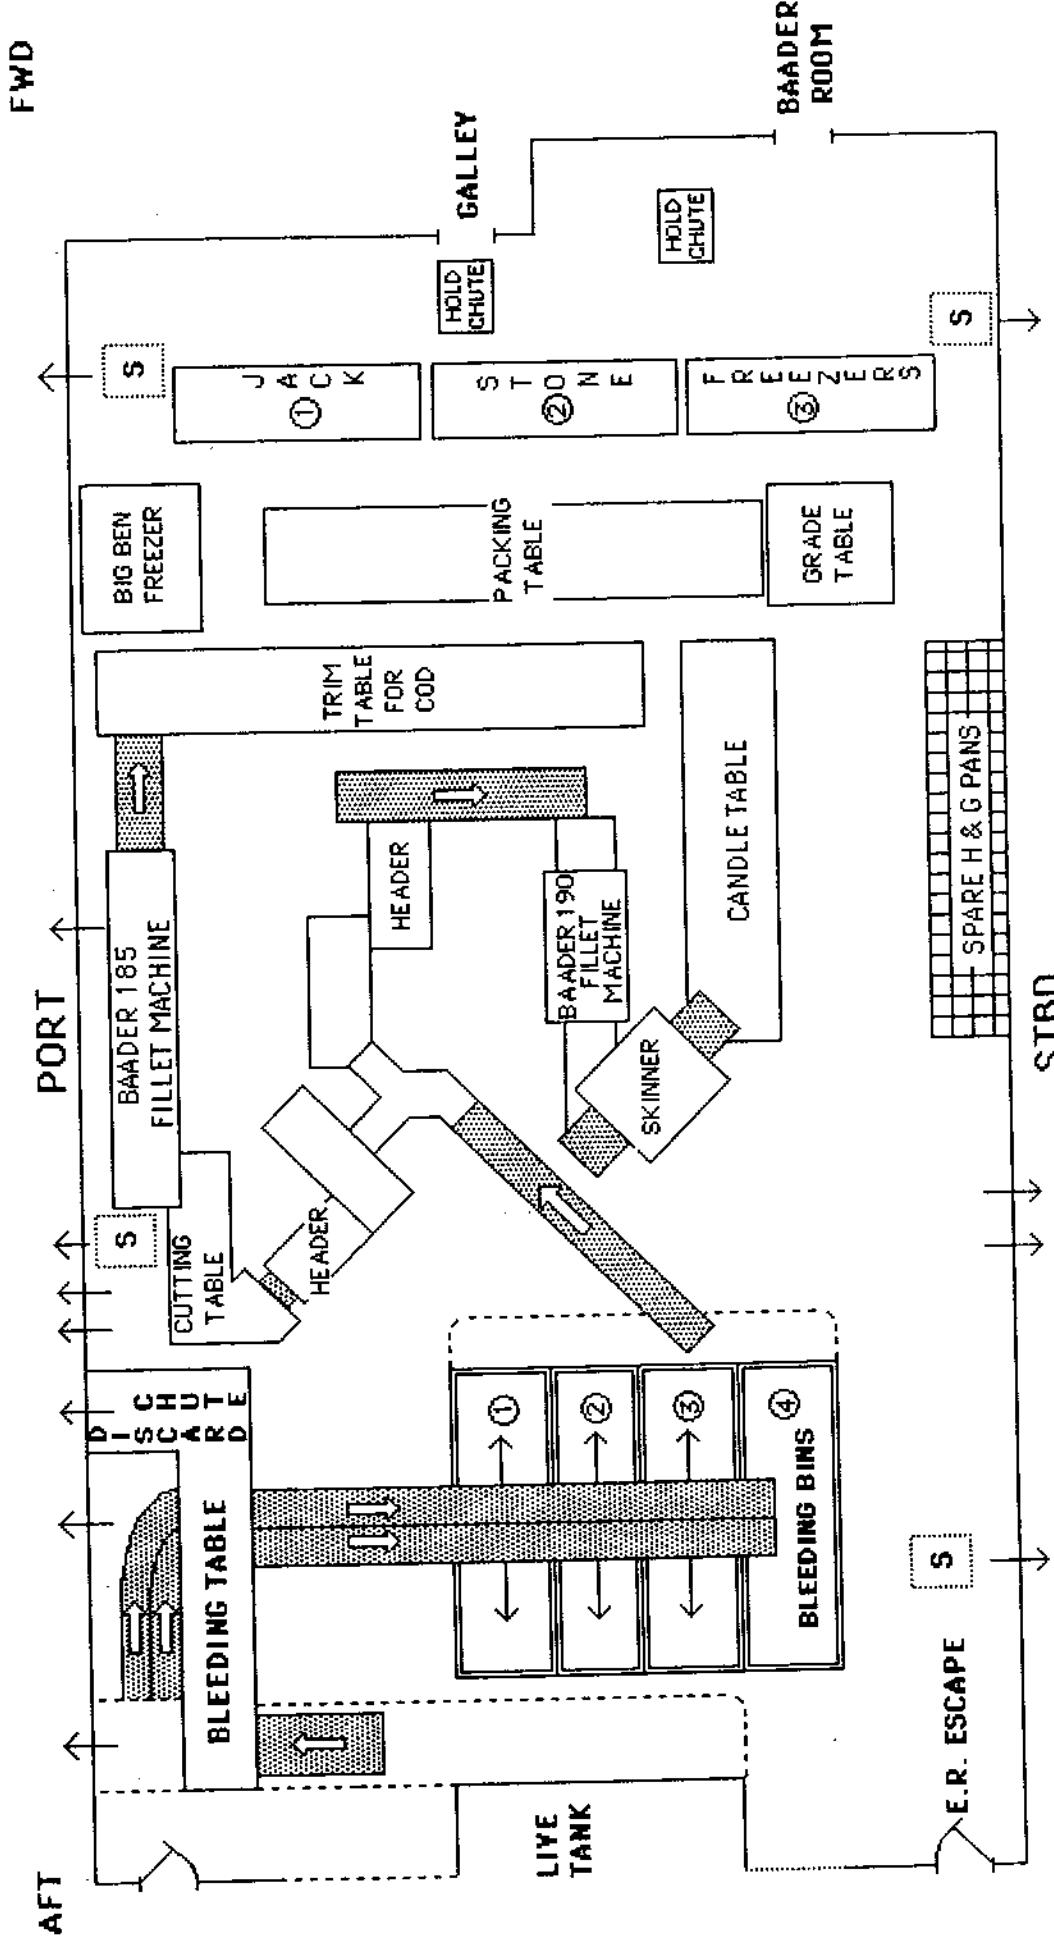
Figure 10

Figure (10) illustrates the processing equipment layout. Fish were dropped into the live tank through the hydraulically operated hatch just forward of the stern roller on the trawl deck. According to Siemons, the National Marine Fisheries Service (NMFS) Observer, [REDACTED] measured the live tank and told him it held about forty to forty-five thousand pounds of fish. Siemons told [REDACTED] that it held forty to forty-two thousand.

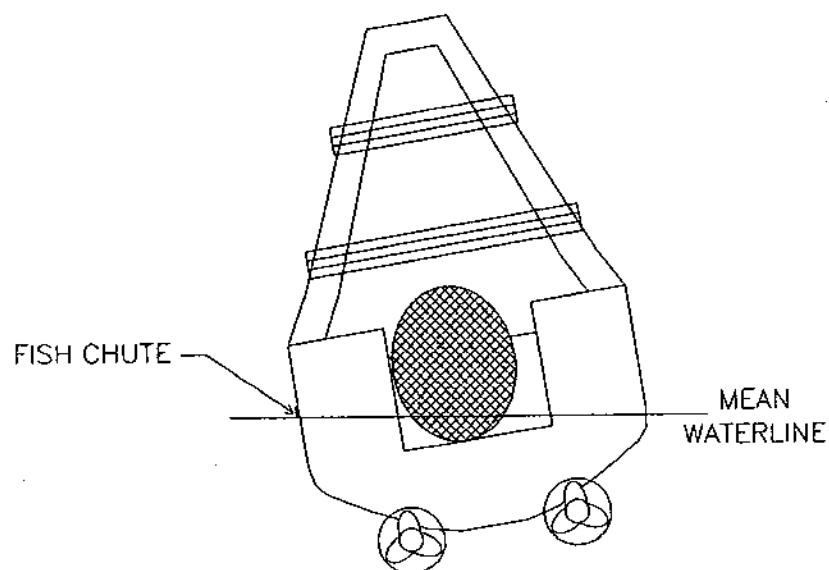
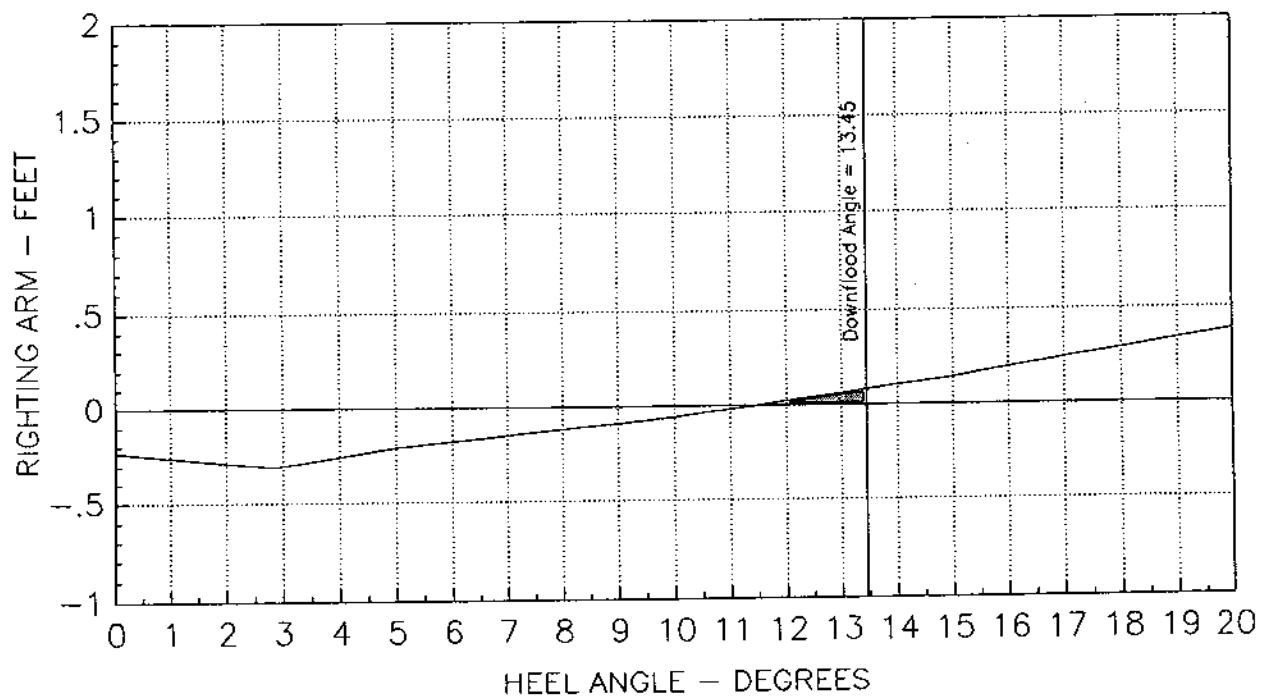
Figure (18)

## EQUILIBRIUM LIST ANGLE FOR LOAD CONDITION 5 M 2
