## **MARINE CASUALTY REPORT**

M/V ANGELINA LAURO (ITALIAN);  
FIRE ON BOARD WHILE DOCKED IN  
CHARLOTTE AMALIE HARBOR, ST.  
THOMAS, USVI, ON 30 MARCH 1979  
WITH NO LOSS OF LIFE

U.S. COAST GUARD  
MARINE BOARD OF INVESTIGATION REPORT

REPORT NO USCG 16732/01282

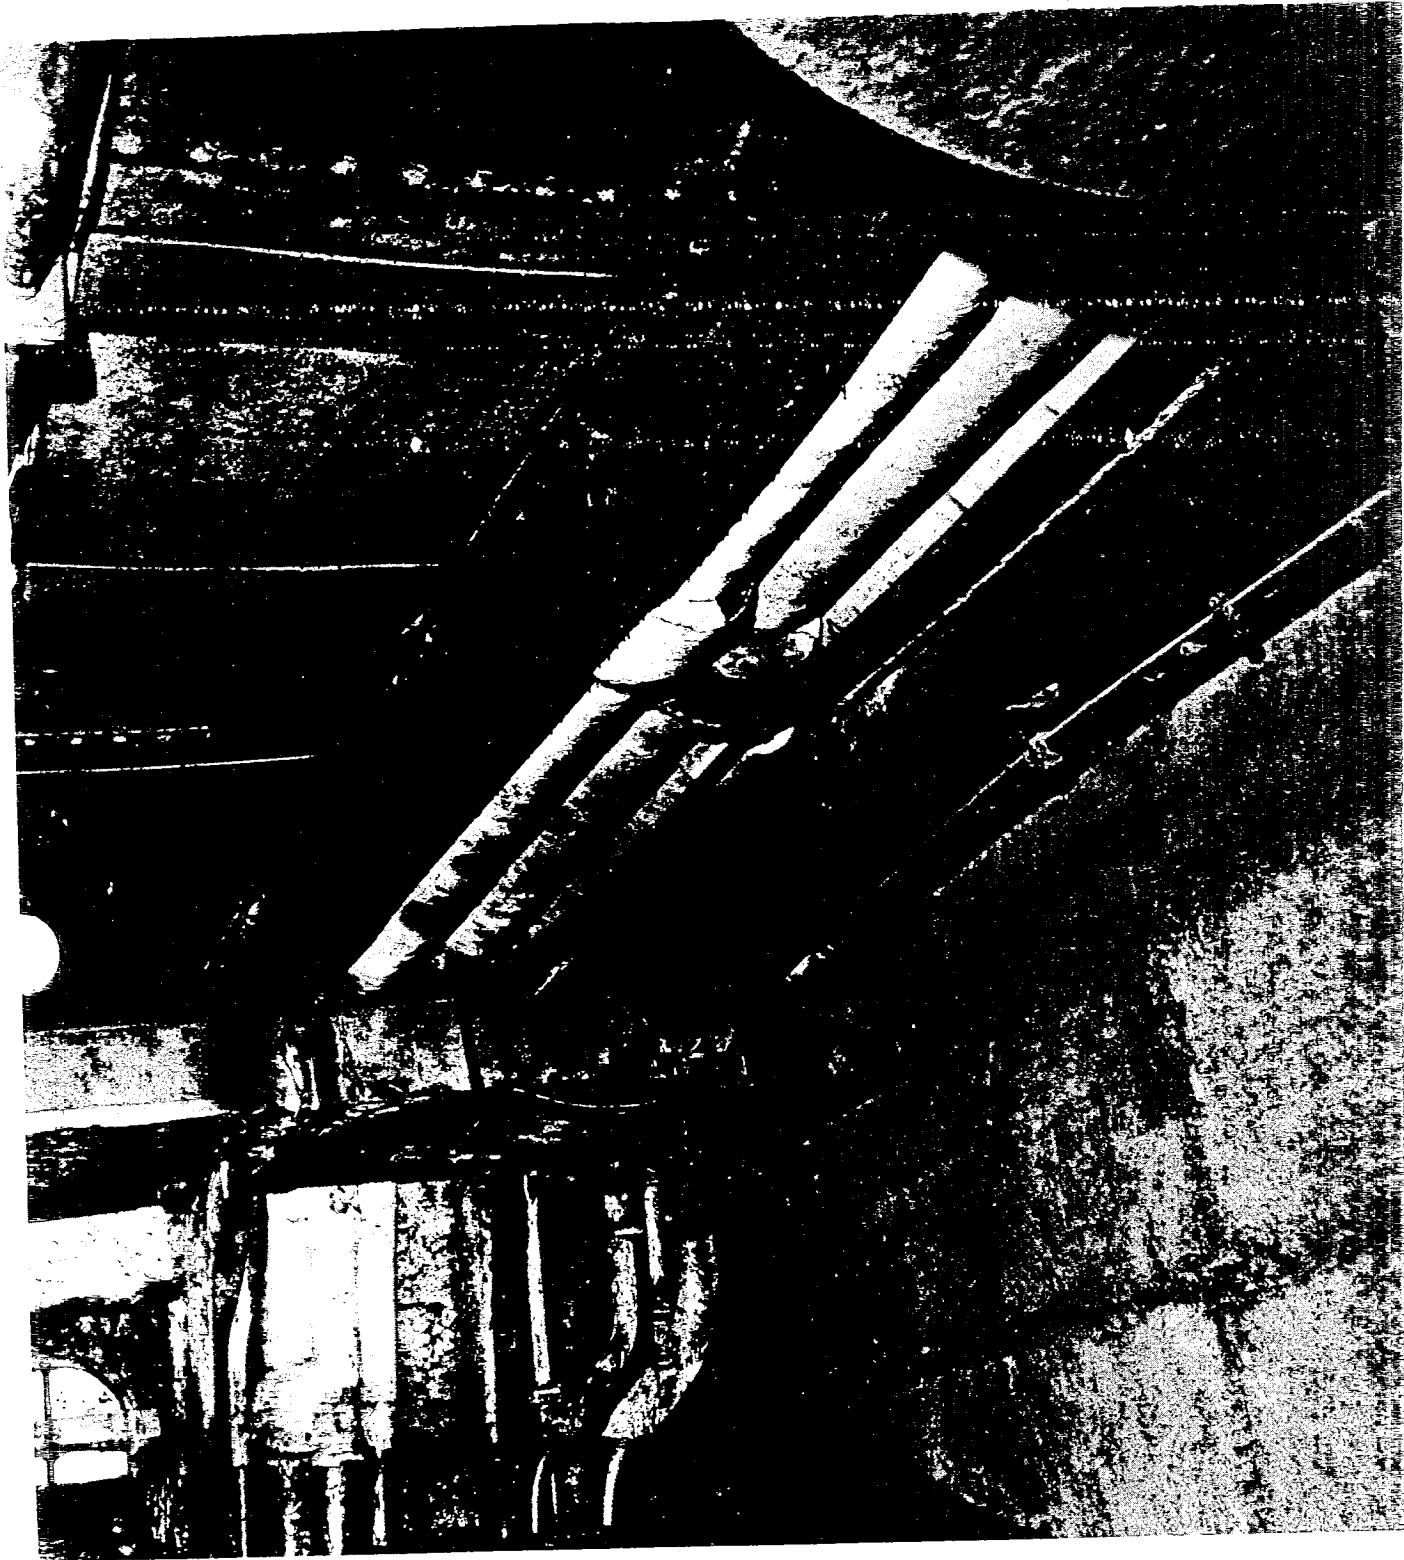
38. A post fire examination of the hood exhaust duct revealed that the damper on the galley side of the hood exhaust duct did not close, although the fusible link had melted. The damper on the dining room side had closed; however, it was severely warped. The inside of the duct had a heavy residue of burned grease, however; Chief Crew Cook [REDACTED] claimed that the vent was frequently cleaned and had been so as a matter of routine for as long as he was on the vessel. The hood was equipped with screens intended to catch and condense the grease vapors from cooking. Several witnesses said they were regularly changed, and [REDACTED] stated that this was a matter taken care of by the engineering department. The vent screens were changed on the 28th of March and normally changed once a week and examined by the ships engineers and by inspectors during Coast Guard examination. Also present in the hood was a steam smothering line. The line was traced where it comes out of the hood at the port side of the ship, down to the decklevel, and then forward to the port corner of the galley, thence vertically where there was a manual valve at ceiling level for activation. This system was not used to fight the fire.

Figure 9  
Continental Dining Room  
View of the Crew Galley  
Exhaust Vent

Action: This recommendation is concurred with. Although such procedures have previously been unwritten, galley exhaust ducts have long been identified as potentially unsafe areas aboard vessels, requiring the specific attention of both the Coast Guard inspector and the crew of the vessel. A soon to be published amendment to Volume II of the Marine Safety Manual (CG-495) sets forth detailed examination procedures regarding galley exhaust ducts. These procedures are required to be followed during the biennial and mid-period inspection of U. S. vessels and during SOLAS verification examinations of foreign flag vessels. They include the removal of sufficient inspection plates to insure that the duct wall is clean and free of grease and that an operational test of the fire damper is carried out.
