MARINE CASUALTY REPORT

SS BADGER STATE

EXPLOSION ABOARD AND EVENTUAL SINKING

DECEMBER 26, 1969

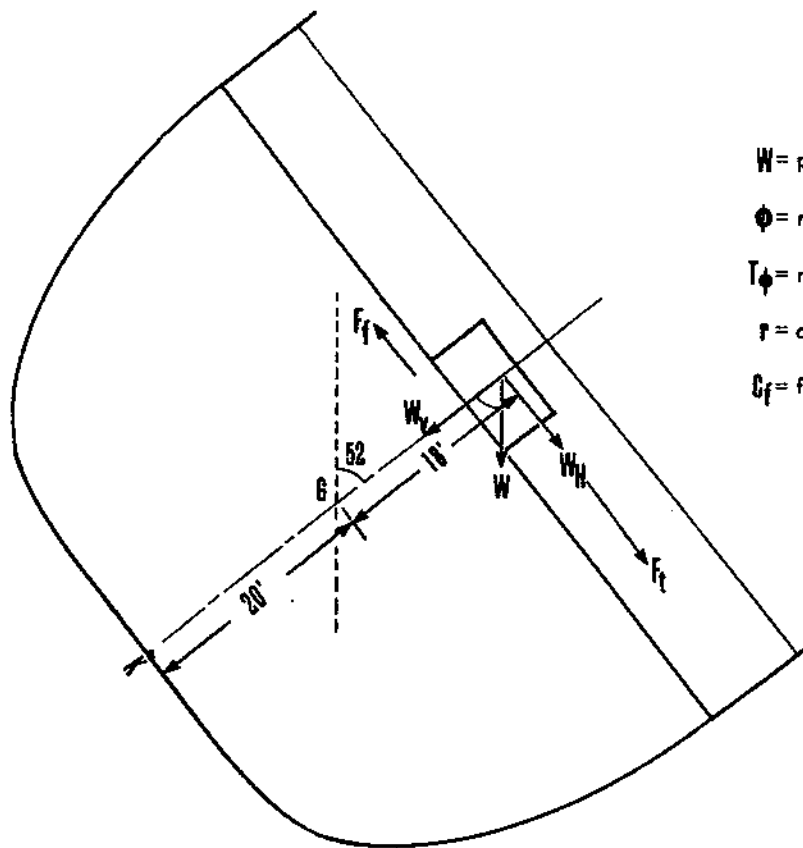
FIG. I

The ship accelerations associated with roll, pitch, heave, surge, yaw, and sway all produced forces on the bombs, the pallets, and the dunnage. The pitch and roll angles also caused components of the bomb weight forces to be shifted from the decks to the blocking, sheathing, and sweatboards. The reduction of deck gravity force at ship inclinations in turn reduced the friction forces under the bomb pallets. Figure 1 illustrates the reactions of roll tangential accelerations, gravity, and friction by a bomb pallet when the BADGER STATE rolled to 52° . The additional forces caused by pitch, heave, yaw, and sway, and by roll centrifugal forces are considered small by comparison and may either add or subtract from the other forces, depending on the particular ship motions at that moment. Adjacent pallets would experience slightly different tangential forces due to the longer distance to the axis of roll (assumed to be center of gravity) and because the forces would be at a small angle with the deck. The variations, however, tend to compensate and would be small. Six 2,000-pound bomb pallets are assumed to have been in the forward athwartship row of bombs. This would result in a load on the support sheathing and blocking in excess of 14,000 pounds, which could not be sustained. Once the bombs commenced moving, they built up kinetic energy so that upon impact, this added a large force to those already described and further broke down any bounds. Therefore, although future rolls did not again reach this maximum value, the slack in the cargo allowed added forces to destroy the dunnage at lower amplitudes of roll.

The exact mechanism of the failure of the blocking and hull sheathing cannot be reconstructed. However, among the peak load points were those at the bomb nose blocking. With the bombs loaded nose to nose athwartship, the two outboard bomb noses had to carry the total load from the other bombs in that row at the maximum roll inclination. The bomb nose, with a diameter of 4.625 inches, had a centerline hole of 3.772 inches. This required the blocking, in contact with the two nose areas of one pallet, to support about 11,875 pounds over an area of about 11.8 square inches, with a resultant pressure of about 1,000 pounds per square inch. Another area of peak loading occurred where the hull curvature allowed only one bottom corner of the outboard pallet to press against the sheathing board and support the lateral forces of the entire row of bombs. Although some additional side support may have been added in the case of the BADGER STATE, even recent Navy-promulgated standards do not require any such additional side support for this "one-point technique of unit load positioning." Without additional support, the bearing surface of this technique is so small that the side forces encountered on the BADGER STATE would readily have crushed the sheathing support. Even additional support, in the form commonly used, probably would not have increased the bearing area on the sheathing and prevented crushing of the sheathing in this case. The compressive strength perpendicular to the grain fiber of Douglas fir varies with type, quality, and moisture content. Results of tests conducted on small clear specimens indicate that the coast-type Douglas fir has an average compressive strength of 440 p.s.i. in the "green" (38 percent moisture) condition to 870 p.s.i. in the air-dry (12 percent moisture) condition. Western hemlock, also reported as being used for dunnage has respective values of 390 and 680 p.s.i. Since the lumber used during loading was wet, the values applicable to the lumber aboard the BADGER STATE were probably near the lower values. Some of the stowage failures undoubtedly occurred because, at the large angles of roll, the dunnage was loaded beyond its compressive strength.
