UNITED STATES COAST GUARD

**INVESTIGATION INTO THE CIRCUMSTANCES
SURROUNDING THE LOSS OF PROPULSION
ON THE BULK CARRIER**

BRIGHT FIELD

**AND ALLISION WITH THE RIVERWALK
SHOPPING COMPLEX ON DECEMBER 14, 1996,
NEW ORLEANS, LOUISIANA, WITH MULTIPLE
INJURIES AND NO LOSS OF LIFE**

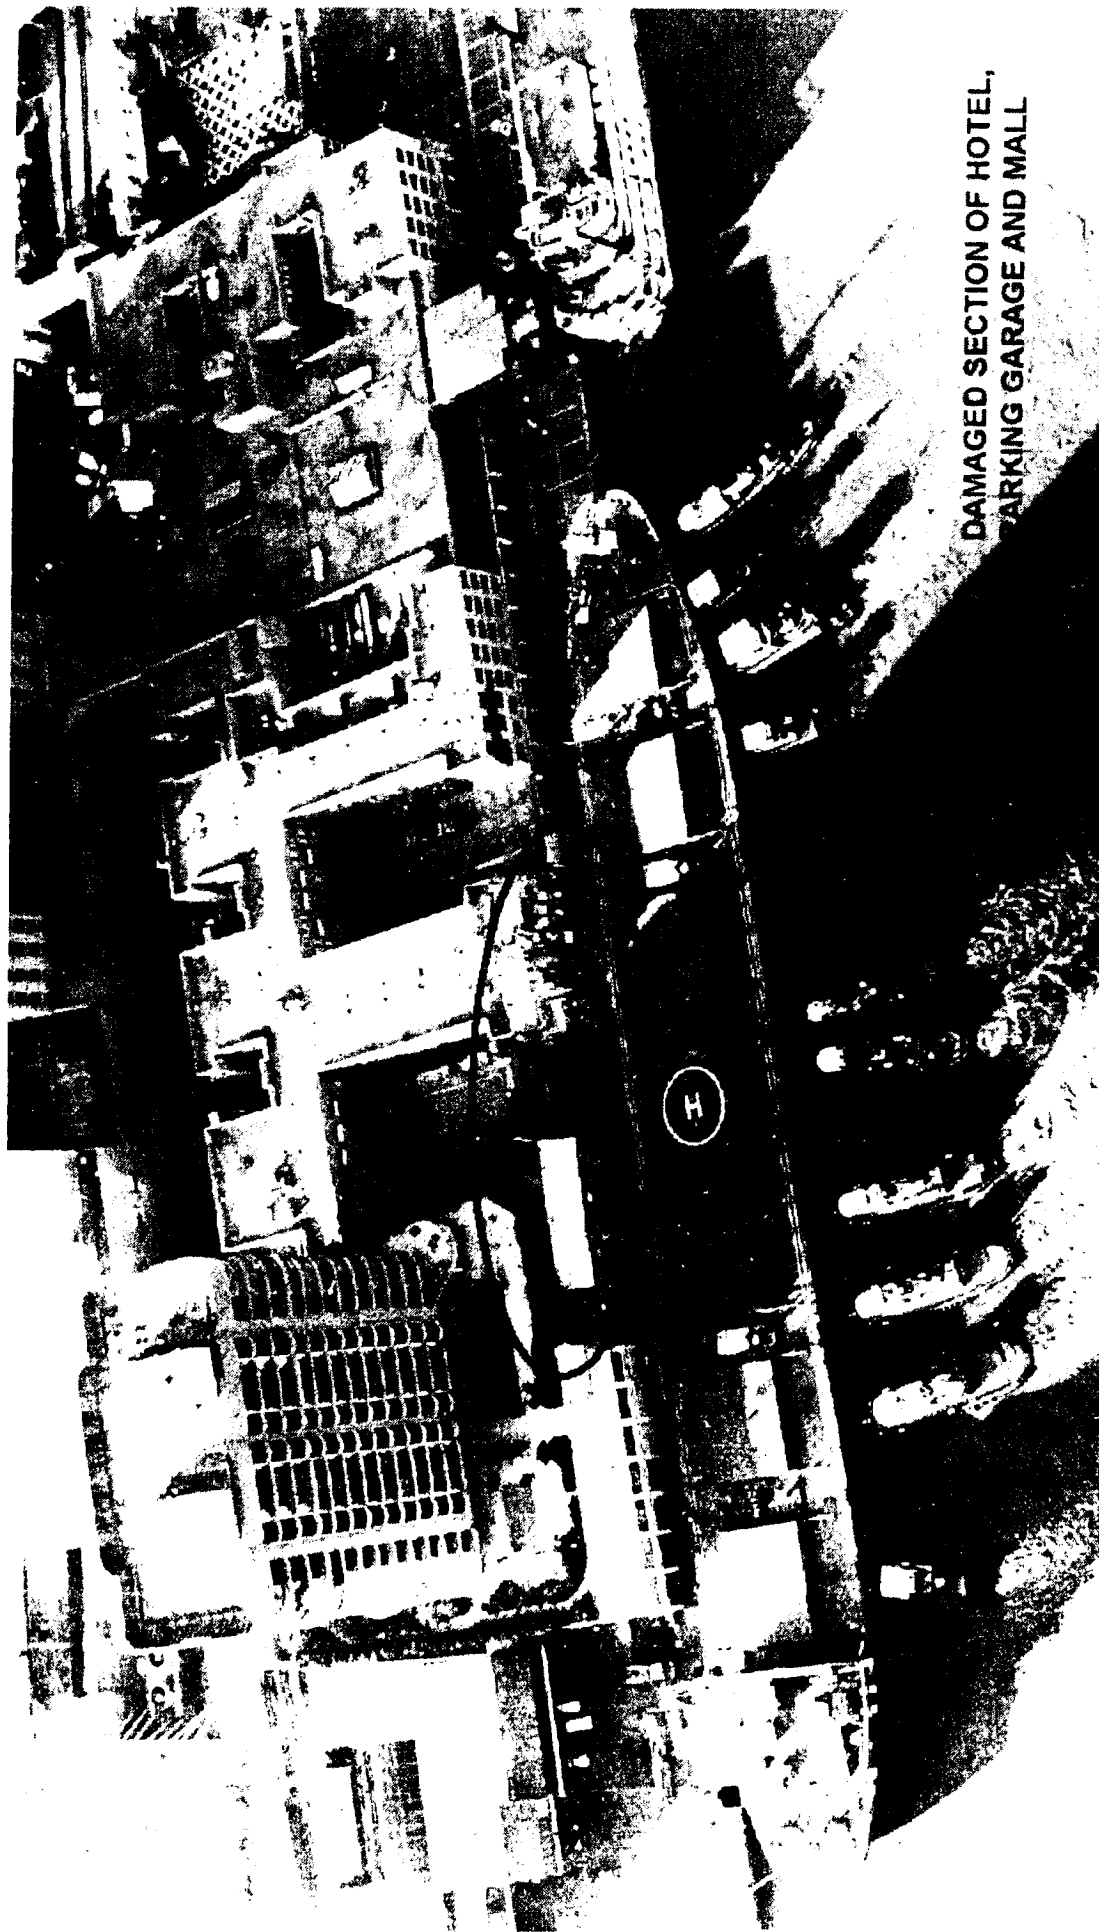
FIGURE 1

The allision caused significant damage to the Riverwalk structure, collapsing about 350 feet (122 meters) of the open pier and damaging part of the adjacent condominium and garage. Several riverside rooms in the Hilton Hotel, as well as several of the shops in the mall, were damaged. Because of concern that additional sections of the damaged structures might collapse if the vessel was moved, tugs continued to assist in holding the BRIGHT FIELD in position for three weeks until emergency bracing and repairs were made to the damaged structures. Structural damage to the pier, hotel, and condominium is estimated at \$ 10 million. Non-structural damage to shops in the mall is estimated at \$ 5 million. See Figure 1 for the most inclusive view of the damage.

BRIGHT FIELD AT REST AND PIER DAMAGE

DAMAGED SECTION OF HOTEL,
PARKING GARAGE AND MALL
