**MARINE CASUALTY REPORT**

**USCGC BLACKTHORN, SS CAPRICORN;  
COLLISION IN TAMPA BAY  
ON 28 JANUARY 1980 WITH LOSS OF LIFE**

**U.S. COAST GUARD  
MARINE BOARD OF INVESTIGATION REPORT**

**REPORT NO. USCG 16732/01279**

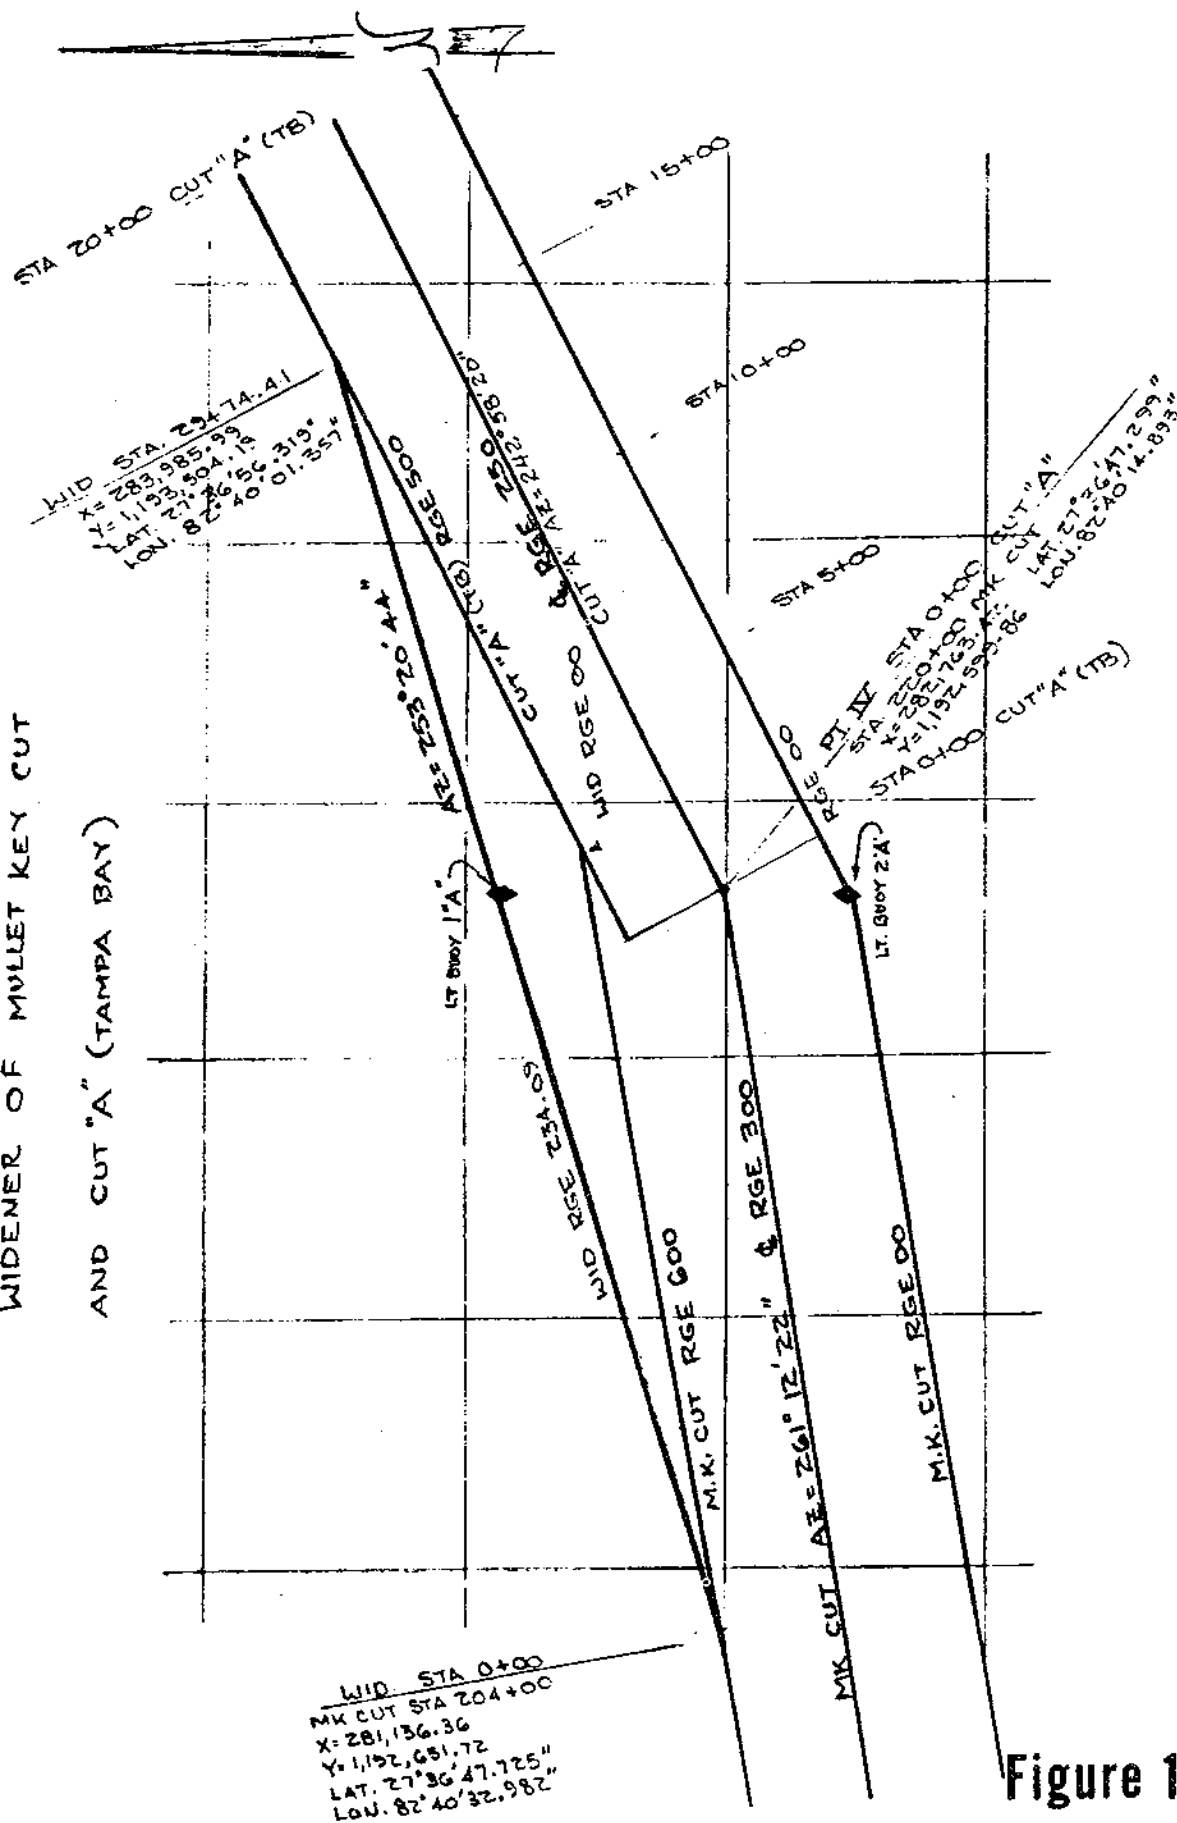
### Figure 1

WIDENER OF MULLET KEY CUT

AND CUT "A" (TAMPA BAY)

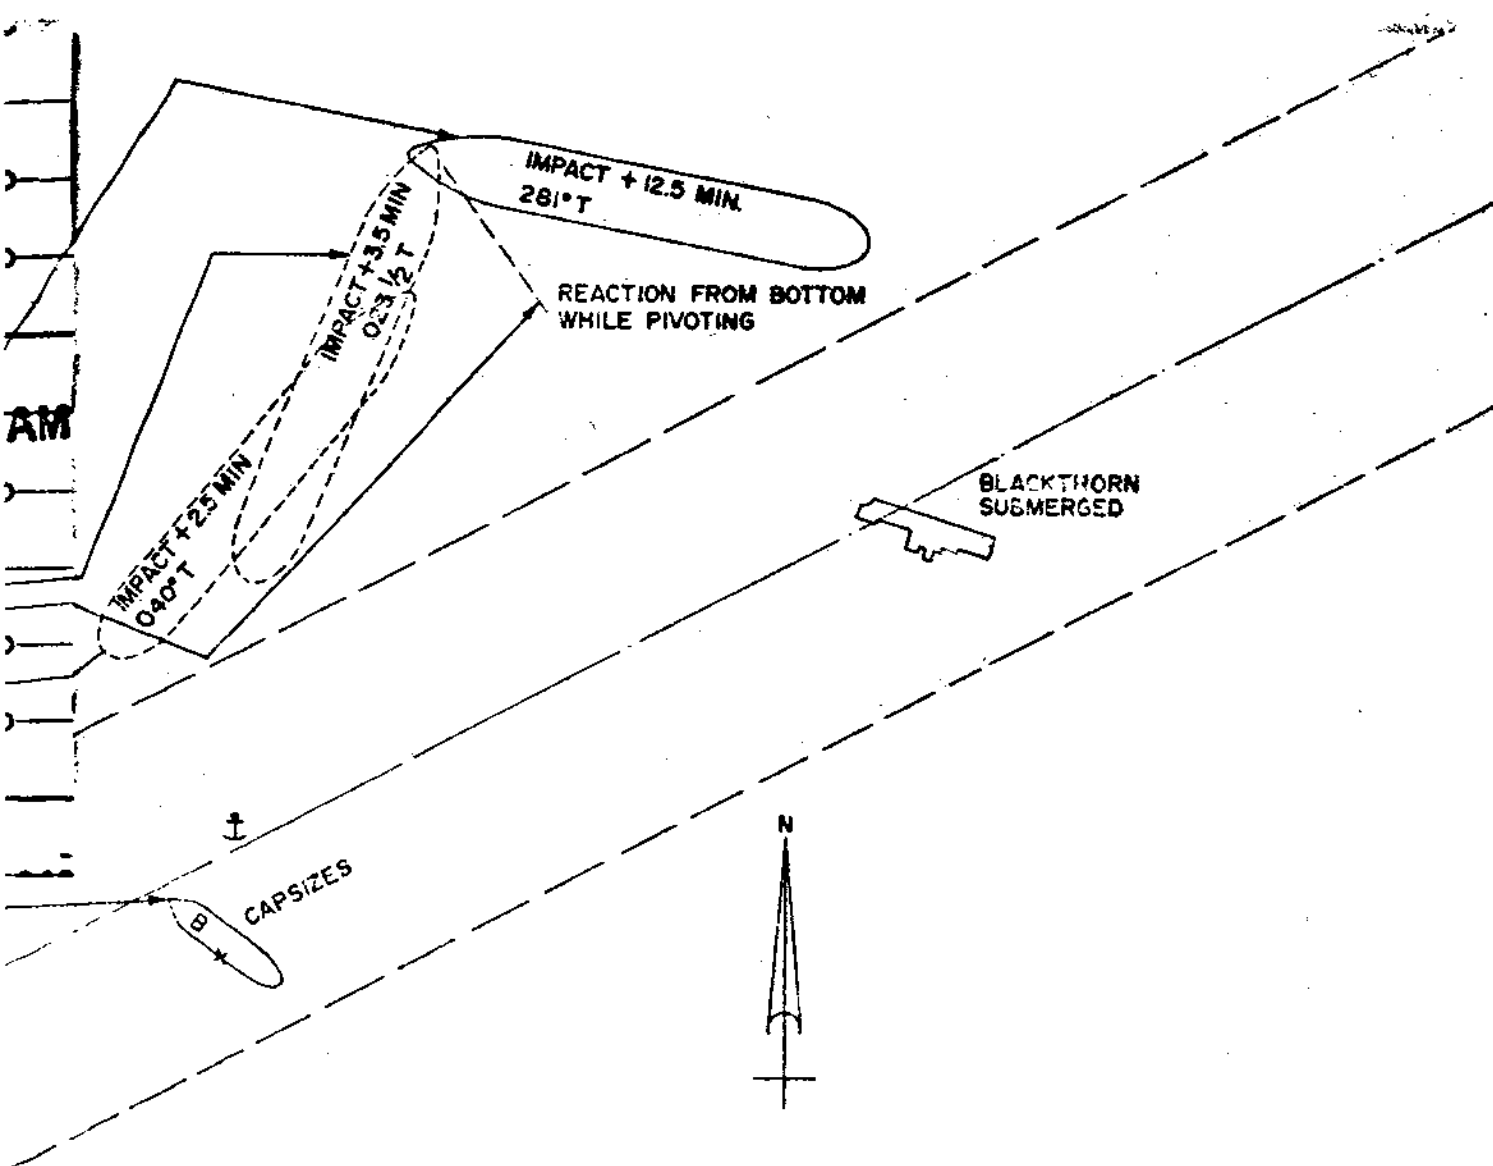
CHART C

ALL POSITIONS ARE ESTIMATES  
BASED ON EVIDENCE

TAKEN FROM CHART 11414.  
OUTER BOUNDARY LINES OF  
THE CHANNEL ARE APPROXI-  
MATE DUE TO THE DISTORTION  
OF CHART 11414 IN THIS AREA.
