UNITED STATES COAST GUARD

INVESTIGATION INTO THE CIRCUMSTANCES
SURROUNDING THE COLLISION BETWEEN THE

M/V BALSA 37

ON AUGUST 10, 1993, WITH NO LOSS OF LIFE

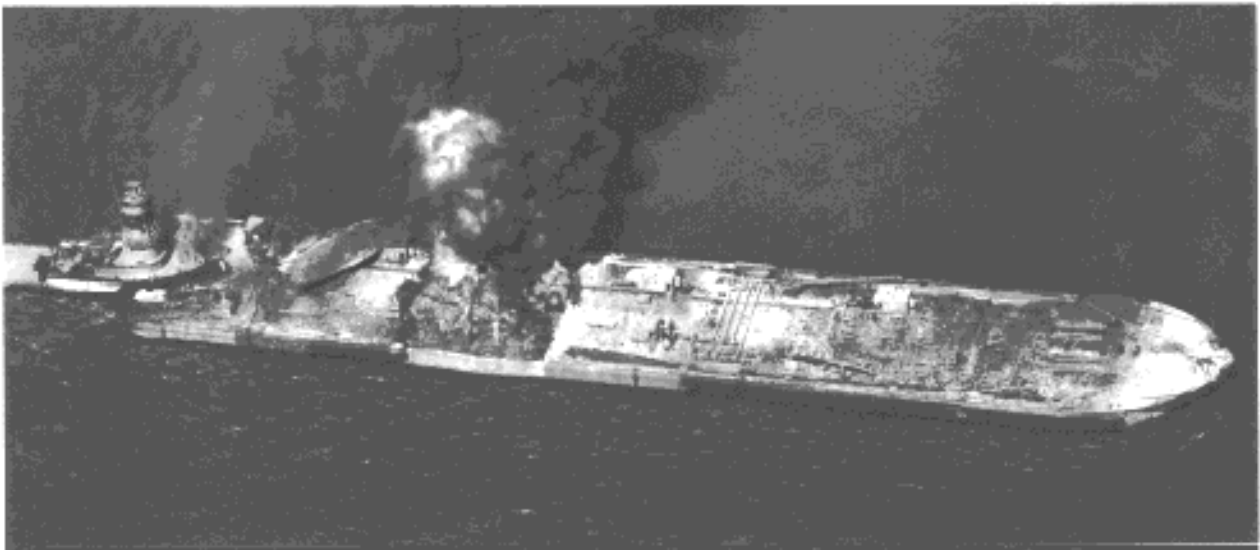
The SEAFARER tow grounded near Fort De Soto Park. Its No. 6 starboard tank exploded and the fire burned out of control until extinguished by the Tampa Fire Department that evening. The BALSА 37 was grounded south of the channel near Egmont Key to prevent sinking. The BOUCHARD tow proceeded to anchorage near the Sunshine Skyway Bridge while continuing to release oil.

Fire aboard the T/B OCEAN 255

Initially, the OCEAN 255 was ablaze from stem to stern and there was fire on the water surrounding the vessel. Eventually the fire alongside the vessel burned out and the fires forward and aft of the No. 6 starboard cargo tank were extinguished. The fire in No. 6 starboard cargo tank presented the most significant problem to firefighters because the 16,098 barrels of Jet-A fuel were directly exposed to the atmosphere (the tank top having been blown off by an explosion).

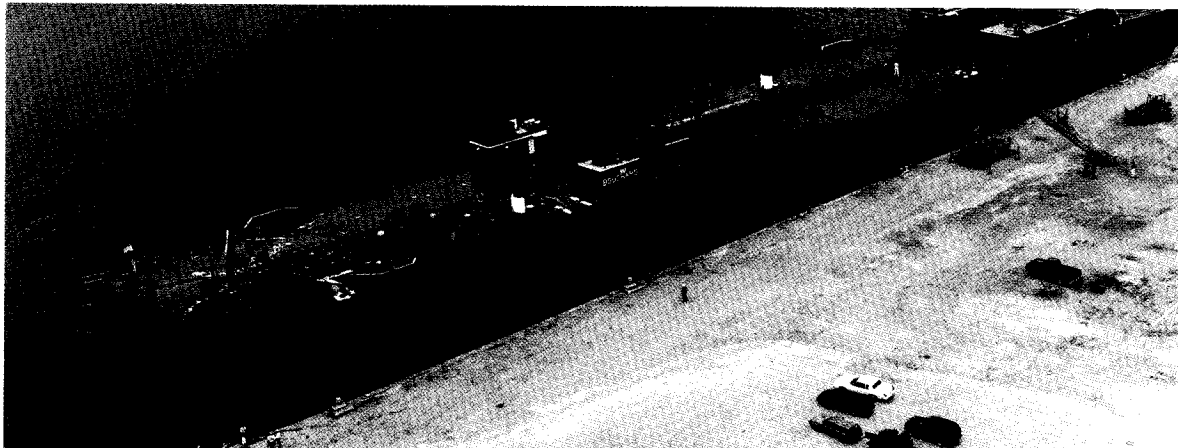
Tug CAPT FRED BOUCHARD and the T/B NO. 155

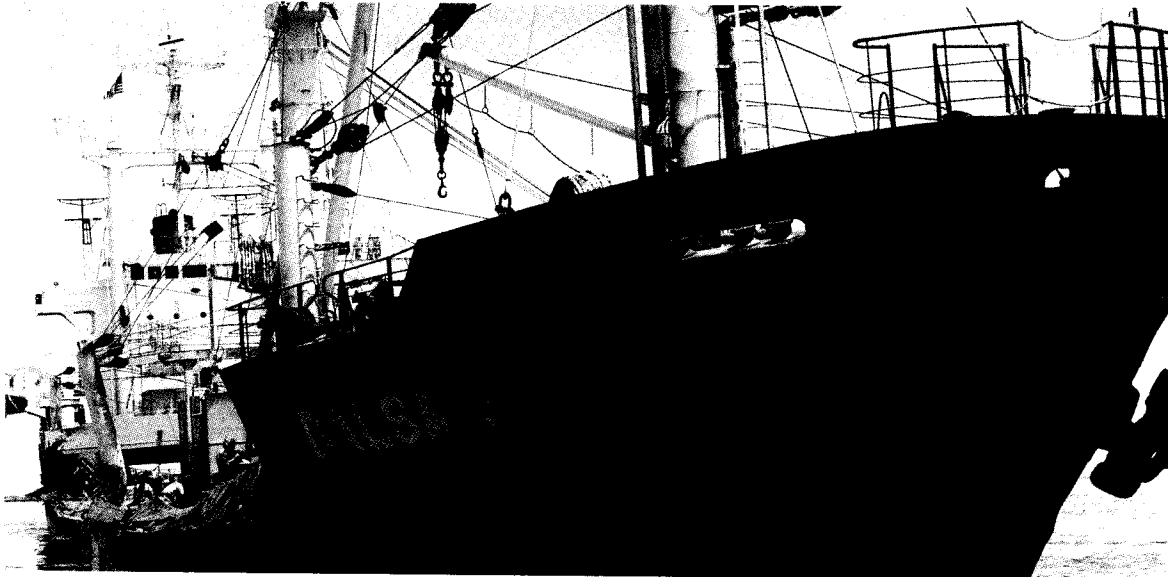
The outbound BALSА 37 steered a course placing it near the centerline of Mullet Key Channel. The BALSА 37 and the SEAFARER tow had made a port-to-port meeting agreement. However, as the vessels approached, each came hard to port to avoid collision. At approximately 0545 (all times EDT unless otherwise noted), the starboard bow of the OCEAN 255 struck the starboard side of the BALSА 37. The impact ruptured the No. 1 starboard tank of the OCEAN 255, igniting its cargo. The SEAFARER crew abandoned ship and was rescued by the Tampa Bay pilot boat MANATEE. The BALSА 37 suffered extensive damage along its starboard side and cargo holds. The BALSА 37 separated from the OCEAN 255 and then collided with the BOUCHARD tow less than one minute later, rupturing the B. NO. 155's No. 1 port tank. 5000 barrels of No. 6 oil were released. The collision damaged the bow of the BALSА 37, rupturing its forepeak tank.

The M/V Balsa 37

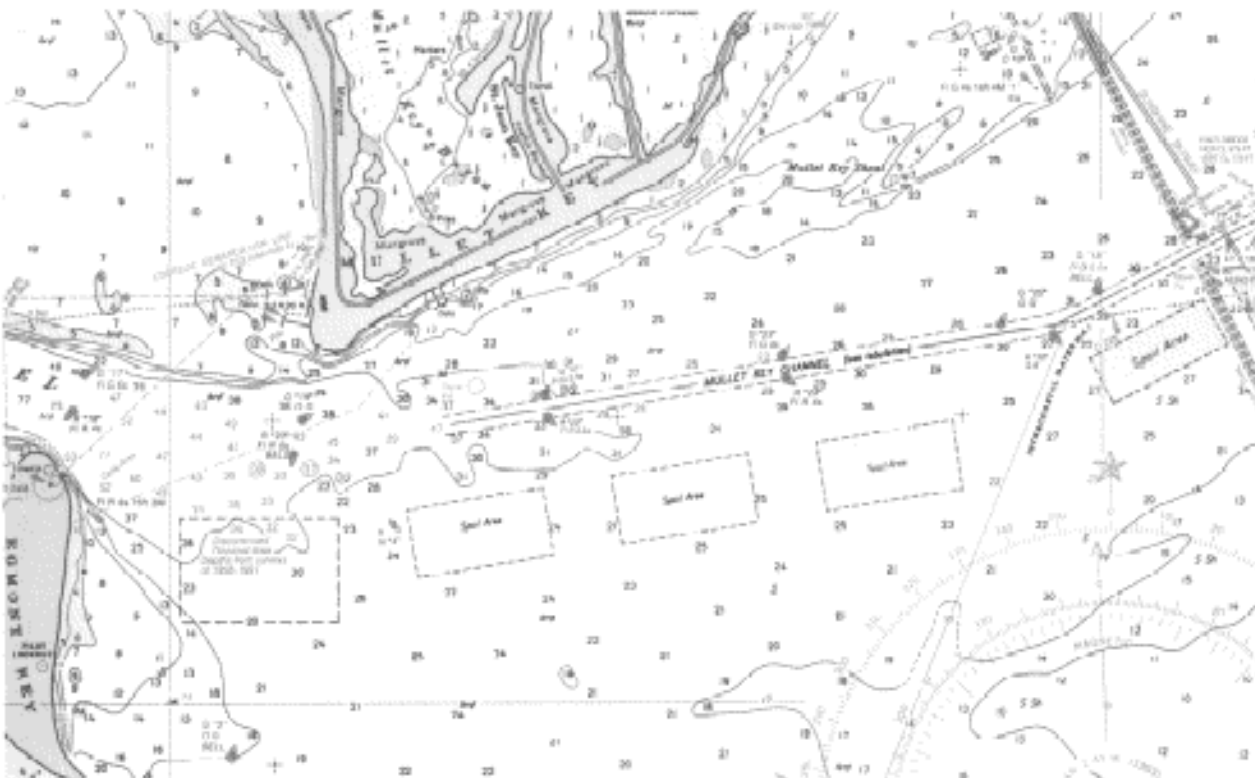
Figure 1 - Portion of chart 11414 showing the area of the collision

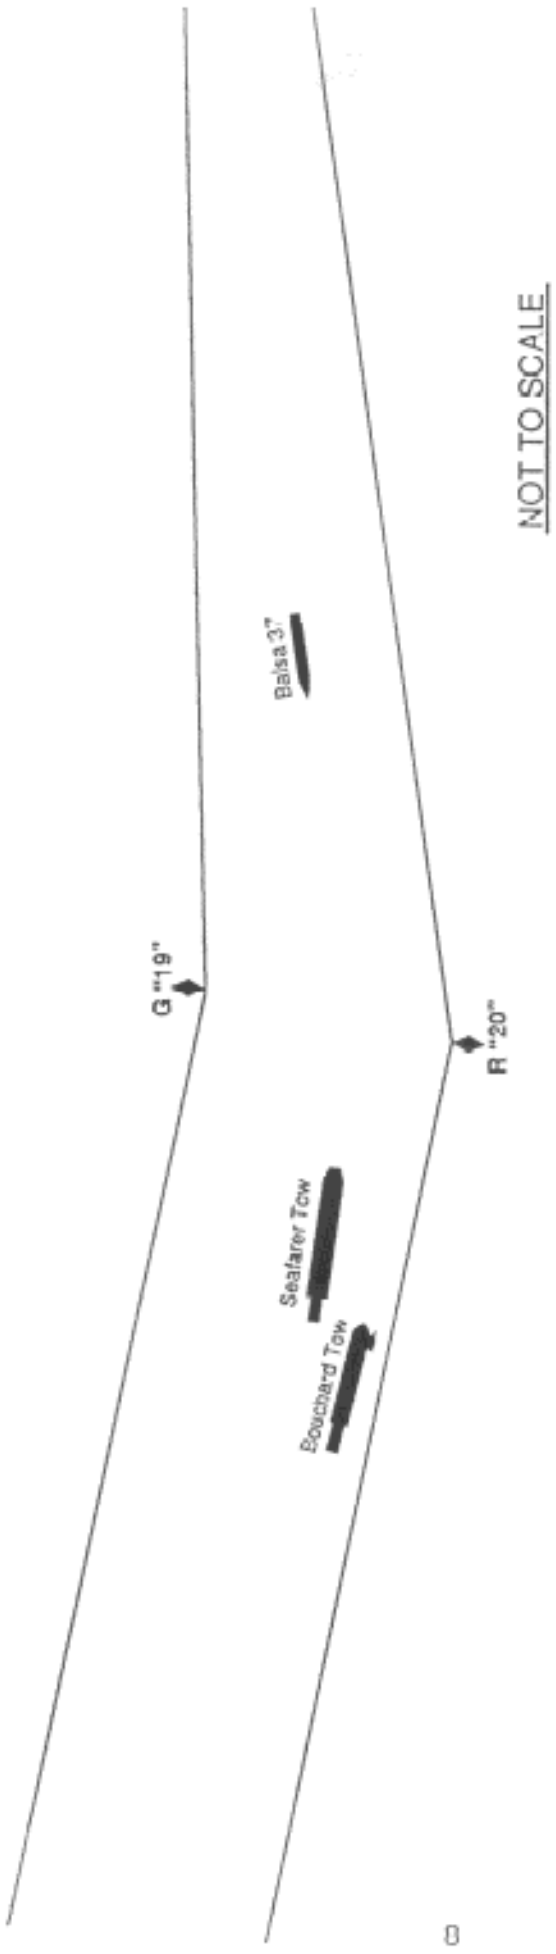
Figure 2

APPROXIMATE POSITIONS AS
VESSELS APPROACHED TURN
