**MARINE CASUALTY REPORT**

**M/V CHESTER A. POLING;  
SINKING IN THE ATLANTIC OCEAN  
ON 10 JANUARY 1977 WITH LOSS OF LIFE**

**U.S. COAST GUARD  
MARINE BOARD OF INVESTIGATION REPORT**

**REPORT NO. USCG 16732/73448**

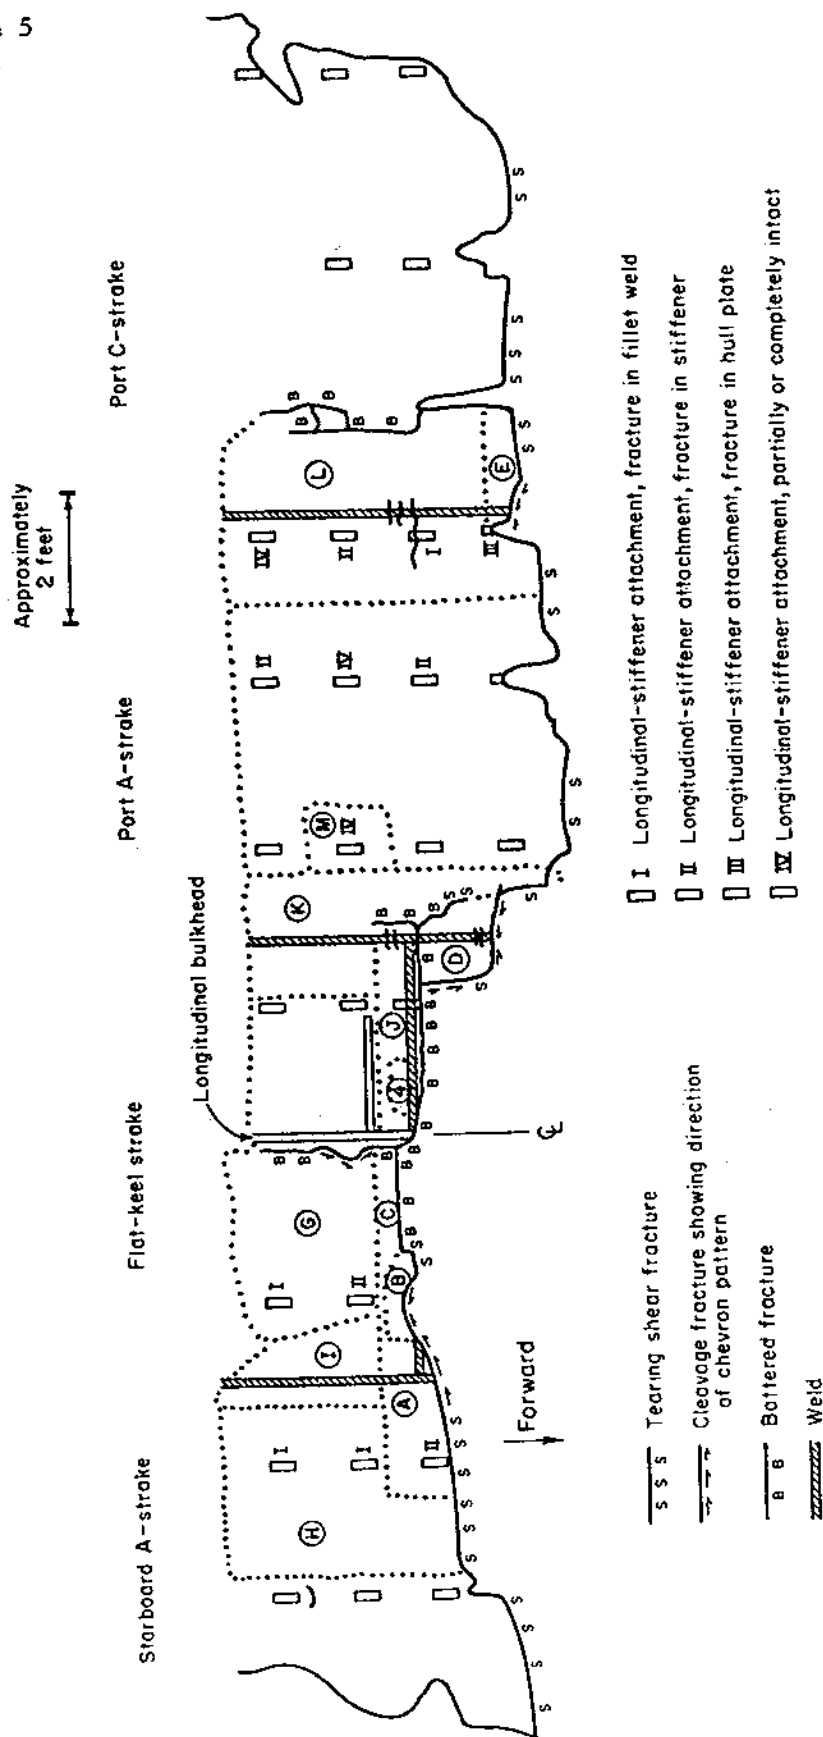
Figure 5

(d) Fractures—A map of the portion of the fracture studied is shown in figure (5). The circled letters designate the pieces that were sent to Battelle. The pieces of the bottom plate were bent with the concave side of the bend generally being upward, especially along the fracture. The centerline bulkhead also was bent, and a vertical stiffener on the bulkhead had been bent backward approximately 90 degrees. Four of the longitudinal stiffeners remained attached to the plate at positions several feet from the fracture, but they had been torn from the plate near the fracture. The stiffeners also were severely bent as though they had been pushed toward the stern. Fractures in the attached stiffeners occurred in one of three places: in the fillet weld, in the stiffener, or in the plate. The locations of some of the individual fractures are indicated by Roman numerals in figure 5. Most of the fracture in the flat keel plate was badly battered, giving the appearance that it had been pounded by the mating fracture surface prior to the ultimate failure. This implies that the two halves of the hull maintained their alignment for some time after some plating and stiffeners failed. The flat keel plate fracture surface was probably a brittle mode failure. Most of the fractures in both A-strakes and the port C-strake were tearing shear fractures. The surfaces were smooth and at approximately 45 degrees to the top and bottom surfaces. Battelle's metallographic examination revealed that the deformation associated with the tearing shear fractures was all downward, indicating that the forward half of the ship was moving downward with respect to the aft half as the bottom hull plate tore apart. A tearing shear fracture, as opposed to a tensile or propagating shear fracture, generally is the final event in a fracture process and is not associated with fracture initiation.

(e) Secondary Cracks—Many secondary cracks were observed in the top surface of the longitudinal seam welds and the plate within a couple of feet of the fracture. Secondary cracks were also observed in the bottom surface of the flat keel within an inch of the fracture. Some of the cracks were opened fairly wide, suggesting that the plate had previously been bent upward and the cracks probably formed when the plate was bent back downward.

FIGURE 5. MAP OF FRACTURE IN THE BOTTOM HULL PLATE OF THE CHESTER A. POLING  
The top (inside) surface of the plate is shown.
