UNITED STATES COAST GUARD

INVESTIGATION INTO THE CIRCUMSTANCES
SURROUNDING THE SINKING OF THE

M/V MISS MAJESTIC

ON LAKE HAMILTON, HOT SPRINGS, ARKANSAS ON
MAY 1, 1999 WITH MULTIPLE LOSS OF LIFE

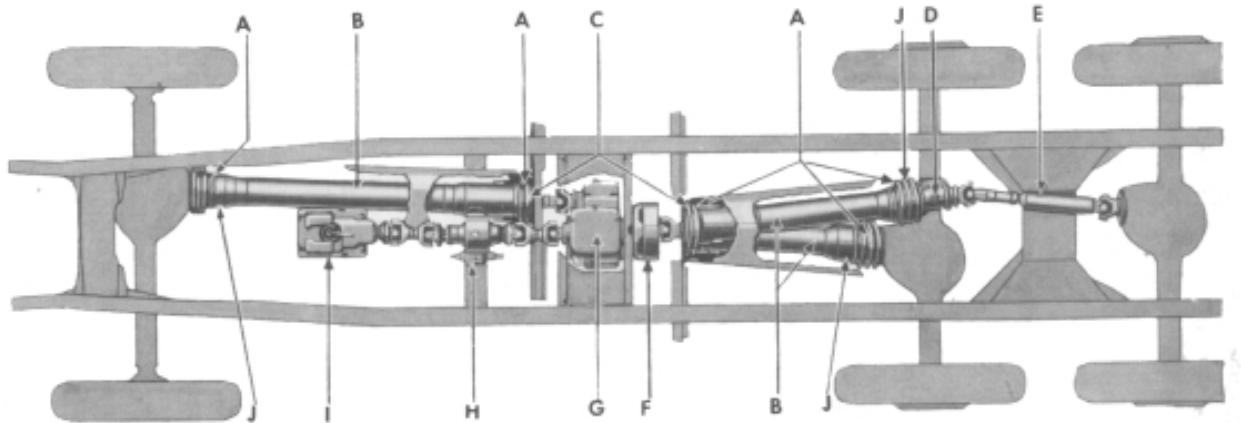
Figure 2: Shows the chassis and drive trains. There were three each 3 inch diameter drain plugs in the molded hull, which also gave access to the engine crankcase, the transmission case, and the transfer case. Each drive shaft was surrounded by a shaft housing, attached to the molded hull and the axle differentials with thin-wall rubber (boot) seals, using a single metal band clamp to secure each boot seal to the shaft housings.
