MARINE CASUALTY REPORT

S/S EXXON HOUSTON

GROUNDING NEAR BARBERS POINT, HAWAII

REPORT NO. USCG 16732/01 HQS 92

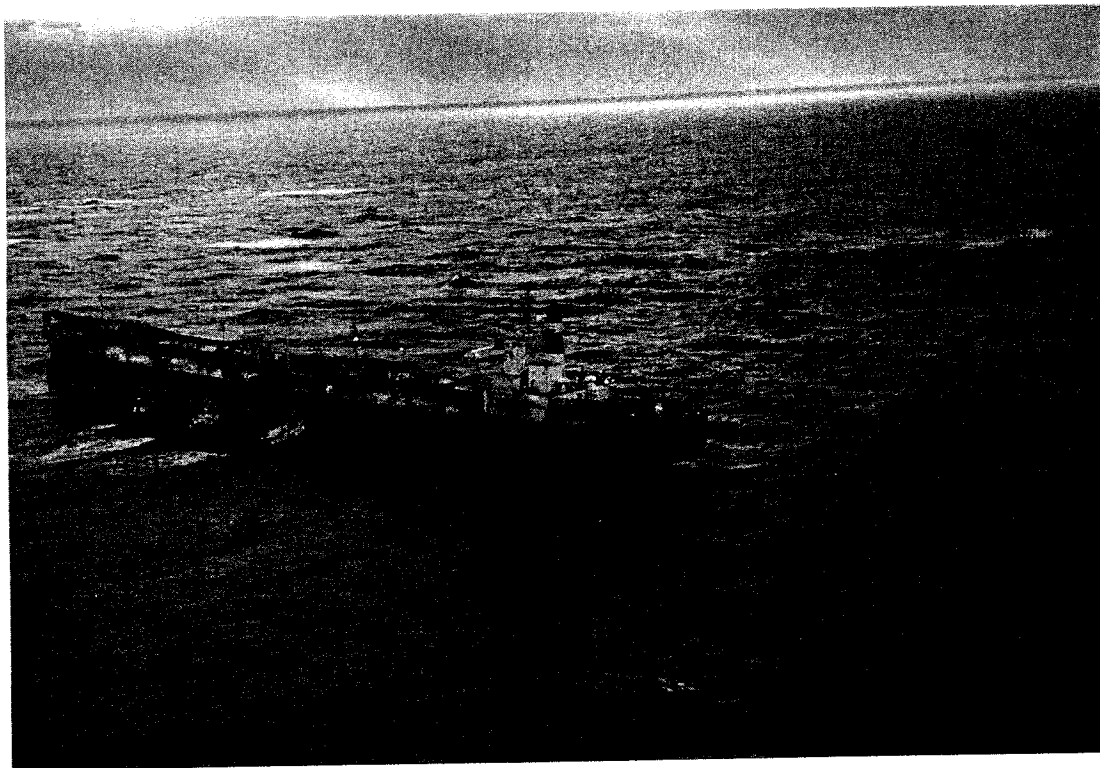
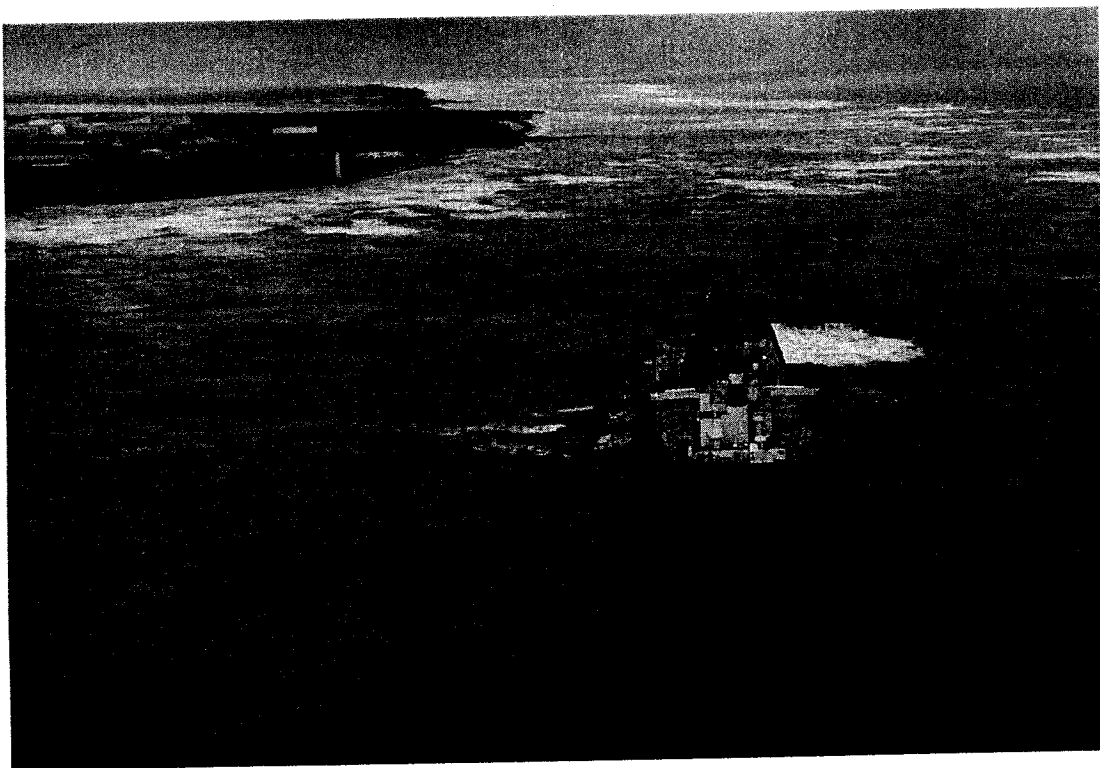
EXXON HOUSTON - AGROUND BARBER'S POINT, 3 MARCH 1989
PHOTO BY - CCGD14(dpa)

Upon grounding of the vessel, the only immediately detectable damage was in the way of the Port Bunker Tank which was leaking bunker oil to the sea and in the engine room double bottoms in the vicinity of the main condenser sea chest. The surveys conducted after freeing the vessel revealed extensive damage in the No. 3 Port Cargo Tank and No. 5 Starboard Cargo Tank. In

addition, several indented areas in scattered areas of the bottom plate with related framing damage was discovered. Based on the age and condition of the vessel, the Exxon Houston was determined to be a constructive total loss.

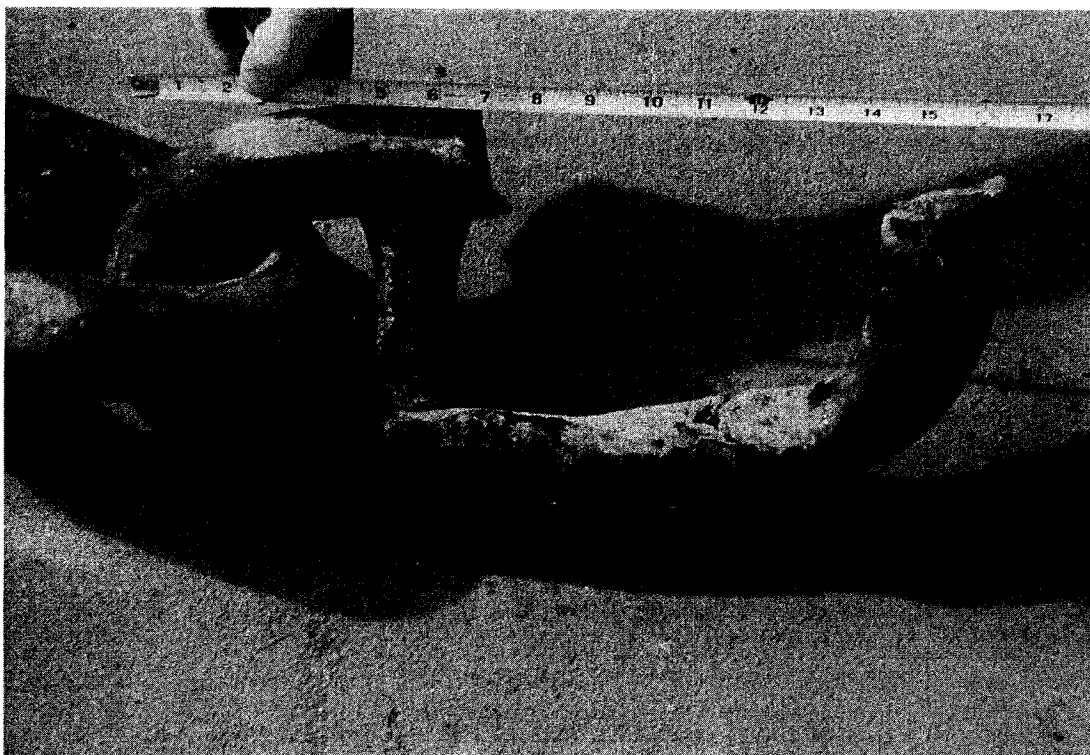
"It is concluded that the failure of link No. 10 in the mooring chain was due to the defects in the weld and to the poor properties exhibited by the base metal immediately adjacent to the weld. The poor properties of the base metal are attributed to the forging design which caused the material to be loaded, effectively, in the transverse direction. The transverse properties, ductility and strength of steels such as used here are undoubtedly lower than the longitudinal properties measured in the tensile test. The defects left in the weld are caused by inadequate ejection of molten metal during the welding process and suggest that a redesign of the weld cycle is warranted."

LINK NO. 10 OF FAILED CHAFE CHAIN. THIS LINK REMAINED ON BOARD EXXON HUSTON AFTER SEPARATION. PHOTO TAKEN BY LT [REDACTED] ON 5 MARCH 1989. EXHIBIT NO. 41
