## **MARINE CASUALTY REPORT**

**FISHING VESSEL FISH-N-FOOL, D.N. 293888**

**CAPSIZING AND SINKING ON 5 FEBRUARY 1987  
IN THE PACIFIC OCEAN APPROXIMATELY 2.6  
MILES SOUTH OF ISLA DE SAN MARTIN,  
MEXICO WITH MULTIPLE LOSS OF LIFE AND  
INJURIES TO PASSENGERS**

**Marine Board of Investigation Report  
and  
Commandant's Action**

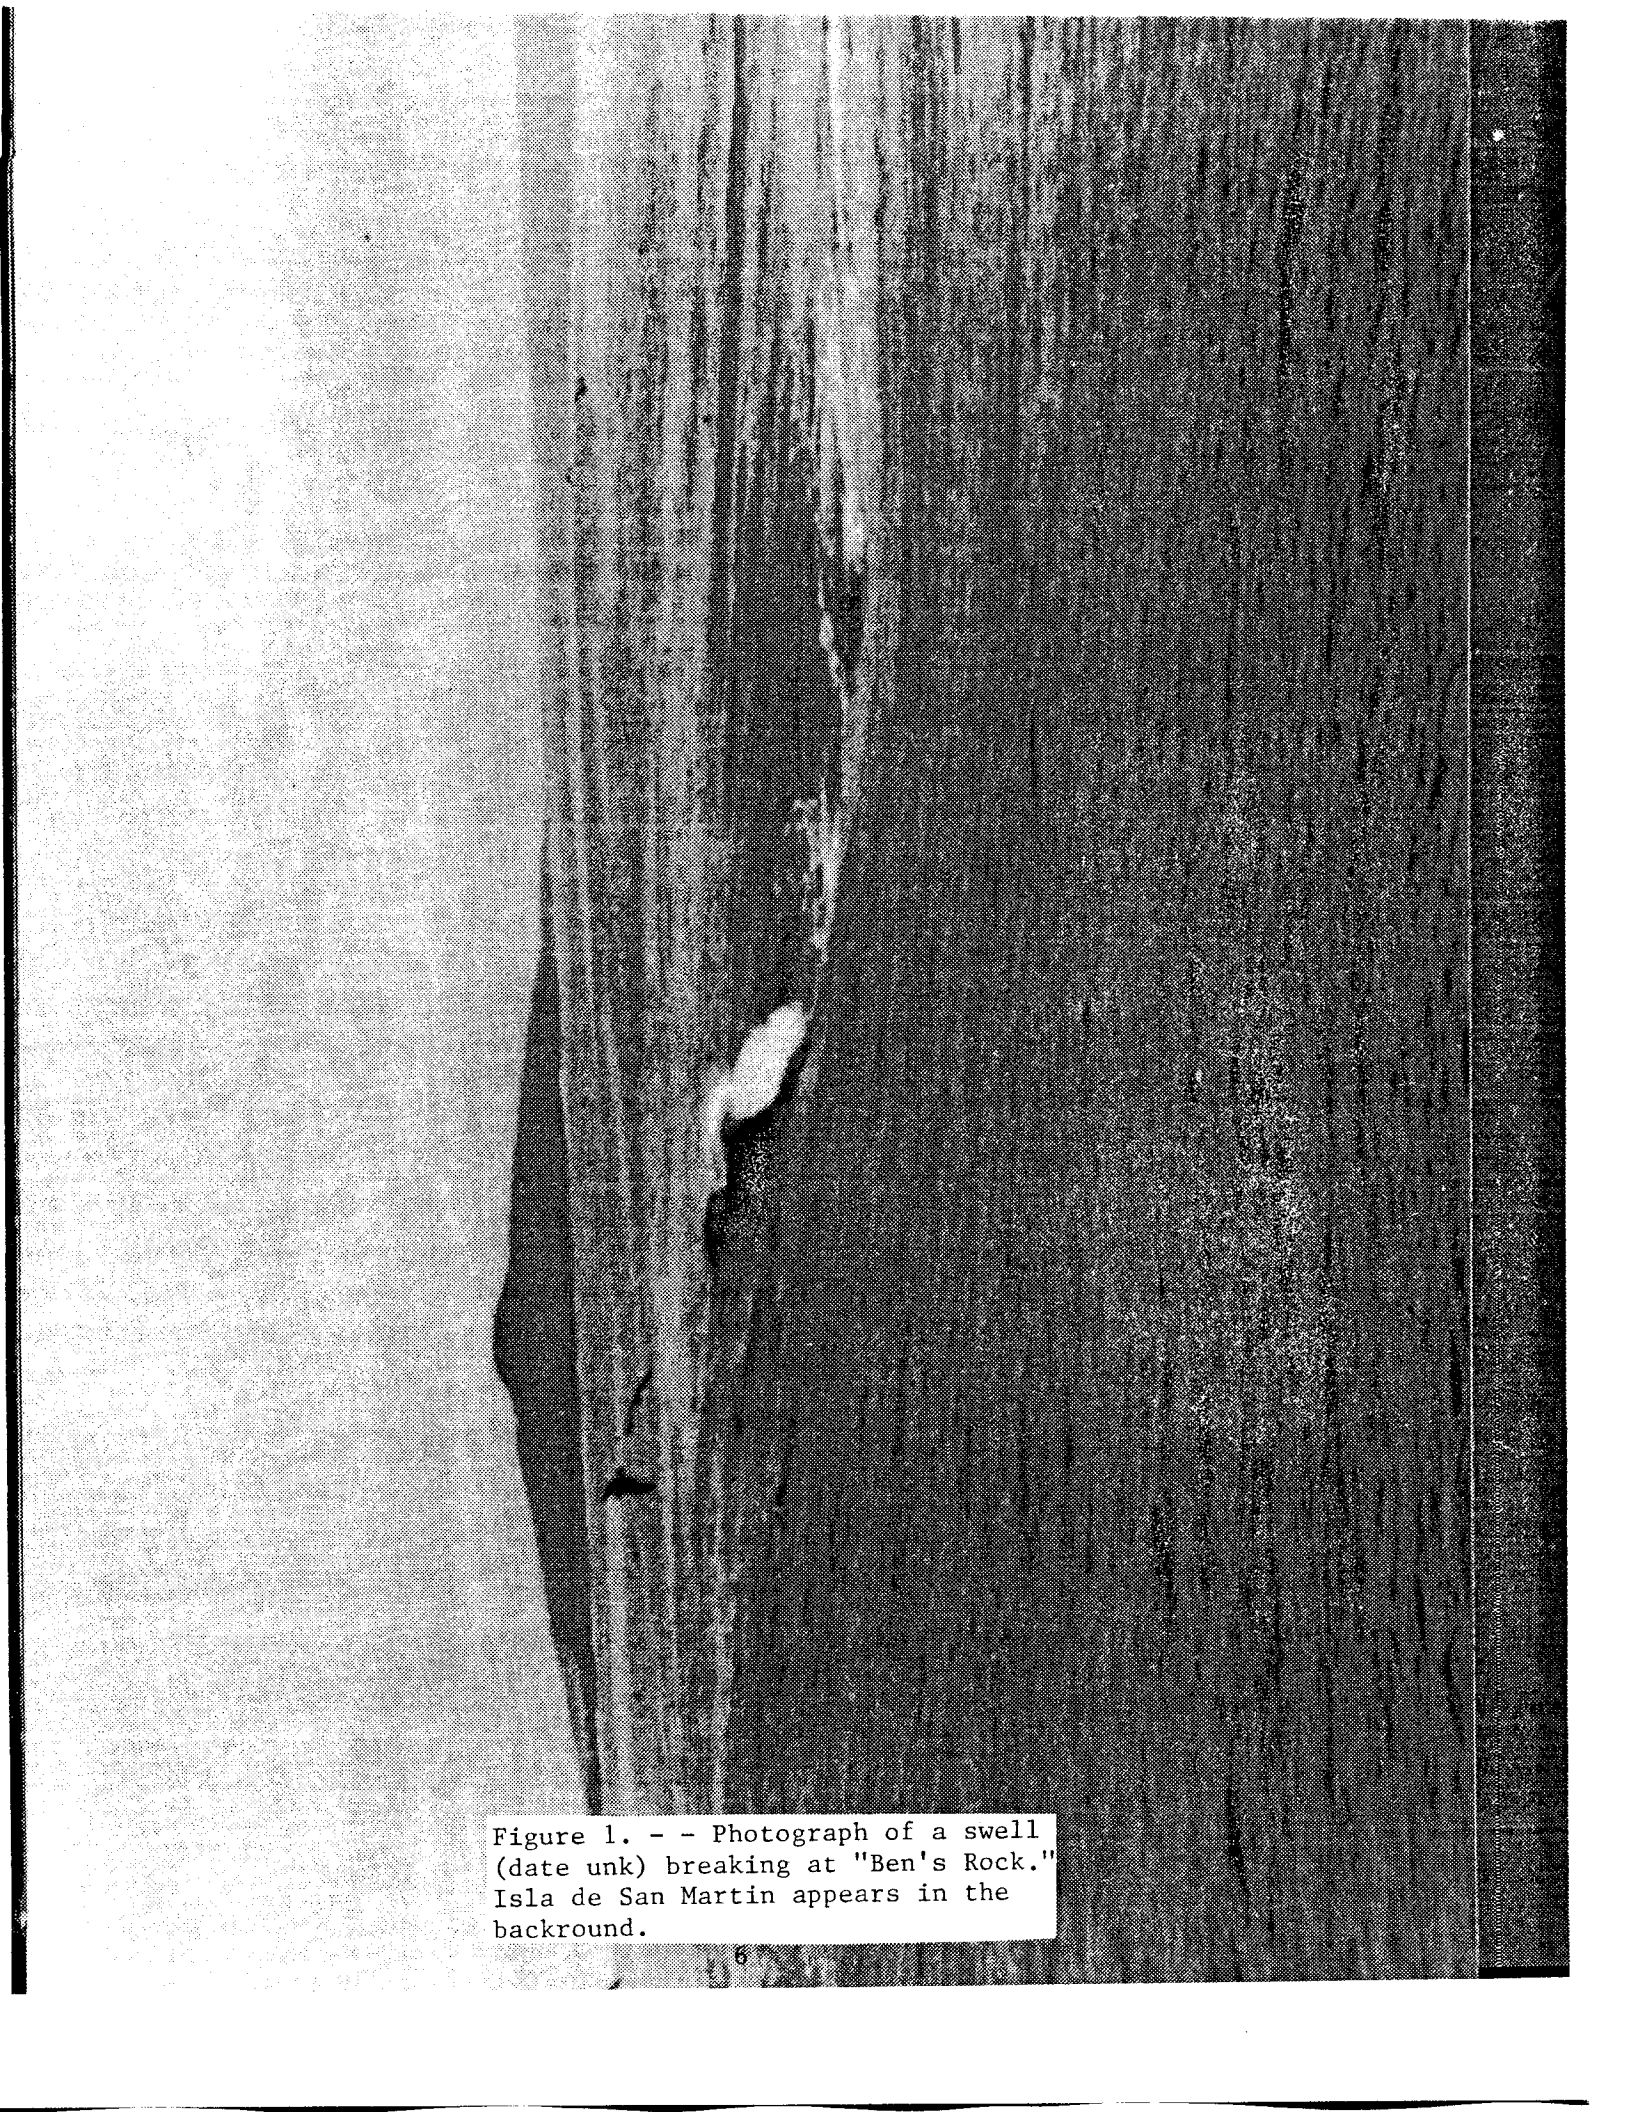
Figure 1. - - Photograph of a swell  
(date unk) breaking at "Ben's Rock."  
Isla de San Martin appears in the  
background.

15. The intermittent nature of the occurrence of large swells breaking at Ben's Rock could produce a false sense of security for operators of vessels approaching or operating around this charted hazard.

16. Prior to its encountering the topography of Ben's Rock, the swell that caused the capsizing of the vessel was probably near the size of the largest swell that could have been expected under existing sea conditions.

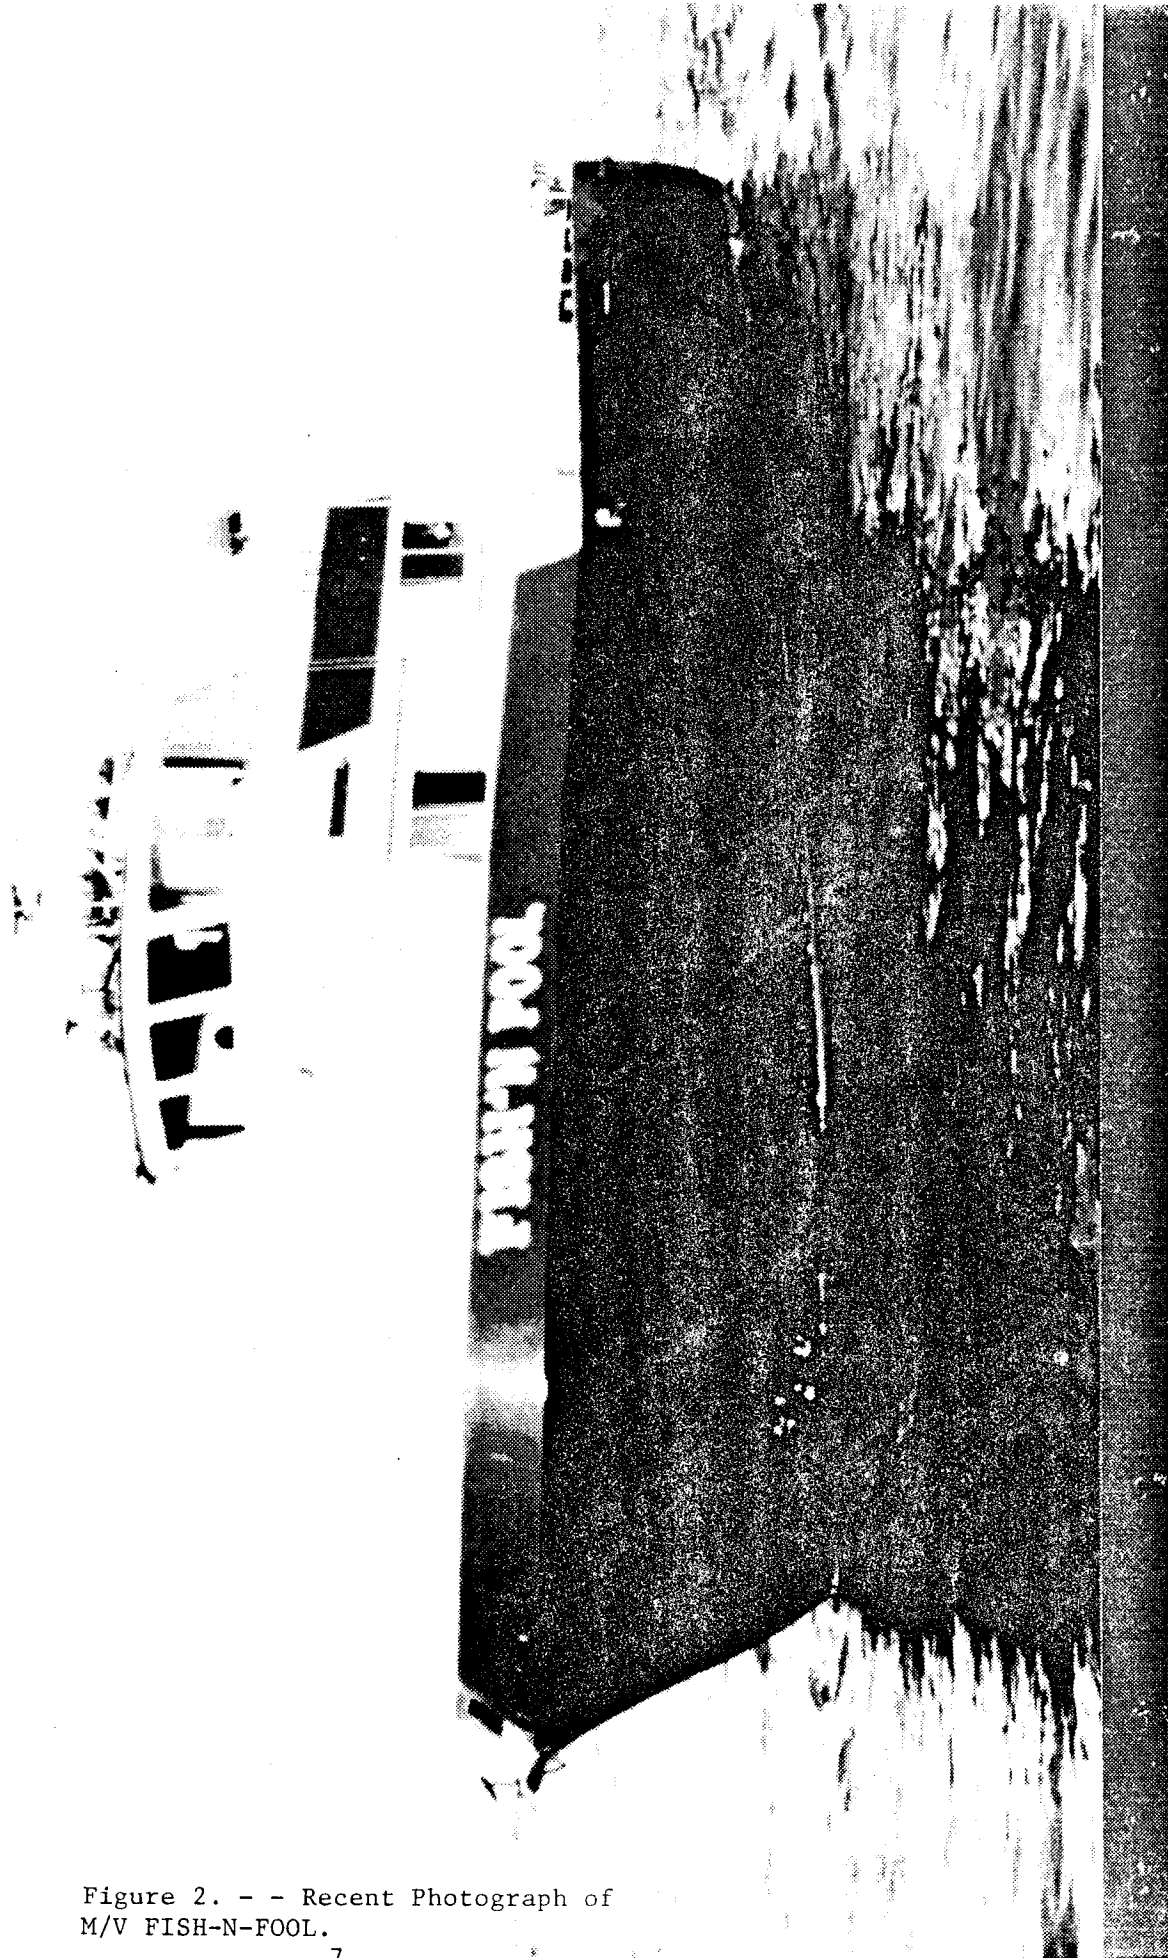
Figure 2. - - Recent Photograph of  
M/V FISH-N-FOOL.
