# MARINE CASUALTY REPORT

UNINSPECTED TOWING VESSEL  
FRANK PALLADINO JR  
O.N. 619166

GREAT LAKES BARGE  
KELLSTONE I  
O.N. 274472

COLLISION WITH A PLEASURE  
CRAFT (OH 0164 YU) IN THE  
SOUTH PASSAGE OF LAKE  
ERIE, ON 1 OCTOBER 1994,  
WITH AN INJURY AND  
MULTIPLE LOSS OF LIFE.

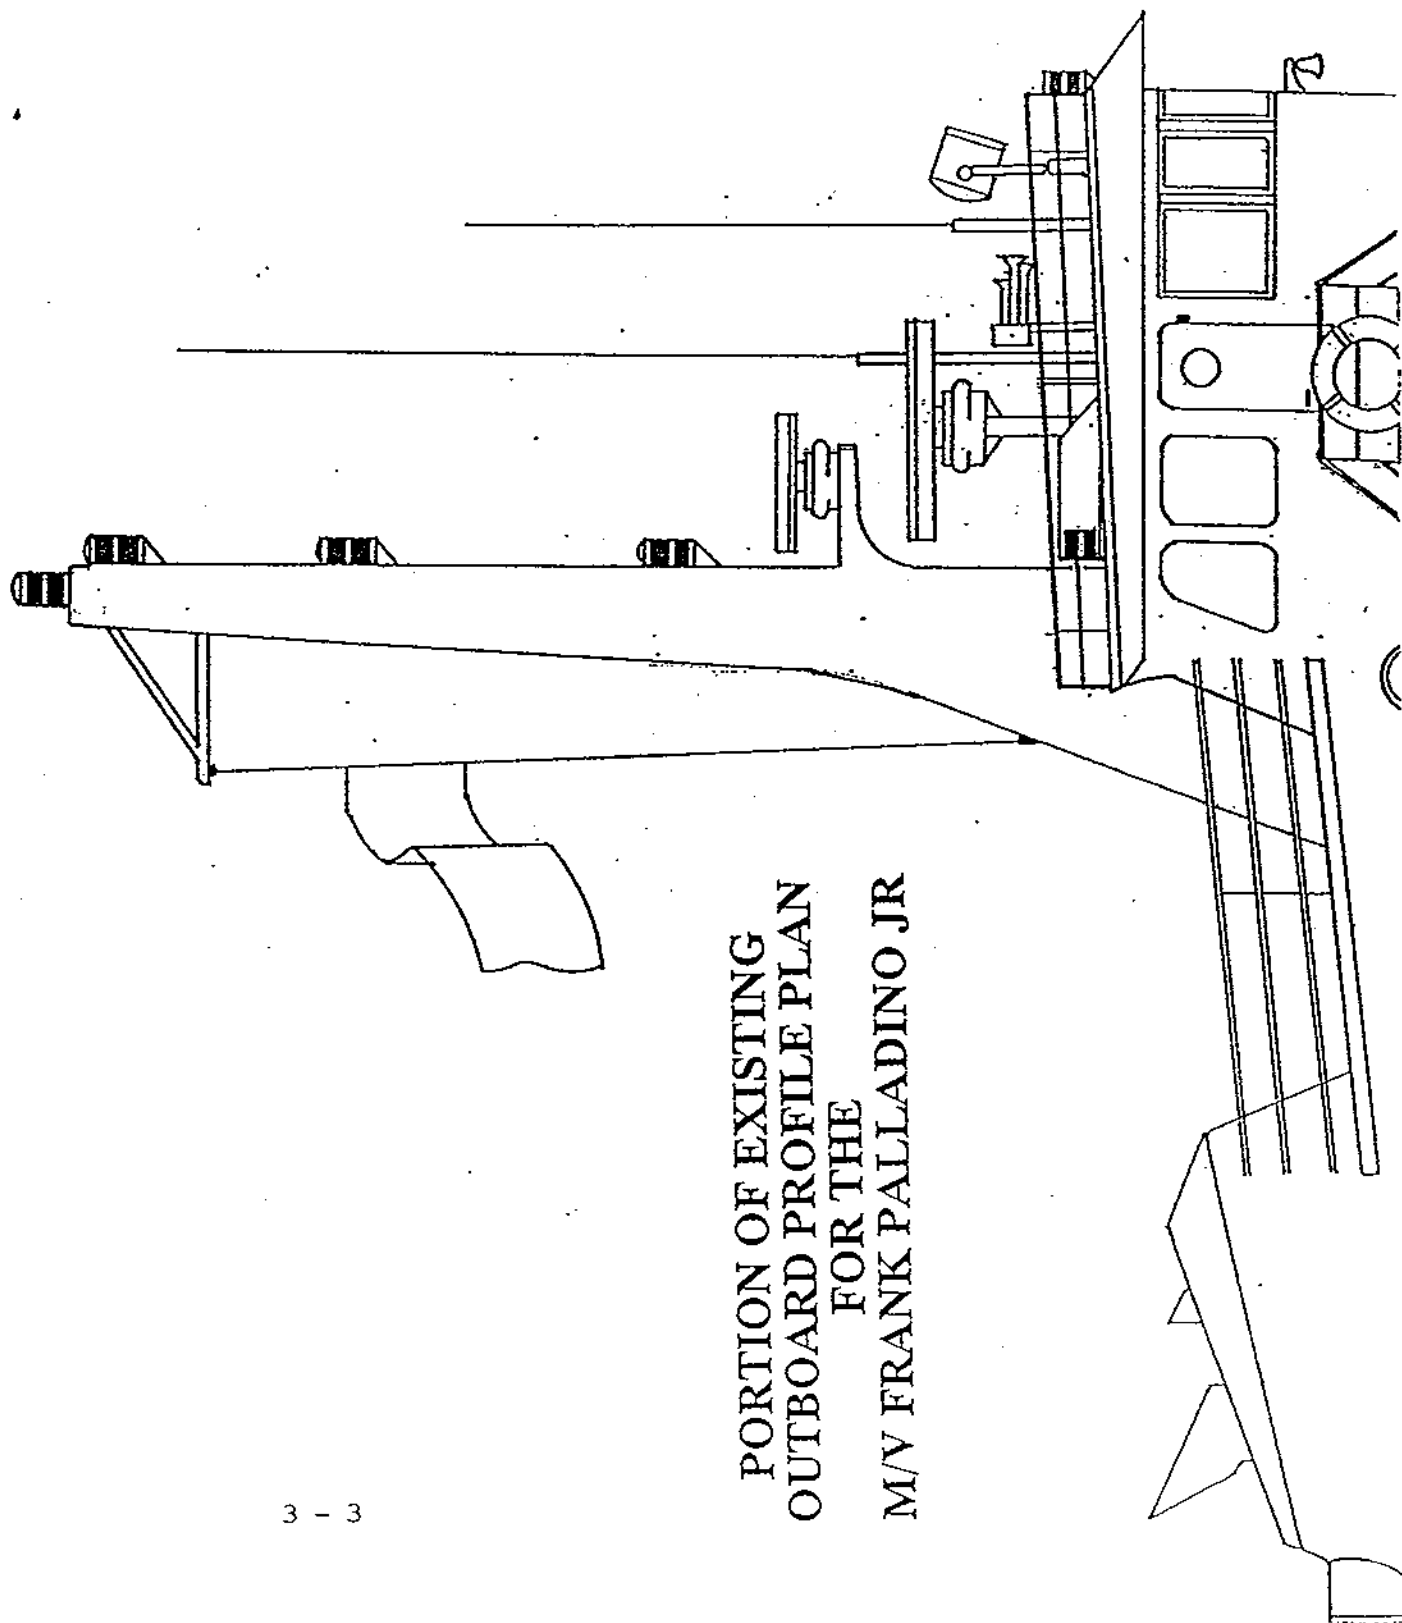
PORTION OF EXISTING  
OUTBOARD PROFILE PLAN  
FOR THE  
M/V FRANK PALLADINO JR

1. A cardboard tube of blueprints for the tug was given by Captain [REDACTED] to LTJG [REDACTED] while the latter was onboard the tug, on 2 October 1994. Captain [REDACTED] stated that he had them in his home on Kelly's Island. In this tube, was found a blueprint marked as "Outboard Profile Plan." A piece of tracing paper was taped over the superstructure of the tug with some drawing on it. The drawing depicted a theoretical modification to the tug which was studied in Cleveland, OH, in 1993. Consideration was given to add a raised pilot control station as an alternative to ballasting the barge. However, the company concluded that ballasting the barge was preferable to operating from an upper control station. [CG2, CG3, CG65A, p. 14; Figure 3 - 1; Figure 3 - 2]

11. "As the main deck of these barges when empty is from 35 feet to 40 feet above the surface of the water, tug captains were unable to see ahead from the tug's regular pilothouse. Upper pilothouses were added and are now the vogue for this work." [Blank, 1989, p. 83]

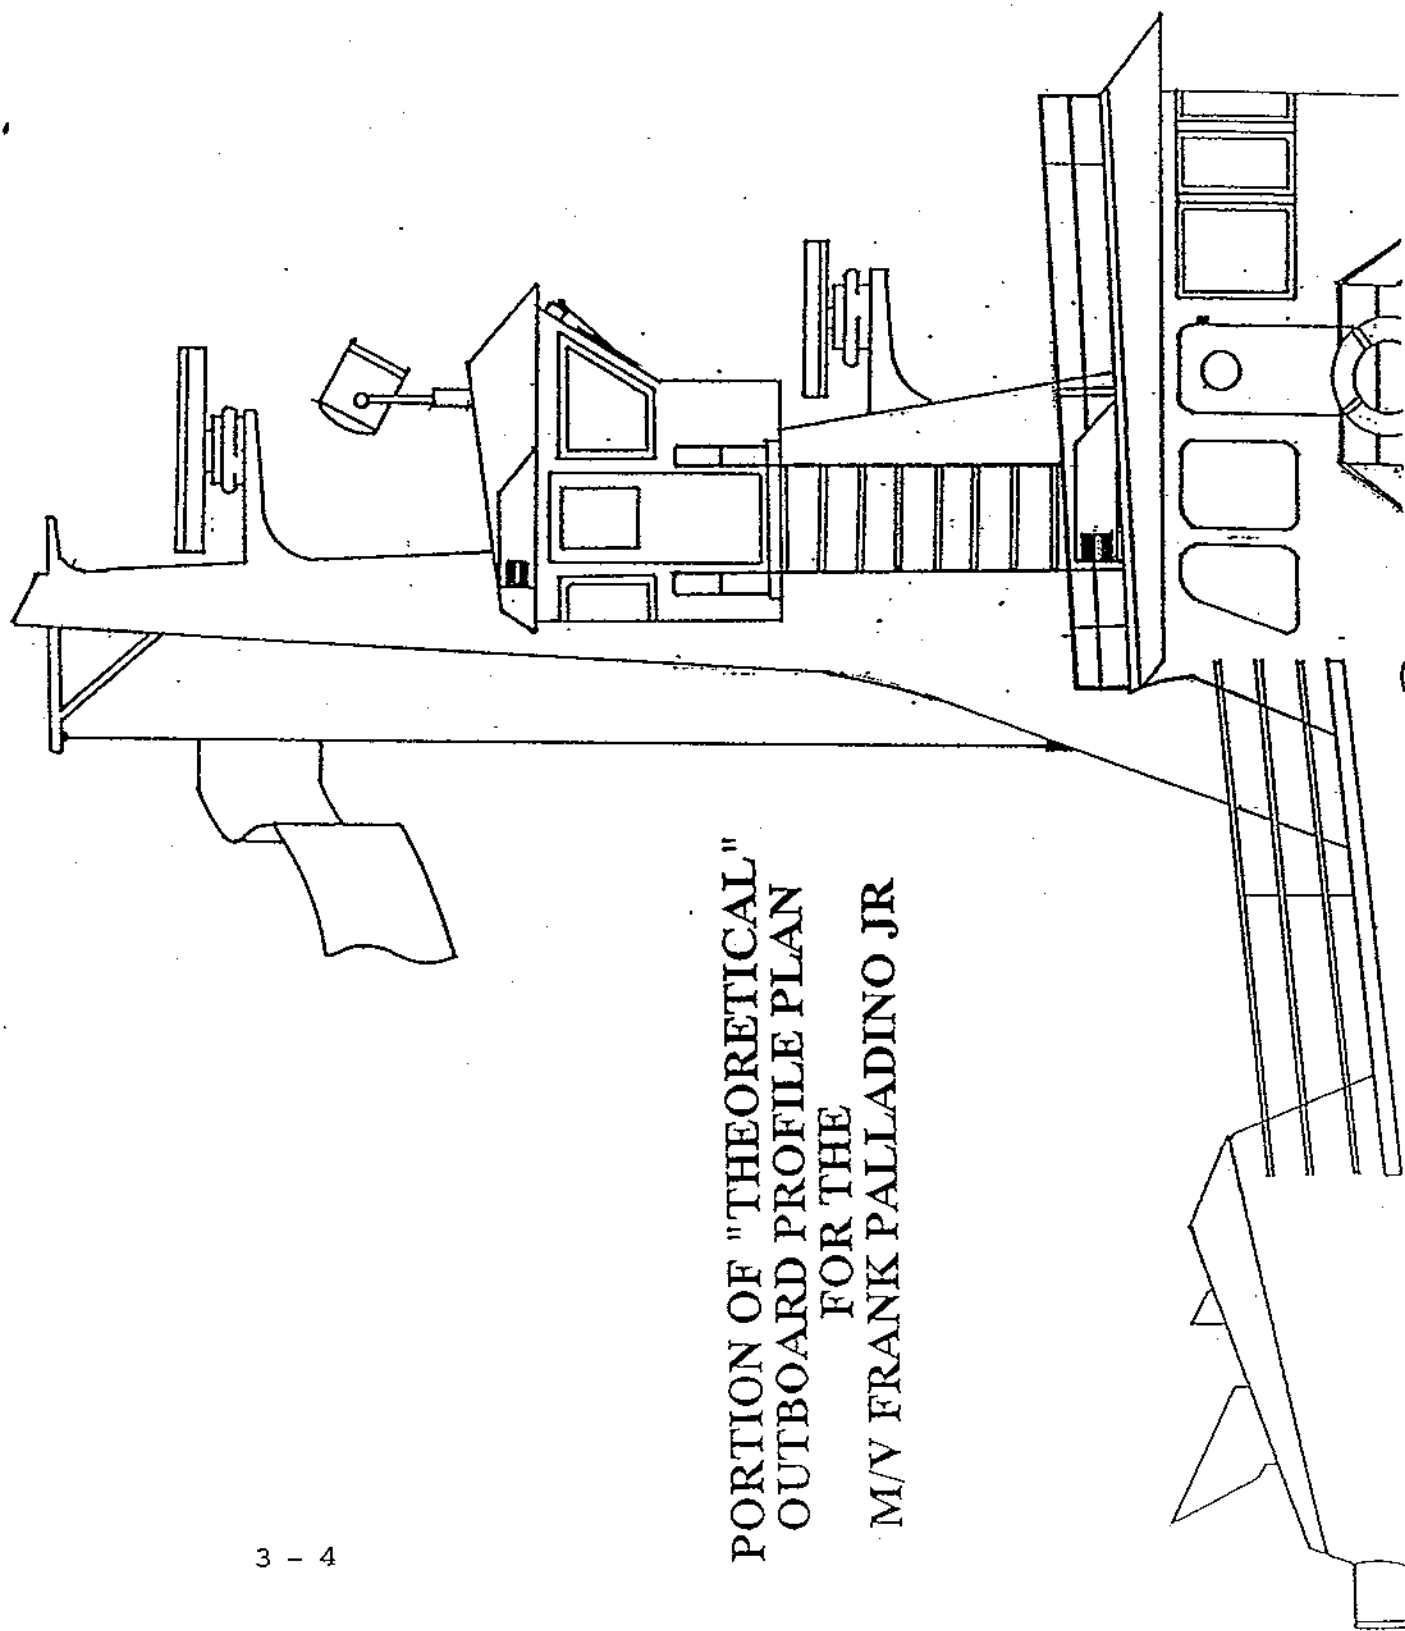
PORTION OF "THEORETICAL"  
 OUTBOARD PROFILE PLAN  
 FOR THE  
 M/V FRANK PALLADINO JR

12. It is an acceptable marine practice to post a bow lookout with suitable communication. "If the tug's pilot cannot see over his tow, knowledgeable personnel with a walkie-talkie should be stationed on the head of the towed unit to advise him of aids to navigation." [Blank, 1989, p. 317]

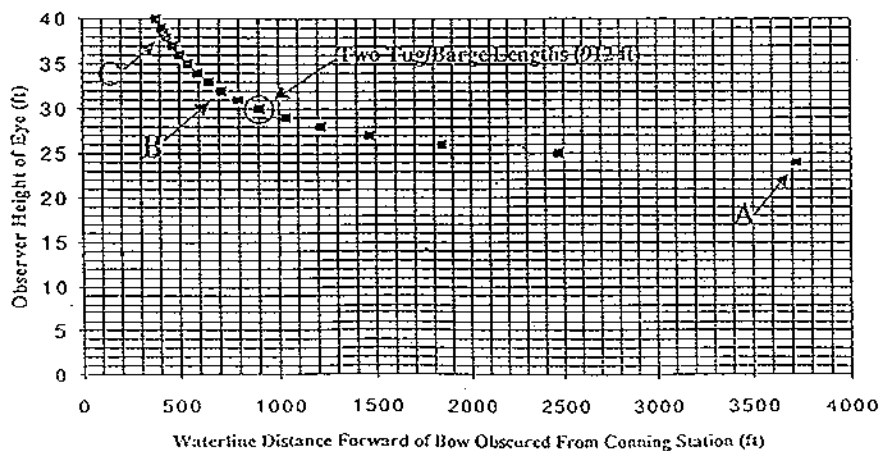
FIGURE 3 - 3

TABLE 3 -1. Waterline distance forward of the bow obscured from the conning station for the towing vessel FRANK PALLADINO JR in the notch of the empty Great Lakes barge KELLSTONE I. The length over all (LOA) for the combination is 456 feet (138.99 m). Two tug/barge lengths is equal to 912 feet (277.98 m).

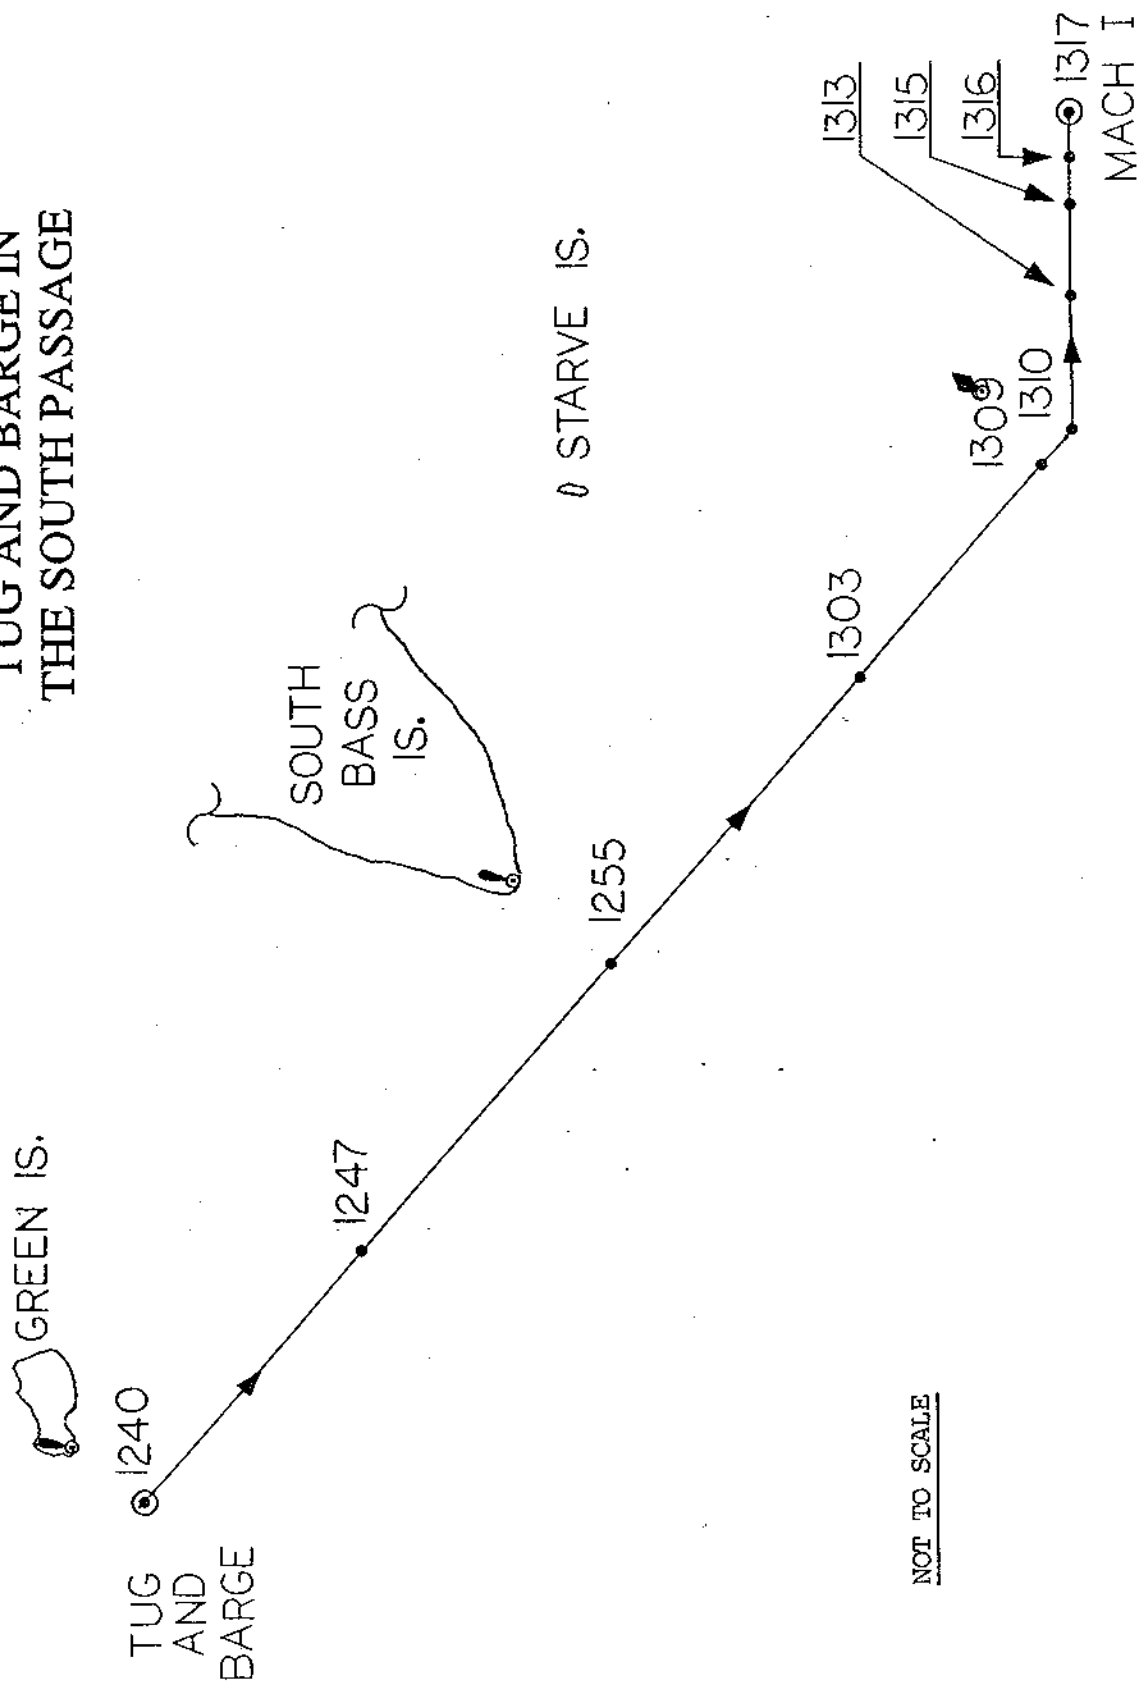
Figure 4 - 2

APPROXIMATE PRE-COLLISION  
DR TRACK OF THE  
TUG AND BARGE IN  
THE SOUTH PASSAGE

30. [REDACTED] saw the Mach 1 at or about 1303 hours, at approximately 1-1/2 miles away. This was about 14 minutes before the accident. [CG38; CG77; Figure 4 - 1; Figure 4 - 2]

32. [REDACTED] first saw the "large black vessel" (i.e., tug and barge) at least 8 minutes before the accident or sometime before approximately 1309 hours. At that time, Mr. [REDACTED] and Ms. [REDACTED] could see down the port side of the barge and all of the bow. They could not see the tug. The second time Ms. [REDACTED] saw it, it had already turned towards her. Mr. [REDACTED] did not believe that the large black vessel represented any danger when he first observed it. [CG77; K18; Figure 4 - 1; Figure 4 - 2; II TR, pp. 55, 56, 130, 131, 149, 150, 160, 165]

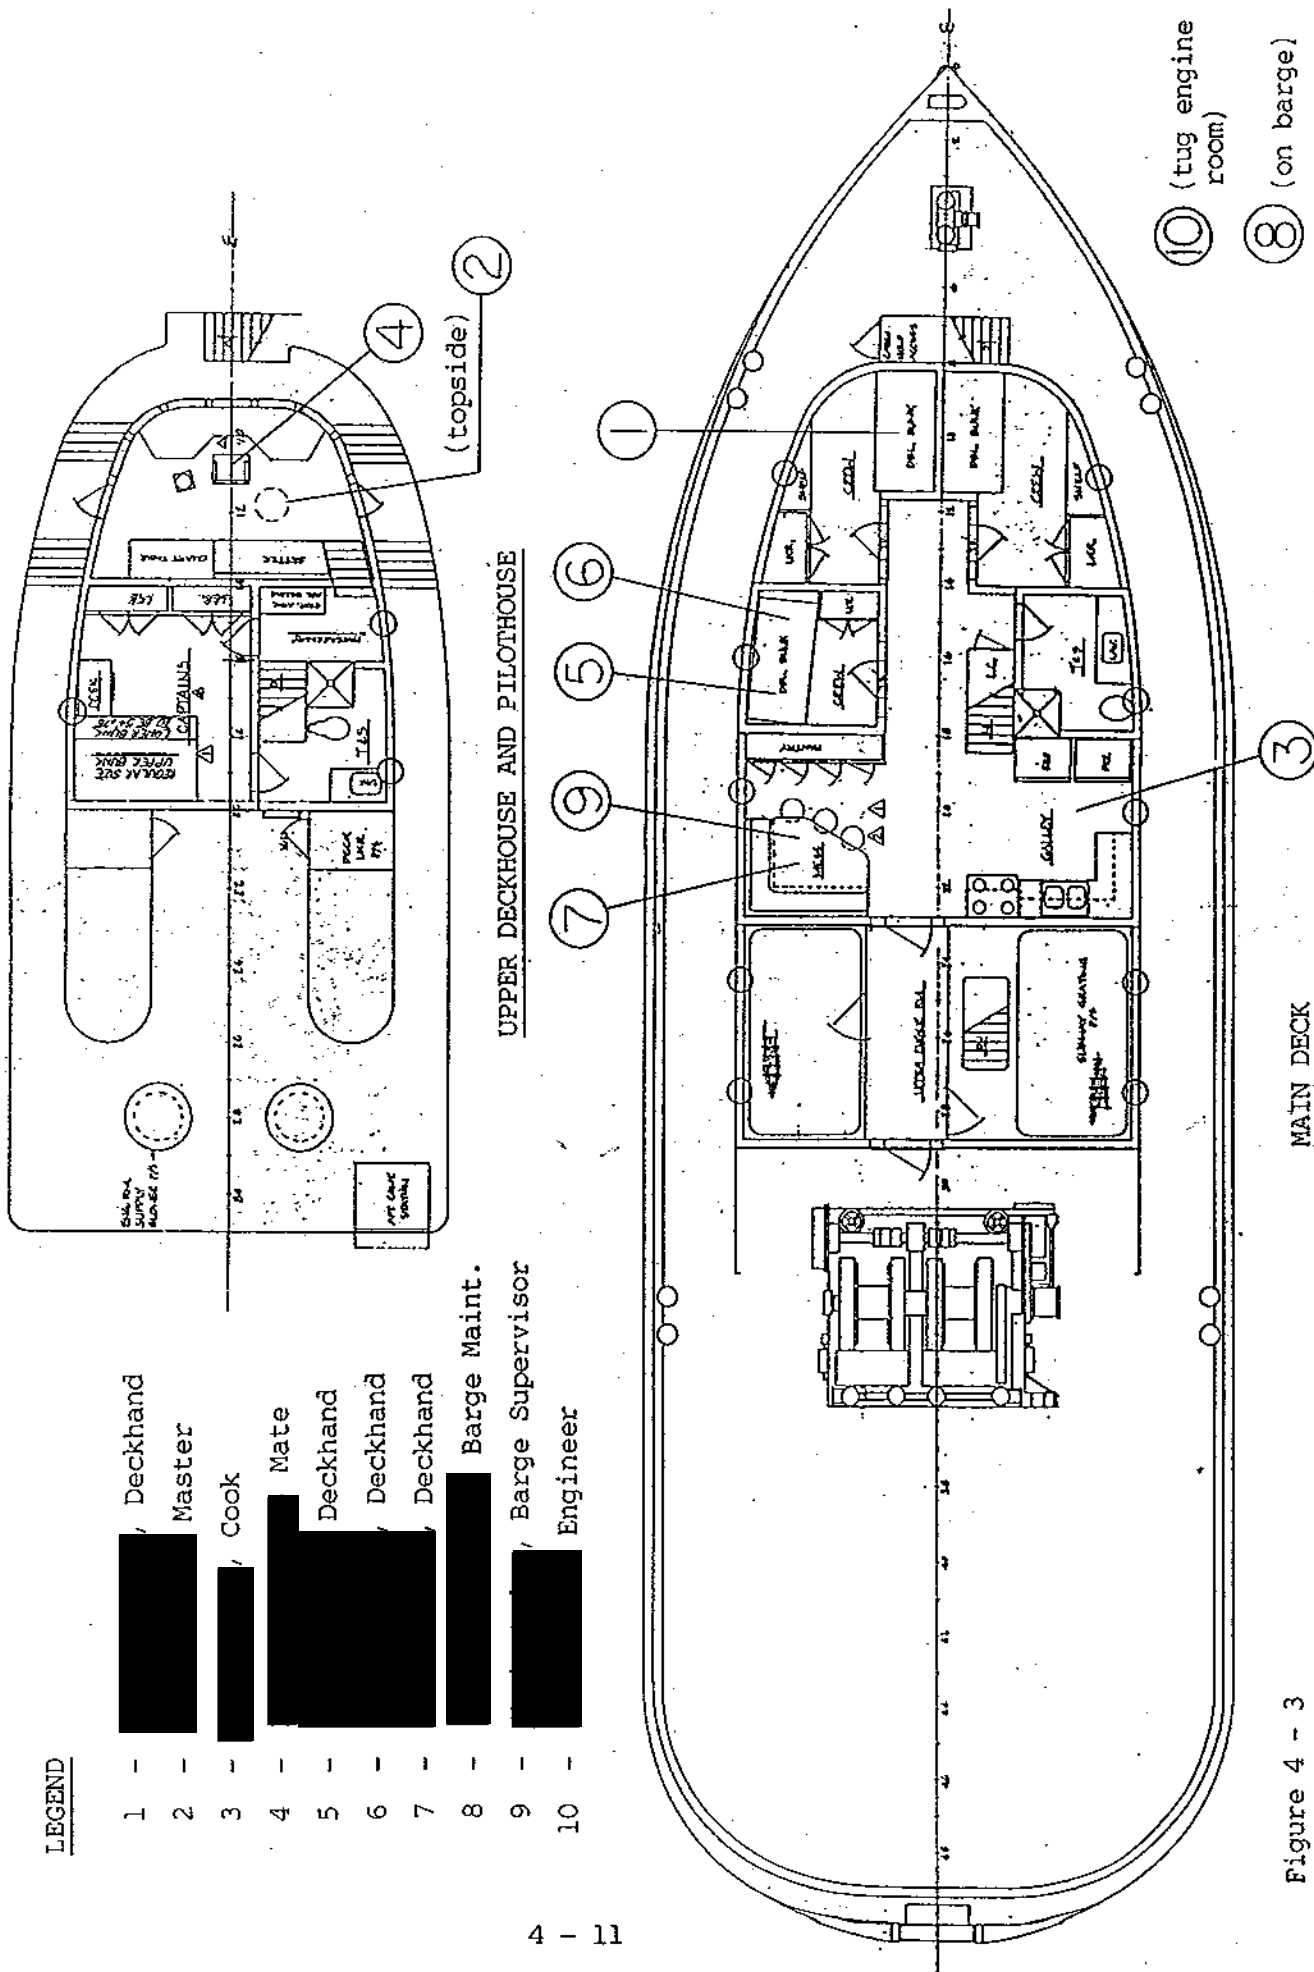
62. Figure 4 - 3 depicts the location of the tug and barge crewmembers at the time of the accident. [CG52]
