MARINE CASUALTY REPORT

**GROUNDING OF THE SS HILLYER BROWN
AT COLD BAY, ALASKA ON 7 MARCH 1973
WITHOUT LOSS OF LIFE**

**U.S. COAST GUARD
MARINE BOARD OF INVESTIGATION REPORT
AND COMMANDANT'S ACTION**

REPORT NO. USCG/NTSB - MAR-75-1

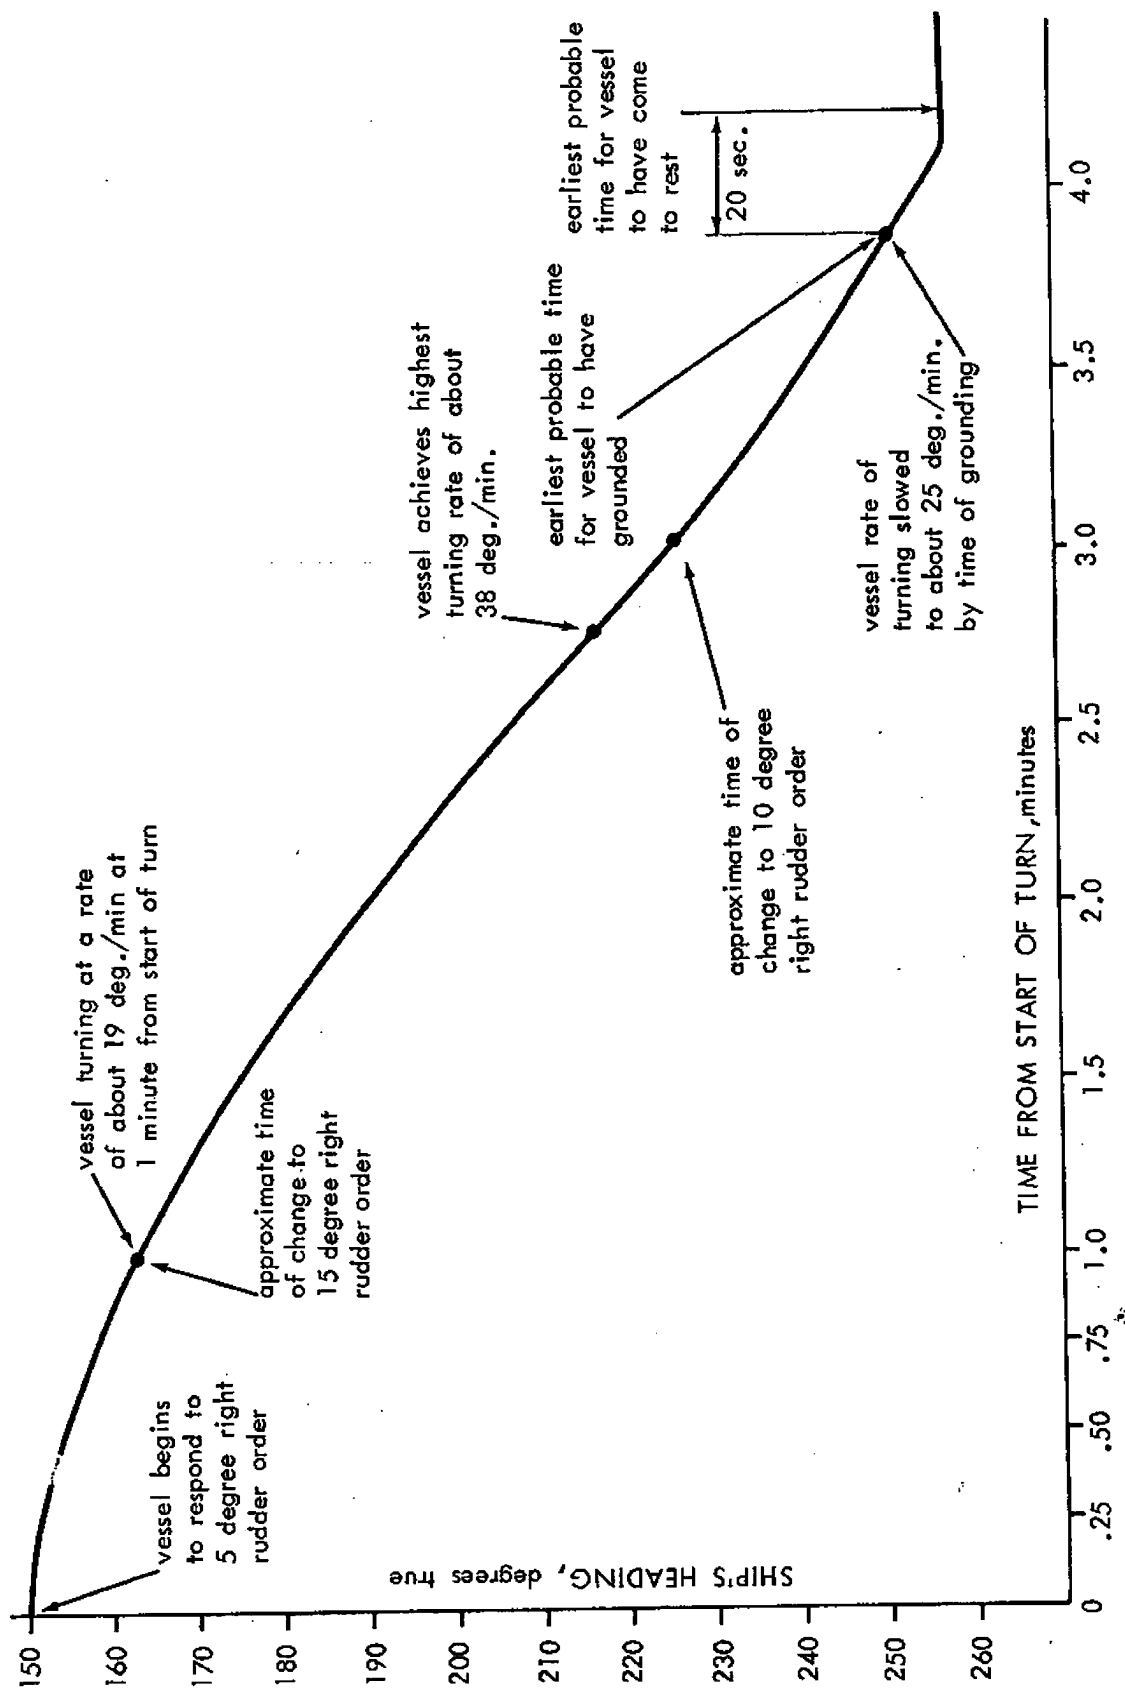
Figure 1. PLOT OF DATA FROM EXPANDED (30 Xs) READOUT OF HILLYER BROWN COURSE RECORDER.

The Board computed the probable track of the SS HILLYER BROWN during the final turning maneuver before the vessel grounded so that the actions of the pilot and master could be evaluated with regard to navigating the vessel and so that the significance of other causal factors could be determined. Because of the crew's inability to recount accurately pertinent events, the lack of suitable automatically recorded data, and the degree of compression of the time scale on the ship's course recorder, there was not sufficient information to determine precisely the vessel's track and the location of the grounding. Deficiencies regarding such pertinent accident information are discussed and appropriate recommendations are made in the Marine Casualty Report on

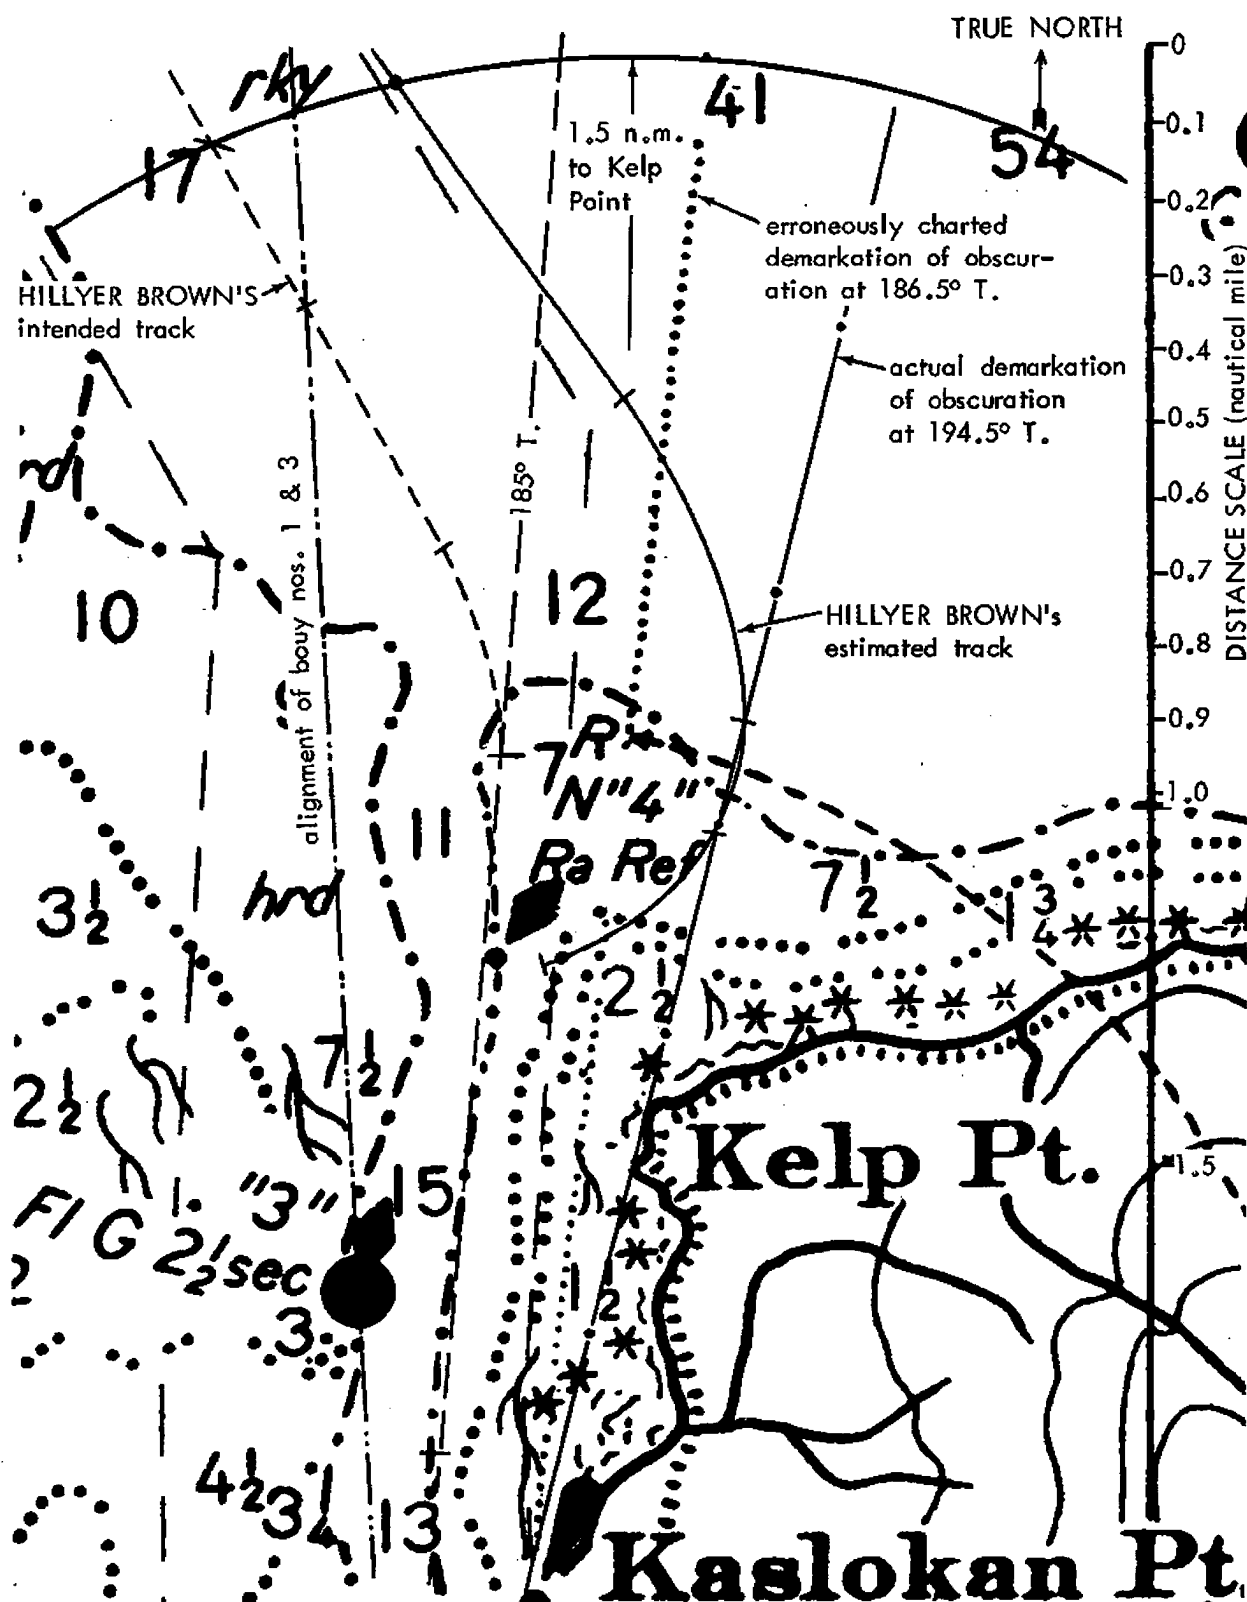
Figure 2. PLOTS OF HILLYER BROWN'S INTENDED AND ESTIMATED TRACKS, SUPERIMPOSED ON ENLARGEMENT OF NOS CHART 8703

In Figure 2, the HILLYER BROWN's intended course, which was determined from the pilot's testimony and from a segment of the vessel's computed track, is shown as a dashed, curved line. The incorrectly charted bearing at which Kaslokan Point Light obscures is shown as a dotted line in Figure 2, and the correct bearing is noted as a broken line with dots bearing about 194.5° T to Kaslokan Point Light.
