**MARINE CASUALTY REPORT**

ENTANGLEMENT OF THE SUBMERSIBLE JOHNSON  
SEA LINK WITH SUBMERGED WRECKAGE OFF KEY WEST,  
FLORIDA ON OR ABOUT 17 JUNE 1973 WITH LOSS OF LIFE

REPORT NO. USCG/NTSB - MAR-75-2

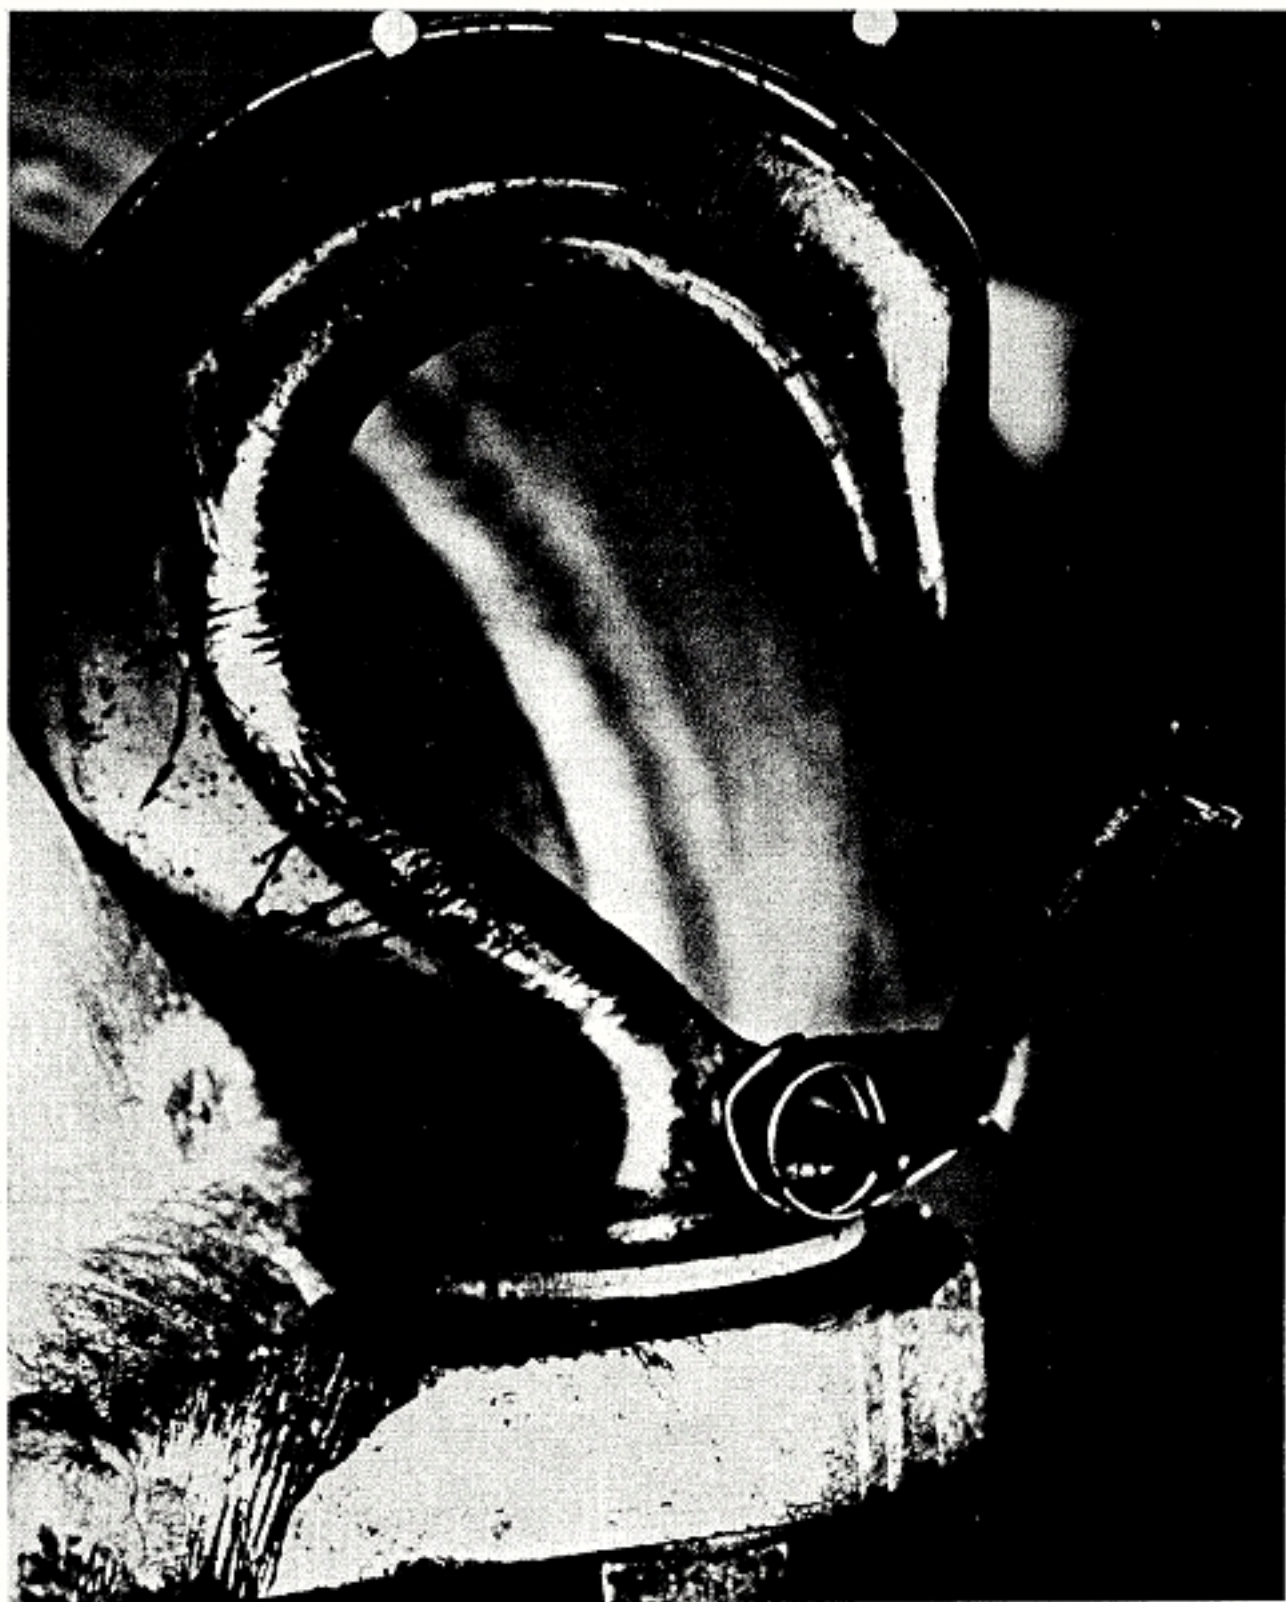
Figure 1 - Starboard<sub>4</sub>Spring Loaded, Housed Hook

Before the JOHNSON SEA LINK submerged on June 17, the hooks were not known to be damaged. A survey of the submersible after the casualty showed that the starboard hook had been damaged by a cable and that the mousing device had failed. (See Figure 1.) The mousing device could have failed when the submersible was raised from the bottom by the grapnel operated on board the A. B. WOOD II. The force exerted during this maneuver would have caused the cable to break free from the hook. Since there was evidence of damage inflicted by a cable at other points on the submersible, it could not be determined if the initial source of fouling was the snagging of the cable by the hook.

23. The SEA DIVER, with the SEA LINK still on board, arrived in its home port of Fort Pierce, Florida on 28 June. During the course of a hull examination subsequent to 28 June certain sections of the SEA LINK displayed evidence of cable scraping. In the general area of where Dr. Meek observed the cable to pass up over the stern of the SEA LINK were a number of structural members that contained scratches and serrations inconsistent with the remainder of its surface. For example, the forward edge of the propeller shroud on the starboard fixed propulsion motor contained deep scratches resembling file marks. Above these abrasions were similar scratches on the plastic cover of a pneumatic valve. Immediately above this plastic cover is an aluminum pad that is welded to a support member of the starboard surface buoyancy tank. Bolted through a hole in this pad is a steel hook which is used to restrain guide lines during retrieval of the submersible but is not used as a lifting hook. The hook is approximately one and a half (1½) inches in diameter and five (5) inches long with a two (2) inch opening. The opening faces downward and is guarded by a spring-loaded mousing device. Both the pad and the hook displayed evidence of chafing by a hard object capable of producing a serrated effect. In addition to the scoring of the hook the spring-loaded mousing device was wrenched from its normally closed position.

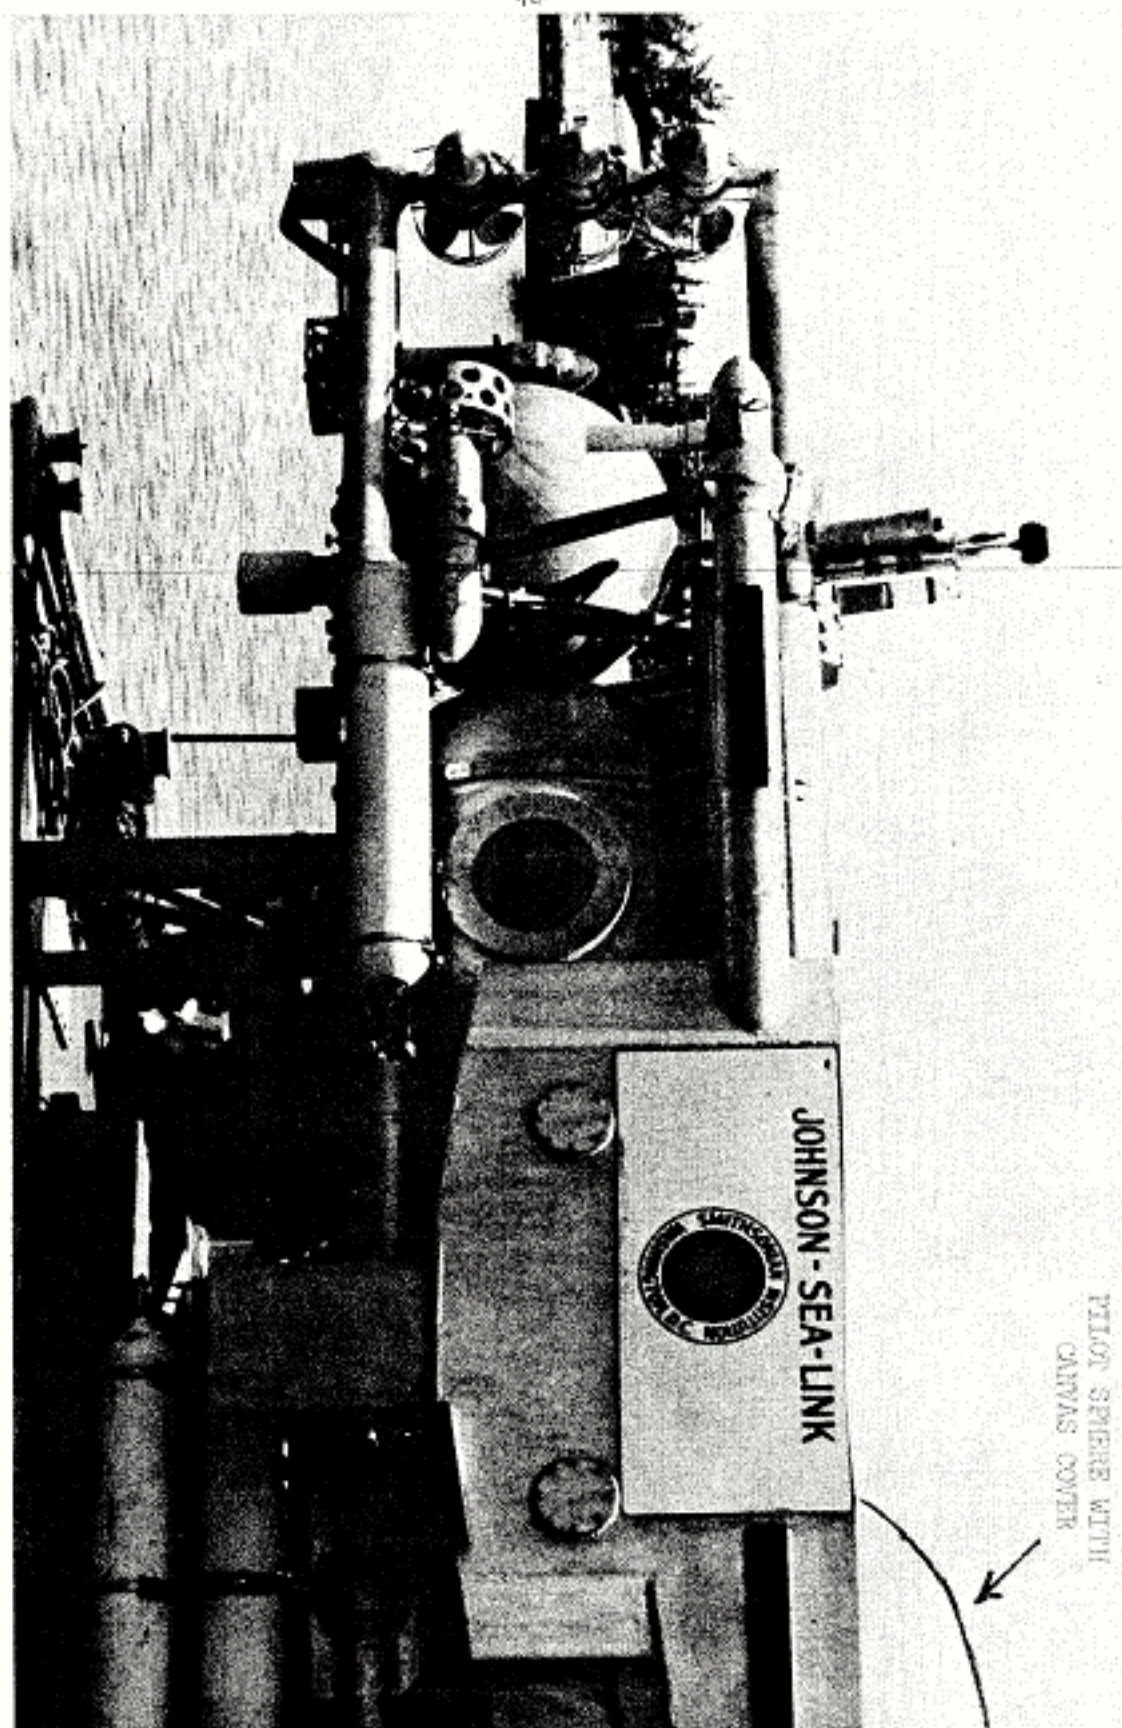
c. The submersible, as a complete unit, defies comparison with any conventional ship or boat shape. Its modular construction lacks the symmetry or "fairing" normally found in both surface and subsurface vessels. This submersible can best be described as an ill defined network consisting of an aluminum framework to which various shapes, containers and appendages have been attached according to their functional value rather than a concern for symmetry. (Photograph appended)
