MARINE CASUALTY REPORT

SS KEYTRADER AND SS BAUNE (NORWEGIAN)

COLLISION IN THE MISSISSIPPI RIVER ON

18 JANUARY 1974 WITH LOSS OF LIFE

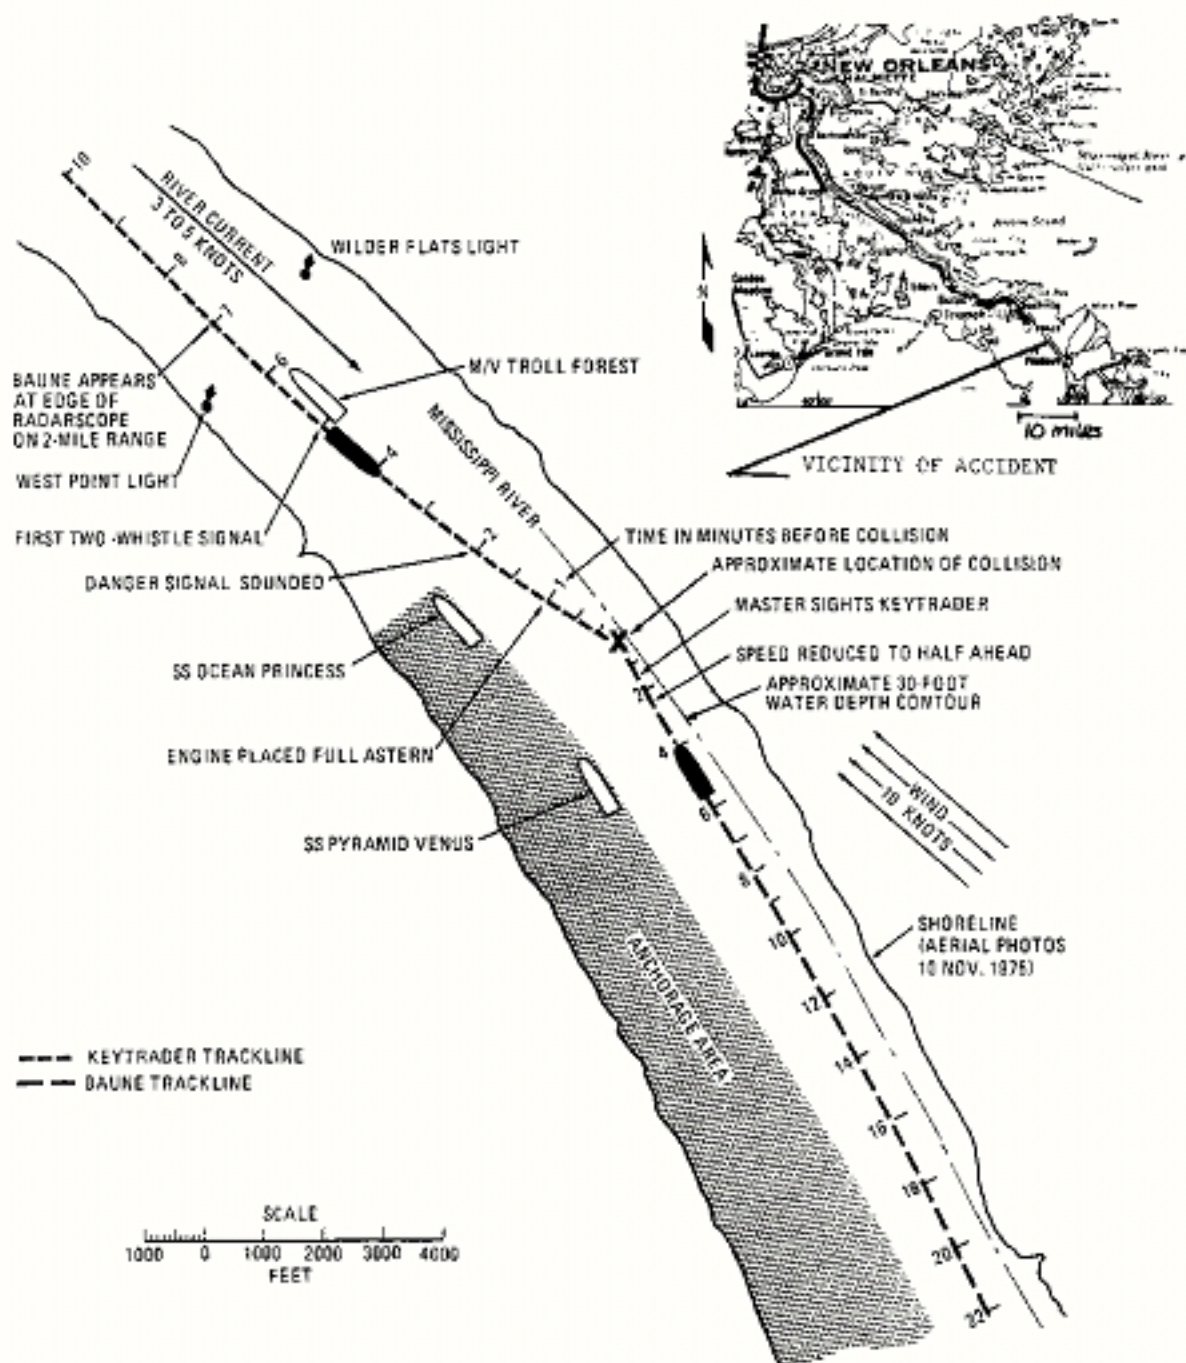
FIGURE 1. PROBABLE TRACKLINES OF KEY TRADER AND BAUNE PRECEDING COLLISION

About 1355, the KEYTRADER passed between the anchored M/V TROLL FOREST and the west bank. (See figure 1.) The TROLL FOREST was anchored approximately 1,800 feet below the West Point light, and between 1,200 and 1,500 feet off the west bank. The KEYTRADER passed approximately 300 feet abeam of the TROLL FOREST. About this time, the master and pilot observed--first on radar and then visually--three vessels, which appeared to be in an anchorage area. They determined that two of the vessels were anchored. The SS PYRAMID VENUS was anchored about 1.5 nmi downriver from the West Point light and about 1,650 feet off the west bank. The SS OCEAN PRINCESS was anchored about halfway between the TROLL FOREST and PYRAMID VENUS and closer to the west bank than the PYRAMID VENUS. Further radar and visual observations of the third vessel, the SS BAUNE, which was eastward of the first two vessels, confirmed that it was underway. Just after passing the TROLL FOREST, the KEYTRADER began to alter course several degrees to port to avoid the ships in the anchorage area.

The Safety Board constructed probable tracklines for the KEYTRADER and BAUNE (See figure 1.) The tracklines show the approximate locations of both vessels at certain times as they proceeded toward the point of collision. The approximate positions of certain anchored vessels were also determined. Accuracy in determining the tracklines was limited by the readability of the ships' course recorders, the reliability of testimony from the ships' crewmen, and the estimated speed of the river's current. The Safety Board has recommended previously that the Coast Guard require the installation of an automatic recording device to preserve vital navigational information aboard oceangoing ships. ^{3/}
