LOSS OF THE
MOTOR TOWING VESSEL
MAJORIE McALLISTER
IN THE ATLANTIC OCEAN
ON NOVEMBER 2, 1969

U.S. COAST GUARD
MARINE BOARD of INVESTIGATION REPORT
and COMMANDANT'S ACTION

ACTION BY
NATIONAL TRANSPORTATION SAFETY BOARD

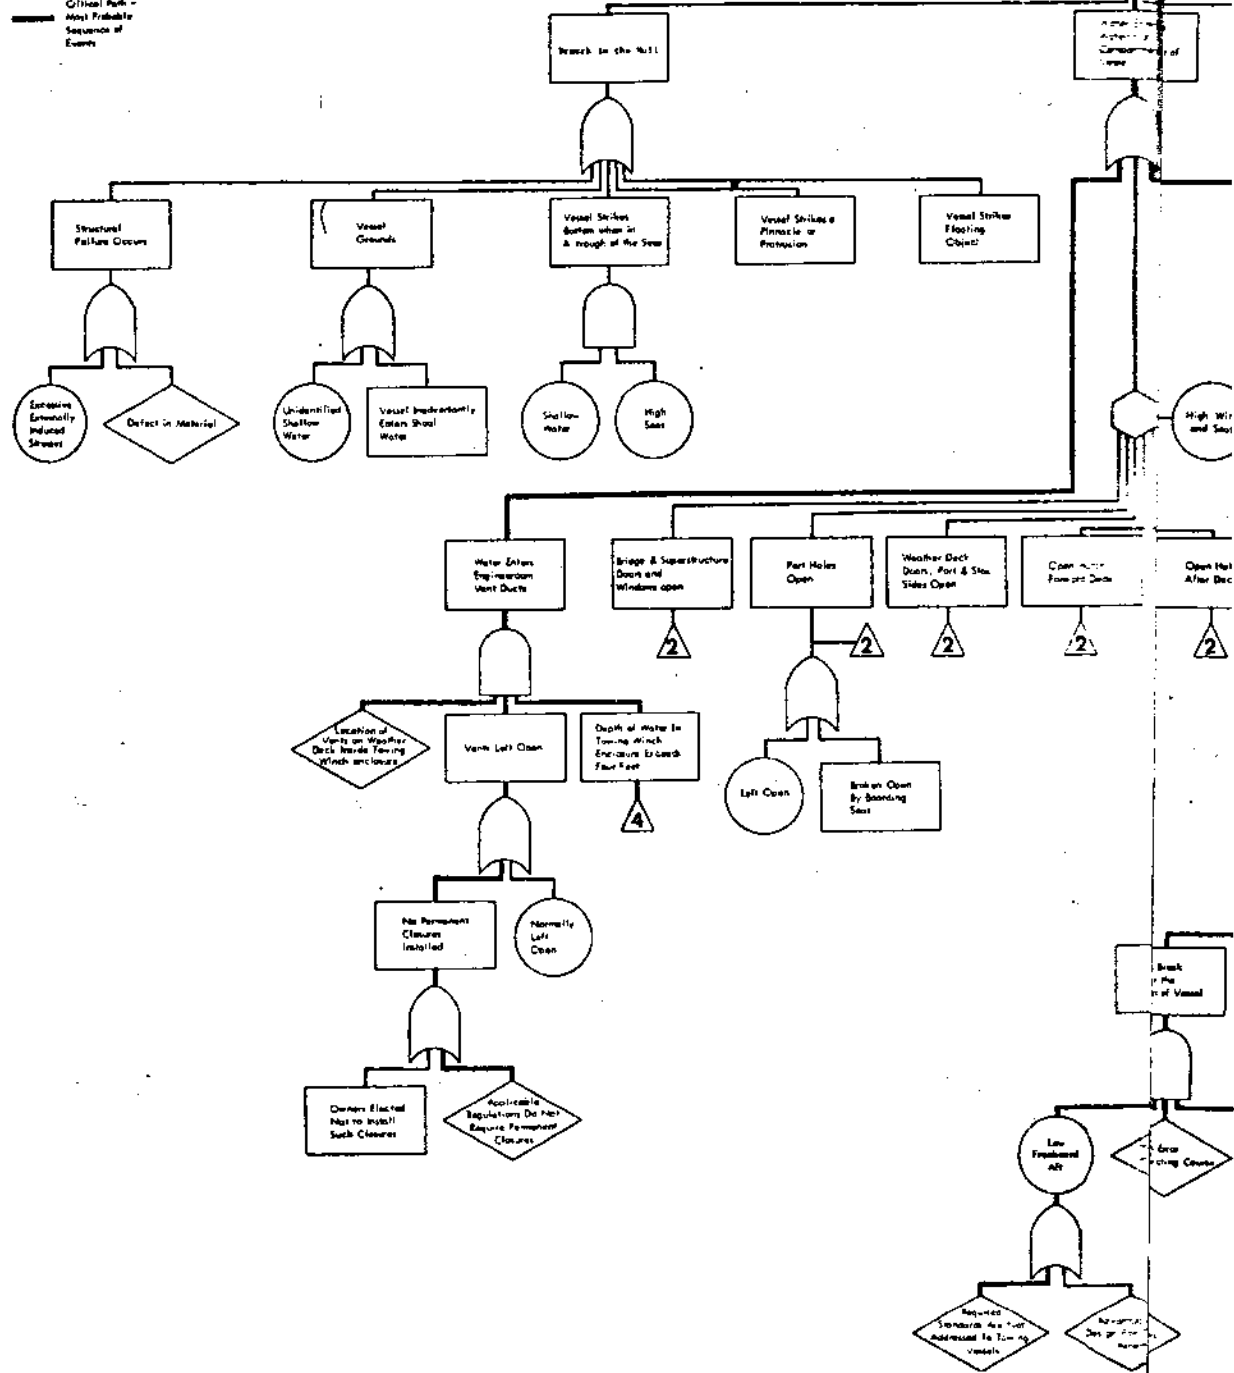
FAULT TREE DIAGRAM

When there is virtually no detailed evidence to evaluate, it becomes necessary to analyze the casualty on the basis of known design details, operating practices, and possible failures. A fault tree diagram (see Attachment A) has been utilized to array the design, operating practices, and failures data in a sequential event format. This type of diagram serves to ensure an orderly and thorough analysis of all reasonably possible causal factors. It is an accepted technique utilized in the aerospace field for pre-accident design safety analysis. The Events and Causal Factors Diagram (see Attachment B) presents the critical path of the sequence of events, as derived from the fault tree, which culminated in the loss of the vessel. This diagram reduces the detailed fault tree diagram by displaying only the most probable sequence of events.

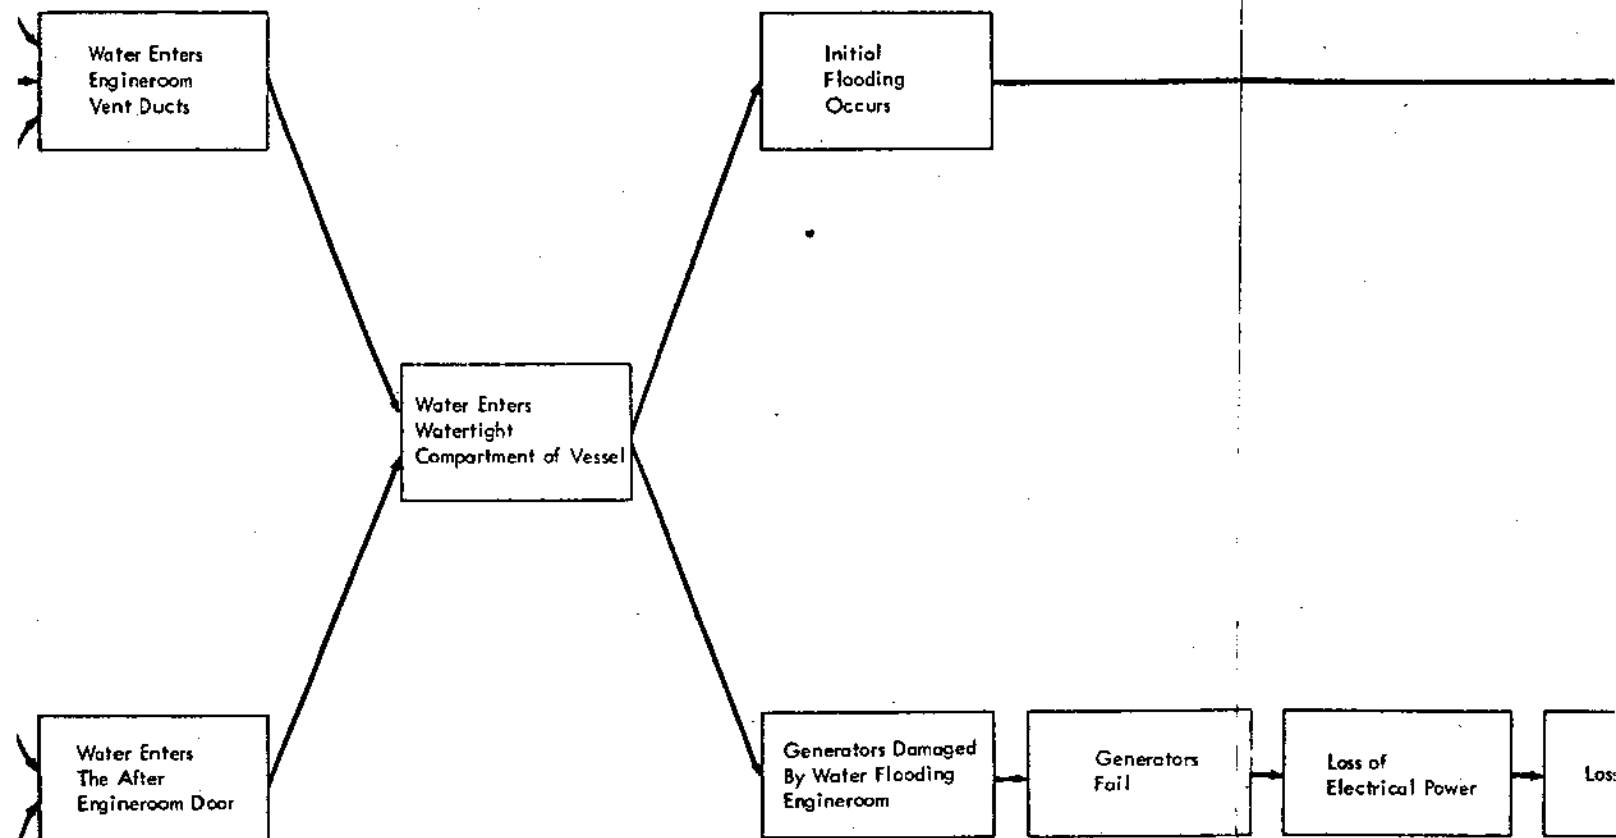
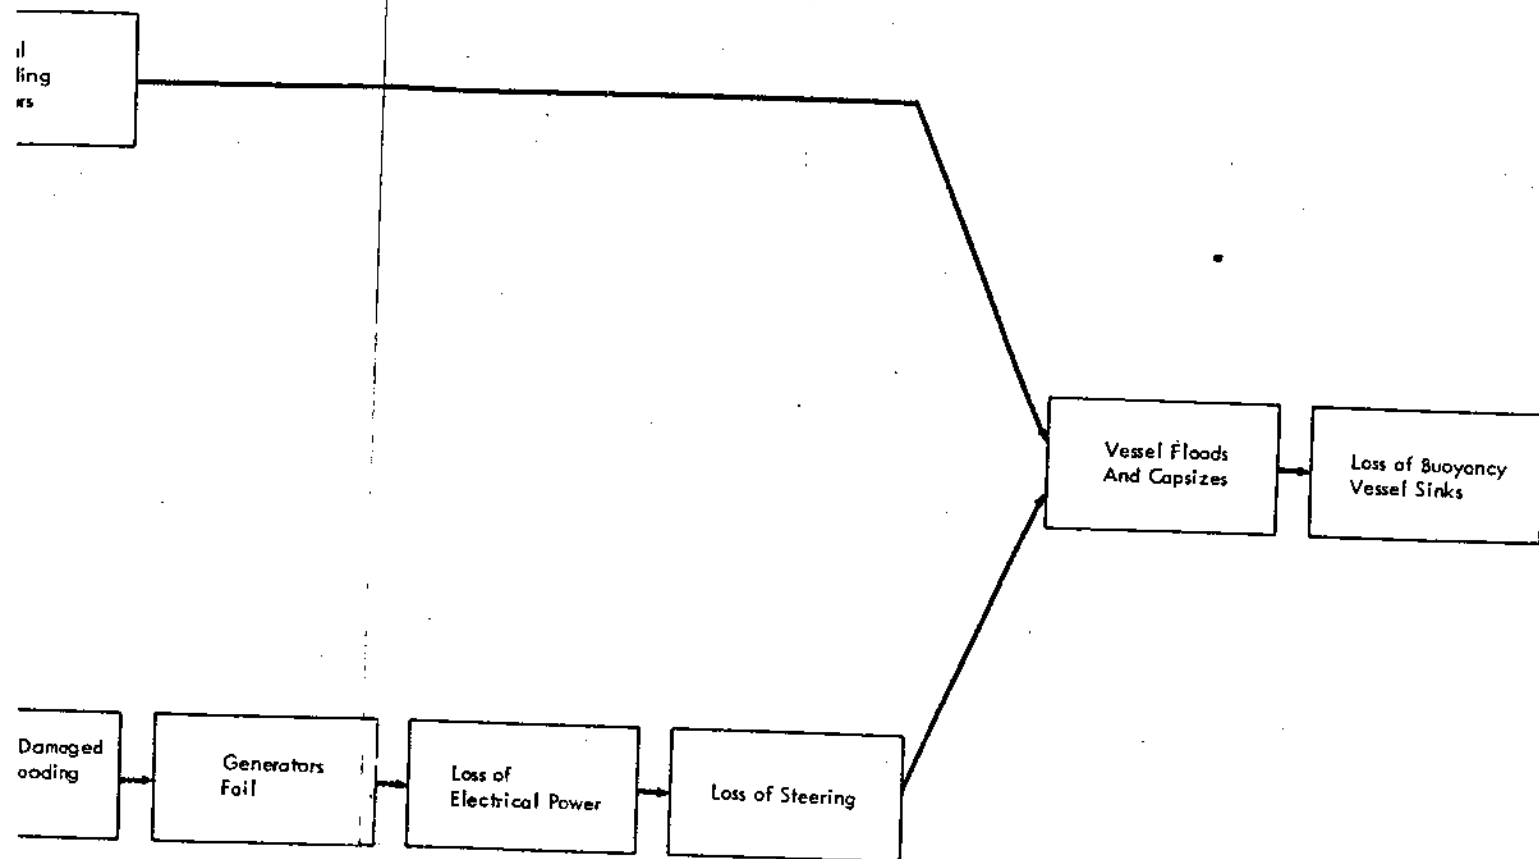
EVENTS & CASUAL FACTORS DIAGRAM

Although in this case a fault tree analysis has been utilized after the fact to determine the most probable causal factors of the casualty, it can also be used effectively for pre-casualty evaluation of design. For example, exactly the same type of analysis could have been done prior to construction of the vessel to determine whether flooding could occur under heavy sea conditions, and what the consequences of flooding might be. As a result, the need for changes in design (larger freeing ports, greater freeboard, more effectively protected ventilators, placement of generators in different spaces, protected electric control boards) or operating procedures (keep watertight door closed) could have been found, and decisions to preclude the occurrence of this type of casualty could have been made. This method of fault tree analysis is one of a number of systematic design analysis methods which have grown up in the aerospace field. Such methods are also capable of being applied to predict accident-causing system failures in the marine field. The fault tree analysis, Attachment A, is an example of this desirable procedure in connection with Recommendation 2. The relationship of events and causal factors is charted in Attachment B.
