**FIRE AND EXPLOSIONS ON TANK BARGE MOS 106
AT LA GRANGE, MISSOURI ON MISSISSIPPI RIVER,
ON MAY 12, 1969**

**U.S. COAST GUARD
MARINE BOARD of INVESTIGATION REPORT
and COMMANDANT'S ACTION**

**ACTION BY
NATIONAL TRANSPORTATION SAFETY BOARD**

RELEASED 9, MAR 1971

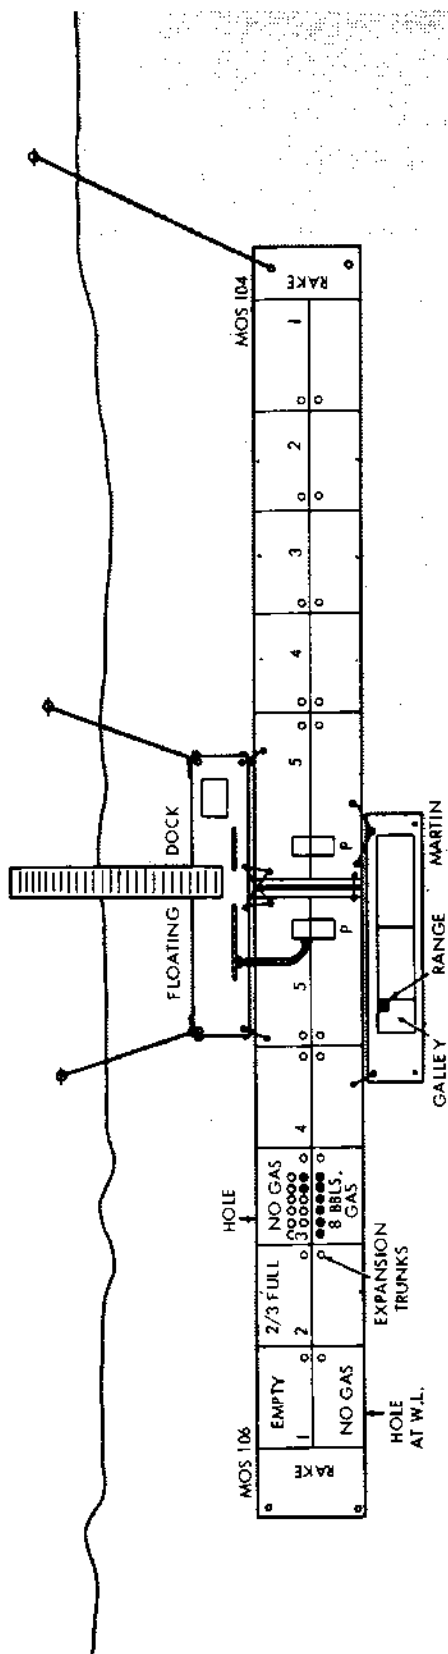
A Coast Guard inspector issued the MOS 106 a permit to proceed to La Grange, Mo., to discharge her cargo prior to effecting permanent repairs. No leakage of gasoline was noted en route to her destination, which included transit of several locks. The tow arrived at the Triangle Oil Refining Company terminal at La Grange, on May 12th. The MOS 106 and MOS 104 were moored, stern to stern, alongside the terminal floating dock, with the MARTIN moored outboard of the barges, heading upriver. The oil-fired galley range on the tug was operating, and the galley door and windows were opened. A sketch of the arrangement of the tow at the oil terminal is attached for reference.

Weather conditions at the time of discharge operations were broken clouds, wind about 5 knots from the southwest, air temperature about 60° F., and water temperature 60° F. The wind was blowing from the direction of MOS 106 over the MARTIN. Sunset occurred at 2011.
