# UNITED STATES COAST GUARD

## INVESTIGATION INTO THE CIRCUMSTANCES SURROUNDING THE COLLISION BETWEEN THE PASSENGER VESSEL **NOORDAM (NA)**

## AND THE FREIGHT VESSEL **MOUNT YMITOS (MT)**

OFF SOUTHWEST PASS IN THE GULF OF MEXICO ON  
NOVEMBER 6, 1993, WITH MINOR INJURIES, NO LOSS  
OF LIFE AND NO POLLUTION

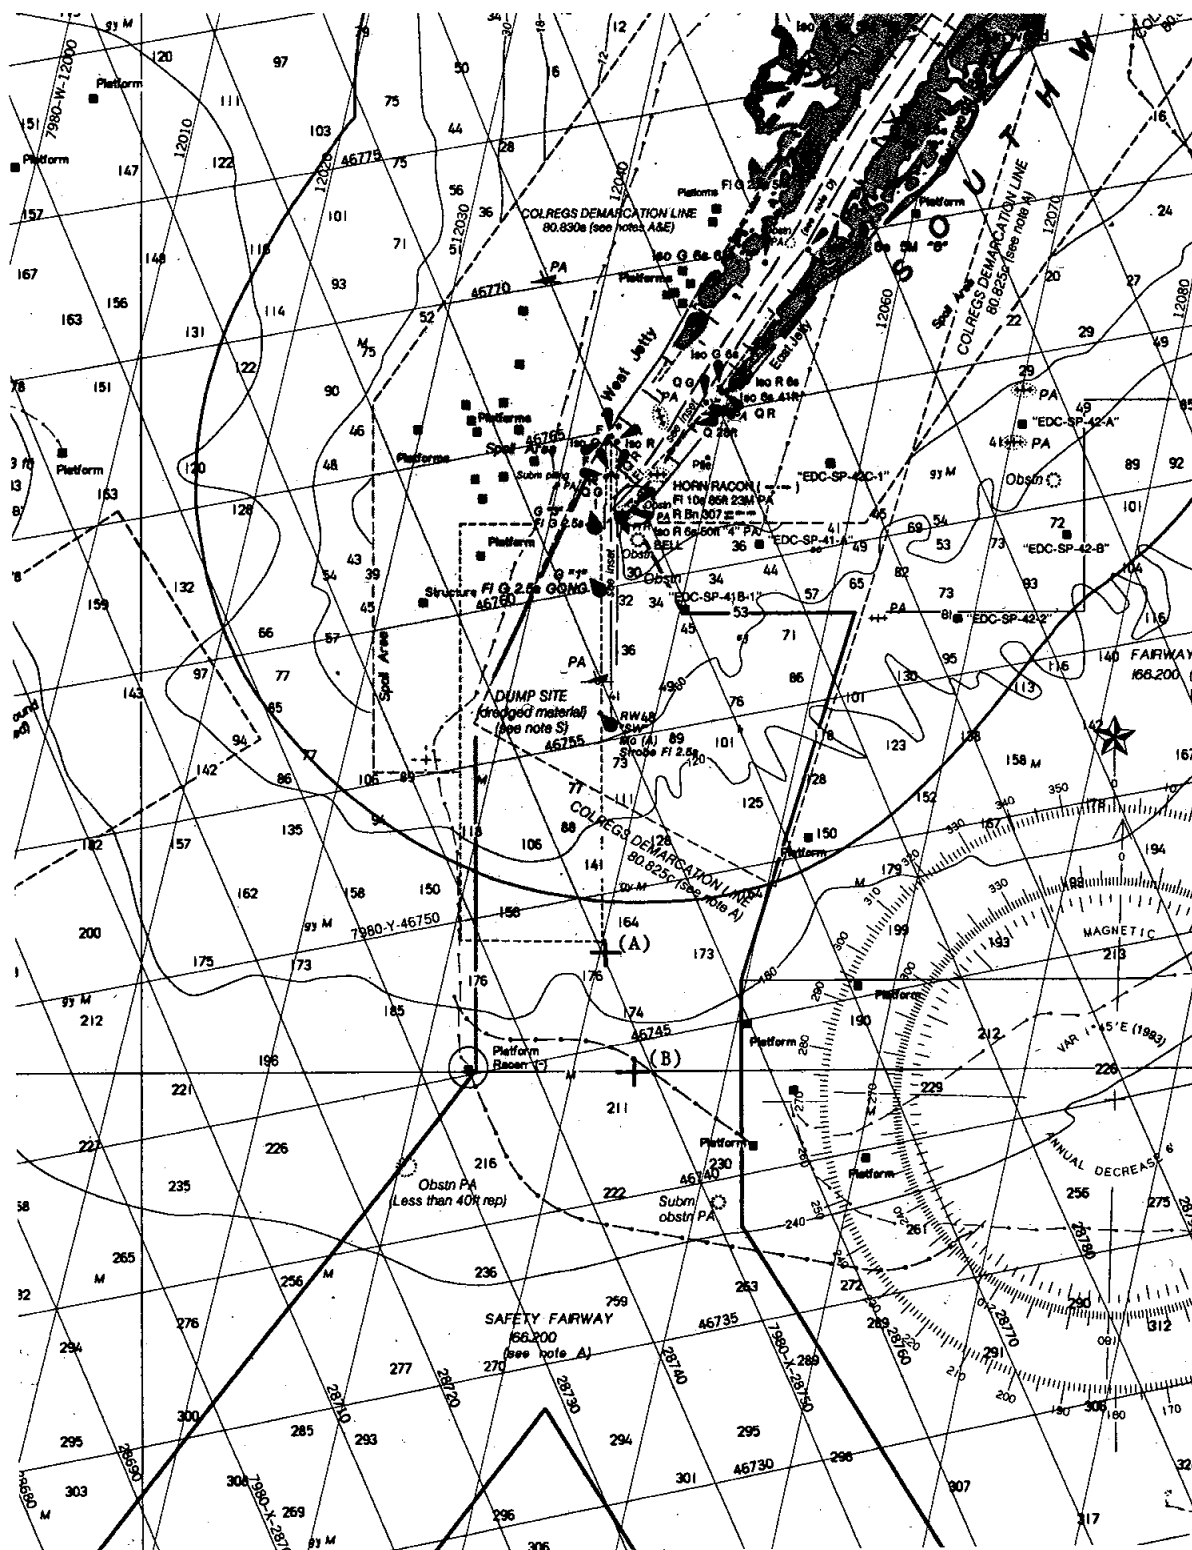
### Approach to Southwest Pass - Gulf of Mexico

- (A) Position plotted by M/V MOUNT YMITOS at the point of collision  
 (B) Position recorded by M/V NOORDAM's GPS at the point of collision

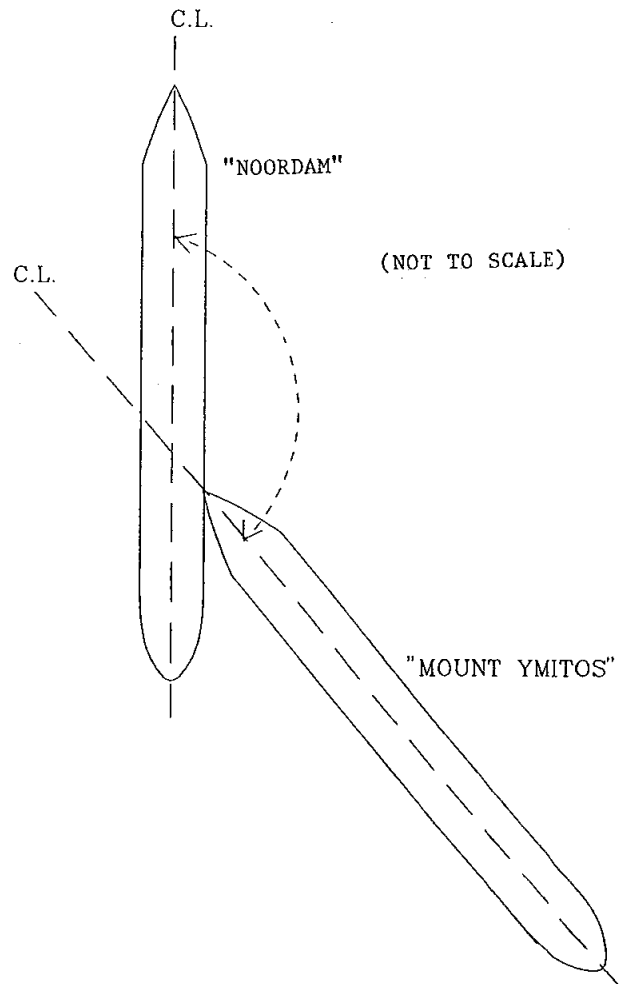
Angle between the vessels at the time of collision

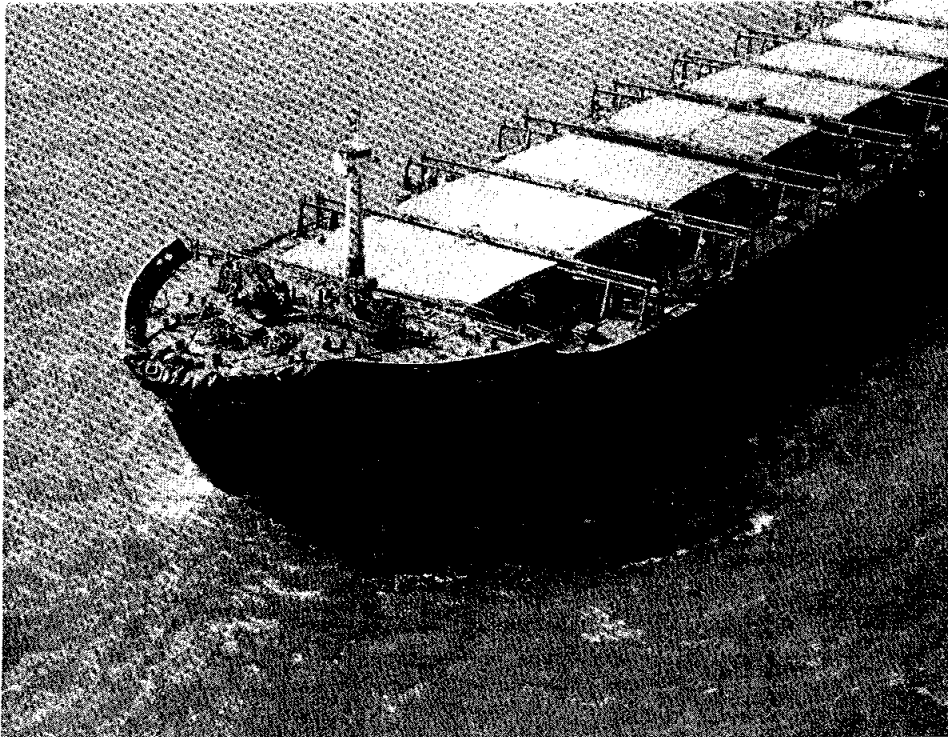
49. The NOORDAM sustained impact damage on its aft starboard side in way of frames 9-1/2 to 41-1/2 extending over four strakes. All of the damage was above the waterline. The MOUNT YMITOS suffered damage to its port bow and bulwarks well above the waterline.

Damaged bow of the M/V MOUNT YMITOS

54. Temporary repairs were performed to the bow of the MOUNT YMITOS with the approval of Bureau Veritas in order to proceed with its cargo to Russia.
