**MARINE CASUALTY REPORT**

**OCEAN EXPRESS (DRILLING UNIT): CAPSIZING  
AND SINKING IN THE GULF OF MEXICO ON  
15 APRIL 1976 WITH LOSS OF LIFE**

**U.S. COAST GUARD  
MARINE BOARD OF INVESTIGATION REPORT**

**REPORT NO. USCG 16732/ 61865**

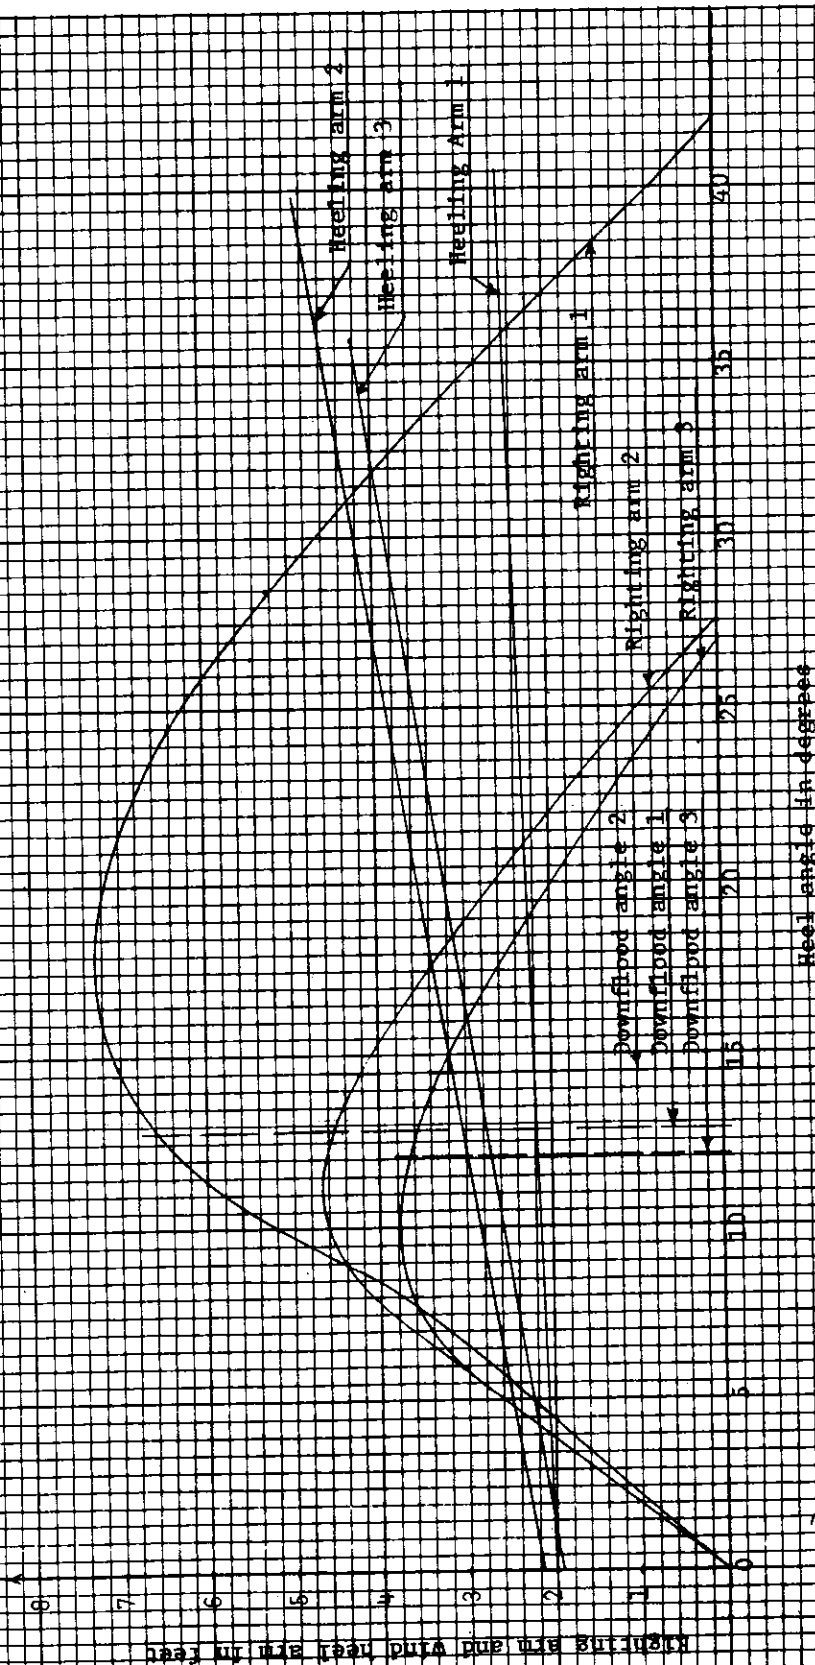
(Wind Heel as per ABS Influx  
Stability Criterion)

1. Mat at 2' separation
2. Mat lowered to 127' separation
3. Combination of mat lowered to 127' separation and an approximate 19" loss of freeboard
