MARINE CASUALTY REPORT

SS OGDEN WILLAMETTE: MAJOR ENGINE ROOM FLOODING

ON 16 JUNE 1982

REPORT NO. USCG 16732/0210

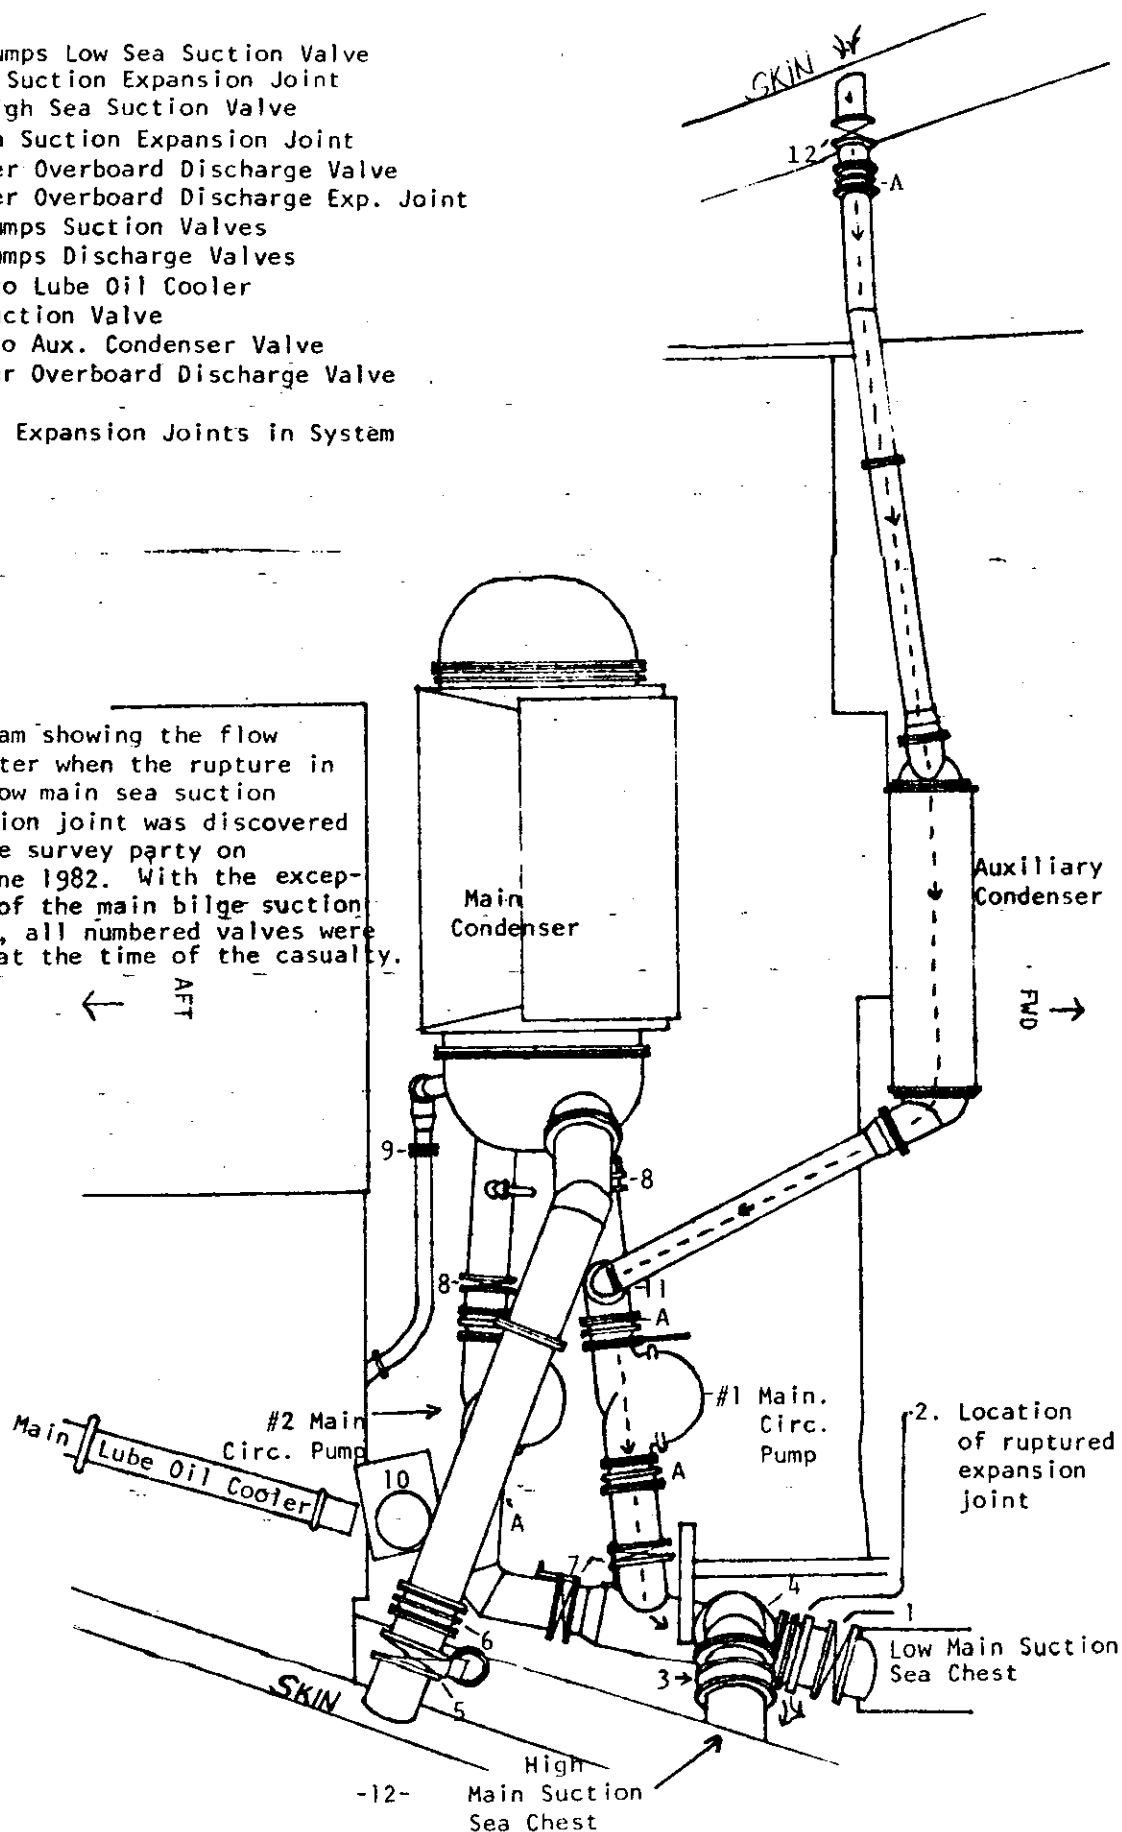
Figure 1. Diagram showing the flow of water when the rupture in the low main sea suction expansion joint was discovered by the survey party on 29 June 1982. With the exception of the main bilge suction valve, all numbered valves were open at the time of the casualty.
