MARINE CASUALTY REPORT

SS POET: DISAPPEARANCE IN THE ATLANTIC OCEAN AFTER DEPARTURE FROM CAPE HENLOPEN, DELAWARE ON 24 OCTOBER 1980 WITH LOSS OF LIFE

MARINE BOARD OF INVESTIGATION REPORT

REPORT NO. USCG 16732/11486

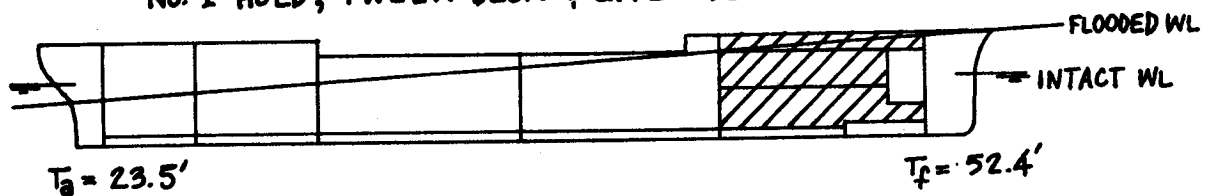
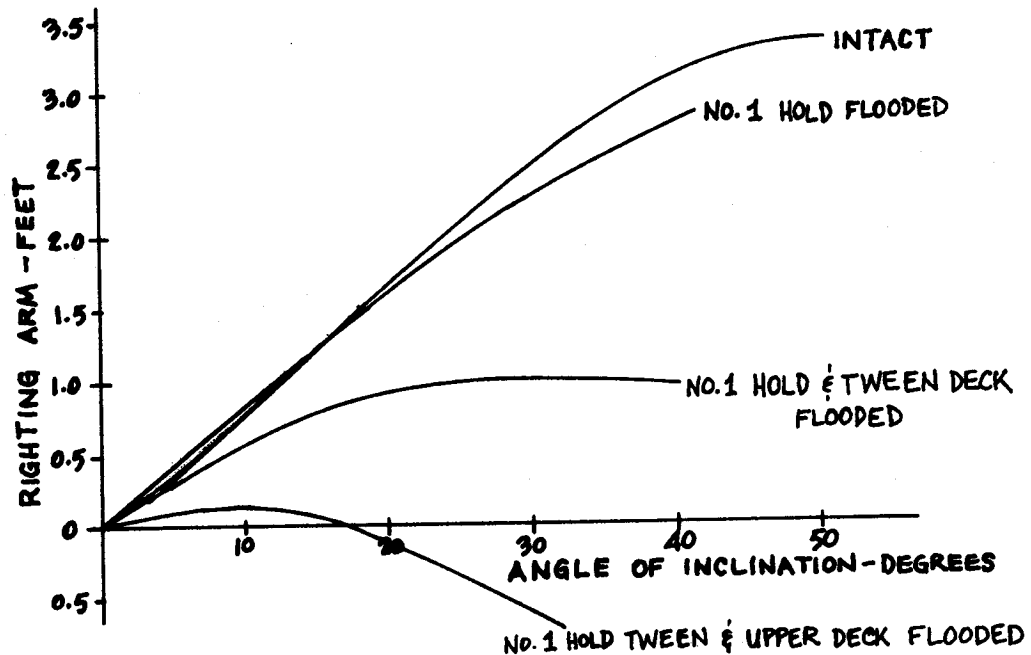
FIGURE 2
 Flooding of No. 1 Hold, Drafts and Statical Stability Curves

NO. 1 HOLD, TWEEN DECK & UPPER DECK FLOODED

- NOTE: 1. Righting Arm Curves have been corrected for free surface effect of flooding water.
 2. Taken from Board Exhibit 166, Figures 320-1 and 320-2, pages 43-44.

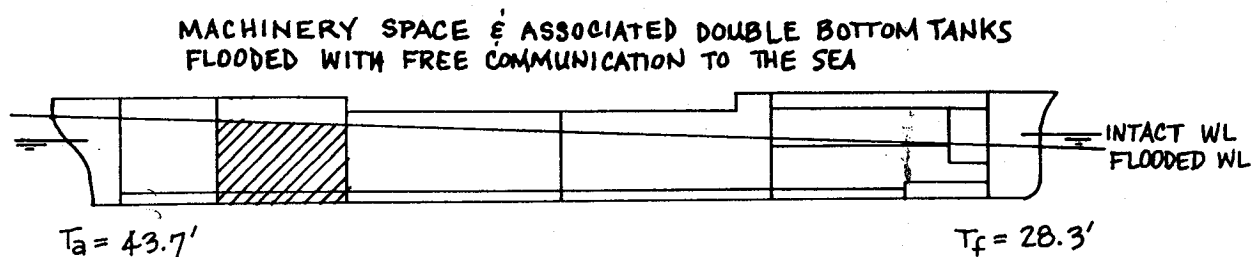
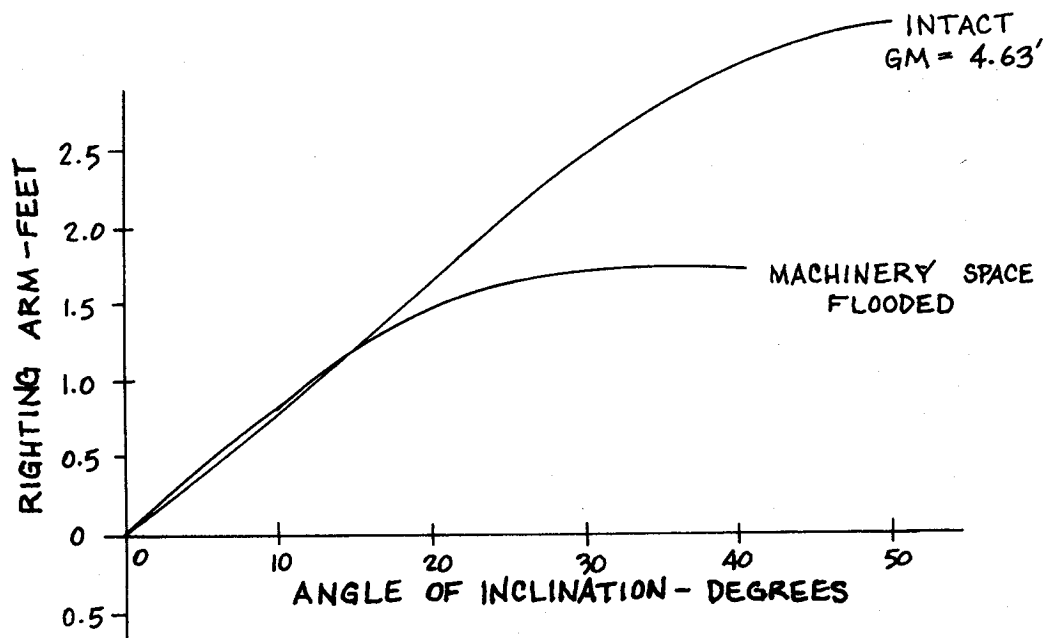
FIGURE 3
Flooding of Machinery Space, Drafts and Statical Stability Curves

- NOTE: 1. Righting Arm Curves have been corrected for free surface effect of flooding water.
2. Taken from Board Exhibit 166, Figure 321-1, page 46.
