# MARINE CASUALTY REPORT

## TANKSHIP PUERTO RICAN

EXPLOSION AND FIRE  
IN THE PACIFIC OCEAN,  
ON 31 OCTOBER 1984

REPORT NO. USCG 16732/0003 HQS 84

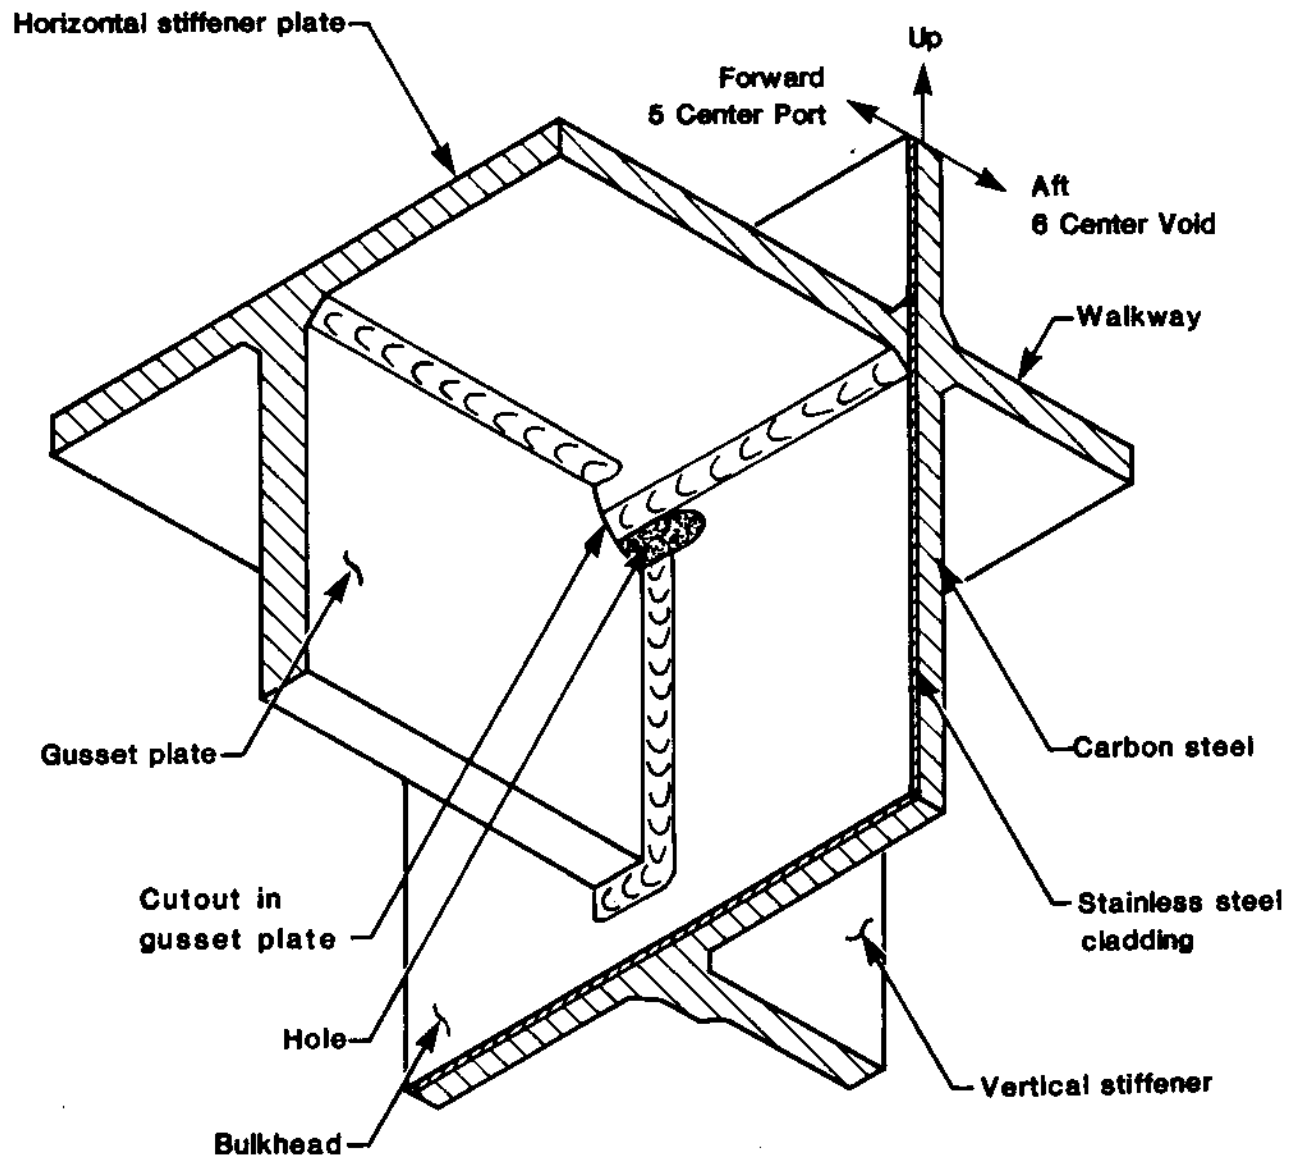
Figure 3. Sketch of hole in bulkhead between Tanks 5 Center Port (5CP) and 6 Center Void (6CV) for Case 1, seen from inside Tank 5CP below the hole.

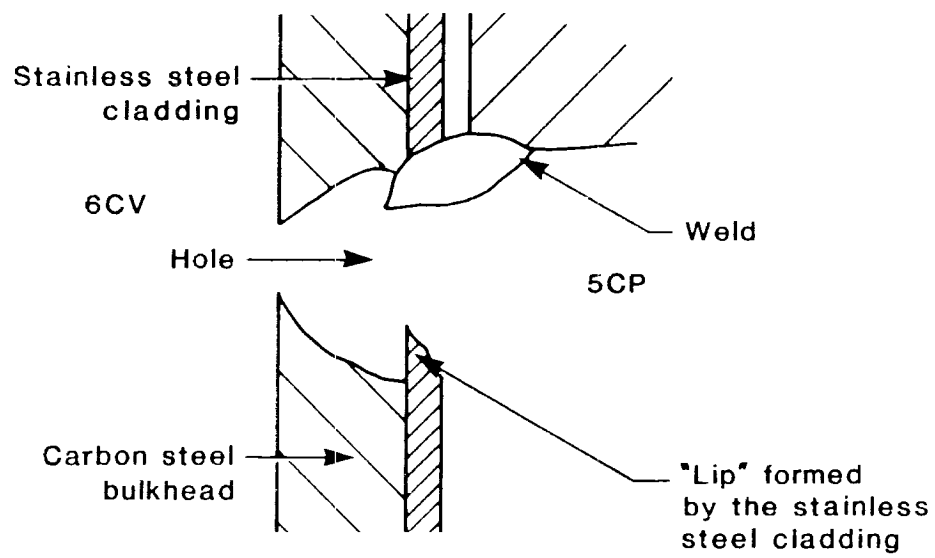
Figure 4. Schematic vertical cross section of the hole in the bulkhead between 6CV and 5CP.

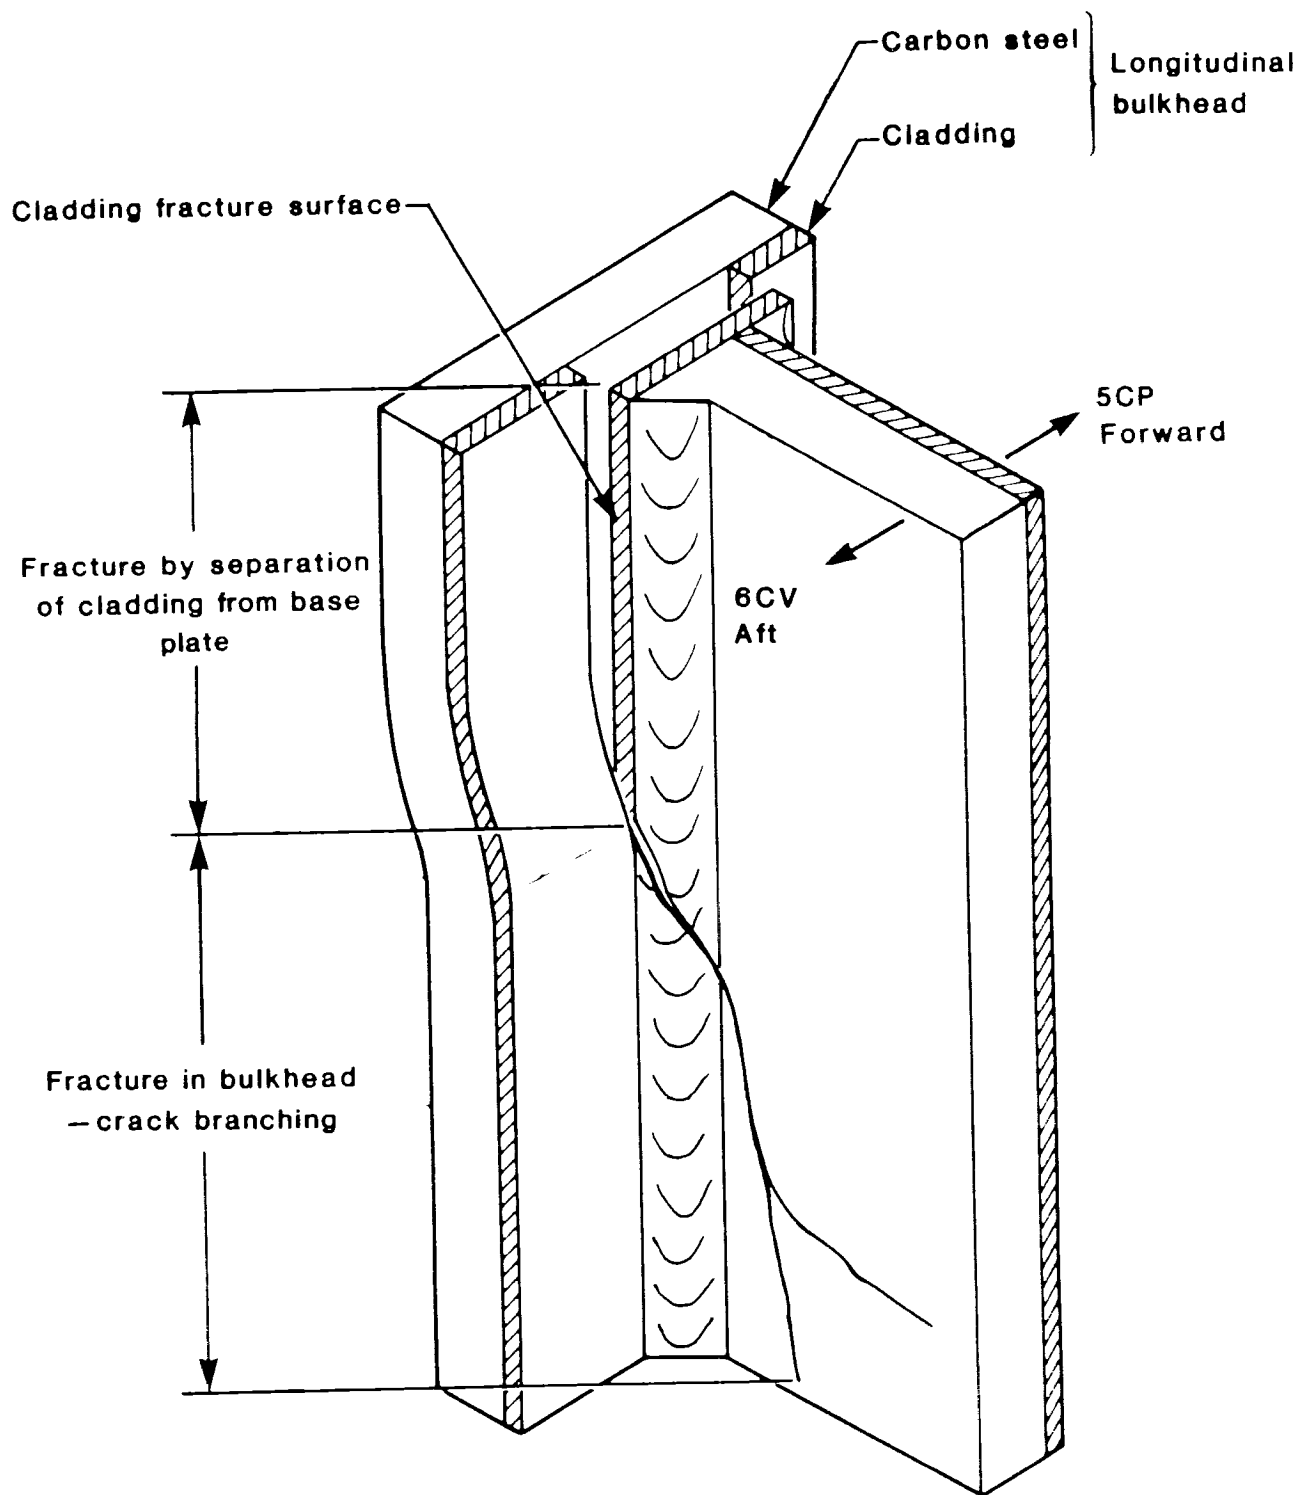
Figure 5. Sketch of different fracture paths in Cases 2 and 3.

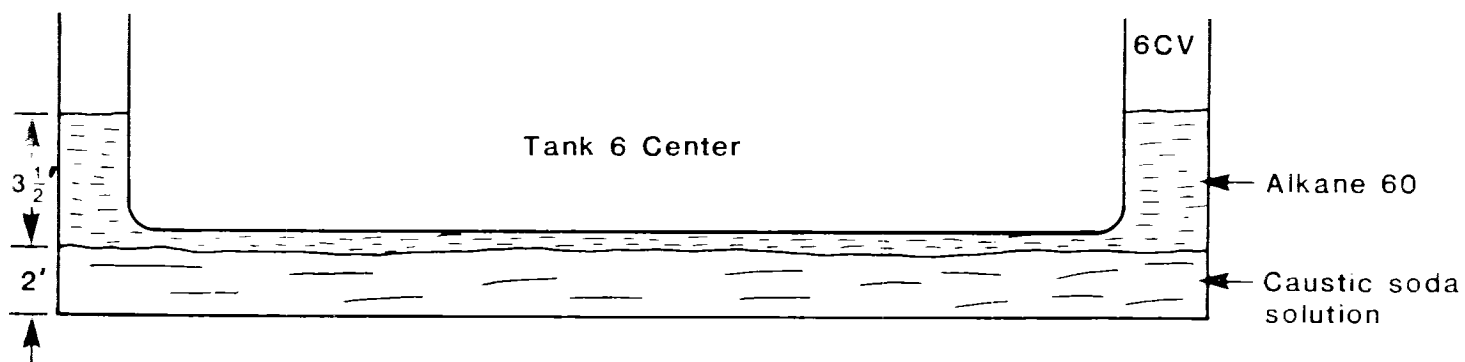
Figure 6. Schematic showing caustic soda solution and Alkane 60 in 6CV shortly before the casualty.

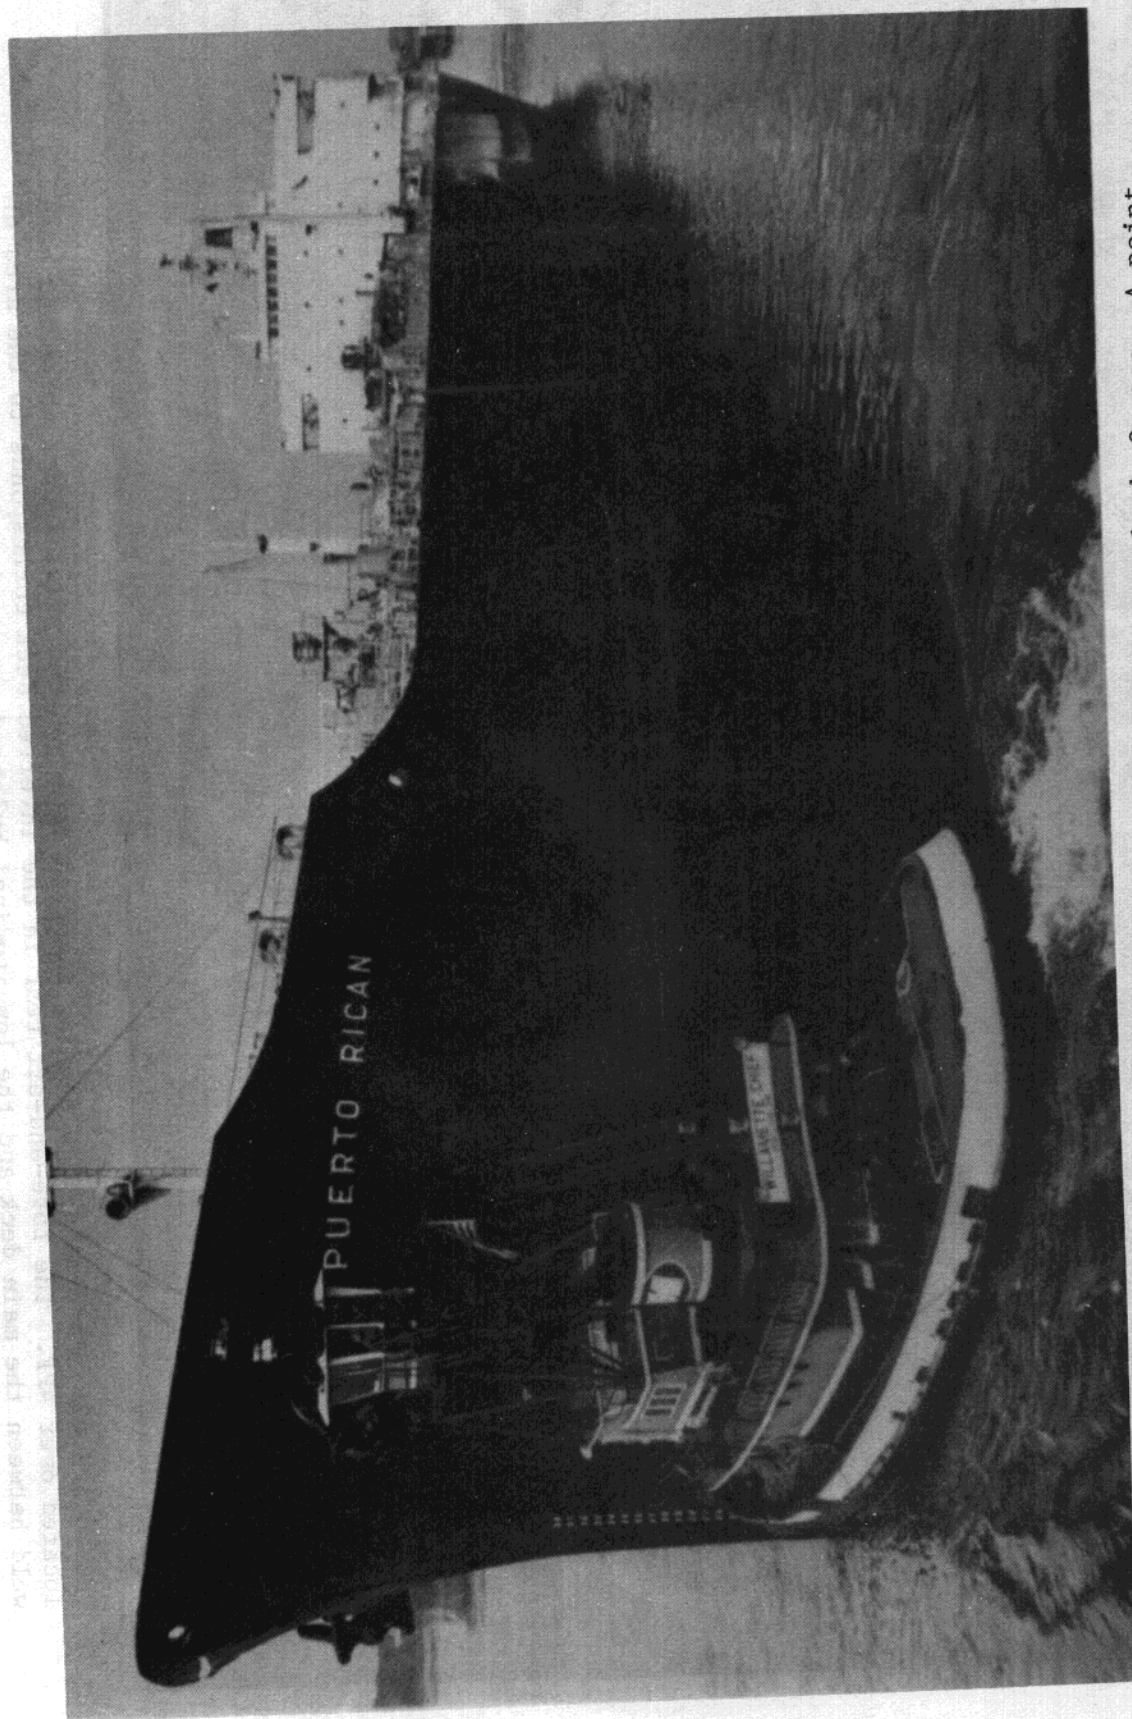
PHOTOGRAPH #1: The S.S. PUERTO RICAN on September 11, 1984 in Portland, Oregon. A point of interest is the light colored area on the hull aft of the kingpost. This appears to be in way of the number 4 port wing tanks. The Board could not determine the reason for this discoloration. (LAARS Photography Photo)

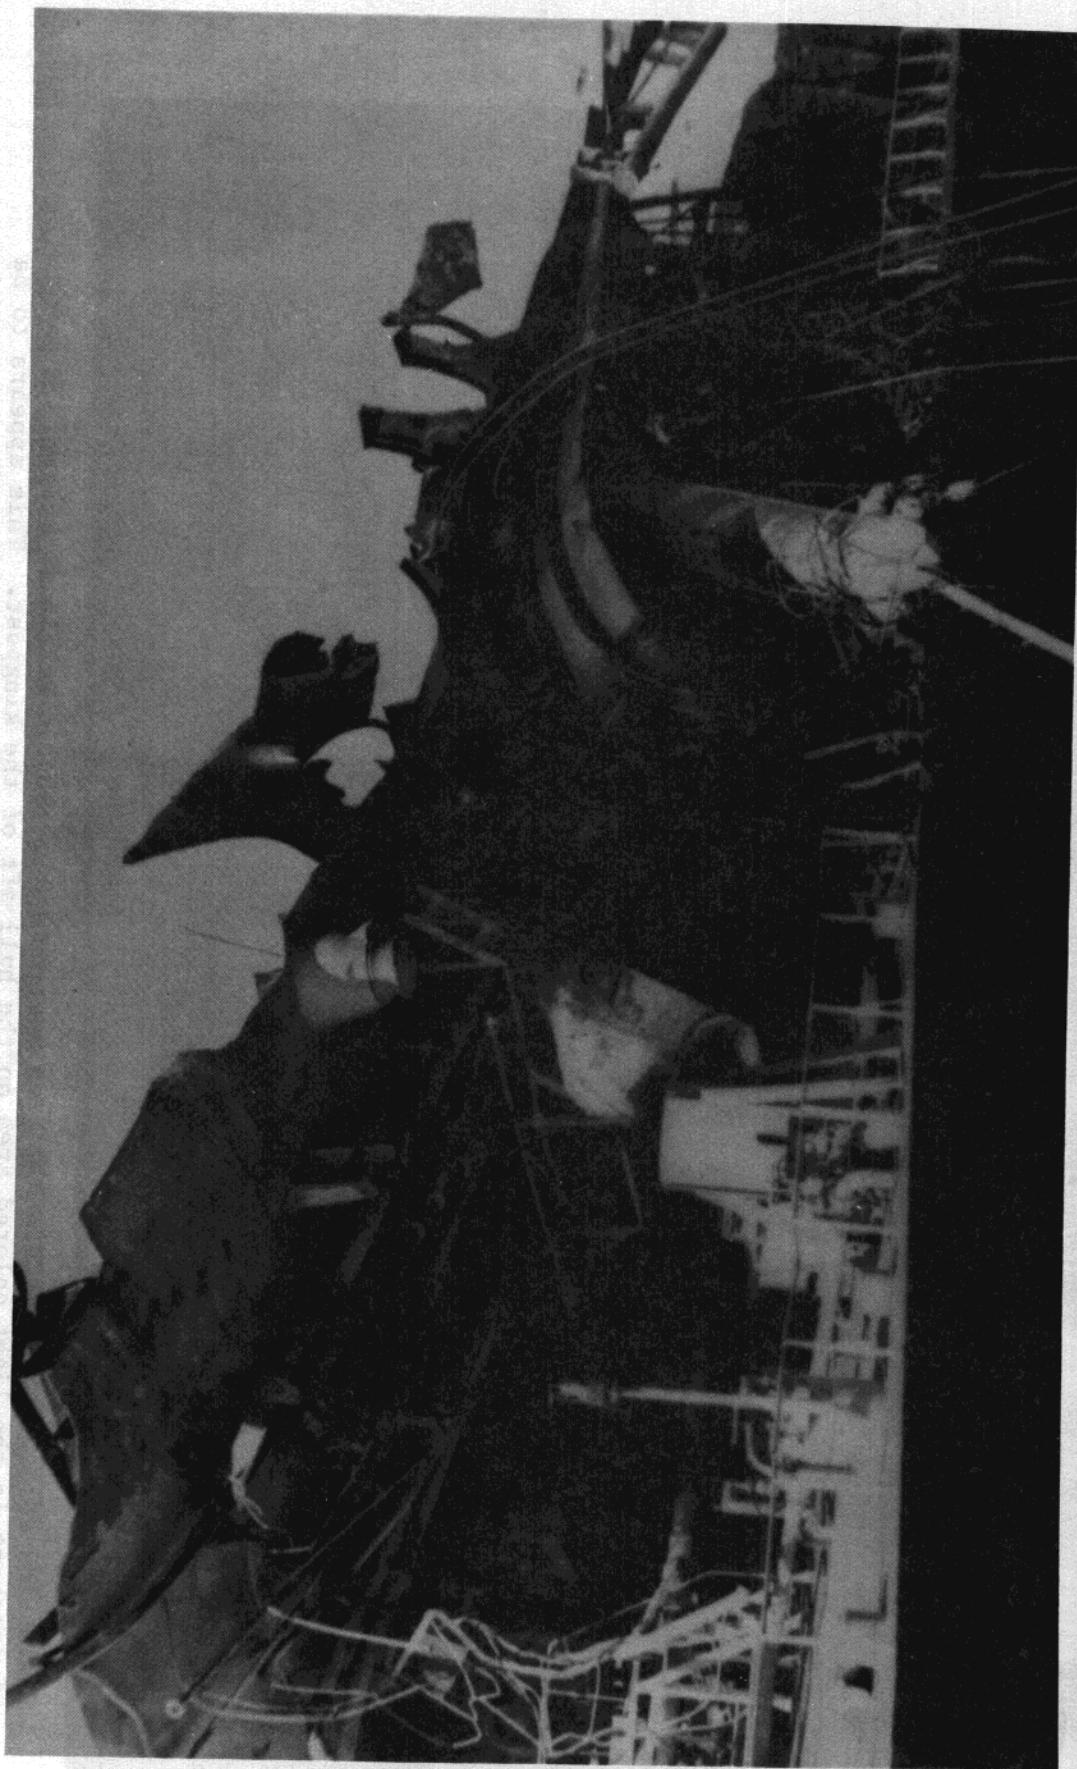
PHOTOGRAPH #2: Port-side view showing inverted deck and the pilot ladder which had been located over 4PF. The fore-and-aft tear in the inverted deck corresponds to the area of weld between the main deck and the longitudinal bulkhead separating 6CV and 4PA. Taken at approximately 0930 on November 1, 1984. (USCG Photo)

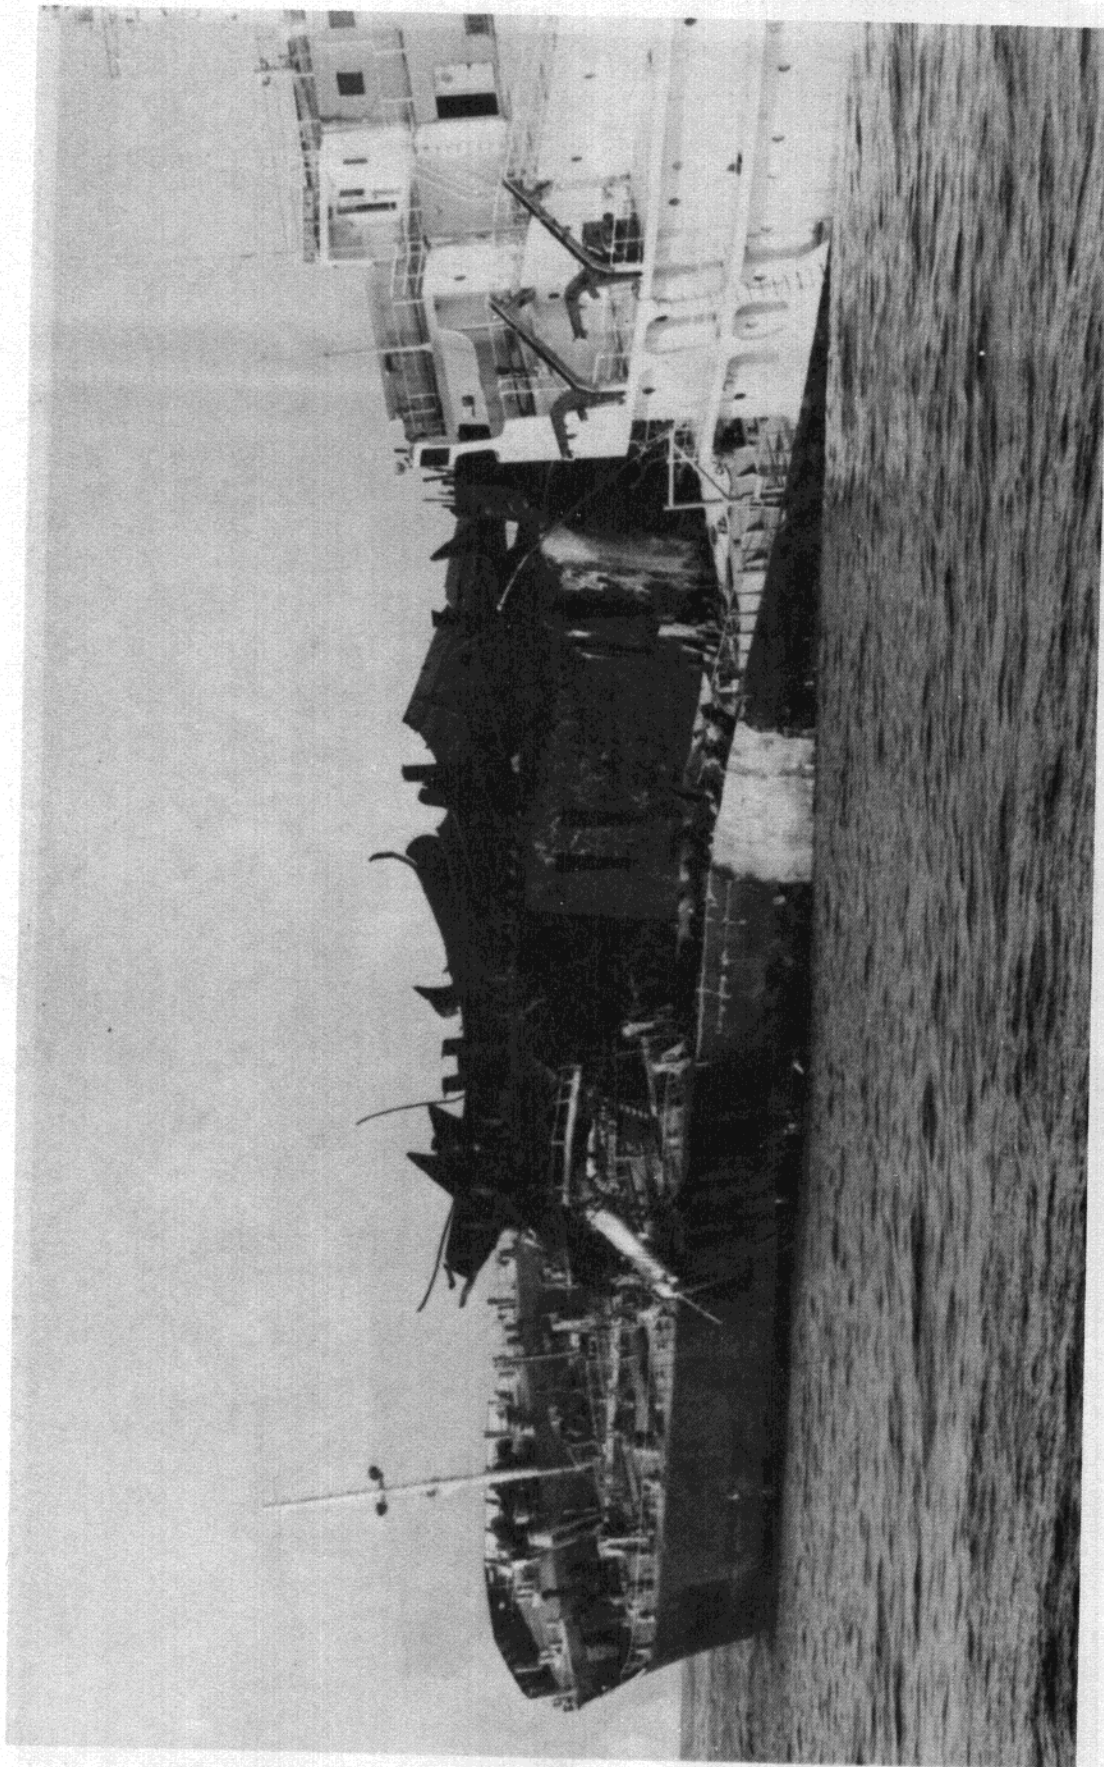
PHOTOGRAPH #8: PUERTO RICAN under tow on November 1, 1984 at approximately 0930 in position approximately 35.5 miles at 215°T from Point Bonita. The swell in the foreground gives the illusion that the stern is awash. The angular difference at the gunwale shows the area where the forebody separated from the stern on the port side at the main deck. (USCG Photo)

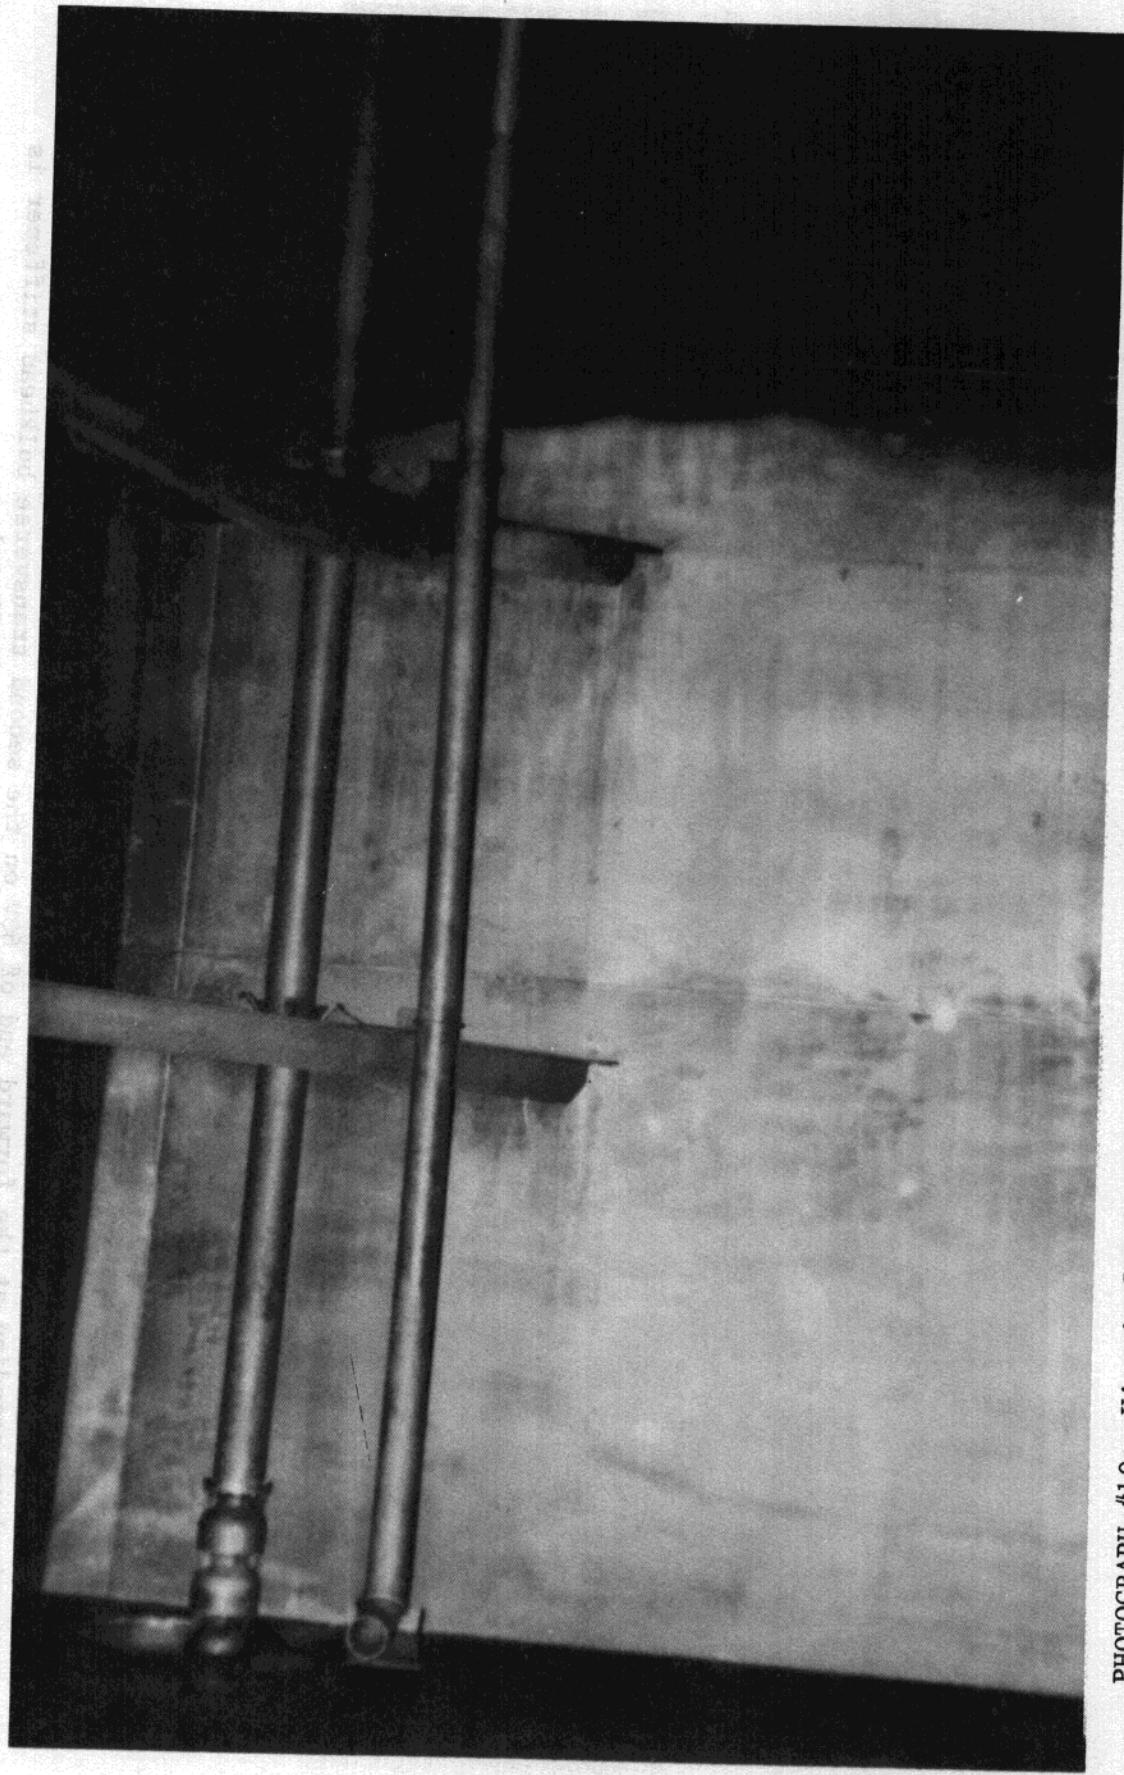
PHOTOGRAPH #10: View in 5CP looking aft at the bulkhead between 5CP and 6CV where it joins the centerline bulkhead. The hole is located just inboard of the end of the second horizontal corner bracket, which is 16'6" from the deck, and outboard of the center longitudinal bulkhead. This location is shown by letter "A". Note the fire effected zone on the bulkhead approximately 18' above the deck. (Fa AA Photo taken November 19, 1984)

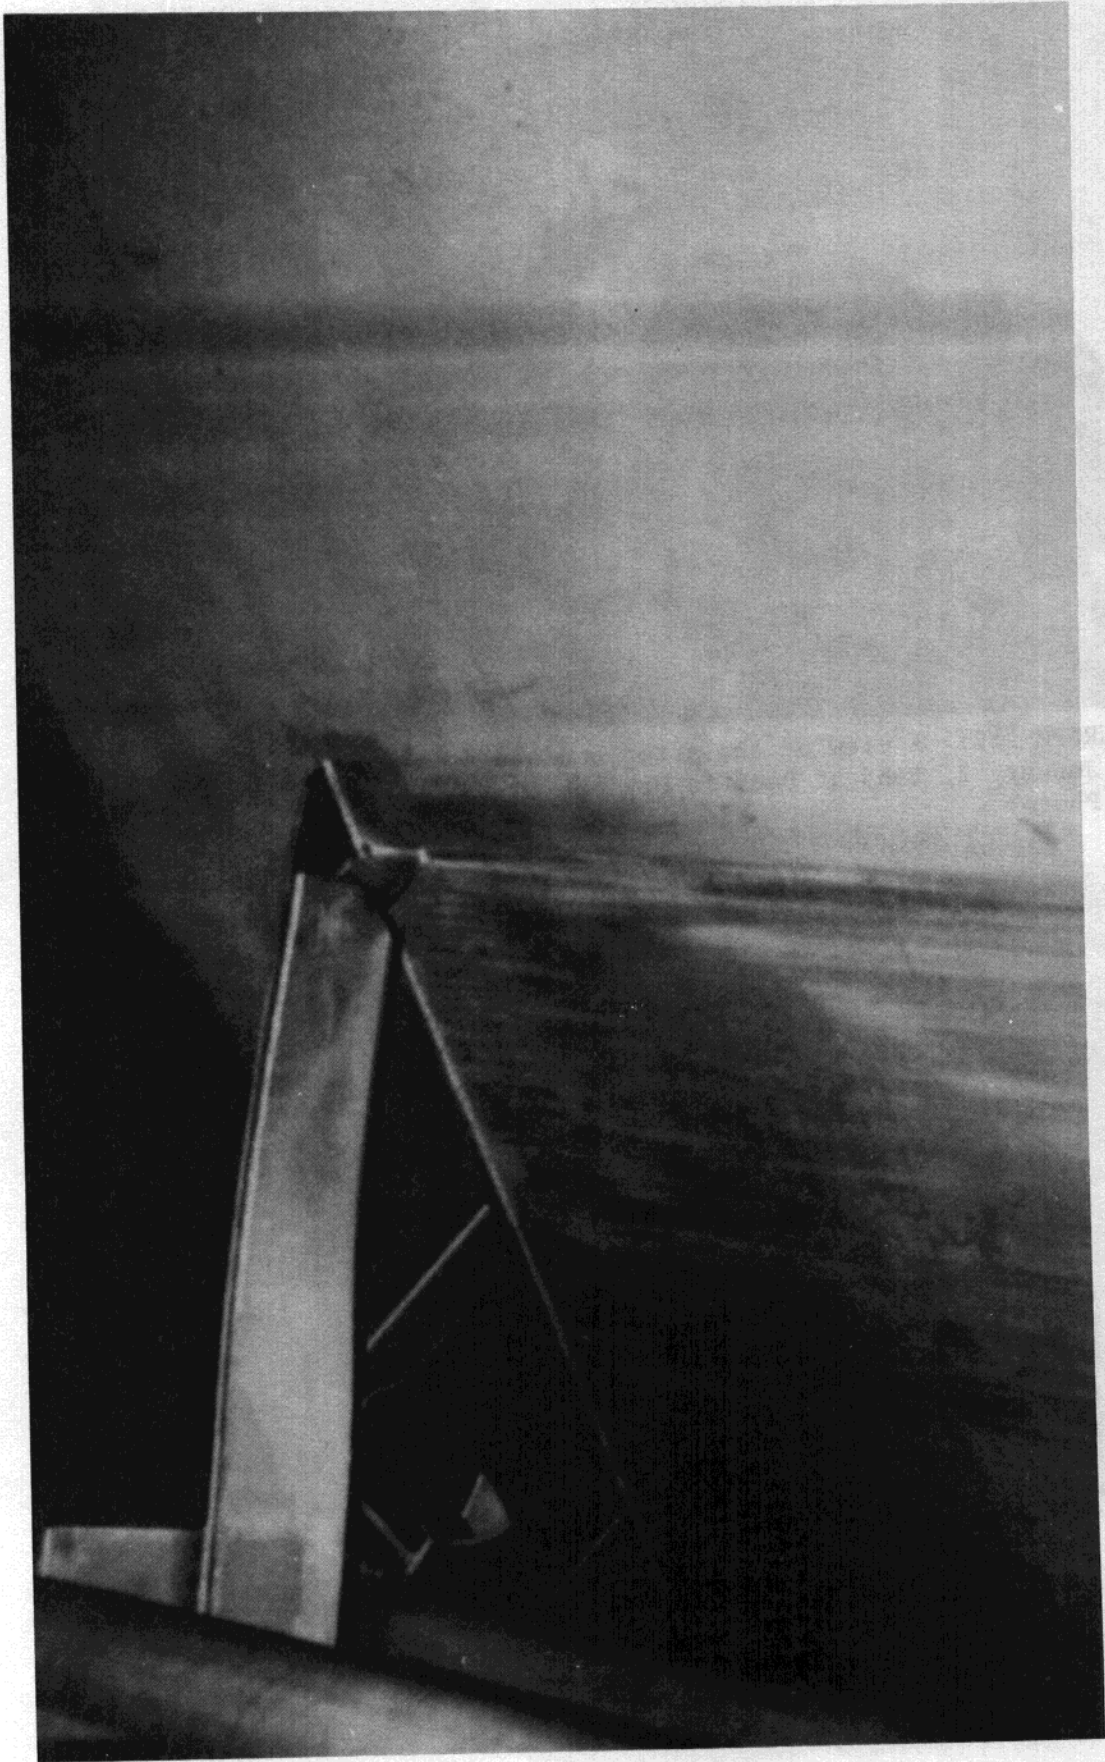
PHOTOGRAPH #11: A detailed view showing the hole from the 5CP side. It is located below a horizontal stiffener plate and behind a cutout in a vertical gusset plate which are part of a horizontal corner bracket. (FaAA Photo taken November 19, 1985)

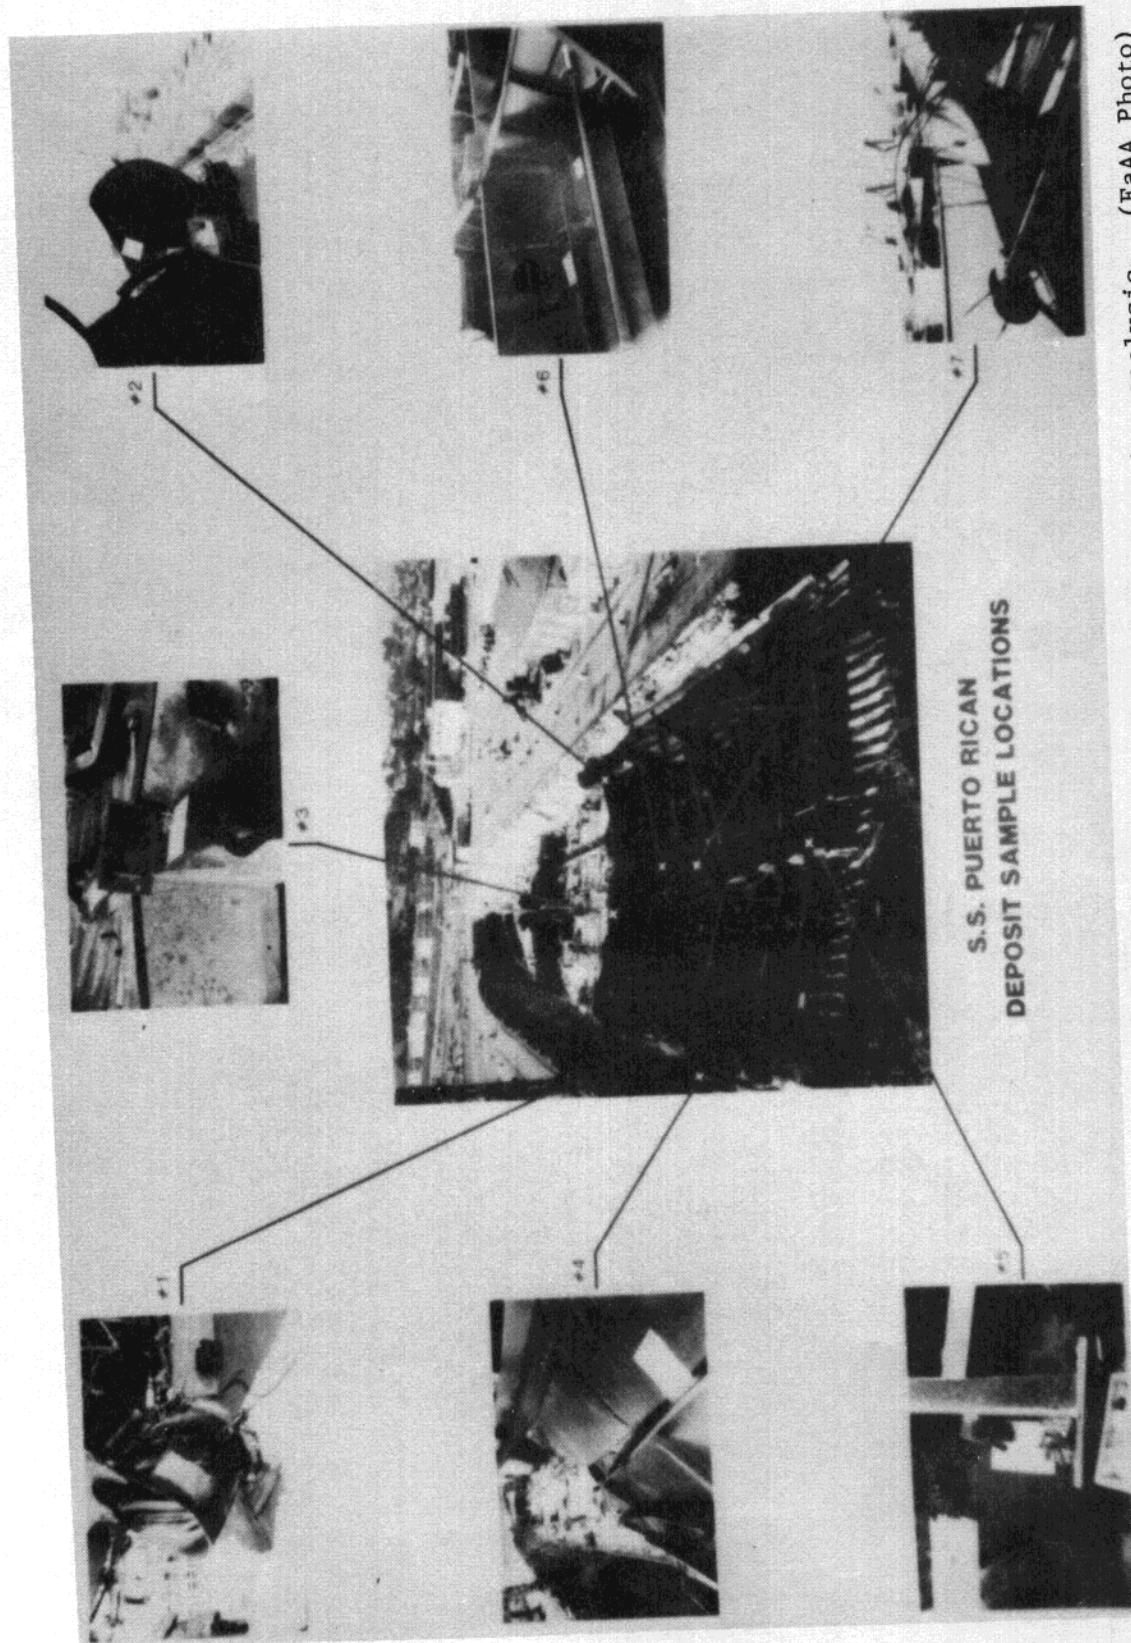
PHOTOGRAPH #14: The seven locations from which deposits were taken for analysis. (FaAA Photo)
