MARINE CASUALTY REPORT

COLLAPSE AND SINKING
OF MOBILE OFFSHORE DRILLING UNIT
RANGER I IN THE GULF OF MEXICO
ON 10 MAY 1979 WITH LOSS OF LIFE

U.S. COAST GUARD
MARINE BOARD OF INVESTIGATION REPORT

REPORT NO. USCG 16732/93621

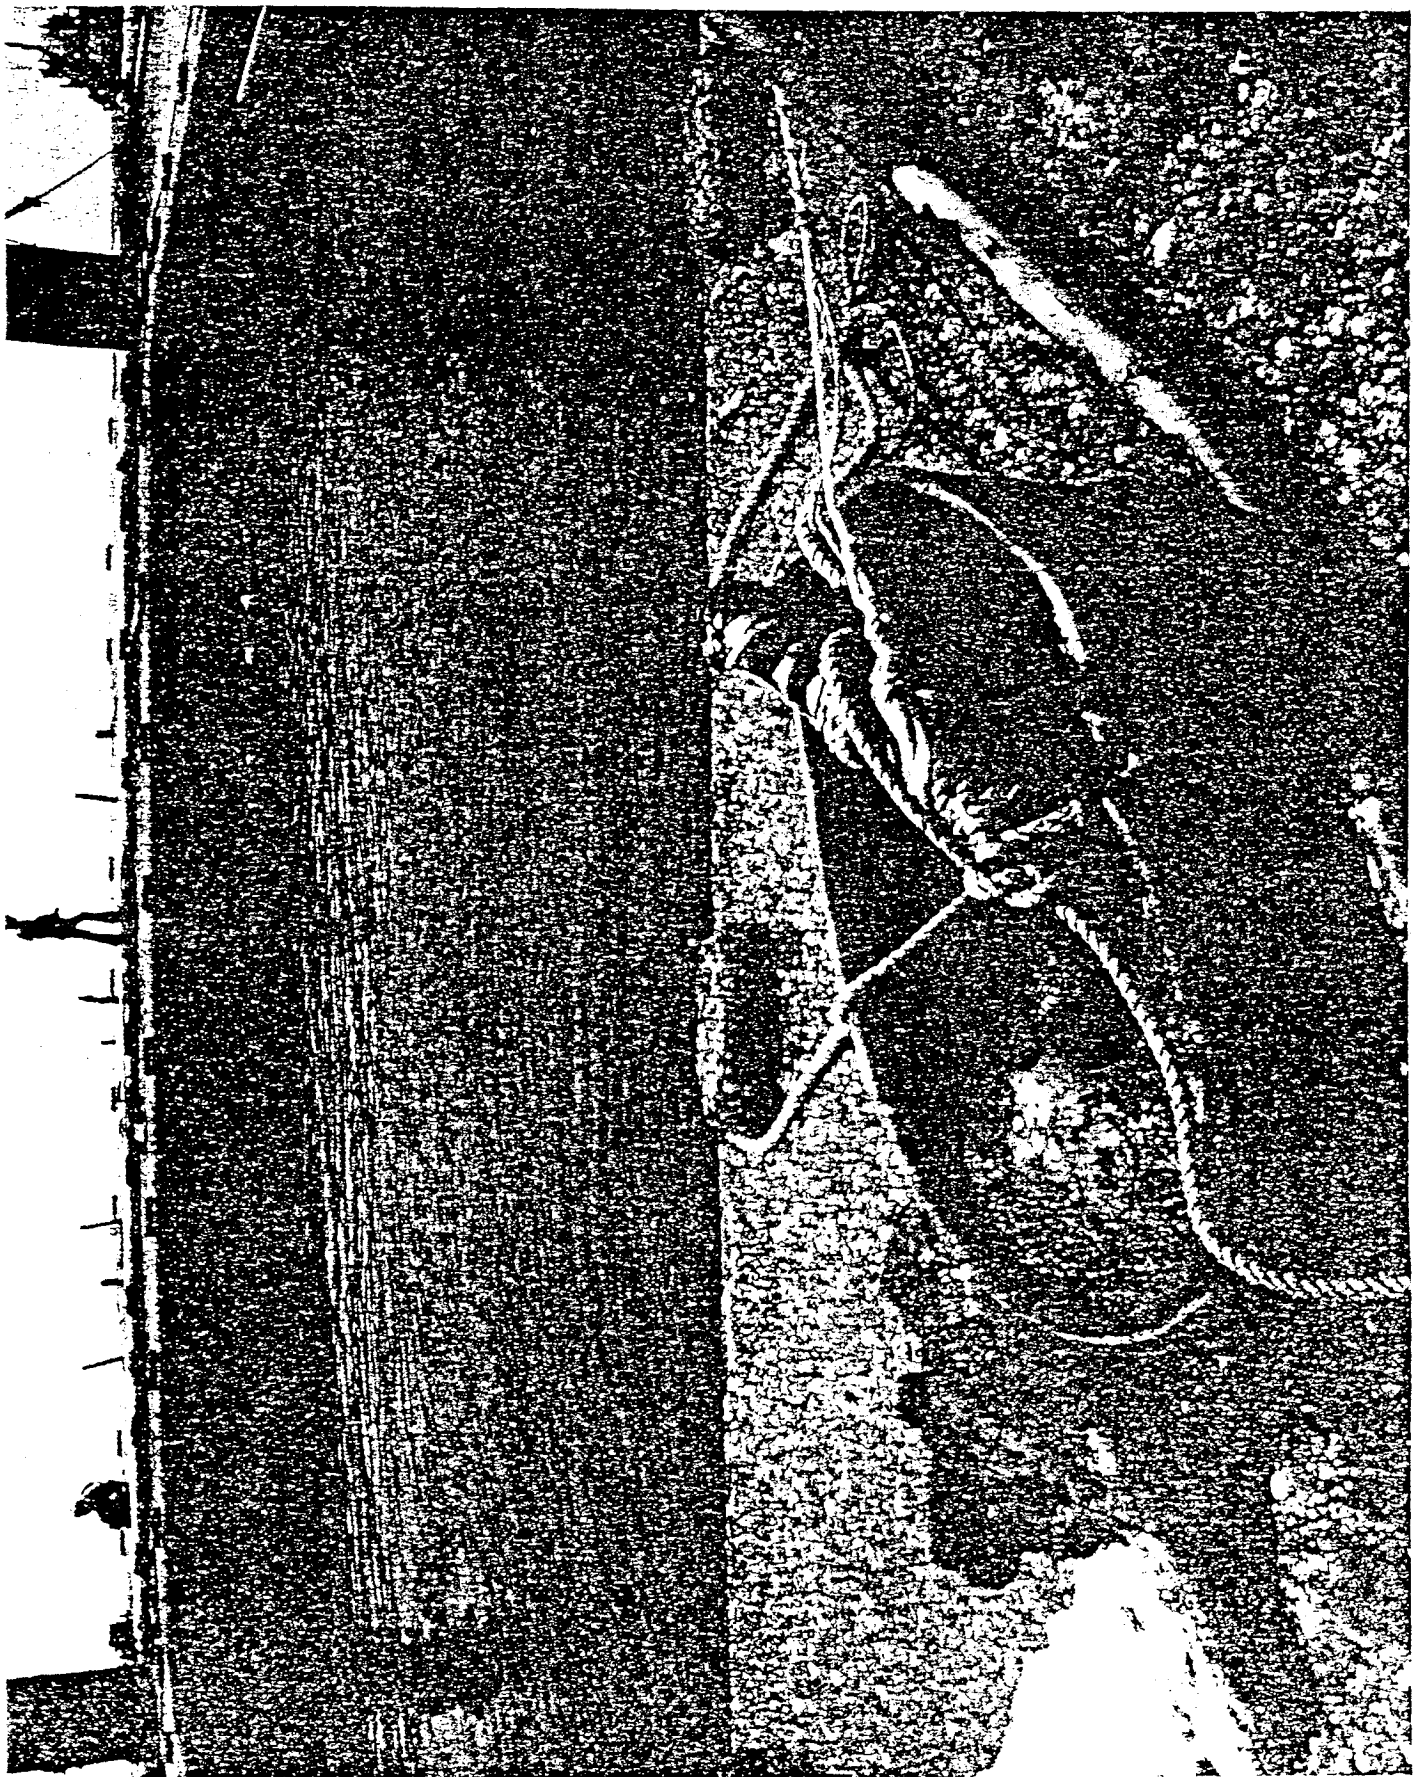
The stern support leg was fractured near its connection to the mat. This catastrophic fracture began on the port side of the leg at the upper toe of a continuous fillet weld that attached a stiffener ring to the stern leg. The fracture extended completely around the leg and was inclined upward toward the starboard side. A stub of the stern leg remained attached to the mat. It varied in height from 4 inches on the port to 15 inches on the starboard side. The fractured surfaces showed matted chevrons that pointed to the port side of the leg. The mat deck plating was pushed in on the port side and the barnacles in way of this deformation were scraped off. The lower end of the fractured leg mated with the deformation in deck plating when it was inclined from the vertical about 9 to 11 degrees to starboard. The upper end of this leg was sheared at the 90 foot level. The starboard leg was bent at the 38 foot level and it remained attached to the mat. The upper end was sheared at the 90 foot level. The port leg was broken off at the 68 foot level. (See figure 6)

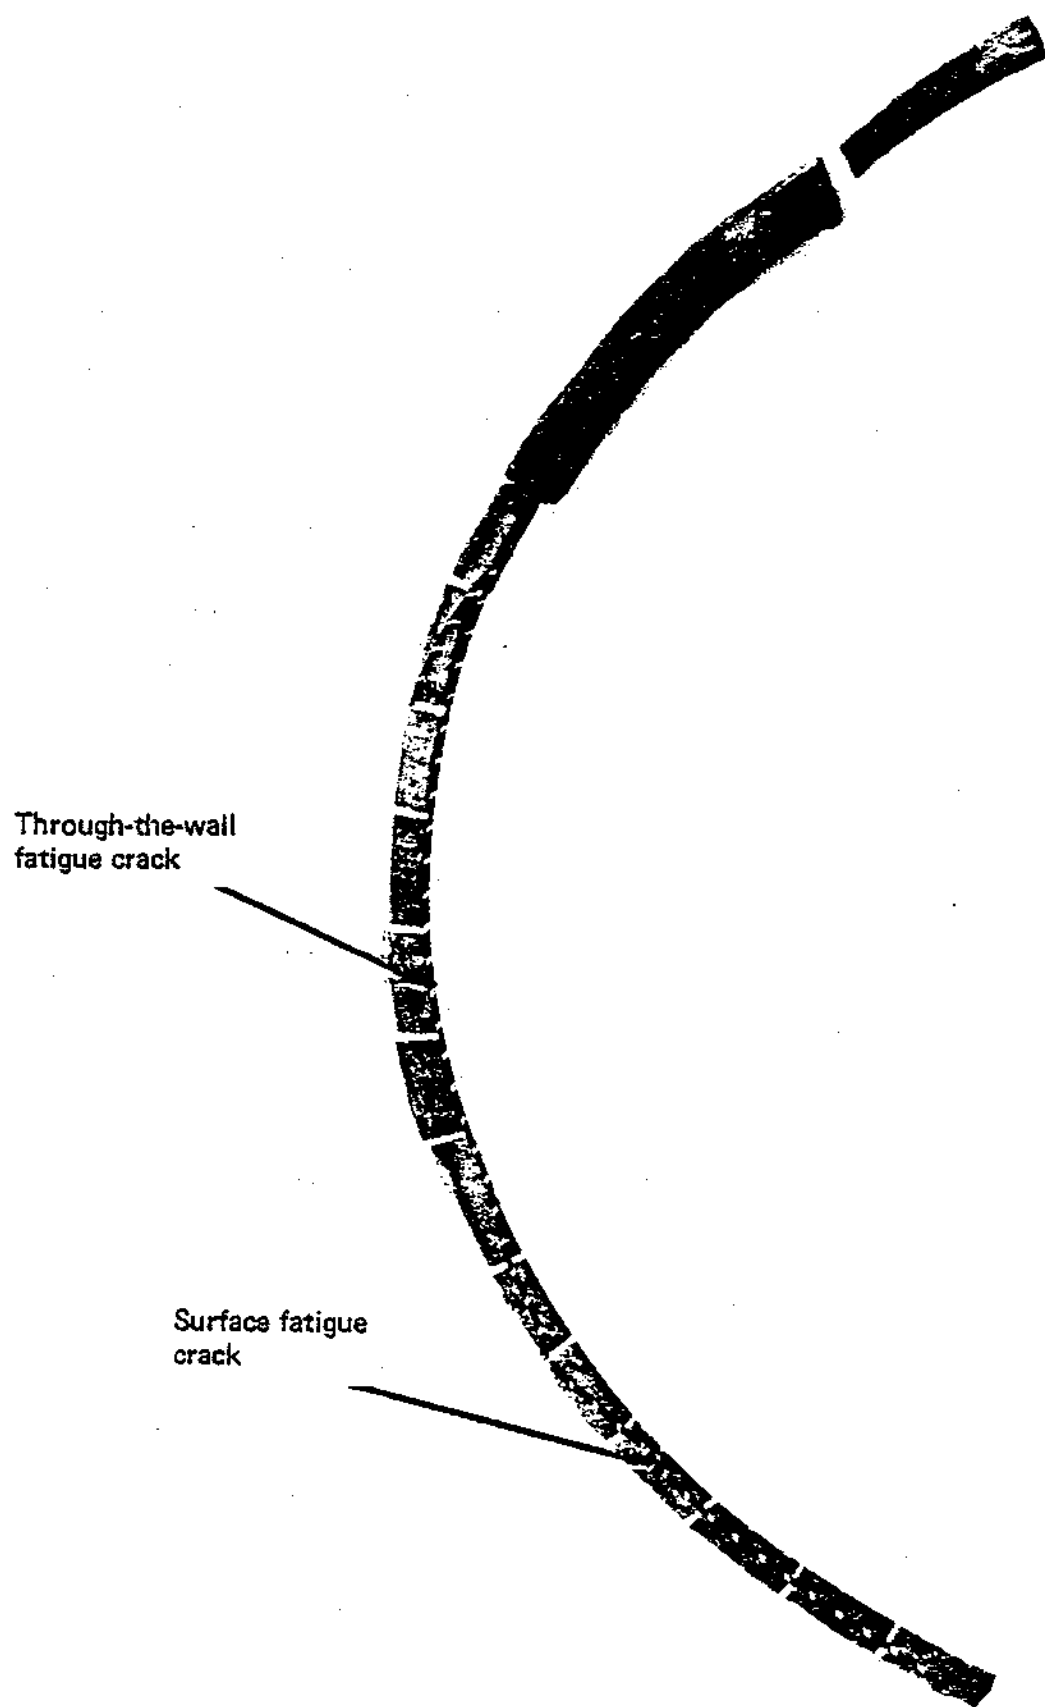
SEM studies were inconclusive in identifying fatigue on the catastrophic fracture surface because of heavy oxide and surface deposits. However, TEM studies showed a through-the-wall fatigue crack of about 23 inches centered on the port side of the stern leg and a surface crack of about 14 inches centered on the after port side of the stern leg. The two fatigue cracks joined on the port side. The surface crack extended 50 to 70 percent through-the-wall of the stern leg. Also, the TEM studies were used to count fatigue striations on the surface of the catastrophic

fracture. Although fine fatigue striations were removed by corrosive action of the sea water, the studies showed that the 23 inch fatigue crack was propagating for at least 400 days. TEM studies of the starboard side of the catastrophic fracture showed a quasi-cleavage mode of failure. (See figure 7)

FIGURE 7 – CATASTROPHIC FRACTURE SURFACE OF PORT SIDE OF STERN LEG.
