MARINE CASUALTY REPORT

**Capsizing and Sinking
Of The
MOBILE OFFSHORE DRILLING UNIT
ROWAN GORILLA I
In The North Atlantic Ocean
On
15 December 1988**

**U.S. COAST GUARD
MARINE BOARD OF INVESTIGATION REPORT
AND
COMMANDANT'S ACTION**

REPORT NO. USCG 16732/02 HQS 92

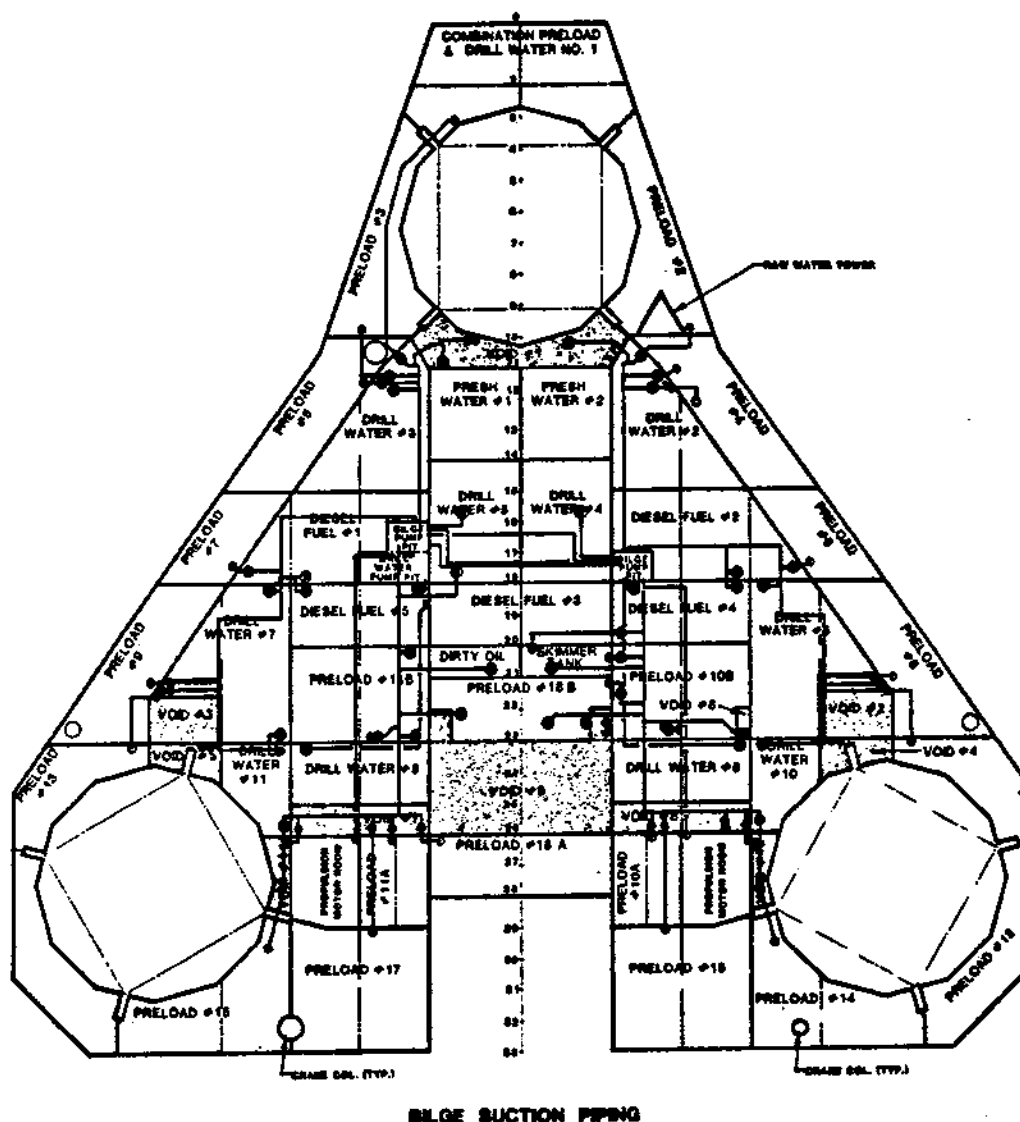
Figure 2

Aboard the ROWAN GORILLA I, one of the crewmen detected flooding in preload tank 14 during a routine sounding. The only means of determining the condition of the preload tanks was through two inch sounding tubes located on the main deck (See figure 2). Secondary or remote means were not provided. The tank was opened and inspected and a vertical fracture was discovered in way of the stern, permitting a steady spray of water to enter the tank. Preload tank 15 was also entered and a horizontal fracture was discovered in way of the stern, though only "weeping". The Rig Superintendent directed that the eductor system take suction on preload tank 14. The Senior Barge Engineer observed the fractures in both tanks. He stated the crack in preload tank 14 seemed to open and close as the stern was struck by waves.

INNER BOTTOM TANK LAYOUT
