# MARINE CASUALTY REPORT M/V SAN MATEO

CAPSIZING IN MORRO BAY, CA  
ON FEBRUARY 16, 1983  
WITH NO LOSS OF LIFE

MARINE BOARD OF INVESTIGATION

REPORT NO. USCG-M-84-6

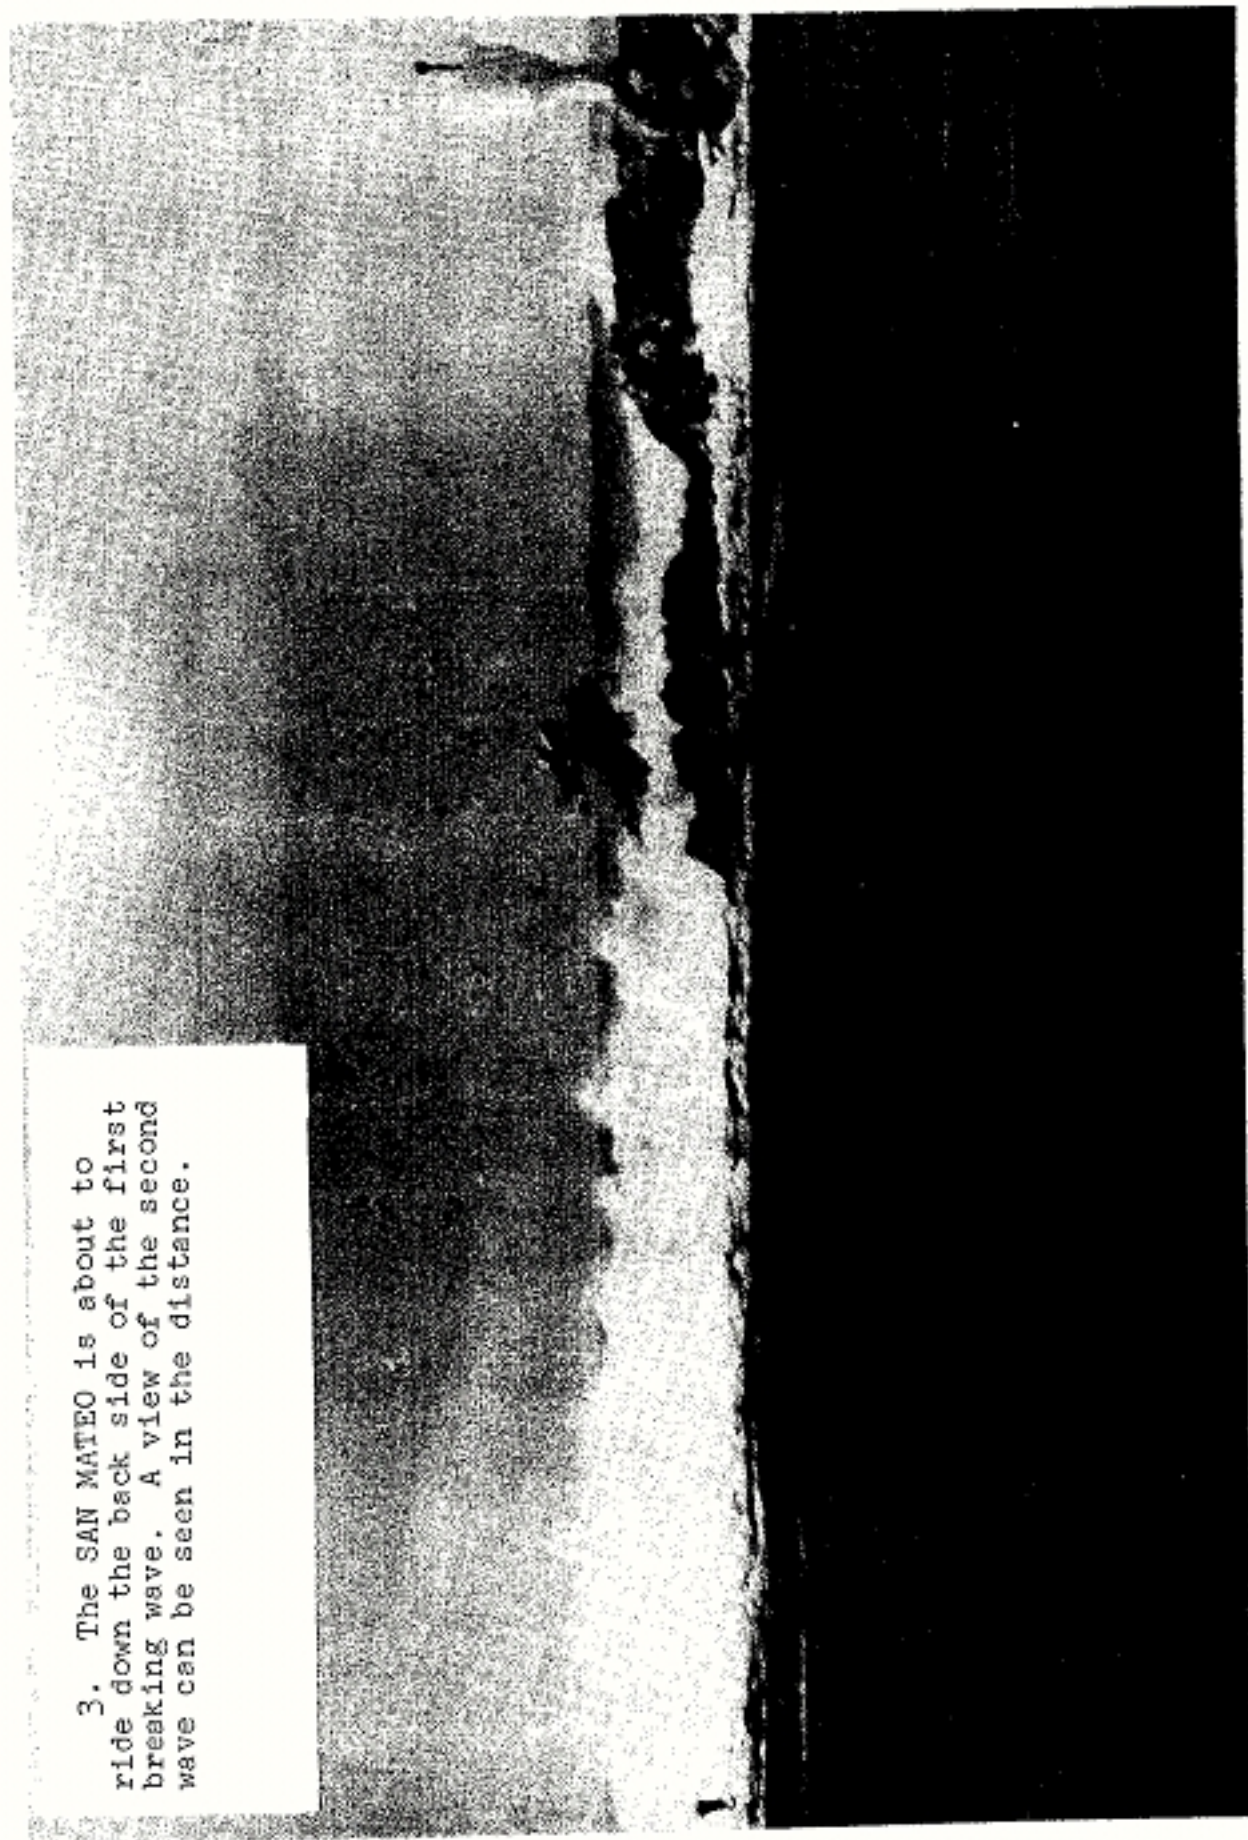
3. The SAN MATEO is about to ride down the back side of the first breaking wave. A view of the second wave can be seen in the distance.

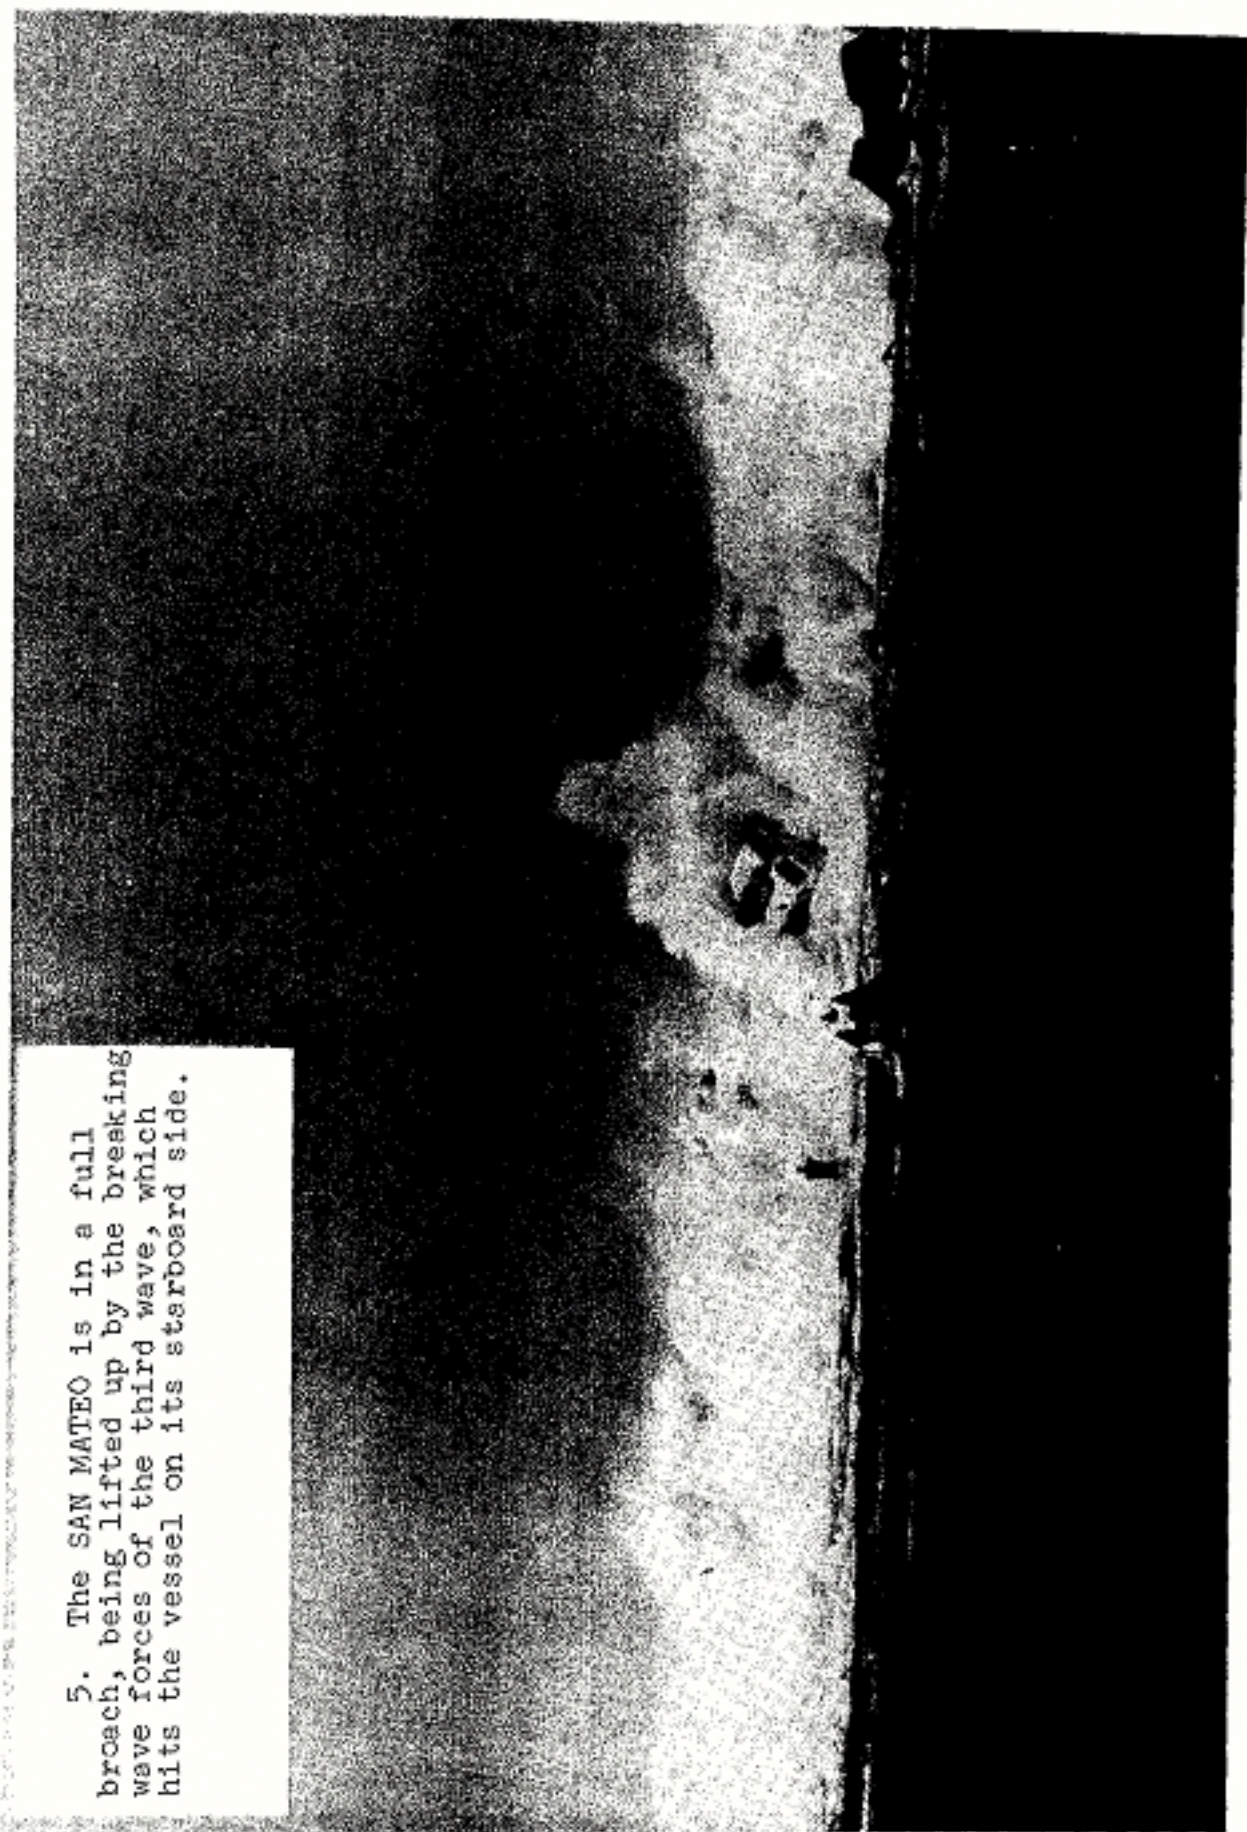
5. The SAN MATEO is in a full  
broach, being lifted up by the breaking  
wave forces of the third wave, which  
hits the vessel on its starboard side.
