BOARD OF INQUIRY REPORT
CONCERNING THE LOSS OF HAZARDOUS MATERIALS
NEAR THE NEW JERSEY COAST
ON 3 JANUARY 1992

**M/V SANTA CLARA I (PN)- BOARD OF INQUIRY CONCERNING LOSS
OF HAZARDOUS MATERIAL IN THE ATLANTIC OCEAN NEAR THE NEW
JERSEY COAST ON 4 JANUARY 1992**

M/V SANTA CLARA I (PN) LOSS OF HAZARDOUS MATERIAL IN THE ATLANTIC OCEAN OFF THE NEW JERSEY COAST ON 4 JANUARY 1992

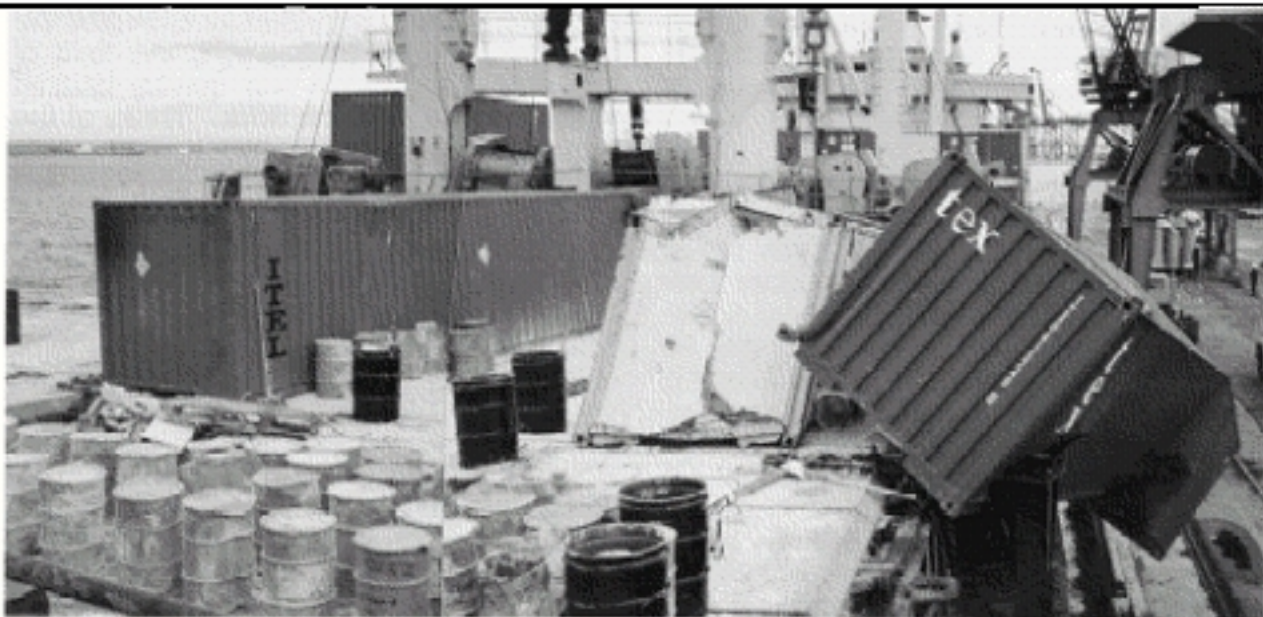
holds, resecuring cargo not scheduled for discharge in Baltimore. Several containers, trucks, and break-bulk packages below deck were found broken loose and damaged. In the #1 Upper Tween Deck (UTD), two pallets of Magnesium Phosphide were upset, with the drums and contents mixed with loose lumber and damaged cartons of wine. At least two other dangerous cargoes were similarly adrift in other holds.

Containers at Hatch #2 on arrival in Baltimore (looking aft)

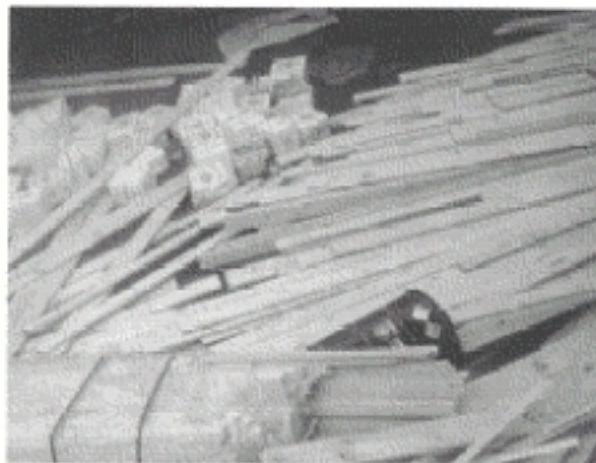
Longshoremen in Baltimore discharged the drums of Magnesium Phosphide, including six still intact on pallets and four loose and broken drums. After discharging the drums, one longshoreman working a forklift in the #1 UTD noticed sparks as the rubber tires on the forklift spun on the gray, granular product on the deck. He promptly exited the hold, and one of the supervisors reported the situation to the shipping company's Port Captain, indicating he "had a problem."

No further cargo work was done in the #1 Upper Tween Deck in Baltimore. Over 800 pounds of Magnesium Phosphide remaining on the deck inside the hold was left, and no report of any hazardous condition was made to the Coast Guard. The ship left Baltimore at 0645 on January 6, reaching the pier in Charleston at 2220 January 7.

Magnesium Phosphide drums spilled in #1 hold

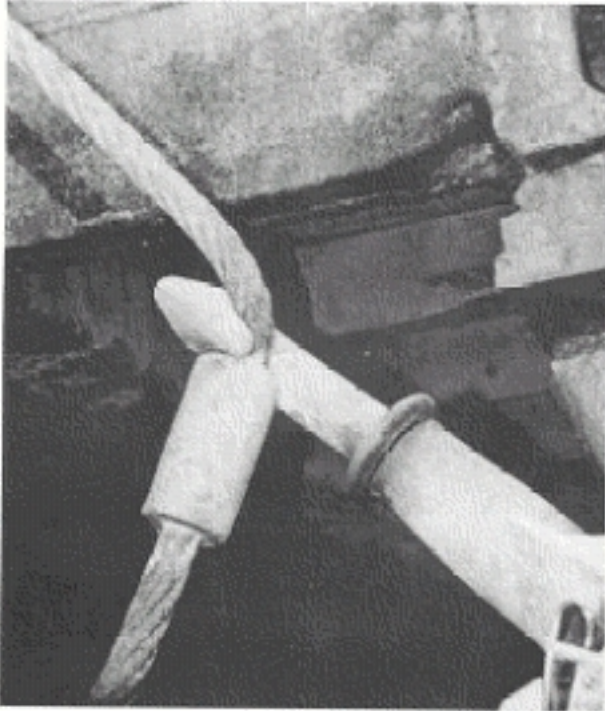
lashings, they result in a severe bend of about 75 degrees and a seriously unbalanced strain on the wire, effectively reducing its cross-section. The bearing surface is also significantly reduced, presenting the potential for a slackened wire to jump out of the hook. The Board observed both types of turnbuckles in use on the #3 hatch, and photos showed similar installation on the #4 hatch in Baltimore shortly after the casualty.

Hook-type turnbuckle with strain on lashing

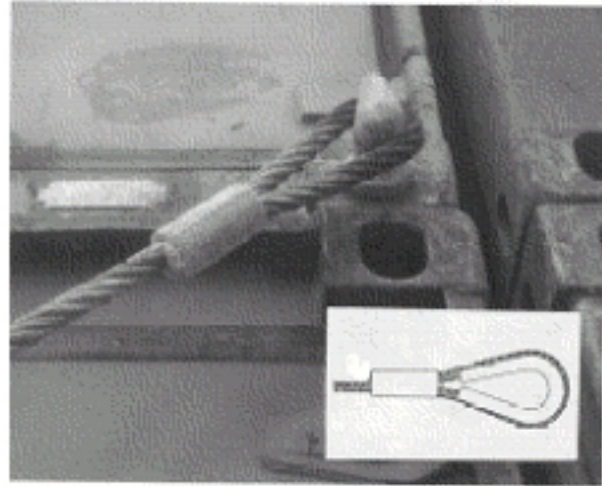
Actual damage was again evident, as the Board found several loose lashings on deck showing permanent deformation and broken strands at the unreinforced eye.

Unreinforced eye over penguin hook
(Inset - with thimble)

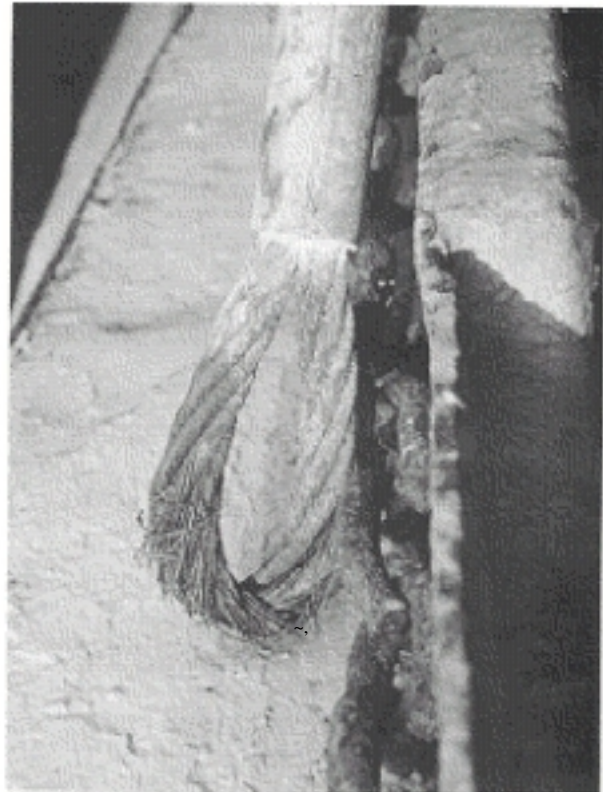
Damaged eye

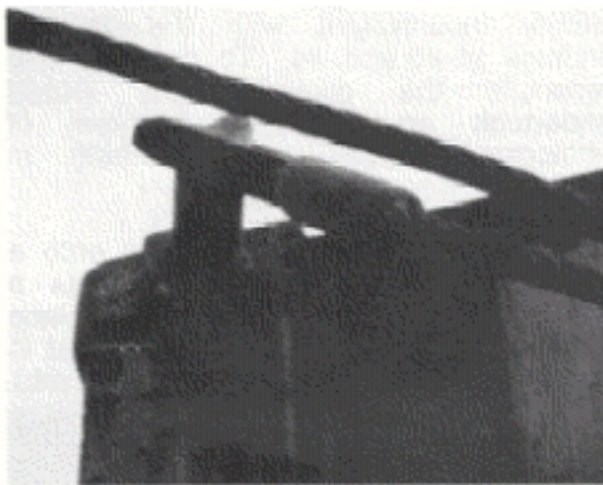
By design, penguin hooks are fitted into the container corner castings simply by turning them in place. The degree of turn is part of the problem; the flexibility of the lashings is the other part. As installed aboard the SANTA CLARA 1, some hooks were observed to be turned at a substantial angle to the axis of the lashing, and in at least one case the lashing was also partially twisted, riding up on the projected hook and taking a bite a little above the elbow of the hook. With cyclic tensioning and slackening of the lashing, it's easy to conceive that it might either incrementally turn the penguin hooks or just fall off.

Twisted eye/hook connection

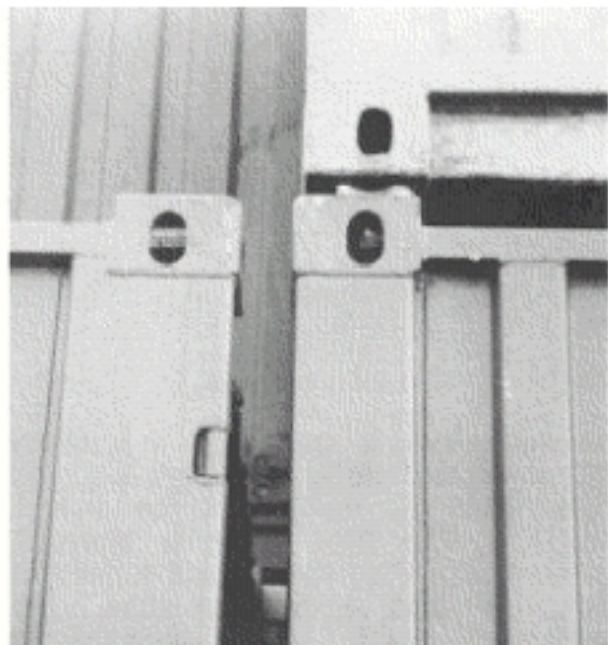
An inherent weakness in this configuration is the stowage of 20-foot containers in the 40-foot spaces on both outboard sides. It leaves no room for lashing the abutting ends of the containers, which are separated by only about 3 inches. At the base they're resting on cones only. Essentially these containers are secured at one end only.

Typical spacing for 20' containers in 40' space

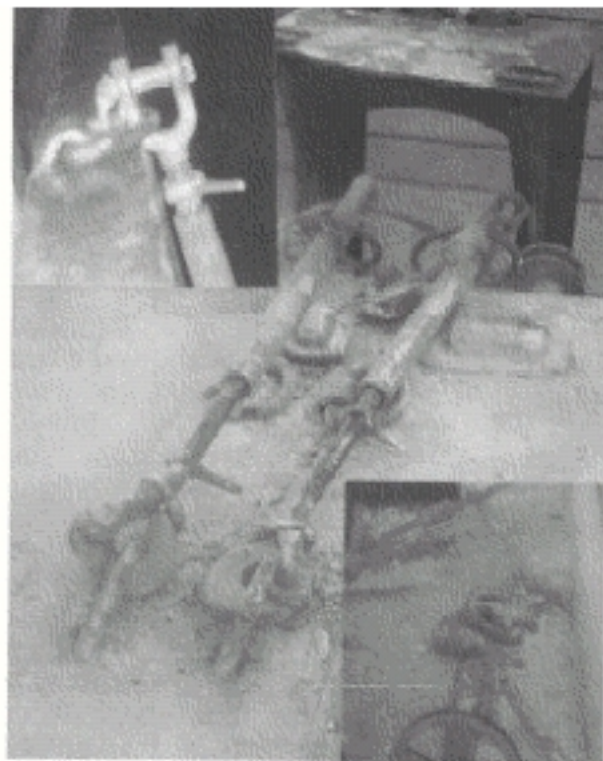
A variety of turnbuckles remaining attached

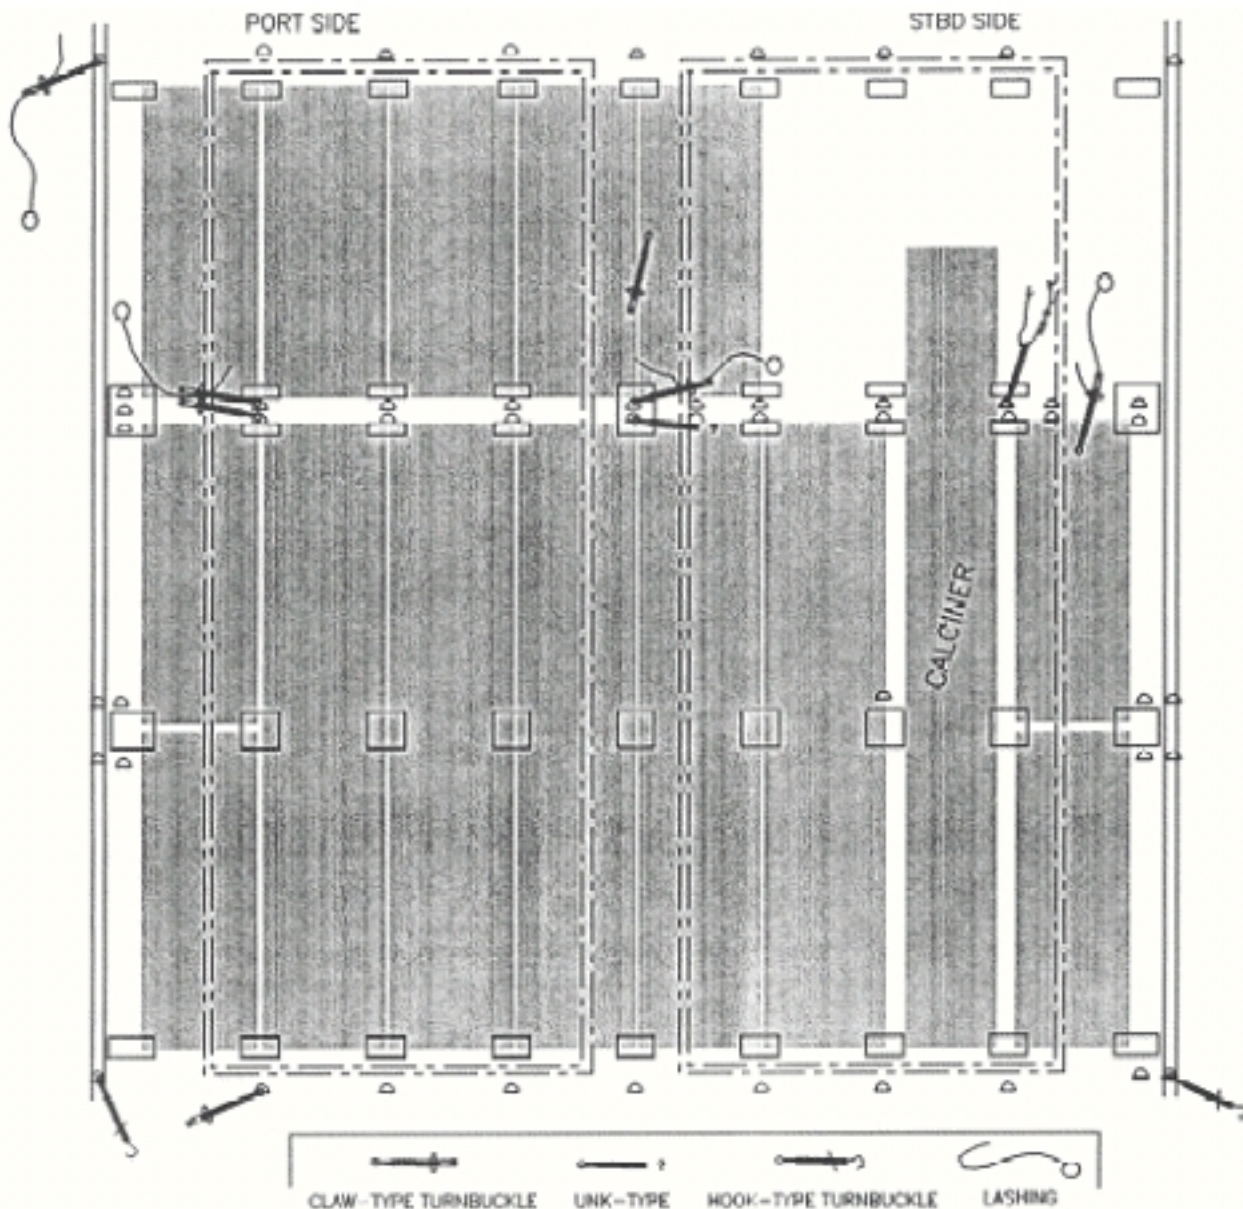
Mapping details from the photos onto a plan view of the #2 hatch reveals a distinguishing pattern - the left-in-place turnbuckles appear to be concentrated in way of exterior container stacks. It also

account for the predominant mix of turnbuckles fitted with bolted clevis jaws or pelican hooks with keepers at the bottom end. Equally improbable is the notion that they broke off - lashings were again more likely the weaker link even in good condition and properly installed. The one remaining explanation is the only real credible one, and the one that the Board embraces - the additional turnbuckles and lashings weren't installed in the first place.

Plan View of #2 hatch upon arrival in Baltimore
(shaded areas show original stowage of containers and calciner)

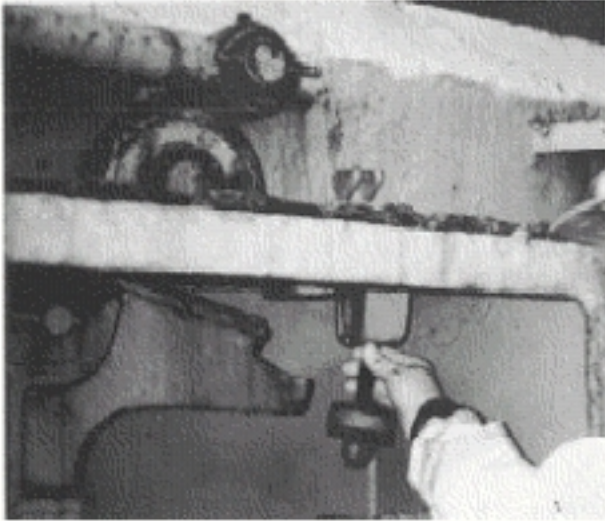
(Incidentally, the Board notes that it is common practice to leave hatch covers unsecured during coastwise voyages, and that classification societies don't require that hatch covers be dogged.)

Unsecured dogs on the hatch covers

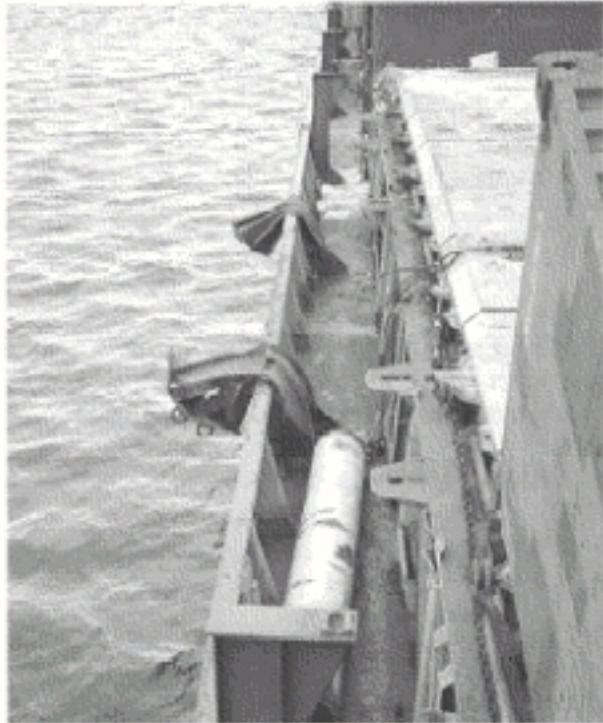
The deck pedestals were the subject of much attention during the few weeks after the casualty, since two adjacent pedestals in way of the #2 hatch had failed catastrophically. Both were bent completely over the bulwark, by 100-120° from their original upright position. Several others in way of #2 showed limited signs of compression damage at the base as well.

Failed deck pedestals
(starboard side looking aft)

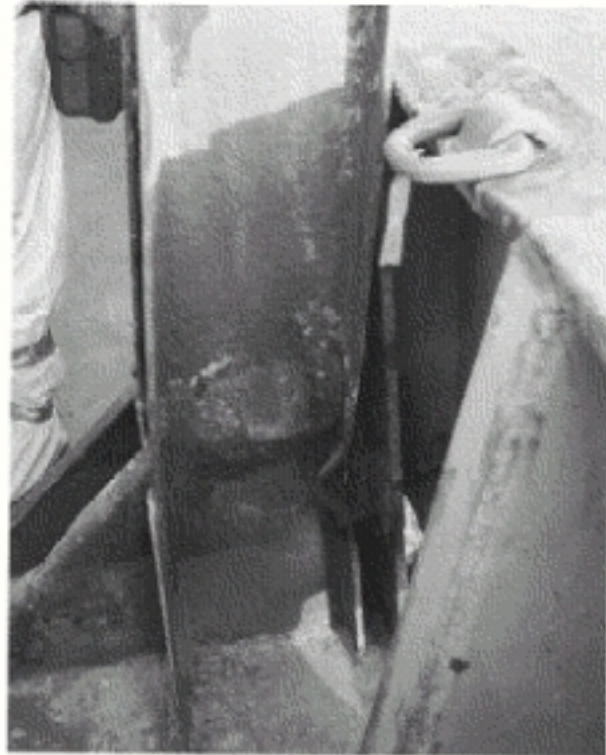
5) Compression damage at the bottom of the various pedestals was at the outboard flange of the beam. Unless the inboard side of the container first broke free from the cones in deck sockets on the hatch cover, all of the transverse and normal forces would have been expressed in a tipping action, downward on the far *inboard* edge of the pedestal. Any compression failure would be expected on the inboard flange, not the outboard one.

Compression damage at bottom of pedestal

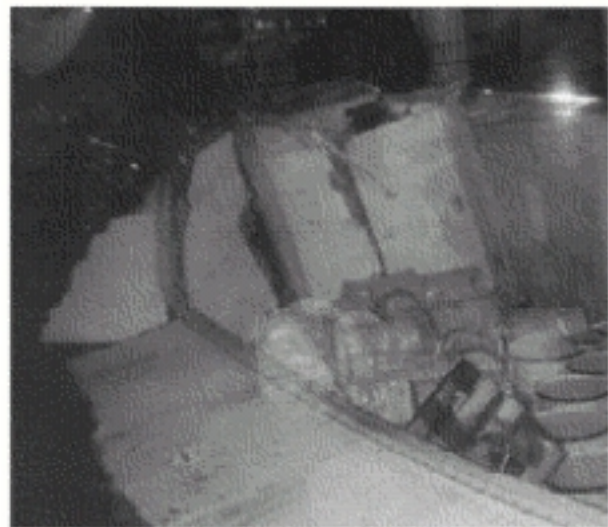
The FRP container in particular drew attention to the construction and maintenance standards. One of the four containers remaining aboard at the #2 hatch, it was the only one which broke apart, splitting at the top, sides, and end walls.

FRP container destroyed during storm

Recommendation 4: Examine the failure and repair history for FRP containers to determine their suitability for continued unrestricted use.

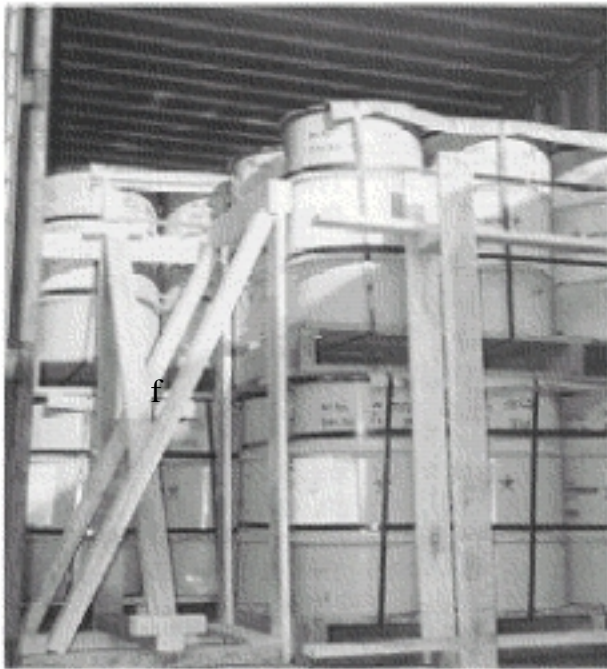
Review of the container packing certificates (which are recommended by the IMDG Code as prerequisite for accepting the containers for shipment, and which were available in this case), revealed no specific procedural problems in packing; the end-result, however, plainly argues the weakness of the overall blocking and bracing scheme used.

inside and belowdeck stowed arsenic container
