MARINE CASUALTY REPORT

**M/V SCANDINAVIAN SEA,
BAHAMIAN REGISTRY O.N. 339313,
FIRE IN THE ATLANTIC OCEAN 9 MILES
SOUTHEAST OF PORT CANAVERAL, FLORIDA
ON 9 MARCH 1984 WITH NO LOSS OF LIFE**

Marine Board of Investigation Report

REPORT NO. USCG 16732/0002HQS 84

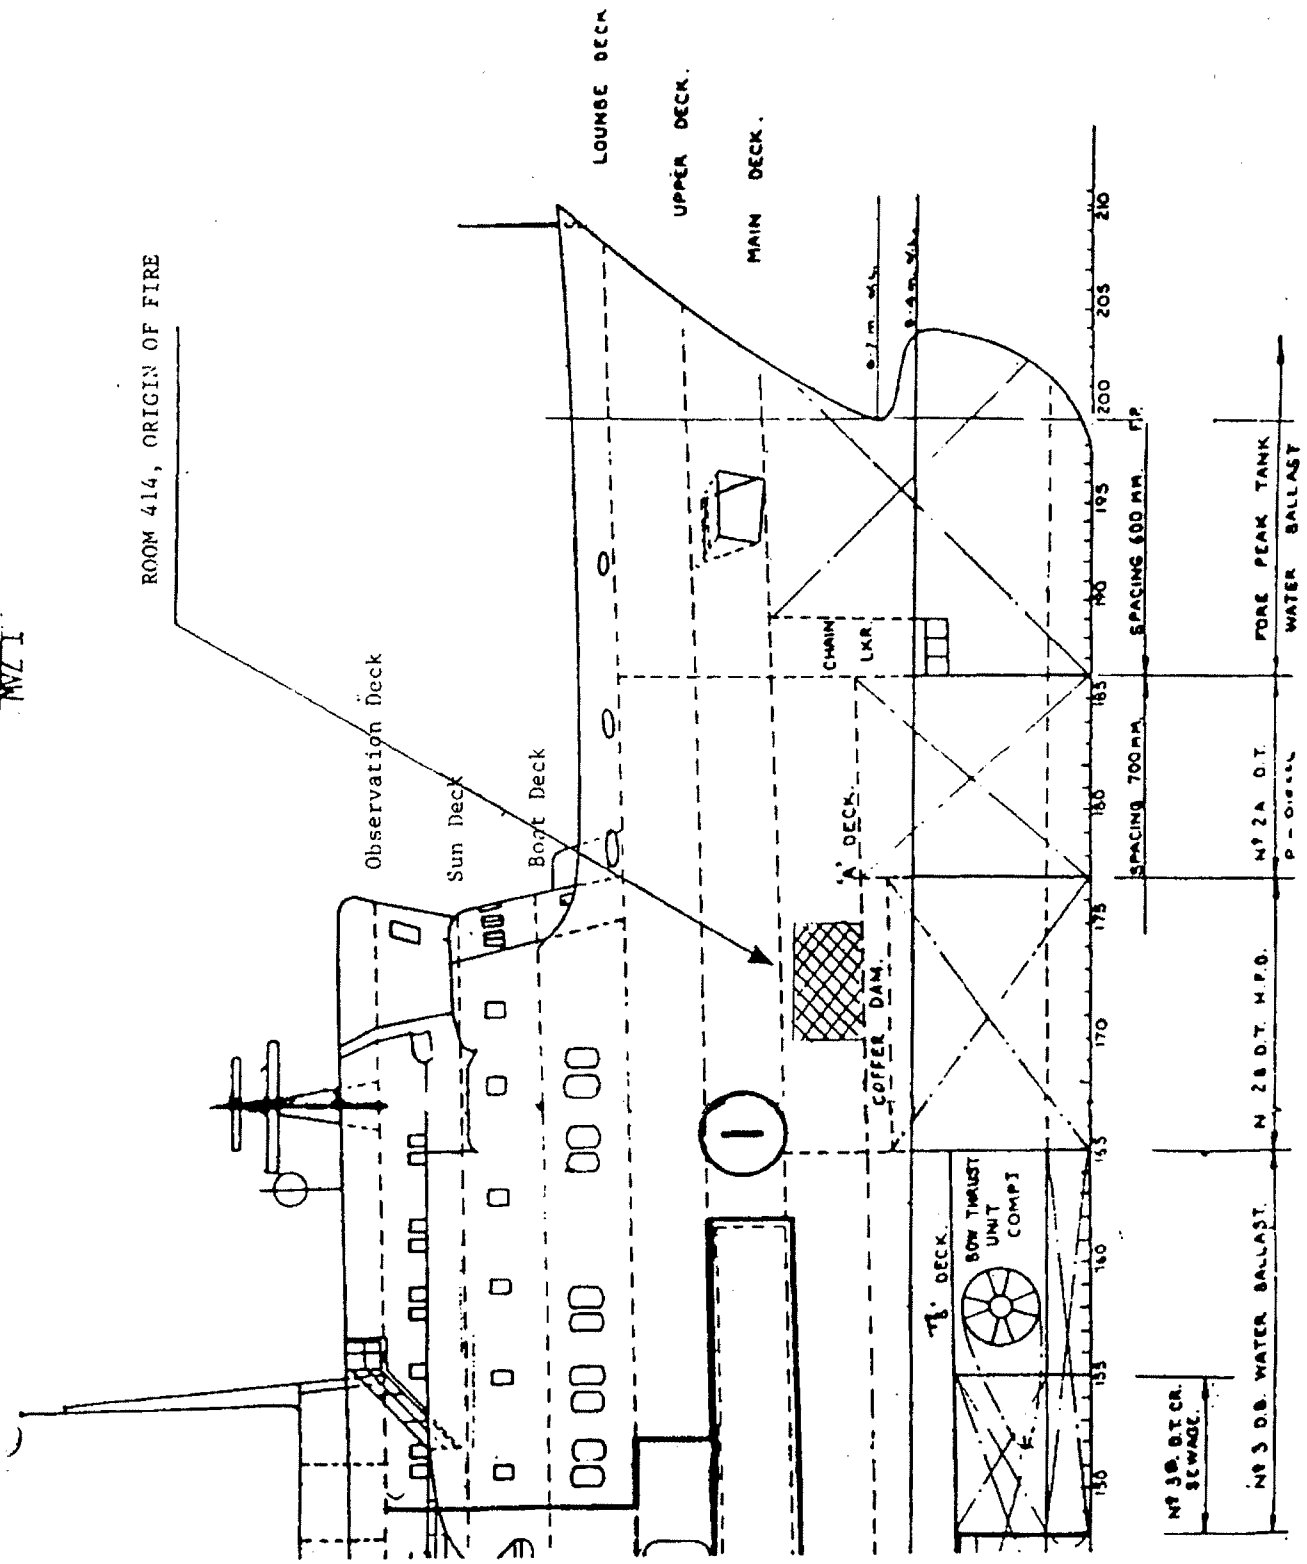
FIRE SCREEN DOOR AT FRAME 153

ROOM 414, ORIGIN OF FIRE

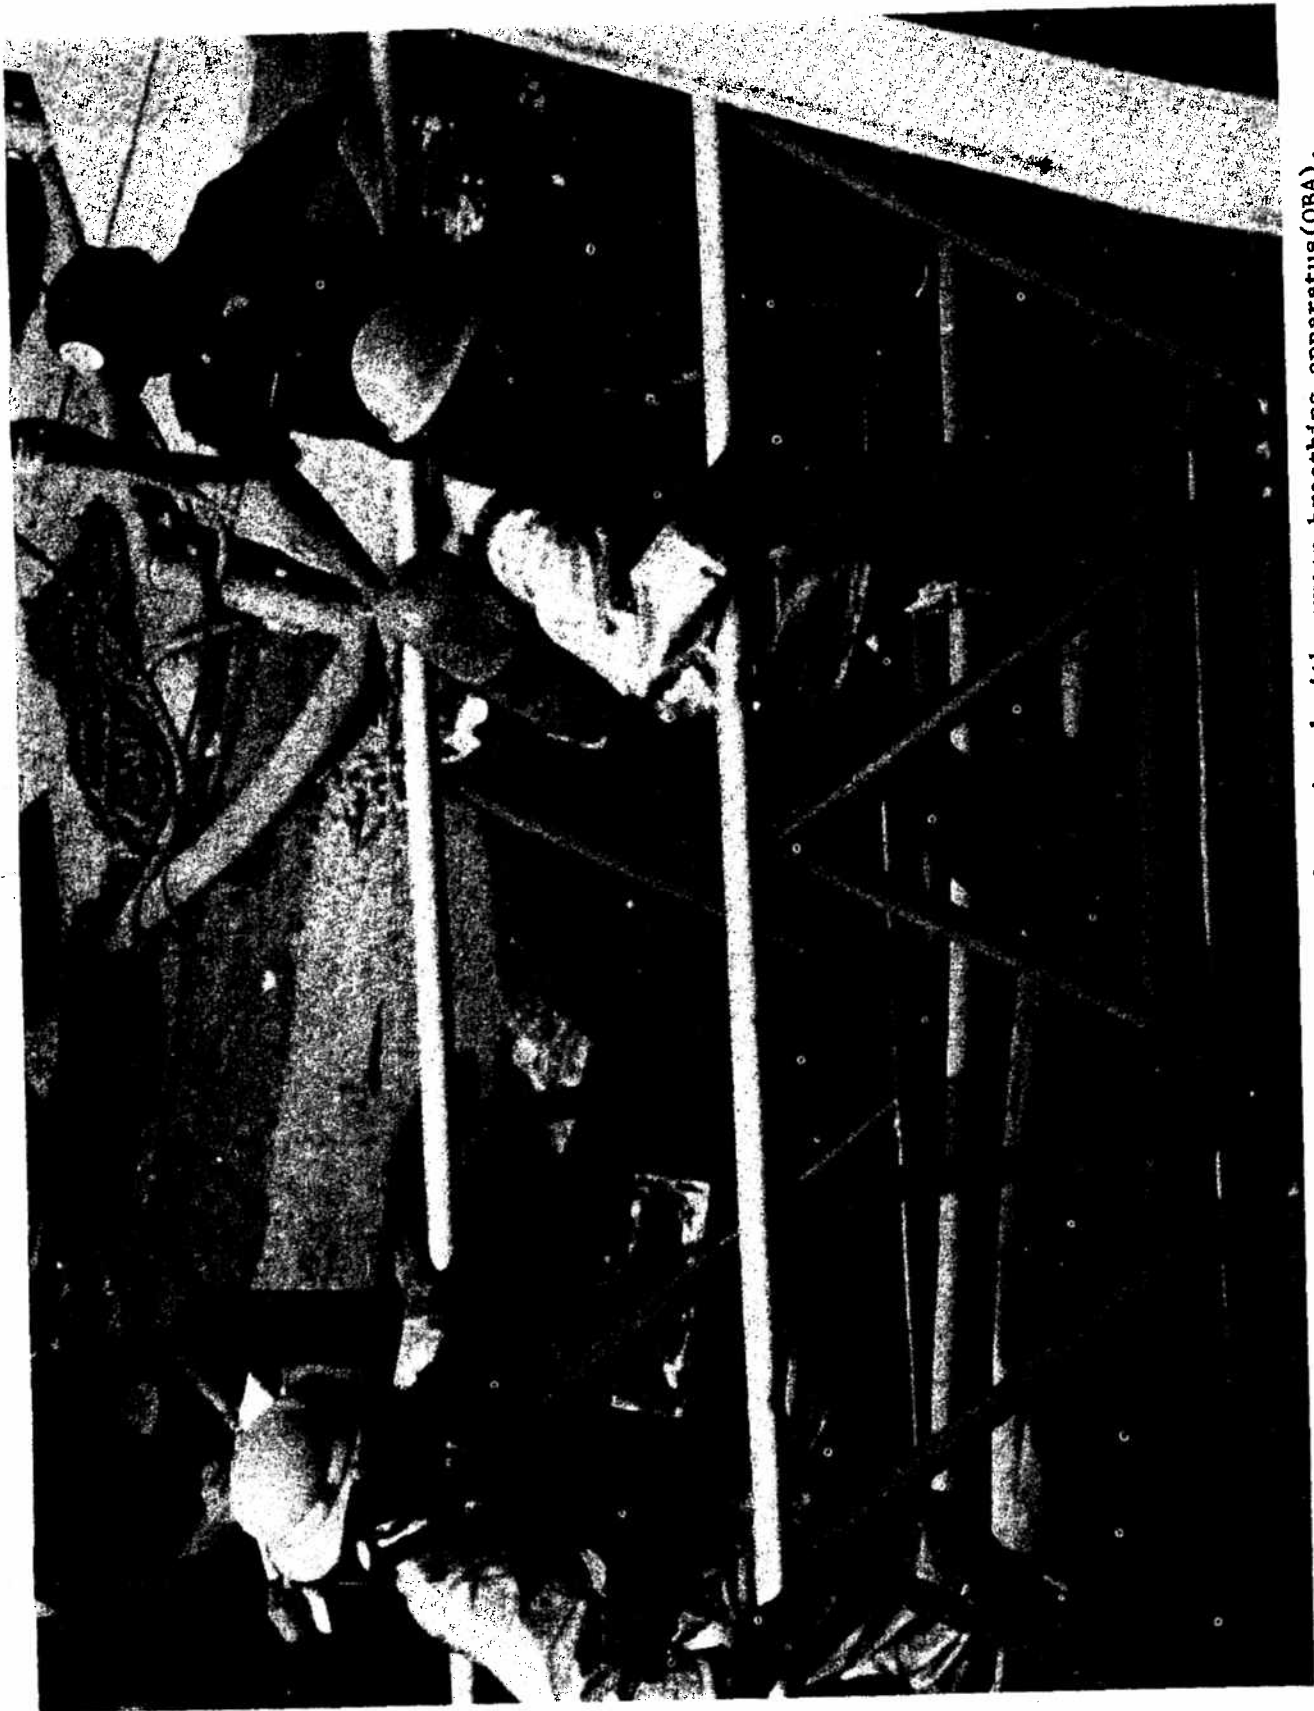
Firefighters enter the vessel. Man on left equipped with oxygen-breathing apparatus (OBA).
Man on right equipped with self-contained breathing apparatus (SCBA). (Official USCG Photograph)
