MARINE CASUALTY REPORT

SS C. V. SEA WITCH - SS ESSO BRUSSELS (BELGIUM);
COLLISION AND FIRE IN NEW YORK HARBOR
ON 2 JUNE 1973 WITH LOSS OF LIFE

U.S. COAST GUARD
MARINE BOARD OF INVESTIGATION REPORT
AND COMMANDANT'S ACTION

REPORT NO. USCG/NTSB - MAR-75-6
RELEASED 2 MAR 1976

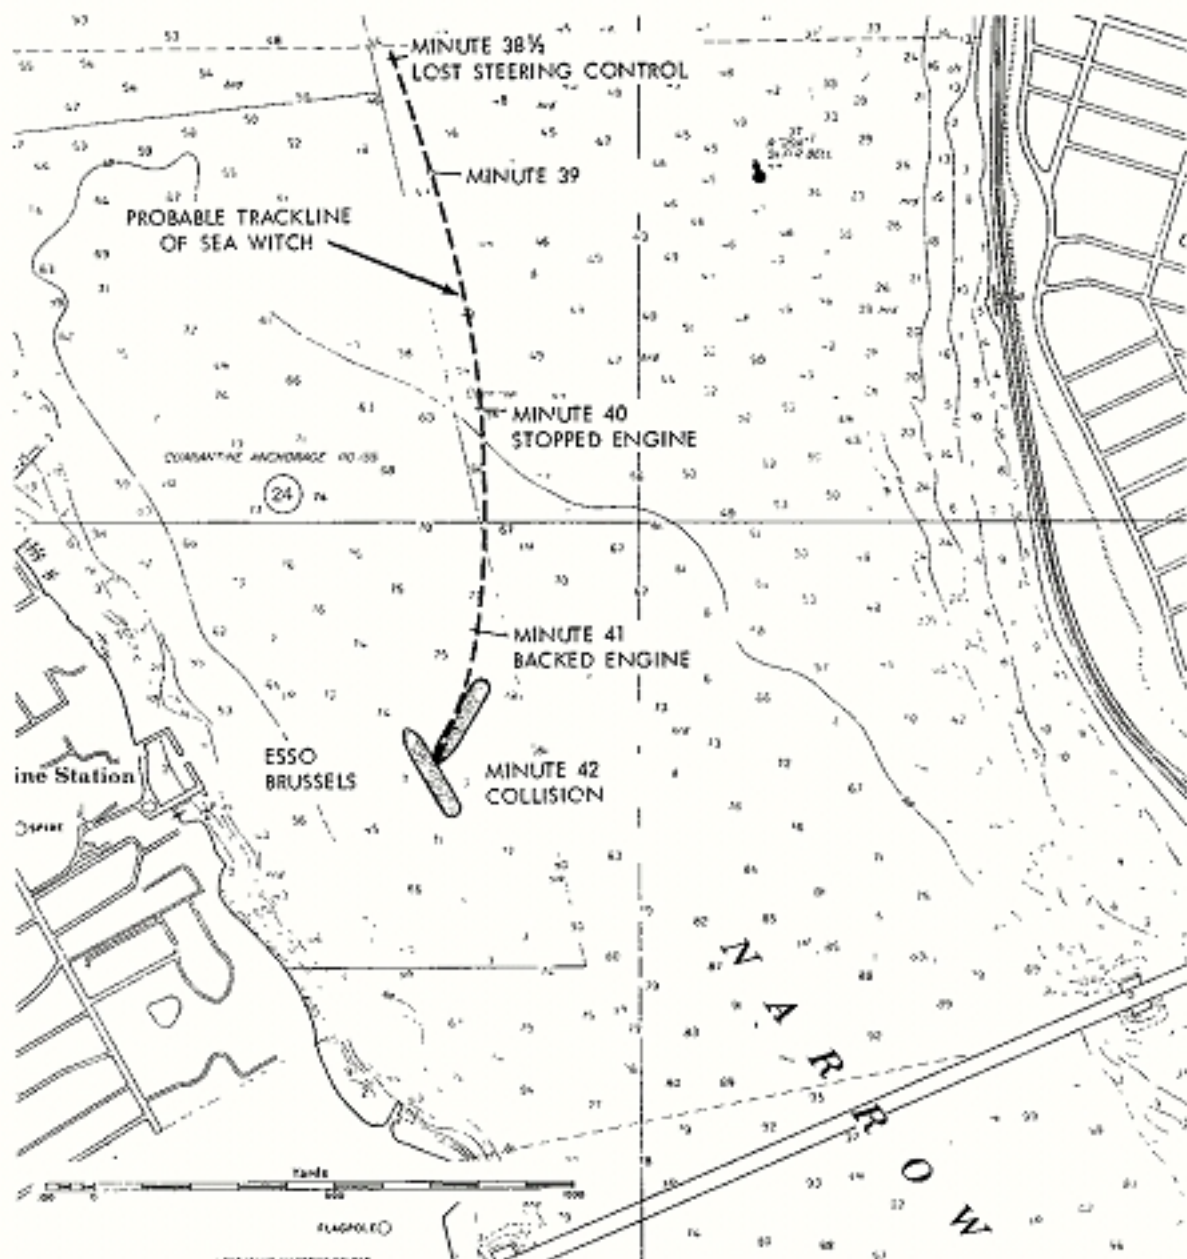
Figure 1. PROBABLE TRACKLINE OF SEA WITCH BEFORE COLLISION

The relative bearing of the ESSO BRUSSELS' bridge remained constant about 19° off the starboard bow almost until minute 41. Although any constant relative bearing less than 90° on a stationary object will result in a spiral path that closes in on that object, the pilot and master on the bridge of the SEA WITCH probably believed that as long as the ship's bow did not point any closer to the tankship, the situation was not serious. It was not until a few seconds before minute 41 that the SEA WITCH's centerline crossed the tankship's stern. At minute 41, when the SEA WITCH was about $1\frac{1}{2}$ ship lengths from the tankship, the pilot backed the SEA WITCH's engine.

Evidently, during about the first $1\frac{1}{2}$ minutes after the loss of steering control, the indications of an impending collision developed slowly; when the indications began to develop rapidly, there was insufficient separation between the ships to avoid the collision.

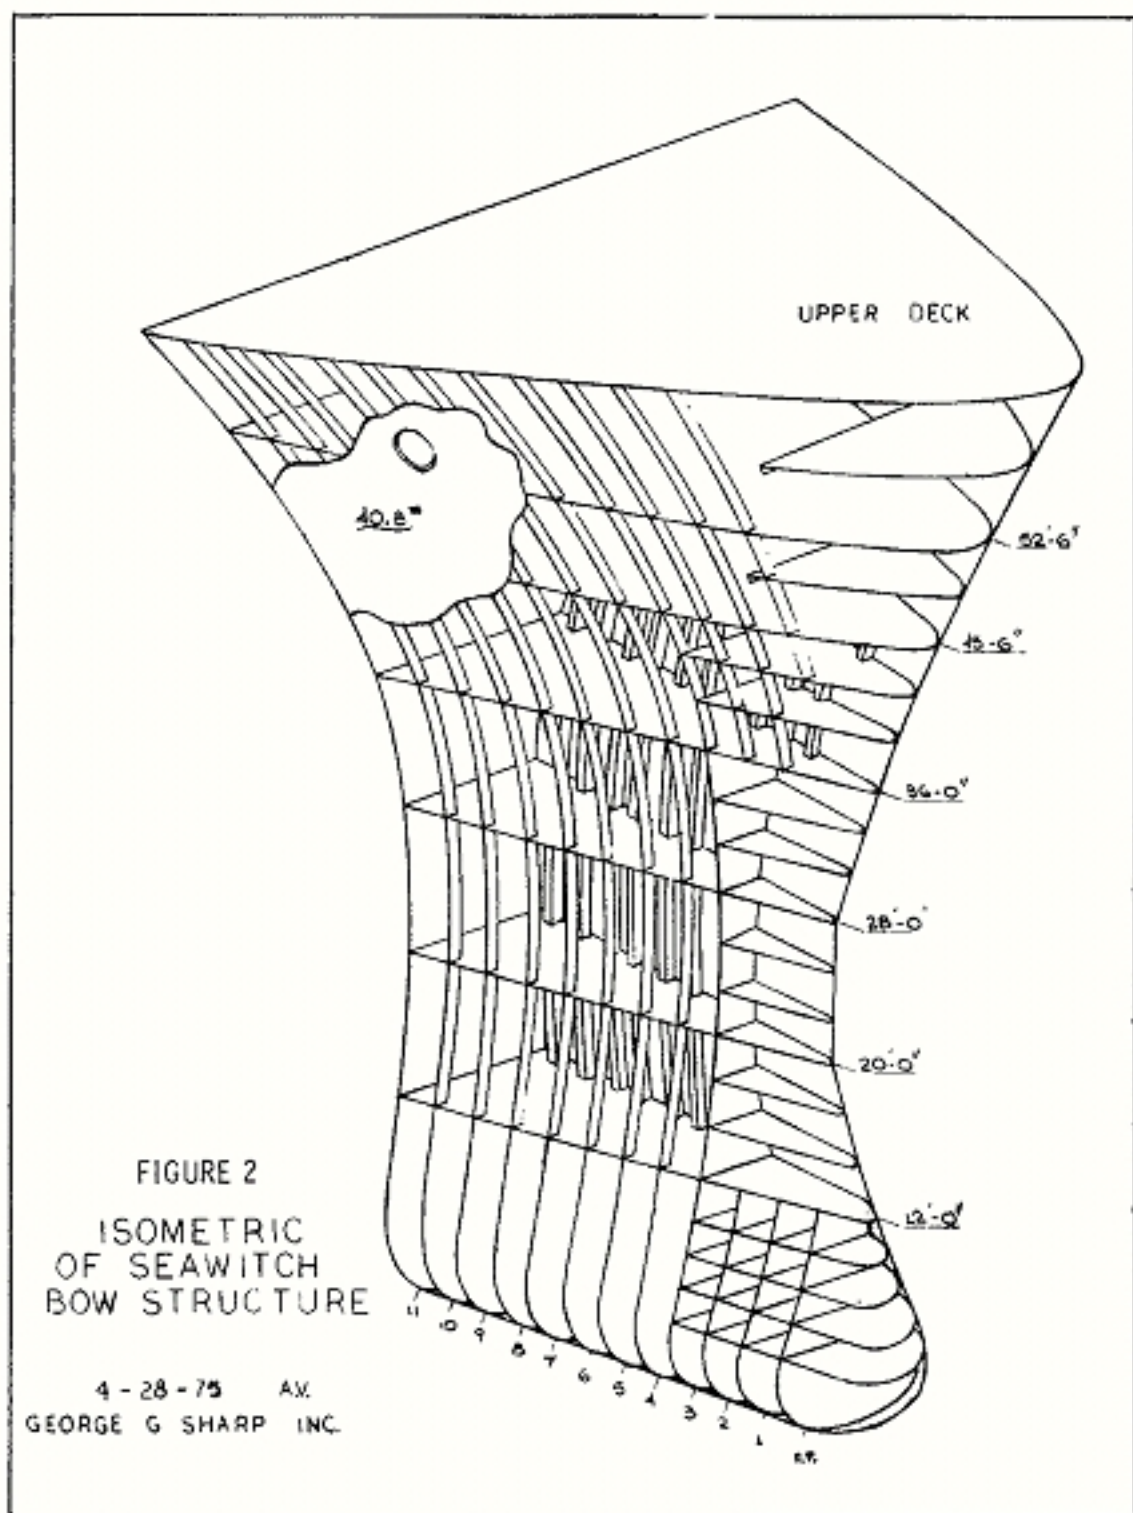
Calculations of the axial strength of the SEA WITCH's bow showed that it could exert a load of 5,000 tons at various stages of crushing before the bow collapses further. This load is about 2.5 times the maximum side resistance generated by a typical tankship of this size ^{1/} when its side shell ruptures. A nonpenetrating bow for the SEA WITCH, therefore, would require a reduction in its crippling strength of more than 2.5 times. A feasibility analysis was made to determine if this could be achieved, given the following practical requirements:

(See Figure 2 for an isometric view of the original SEA WITCH's bow design and Figure 3 for the design of the nonpenetrating bow. To increase clarity, some of the redesigned features, such as the increased stem radius and the prebuckled decks, are not shown in Figure 3.)

- c. All flats in the peak should be eliminated where possible. Floors can replace flats as shell supporting members, floor separation can be increased, and intermediate frames can be added.

- g. The heavy shell plating under the hawse pipe bolsters, which protect against the abrasive action of the anchors, must be eliminated. It can be replaced by half-round fenders cut from pipe and placed vertically.

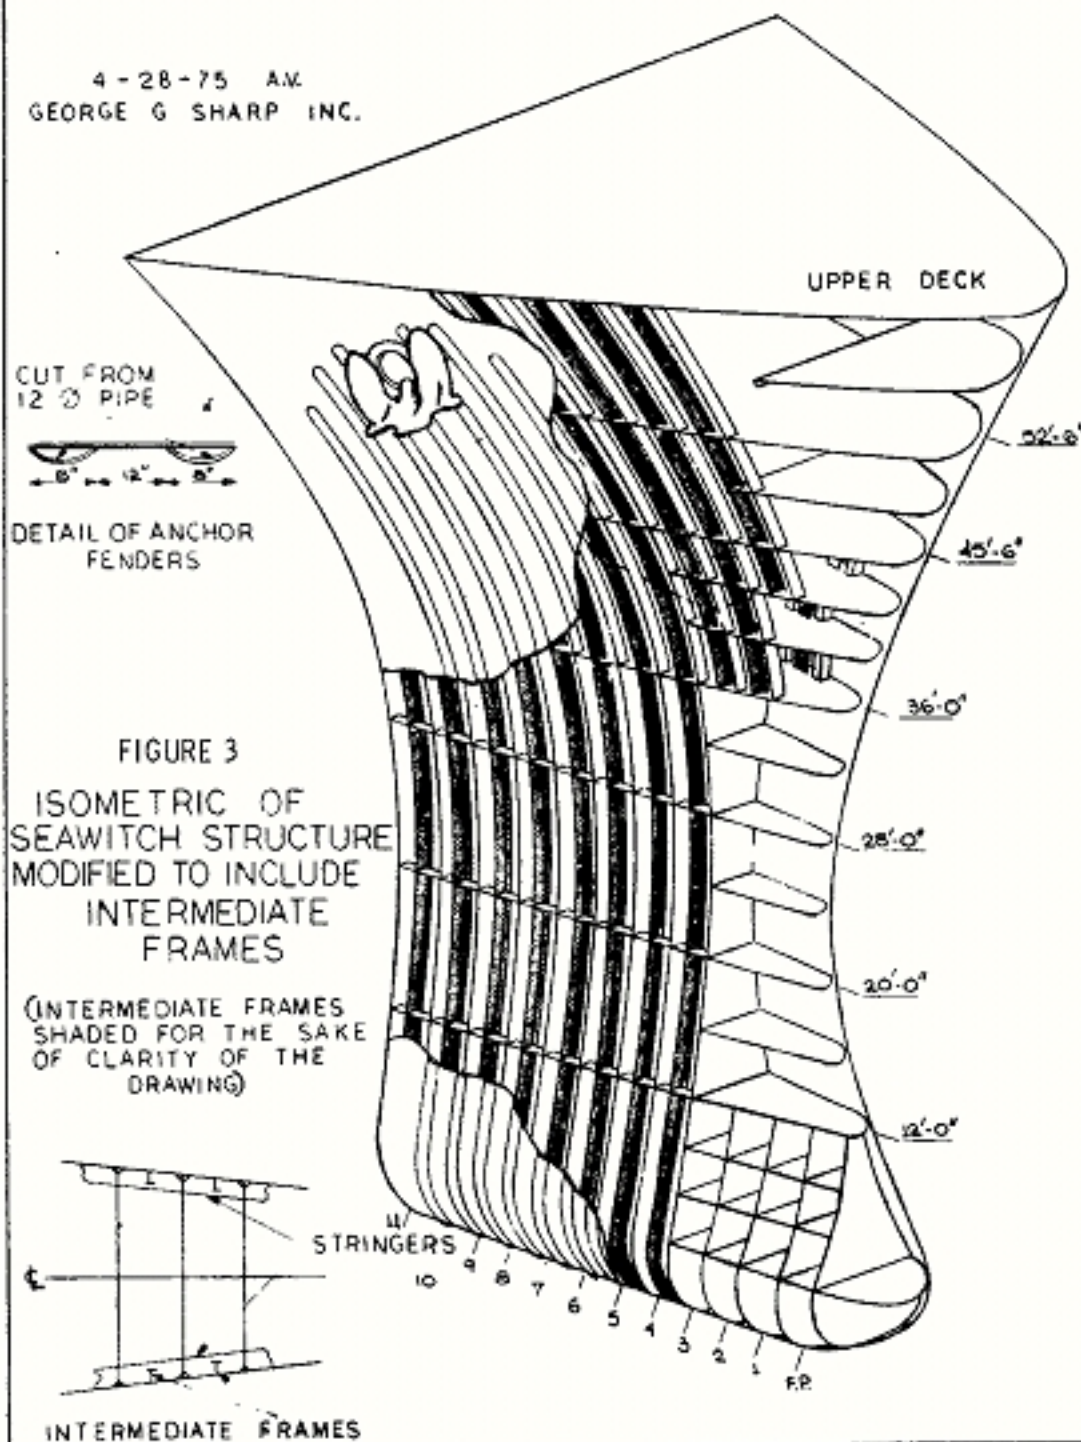
In order to limit bow crushing to $1/20$ of the ship's length, it was necessary to determine the limiting striking velocity which would allow the bow to absorb all of the ship's kinetic energy within that distance. For the SEA WITCH in the fully loaded condition, the limiting striking velocity was determined to be about 6.8 knots. The SEA WITCH struck the ESSO BRUSSELS at about 5 knots. If the SEA WITCH had had this nonpenetrating bow, it would have lacked

the axial strength to penetrate the side of the ESSO BRUSSELS, and the bow could have absorbed the energy without damage to the SEA WITCH's collision bulkhead.
