MARINE CASUALTY REPORT

SS V. A. FOGG; SINKING IN THE GULF OF MEXICO
ON 1 FEBRUARY 1972 WITH LOSS OF LIFE

U.S. COAST GUARD
MARINE BOARD OF INVESTIGATION REPORT
AND COMMANDANT'S ACTION

REPORT NO. USCG/NTSB - MAR-74-8

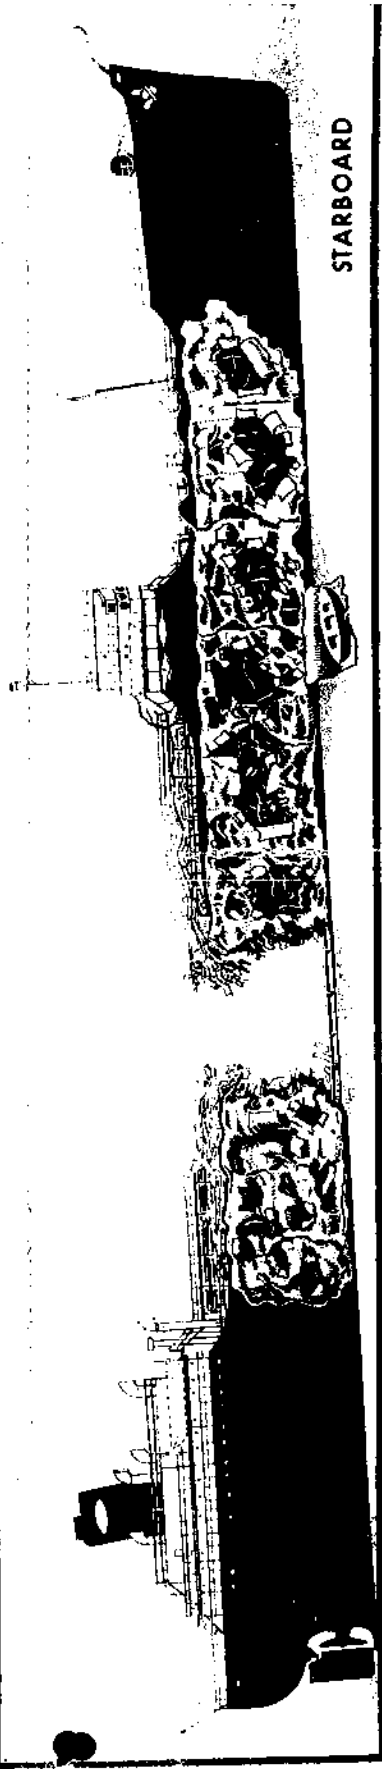
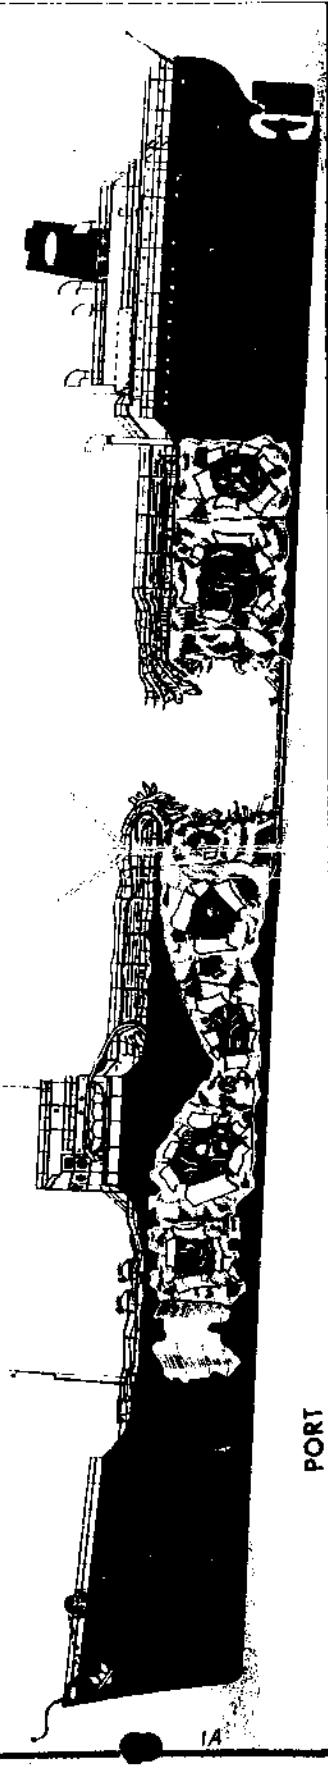
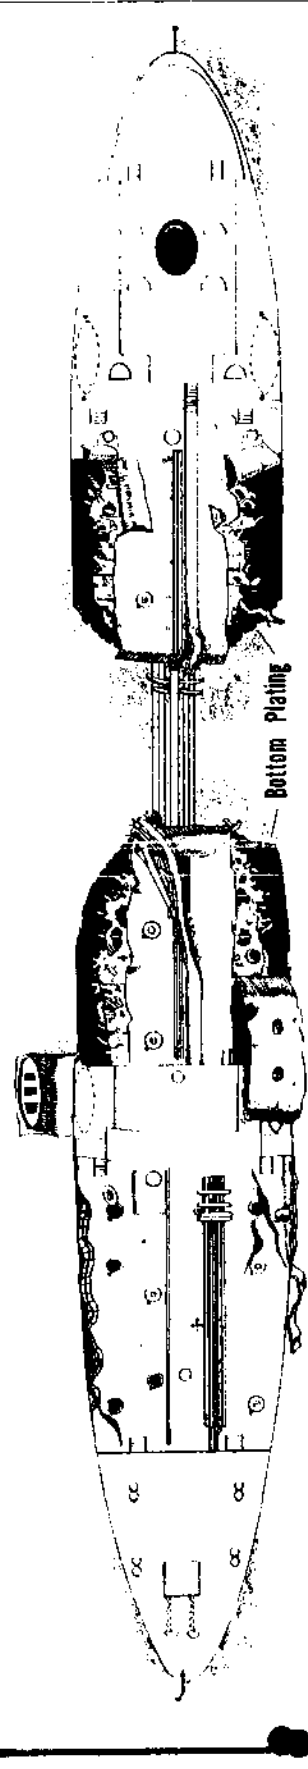
FIGURE 1

Only by viewing the vessel or the exhibits to this report can a true appreciation of the extent of vessel damage be gathered. To help the reader appreciate the gross damage an artist's interpretation is attached. This interpretation does not claim complete accuracy but is illustrative of the massive damage sustained by the vessel. Attached for reference purposes is a photograph of the vessel taken prior to the casualty.

V.A. FOGG DAMAGE
