UNITED STATES COAST GUARD

(T/V VENTURA - F/V LYNN - a-1 24)

From: Chief, Merchant Vessel Inspection Division  
To: Commandant  
Via: Chief, Office of Merchant Marine Safety  
Subj: Marine Board of Investigation; steam tanker VENTURA and motor fishing vessel LYNN, collision Boston Outer Harbor, 28 November 1951, with loss of life

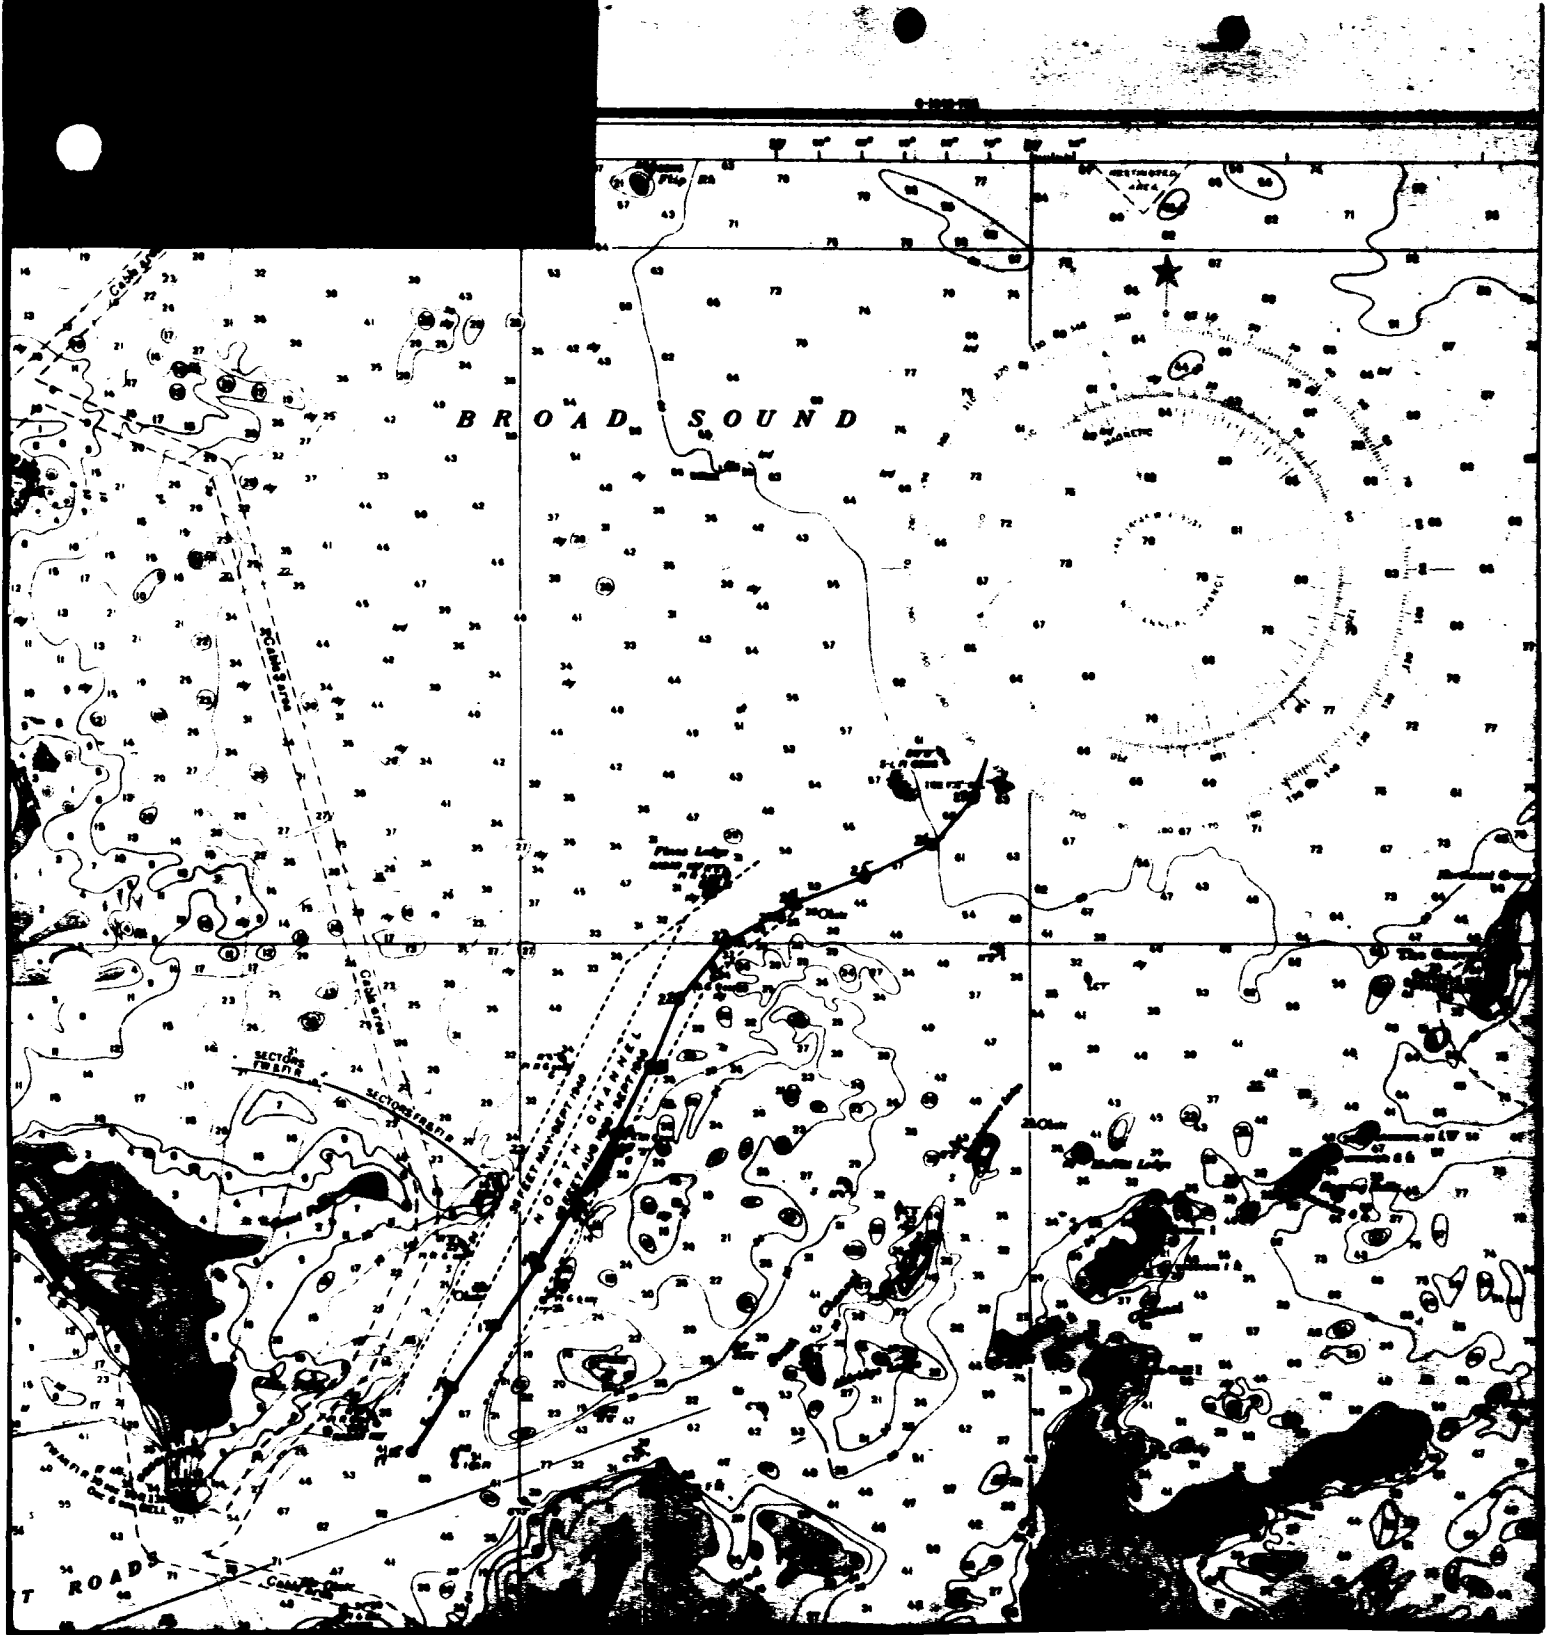
"49. That the course recorder record of the VENTURA for November 28, 1951 (Exhibit 15), is an accurate record of the headings of the VENTURA for the period from 3:04 p.m. until midnight on that date and that the track of the VENTURA from the time she entered North Channel up to the point of collision, as reconstructed from the data in the course recorder record and engine room bell book, is shown by the following plot:

"4. The weight of evidence strongly supports the version of the collision given by witnesses from the VENTURA. The course recorder record of the VENTURA (Exhibit 15) affords an automatically recorded and unbiased record of the headings of that vessel from 3:04 p.m. till midnight on the day of the collision. The heading recorded from 3:04 p.m. until the tug came alongside at 3:25 p.m. agrees with the charted direction of the Union Oil Products Company Dock and the headings recorded from 3:56 p.m. to 4:27 p.m. agree with the headings necessitated by the narrow confines of the channel in the Chelsea River. The geographical layout of the channels traversed is such that a reconstruction of the VENTURA's track based on data in the course recorder record and engine room bell book can readily be oriented to the proper position on the chart and affords

a clear picture of the movements of the vessel from the time it left the dock at Revere until the collision took place. The validity of this reconstruction is enhanced by the fact that the current was at approximately slack water and there was little wind. The reconstructed plot agrees well with the position of the hull of the LYNN when located by divers on the day following the collision.

"5. The pilot of the VENTURA testified that he traversed North Channel on course 029° true and subsequently came right to course 066° true. The reconstruction of the VENTURA's track shows that her heading varied between 020° true and 036° true in running out North Channel, with the average course made good from 5:15 p.m. to 5:22 p.m. being 031° true and that she then came right very slowly until shortly before 5:25. From 5:23 to 5:24 her heading increased from 053° true to 065° true with the average for the minute being 059° true, and from 5:24 to 5:25 her heading ranged from 065° true to 073° true and back to 072° true with the average for the minute being 070° true. From 5:25 until after the collision, the VENTURA's heading was changing continuously to the left and at the moment of impact had decreased to about 30° true.
