## MARINE CASUALTY REPORT

SS OMI YUKON, D.N. 5479 19

EXPLOSIONS AND FIRE ON 28 OCTOBER 1986  
IN THE PACIFIC OCEAN APPROXIMATELY  
1000 MILES WEST OF HONOLULU, HAWAII  
WITH MULTIPLE LOSS OF LIFE AND  
PERSONNEL INJURIES

Marine Board of Investigation Report  
and  
Commandant's Action

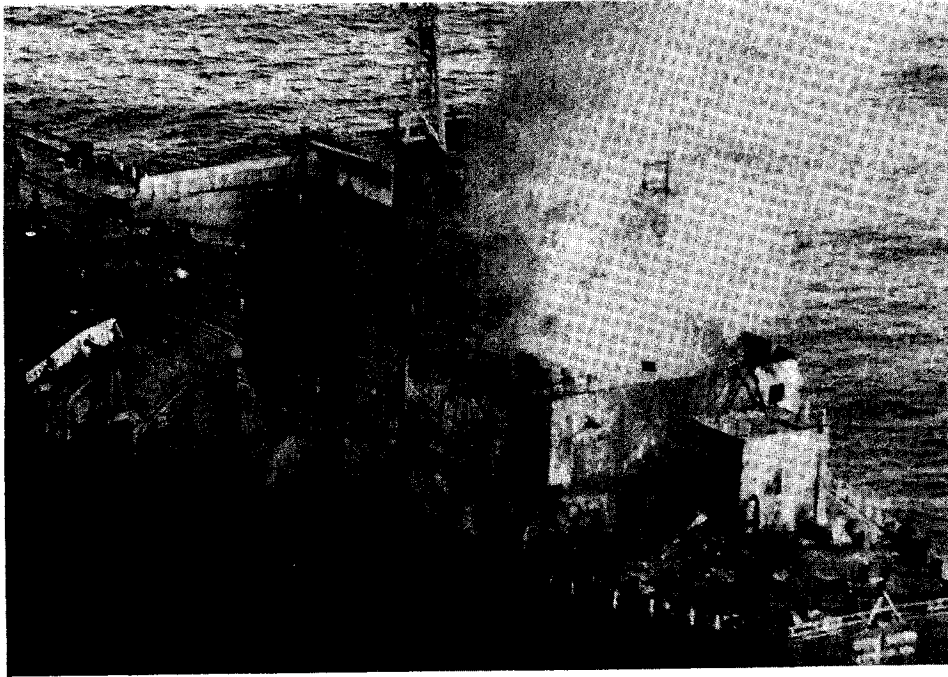
Photograph of the port side of the OMI YUKON taken on 29 October 1986 by LT. [REDACTED], USCG, C-130 pilot.

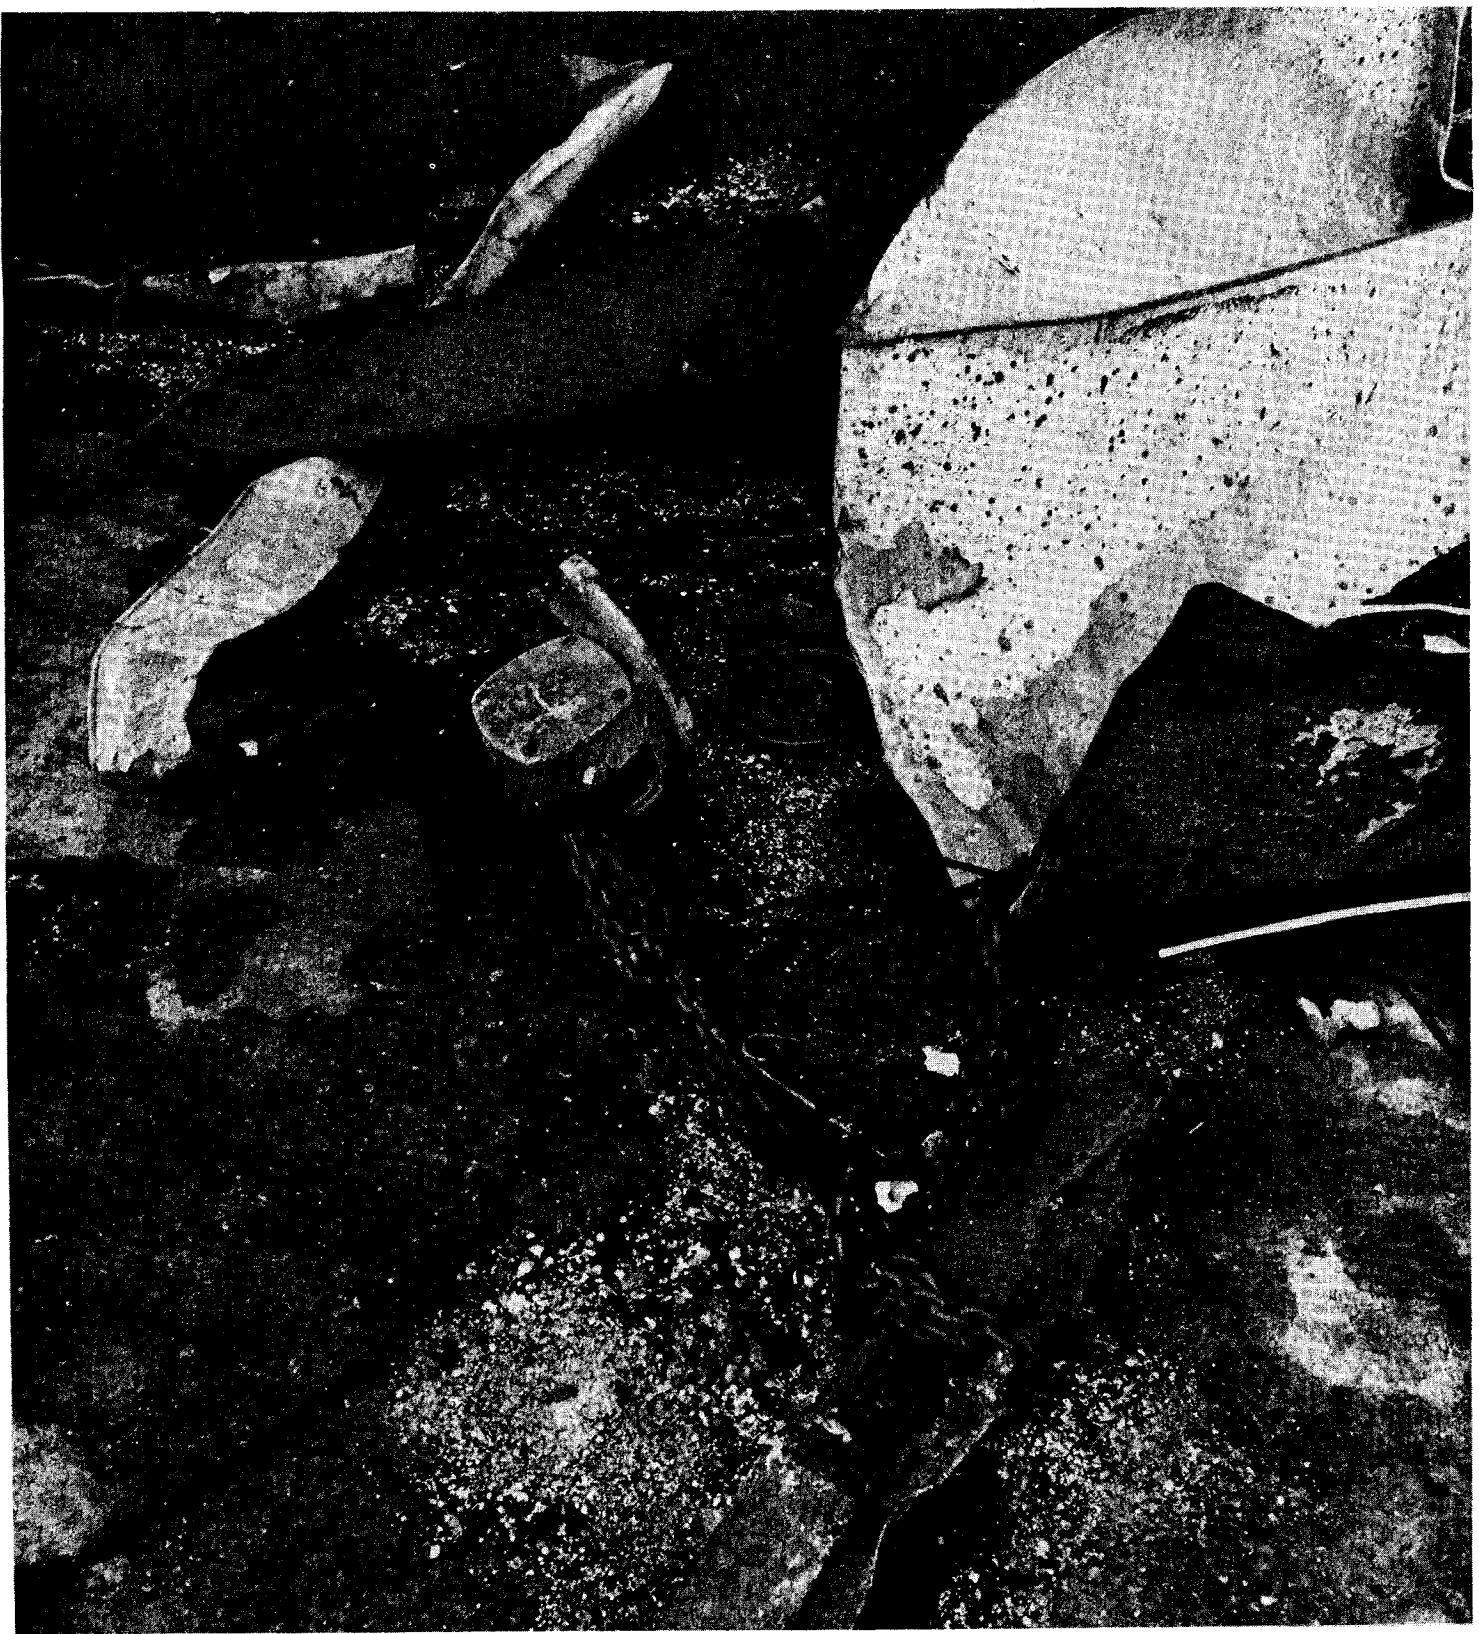
l. Debris found on the starboard aft deck in the immediate vicinity of the aft vent of the starboard fuel oil storage tank included: a burner's ignitor, sheet metal from vent louvers, the pin used for securing the storage boom to the side of the house, partially cut securing bracket for the stores boom, and small metal clamps and fittings used to connect section of oxyacetylene hoses. A section of portable electrical cord was found wrapped around a valve wheel on the accommodation house bulkhead in way of the forward hatch of the starboard storage tank.

m. The friction ignitor was found on the deck within ten feet of the aft vent for the starboard storage tank. The flint end of the ignitor was out of the cup. The ignitor was rusted and appeared to have been affected by heat.

Photograph of debris on the starboard main deck above the aft end of the starboard storage tank. The chain fall shown had been rigged to lower the stores boom during the removal process. A friction ignitor, with the flint end out of the cup, is in the center of the picture. Photograph courtesy of the National Transportation Safety Board.

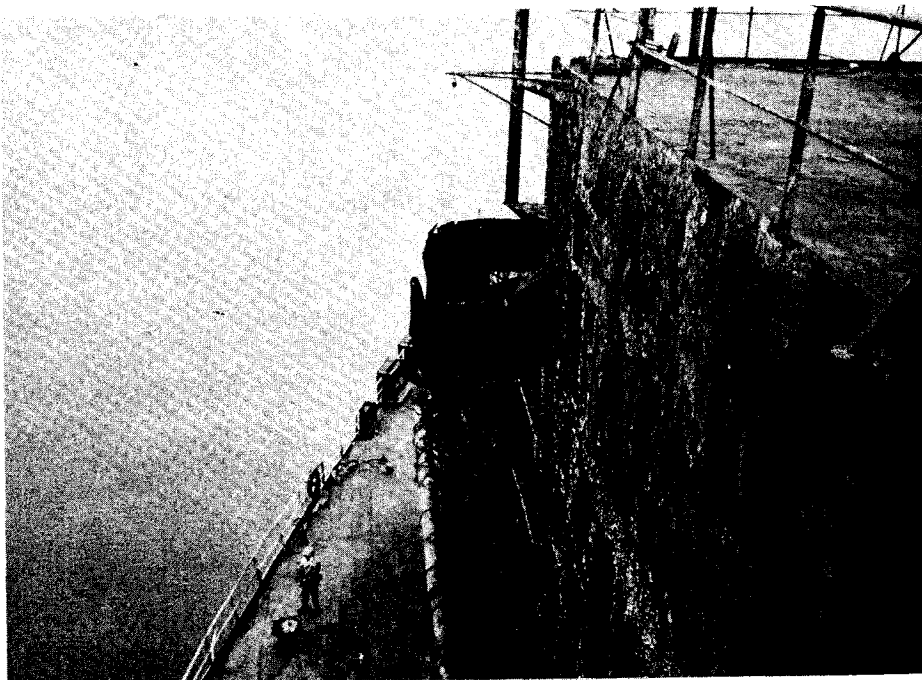
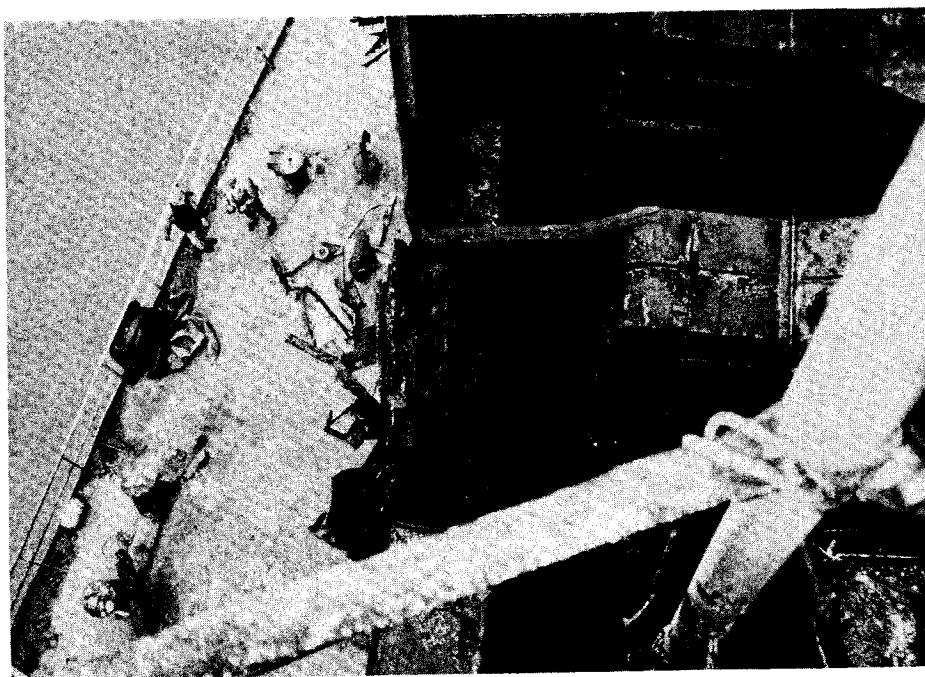
Photographs taken from the bridge deck of the OMI YUKON while the vessel was in Japan depicting an overview of the starboard storage tank. The top picture depicts two cables hanging down from the aft end of the starboard side of the accommodations house. Those cables were the stores boom support cables. The man in the top picture is standing aft of the garbage chute and the aft vent of the starboard storage tank. The lower picture gives a better perspective of the main deck above the starboard storage tank.

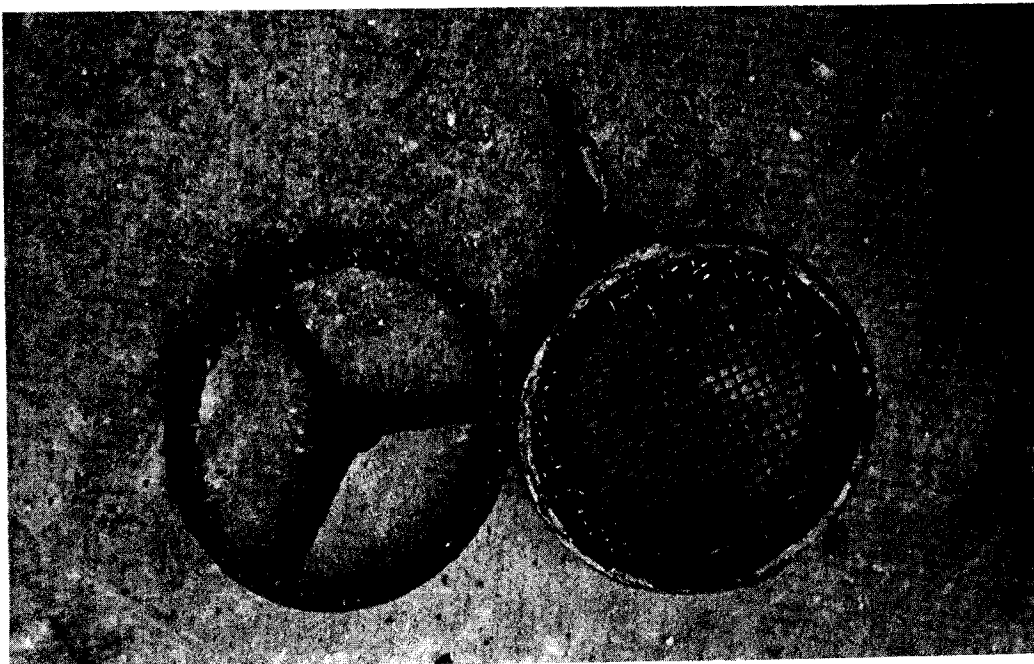
q. The gooseneck vent assembly for the aft vent on the starboard fuel oil storage tank was taken apart and there was no flame screen in the assembly. The coarse protective grid was intact. The ball check was split in half. On the circumference of the gooseneck mouth, above the flame screen assembly, there was an imprint in the paint residue of a previously installed flame screen.

Picture of the removed and taken apart flame screen assembly from the aft vent of the starboard storage tank. Above photographs taken by a HIRI representative.

Recommendation 2: Examination of flame screens on bunker tanks should be reemphasized to all field units and the examinations should occur during inspections for certification, mid-periods, reinspections and foreign vessel examinations. The maritime community should also be informed of the importance of flame screens on bunker tanks.

Action: I concur with this recommendation. Copies of this report will be provided to Officers-in-Charge, Marine Inspection, to reemphasize the importance of closely examining flame screens.

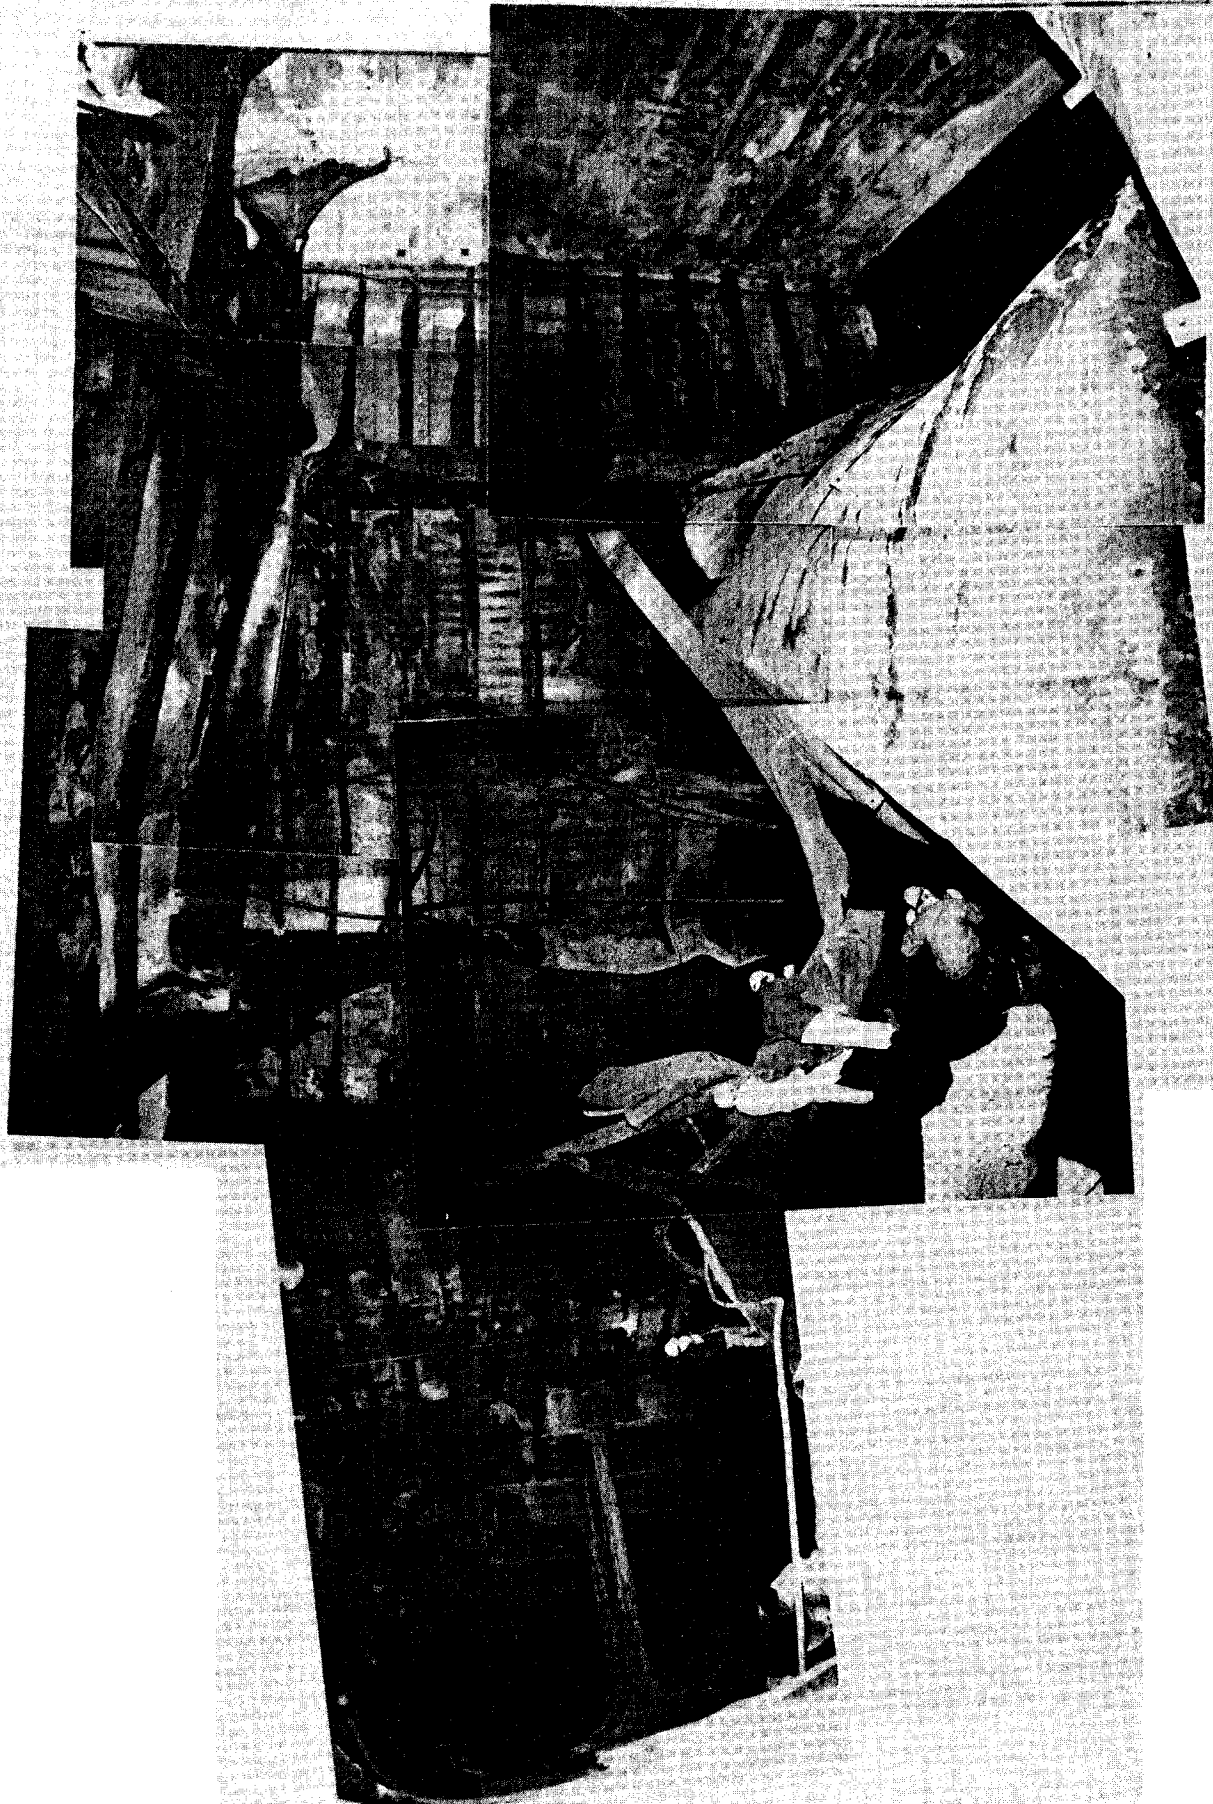
x. Internal examination of the starboard fuel oil storage tank revealed that the aft one of the two upper transverse web frames, located forward of the swash bulkhead was blown aft, where as the swash bulkhead originally located aft of this web was blown forward.

y. The starboard storage tank was opened to the sea when the swash bulkhead angle brackets ripped away from the side shell during the swash bulkheads movement forward as a result of the explosions. There were similar openings in the longitudinal bulkhead separating the engine room and the storage tank where the swash bulkhead was connected and ripped away during the explosions.

Composite photograph depicting the damage to the starboard settler, storage and transverse ballast tanks. The damaged transverse ballast tank starboard forward bulkhead is located at the far left of the picture. Photograph courtesy of the National Transportation Safety Board.

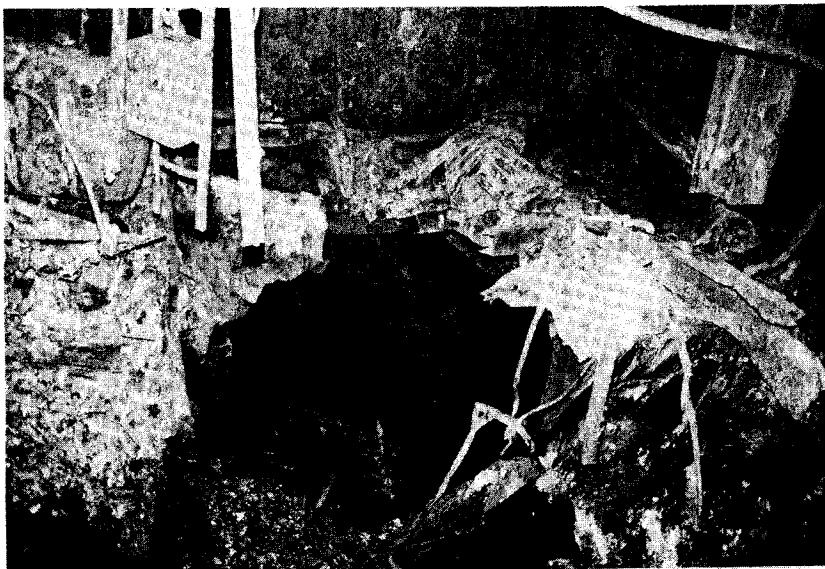
z. The bulkhead common with the engine room and the starboard storage tank had a significant breach large enough to drive a car through. The longitudinal bulkhead was blown into the engine room. The breach into the engine room was immediately forward of the original position of the transverse swash bulkhead in the storage tank.

aa. The major bulkhead penetration into the engine room created by the explosion within the starboard bunker tank was directly outboard of the control room and in way of the main electrical switchboard and automation console. The path of the explosion force which created this penetration was also directly in-line with the casing damage noted on the forward port corner of the boiler casing.

Photograph depicts the breach into the engine room from the starboard storage tank. The control room was located behind the debris in the right corner of the picture. Photograph courtesy of the Tsuneishi Shipyard, Tsuneishi, Japan.
