UNITED STATES COAST GUARD

INVESTIGATION INTO THE CIRCUMSTANCES
SURROUNDING THE SINKING OF THE
UNINSPECTED FISH PROCESSING VESSEL

ALASKA RANGER

OFFICIAL NUMBER 550138, IN THE BERING SEA ON
23 MARCH 2008 WITH THE LOSS OF FOUR LIVES AND
ONE PERSON MISSING AND PRESUMED DEAD

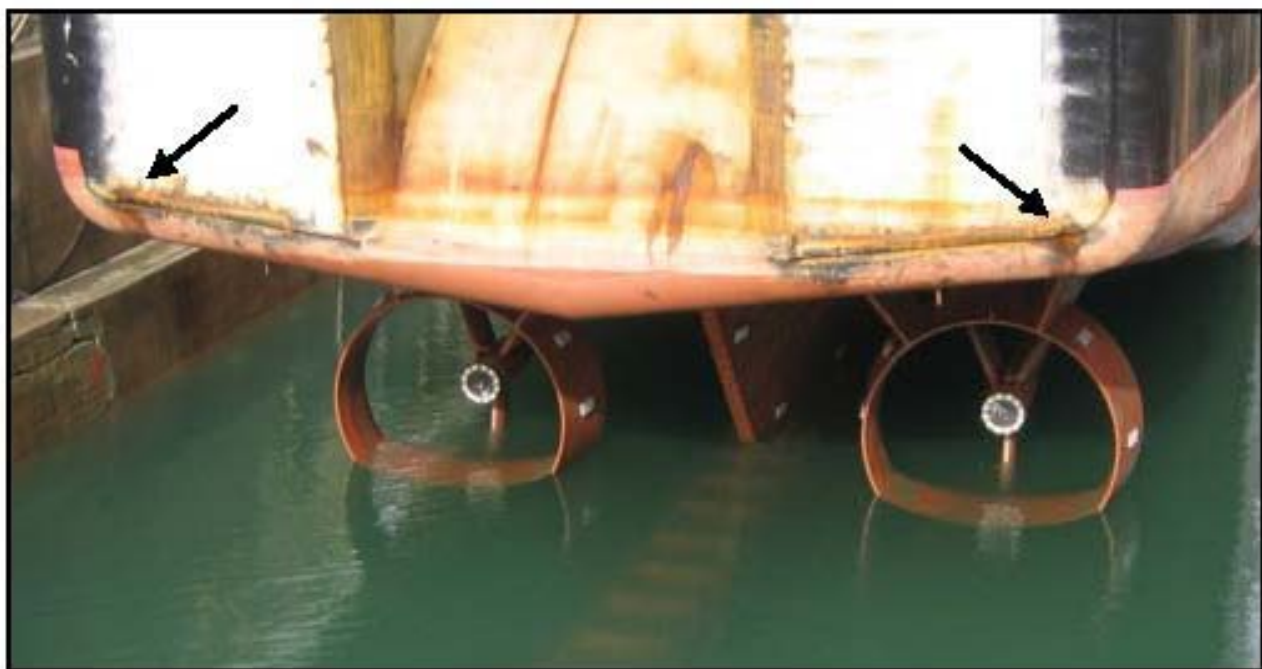
Figure 17: Photograph of the stern taken in 2005 showing water draining from outer transom

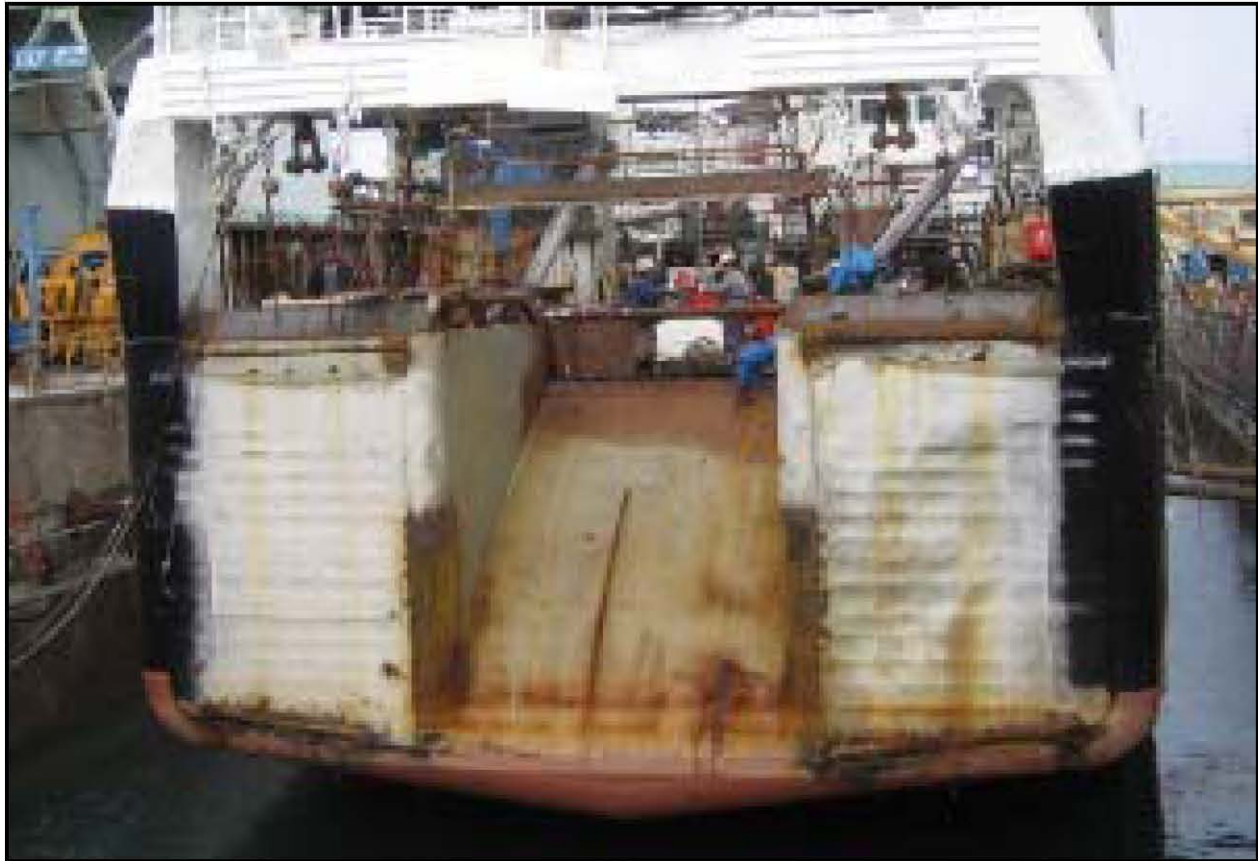
Figure 18: Photograph of the outer transom.

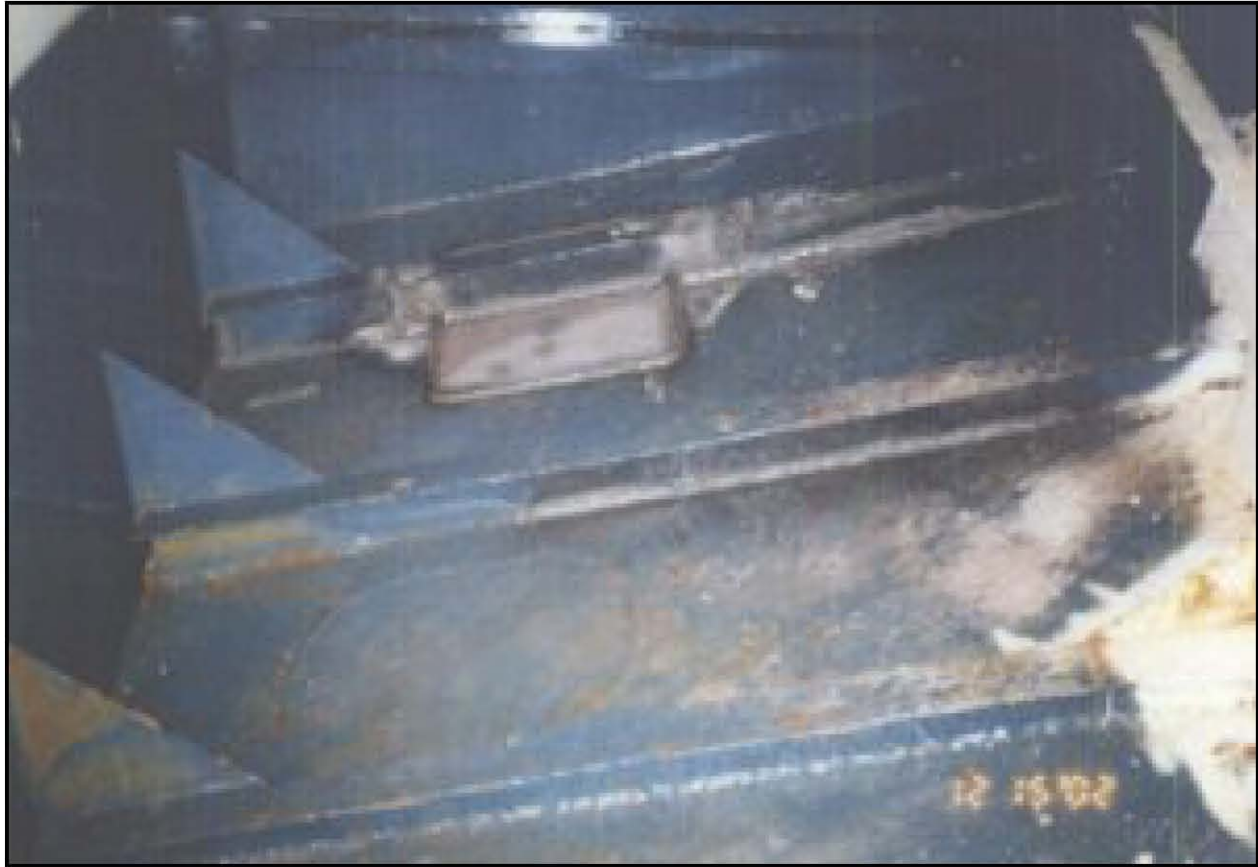
Figure 21: Photograph taken inside of potable water tank showing doubler.

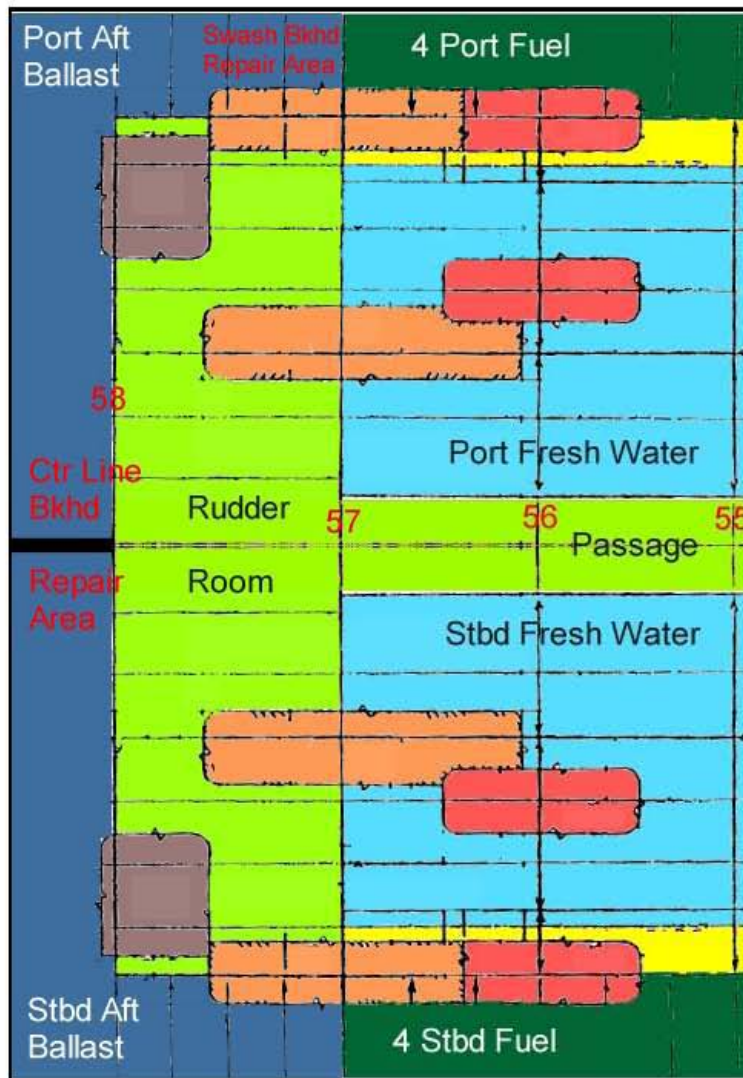
The detailed shipyard drawings specified a 24 mm hull plating insert (orange at top and bottom of Figure 24) installed directly aft of the existing insert (shown in red) to which the outboard shaft bearing housing strut were attached. This insert was directly under the longitudinal bulkhead that separated the #4 fuel oil tank (shown in dark green) and the adjacent cofferdam (yellow) as well as the rudder room (light green) and the aft ballast tank (blue). The shipyard drawing indicated that the bottom 1.8 feet of this longitudinal bulkhead was to be replaced with 24 mm thick plate and additional brackets were to be installed to support the bulkhead.

Figure 24: Portion of drawing developed by shipyard for Kort nozzle installation

The shipyard design also called for similar modifications to the hull plating (second orange area from top) and longitudinal frames in way of the inboard Kort nozzle strut attachments. The inboard hull plating insert was not directly aft of the inboard shaft bearing housing strut (second red area from top). The longitudinal frame and hull plating were located in the potable water tanks (light blue) and rudder room (light green).

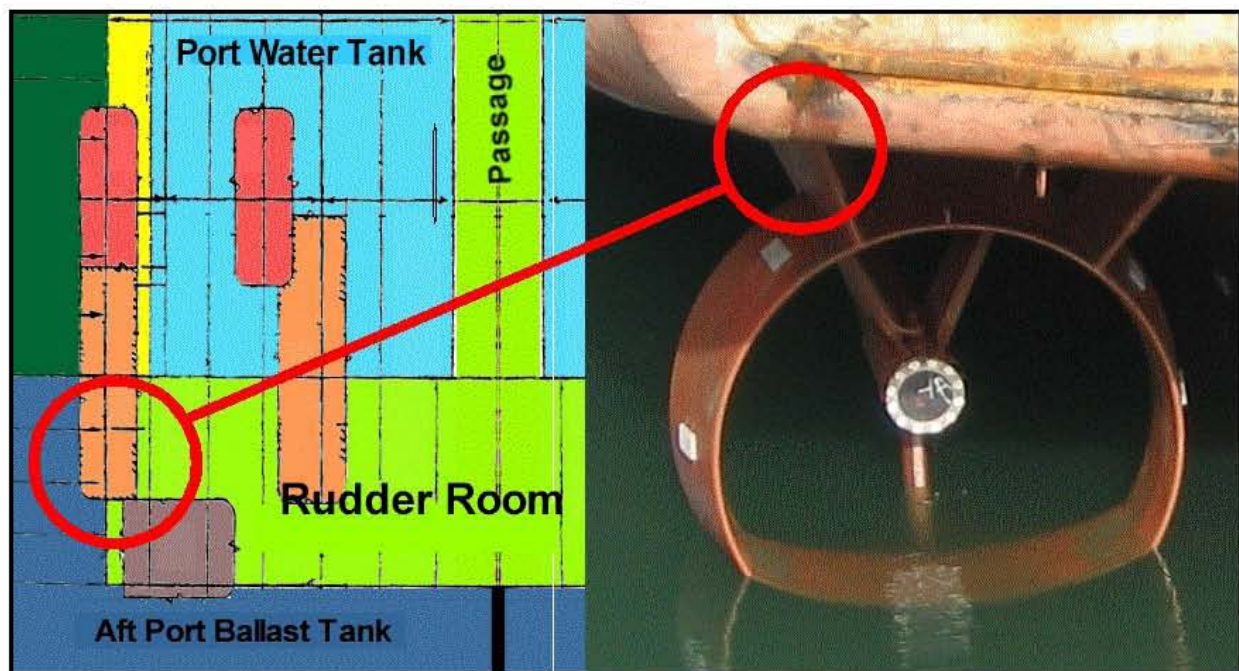
indicated that doubler plates were also located in the hull inside of the cofferdams, but no doubler plates were installed in the rudder room, #4 fuel oil tank, or potable water tanks. If so, the Kort nozzle strut landing areas located in way of the rudder room, aft ballast tanks, #4 fuel oil tanks, and potable water tanks were not reinforced. The load and stresses from the Kort nozzles were not properly distributed, and the struts experienced significant vibrations for which they were not properly reinforced.

Figure 25: Upper right red circle: Location of Kort nozzle strut fractures

Lower left red circle: Location of corroded frames in port aft ballast tank.

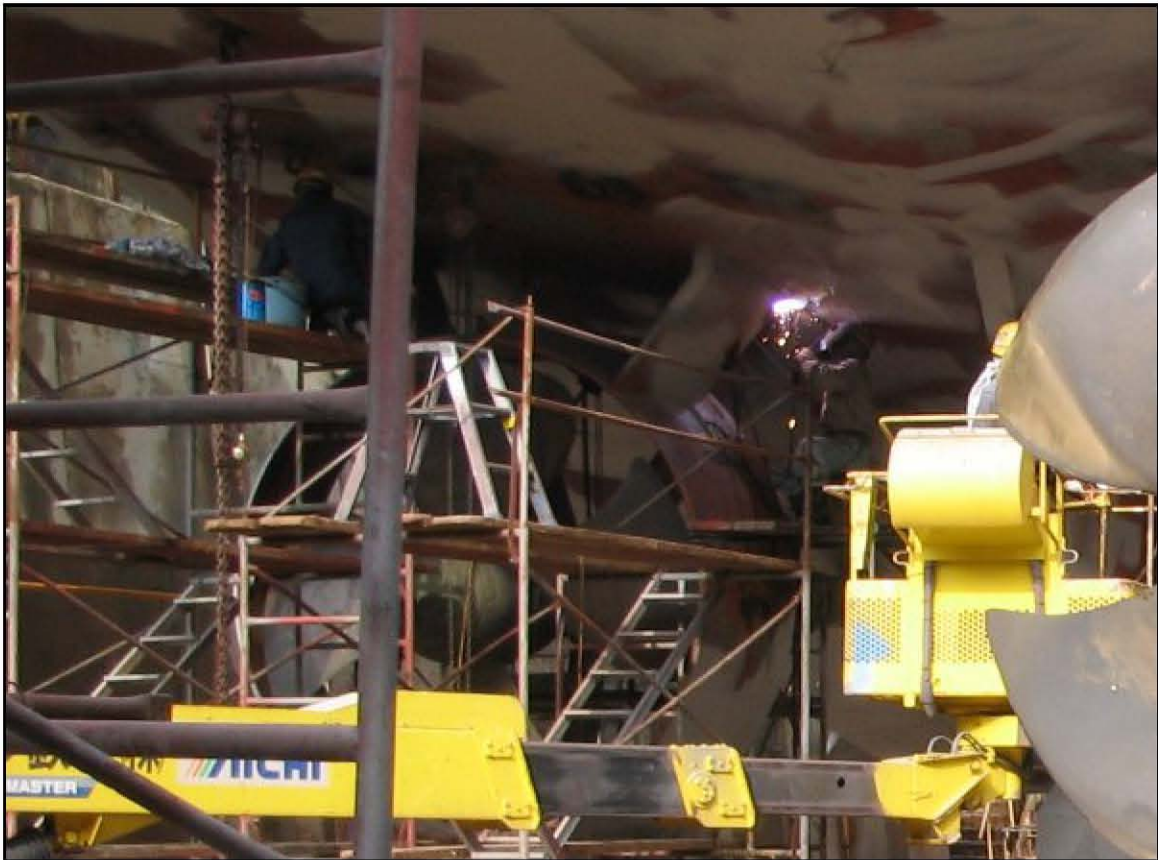
Figure 28: Photograph of worker repairing the inboard port Kort nozzle strut

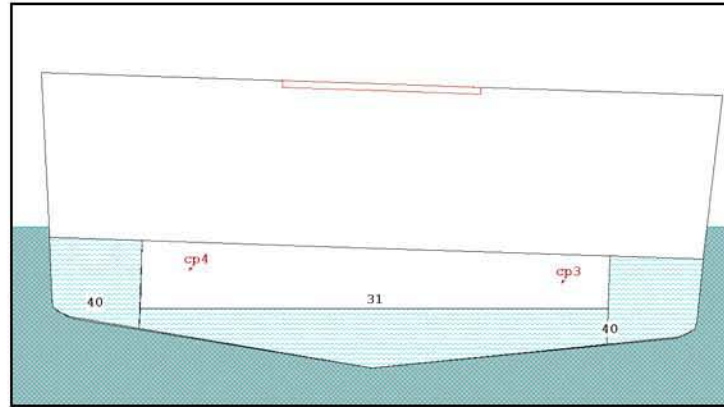
The initial rate of flooding into the Rudder Room was estimated by assuming that the flooding began through the rudder bearing, after the complete loss of one rudder and shaft. McDermott Shipyard Dwg. No. 54271-2101-1, Rev 2, dated October 25, 1973 shows that the upper rudder tube bearing is 9 inches in diameter. It also indicates that the longitudinal, transverse and vertical locations of the top of the rudder tube as being 178.59 ft aft of frame 0, 10.75 ft outboard from centerline and 16.85 ft above baseline. Figure 6, shows the ALASKA RANGER's body plan at the location of the rudder posts. The points labeled "cp3" and "cp4" are the locations of the top of the rudder bearing and the assumed location of flooding.

Figure 6: Example of Rudder Room Flooding at 50%

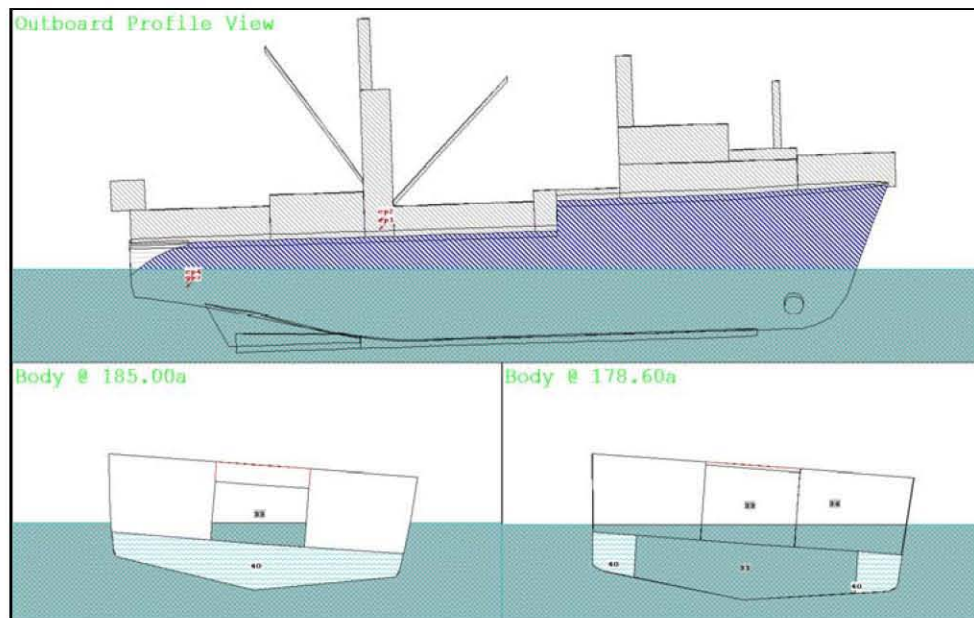
Reference (a) indicated that after the Rudder Room flooded, the next compartments to have reported flooding were the Ramp Room as well as the Harbor Generator Room, Workshop, and Aft Machinery Alley. The flooding of these compartments was modeled as step C in Table 3, and is depicted in Figure 8. In our model, these flooded compartments were allowed to flood to the waterline throughout the scenario so that as the flooding progressed, more water would flow in. It is not clear whether this floodwater came from a hull breach or upward from the rudder room below. However, our model suggested that with the rudder room flooded, the deck in the ramp room would have been 2 feet below the static water line, making a hull breach a reasonable source of flooding.

Figure 8: Step C in 1st Flooding Scenario

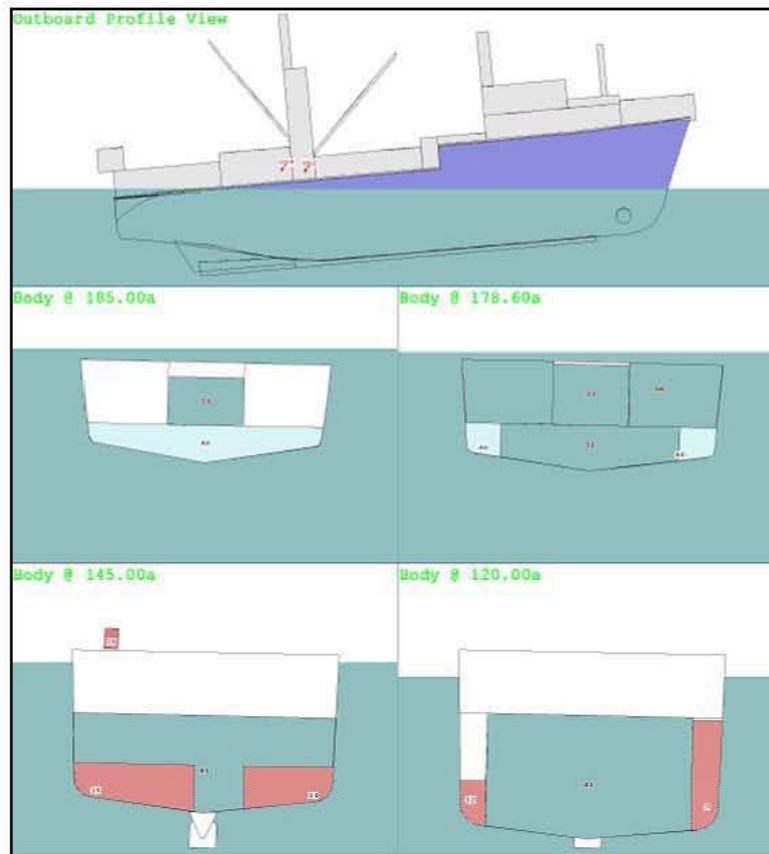
Reference (a) indicated that the Hydraulics Room was the next compartment to flood. The bulkhead at frame 50 was not watertight and so in step D, the entire engine room was allowed to flood. As seen in Figure 9, once the engine rooms were completely flooded, the aft portion of the trawl deck is awash increasing the likelihood that the #4 Hold and the Fish Bin would begin to downflood.

Figure 9: Step D in 1st Flooding Scenario

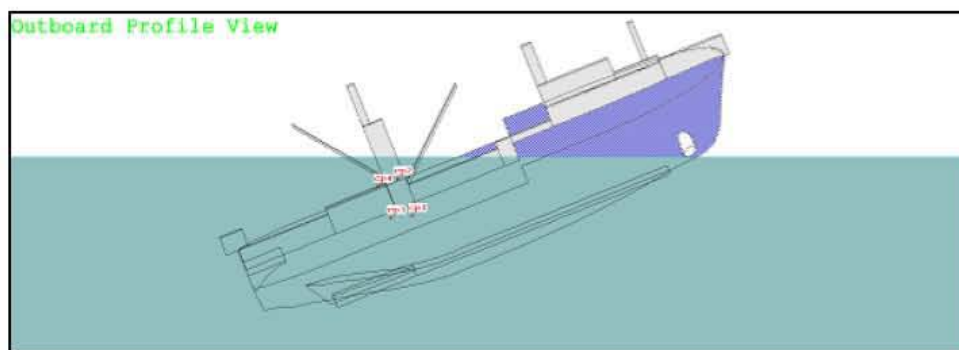
Figure 10 shows the model's attitude with the Fish Bin and #4 Hold flooded. Although this analysis describes one potential sinking scenario, it doesn't predict any significant listing until the model had extreme trim by the stern. Please note that this sinking scenario neglects the effects of wind and sea conditions.

Figure 10: Step E in the 1st Flooding Scenario

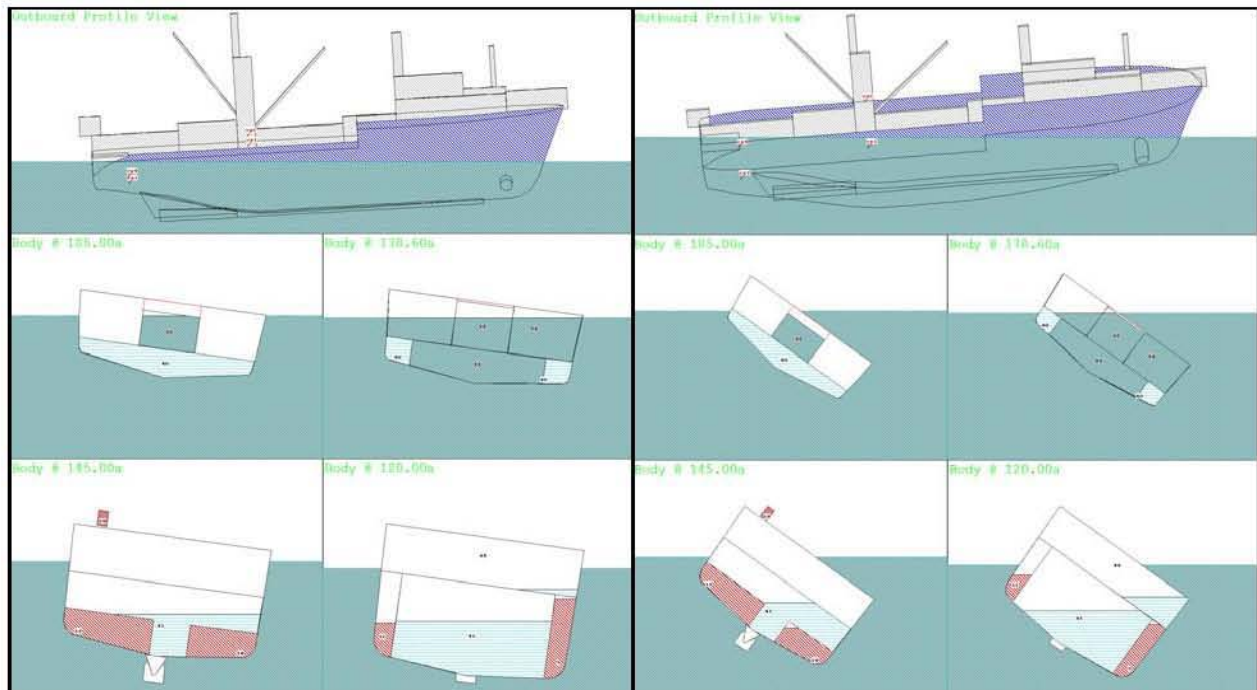
As noted previously, the ALASKA RANGER reportedly listed hard to starboard after losing power (presumably due to flooding in the engine rooms). However, Table 4 shows only between 4° and 5° static starboard heel angle once the engine rooms are flooded. One plausible condition that would increase the free surface effect and create a greater heel angle is a small quantity of flood water on the processing deck. Limited flooding on the processing deck is a reasonable assumption considering the aft end of the trawl deck was nearly submerged in step I of the scenario. When only 15 LT of flood water was added to the processing deck, the model heeled sufficiently to put the starboard corner of the transom in the water as shown in Figure 14. With 50 LT of flood water on the processing deck, the heel angle doubled to 16°. At this point, our model indicated that the starboard side of the trawl deck was underwater from frame 47 to the transom.

Figure 14: Step J in 2nd Flooding Scenario
