INVESTIGATION INTO THE STRIKING OF SUBMERGED
OBJECTS BY THE TANK VESSEL

ATHOS I

IN THE DELAWARE RIVER ON NOVEMBER 26, 2004
WITH A MAJOR DISCHARGE OF OIL

16732
January 19, 2006

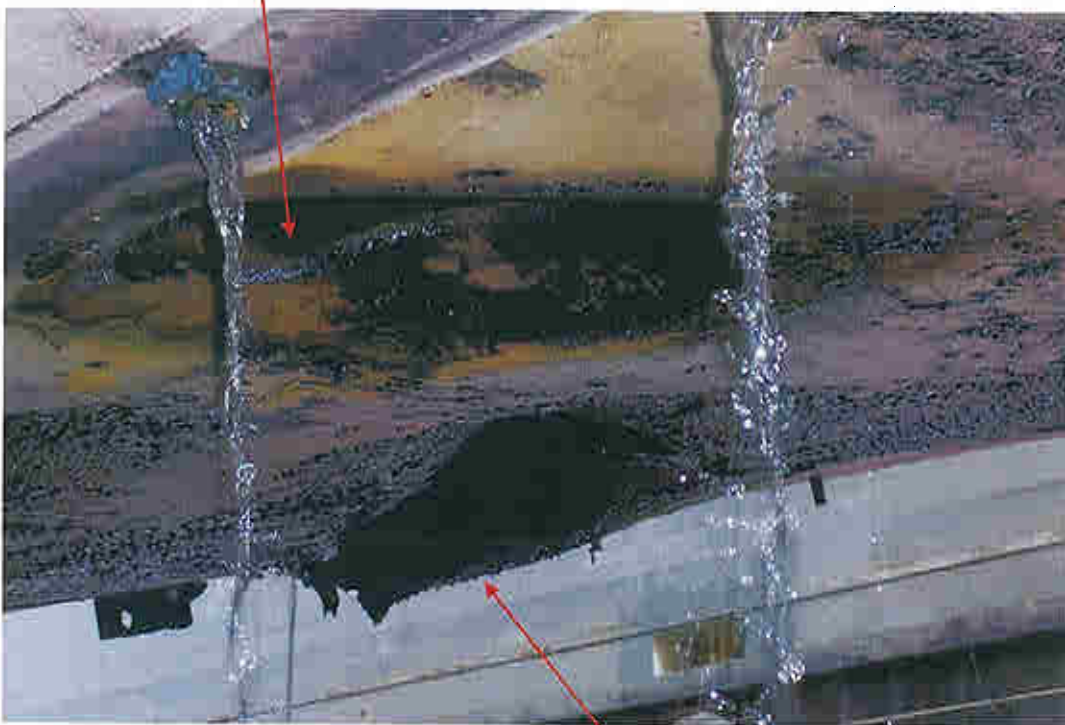
The puncture was located approximately 28" forward and starboard of the longitudinal slice. The puncture was semi-circular with a damage radius of 24" x 11" with hull damage flapped forward in a V configuration. This damage was located only in the #7 center cargo tank.

Semi-Circular Puncture

Main External Damage of the ATHOS I hull

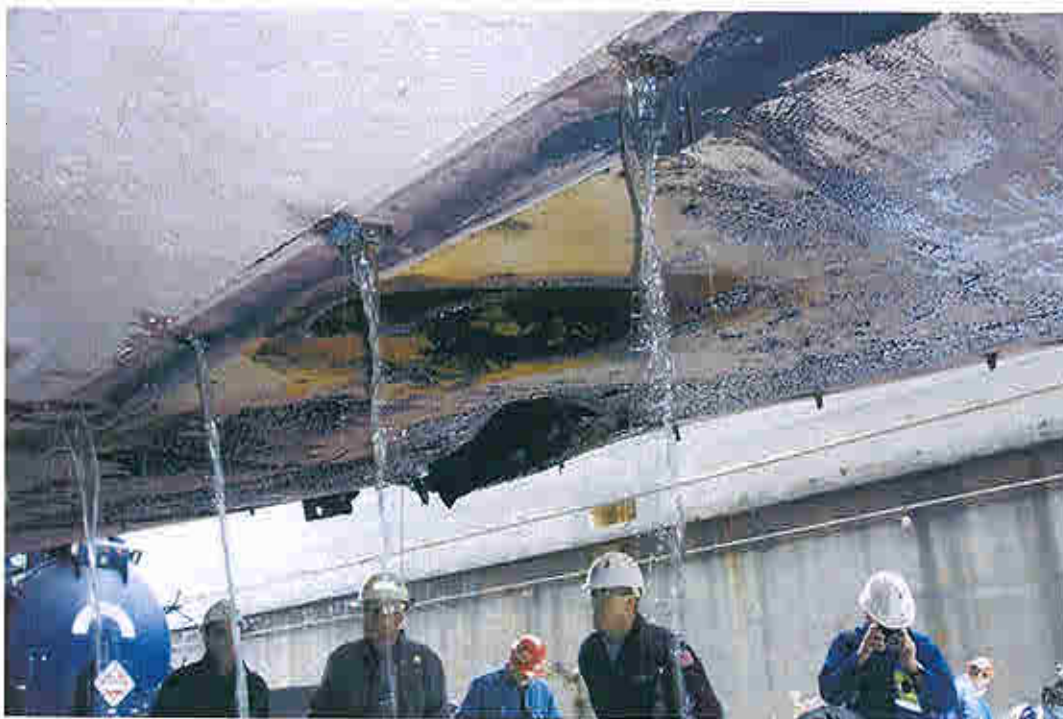
The longitudinal damage was approximately 63" long and was located in the #7 port wing ballast tank, extending into the #7 center tank by 2' on a 45 degree angle from outboard proceeding inboard. The width of the longitudinal damage was approximately 5" aft, with the center width at 9" and narrowing forward into the #7 center tank. Also found were contrasting directions of the fractured plating on both ends of the slice. Approximately 80% of the fractured plating flaps were pointed inboard, with the remaining 20% (at the opposite end of the slice) pointed outwards.

Longitudinal Slice

Main External Damage of the ATHOS I hull

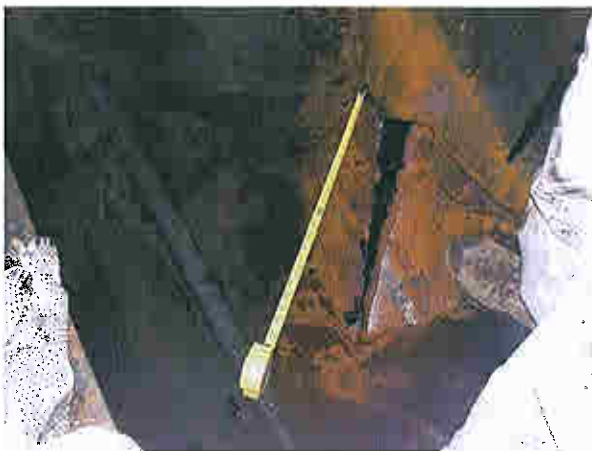
Longitudinal crack intrusion from the #7 Port Wing Ballast Tank into the #7 Center Cargo Tank. ** Viewed from inside the Tank **

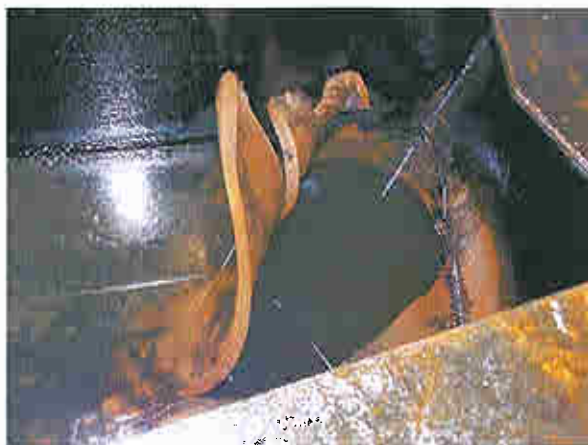
Puncture Damage located in the #7 Center Cargo Tank. ** Viewed from inside the tank **

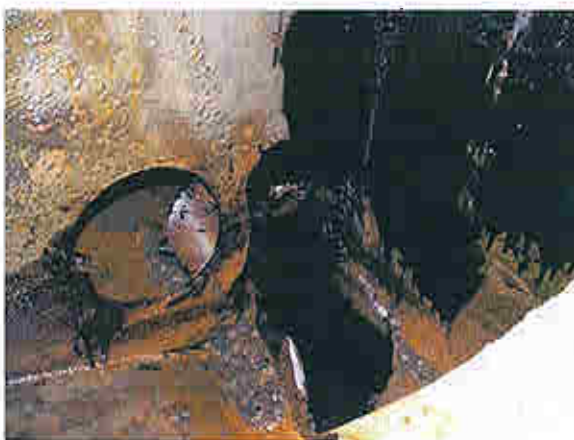
Damage located in #7 Port Wing Ballast Tank
** Viewed from inside the Tank **

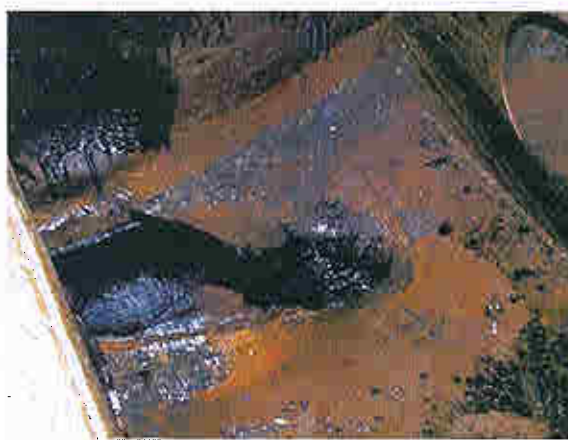
Damage located in #7 Port Wing Ballast Tank
** Viewed from inside the Tank **

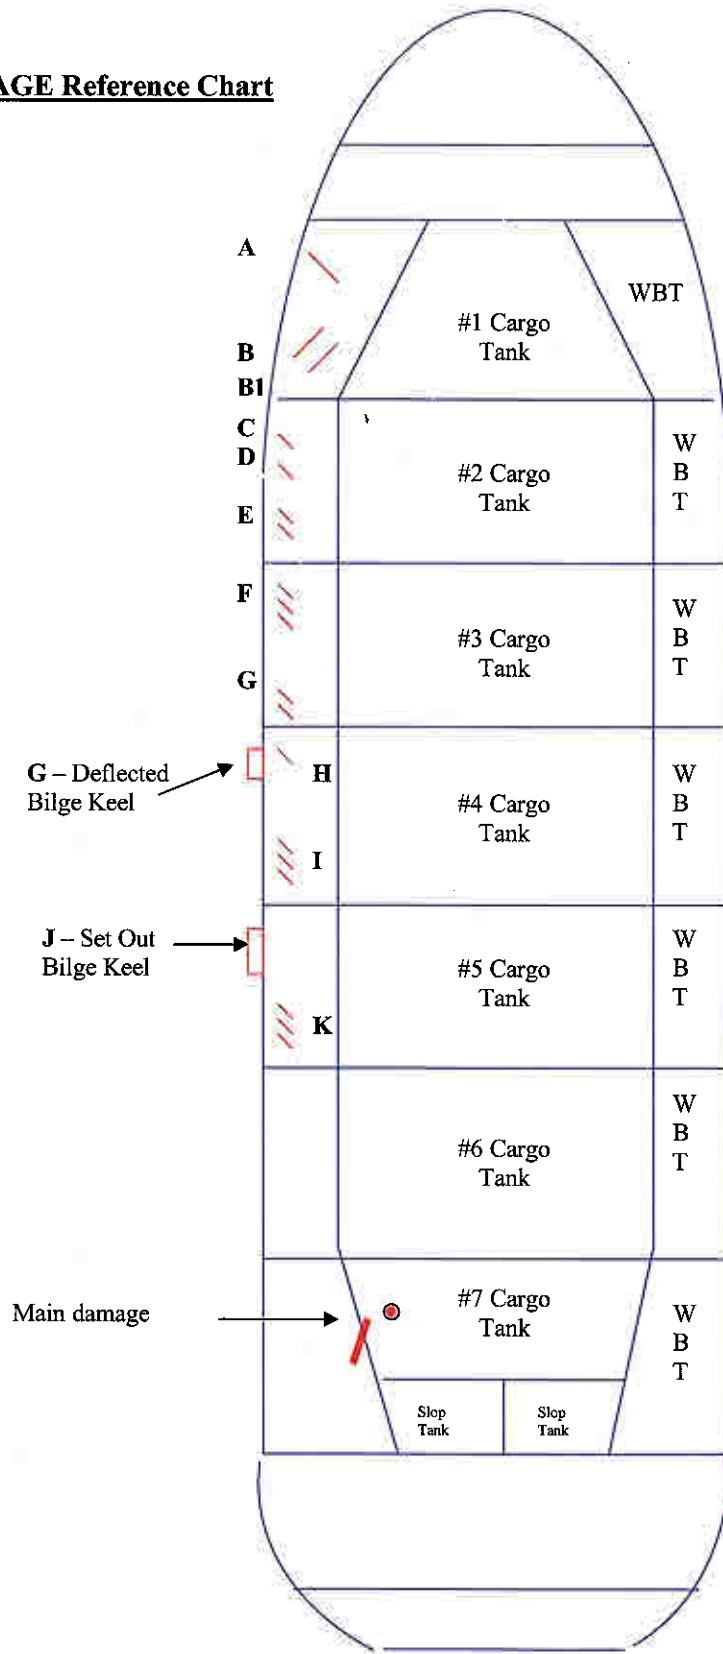
DAMAGE Reference Chart

Other minor hull damage locations (the reference diagram on the following page indicates locations of the damage marked as A through K):

- B. Scrape approximately 7'6" in length, ranging from 1.5" to 3" in width. Vicinity of frame 86-85. 45 degrees off vessel centerline but perpendicular to damage at A.

- I. Minor abrasions from the mid point of 4 Port WBT to 5 Port WBT. Vicinity of frame 69.
- J. A more significant scraped area along with damage and a crack in the bilge keel. Bilge keel "set out" for a longitudinal length of approximately 18". Vicinity of frame 69.

Approximate location of damage shown in red. The previous pages describe the damage in detail.

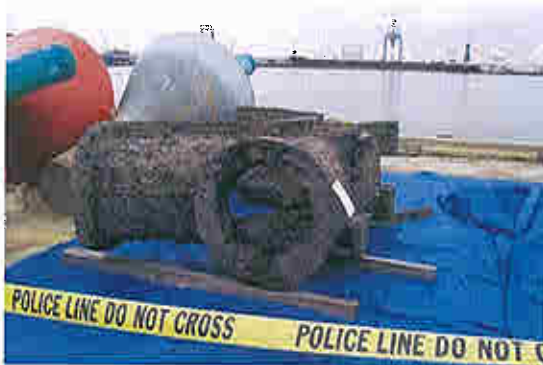
Pump Casing – On the 4th of December 2004 at 1421, Randive dove on an object that was discovered to be a pump casing at the following location - 39° 51.370 N, 075° 13.727 W. The pump casing measured approximately 12'6" long, 6'5" wide, and 3'5" high. The orientation of the pump casing at the time of discovery was parallel to the shore and on an angle, with the one side imbedded 1.5' into the riverbed and the opposite end (discharge flange) sitting on the river floor. A broken shackle was also discovered at the bottom of the discharge flange. At the time of discovery, Randive located a small area of paint that had rubbed onto the pump casing (top center & inside edge of curve on the pump casing,) and took a sample of it (sample # 01). Several notable metal scrapes were also found and located on the top portion of the pump casing. The most significant scrapes were located on the top footing closest to the discharge flange as well as on the top portion of the discharge flange. These scrapes appeared to be fresh with visible marks generally pointed in the same direction.

Pump Casing

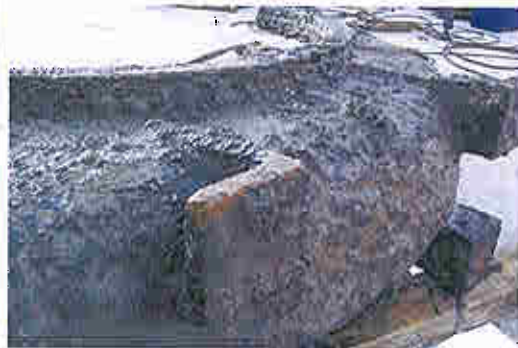
Close-up of the Pump Casing Footing

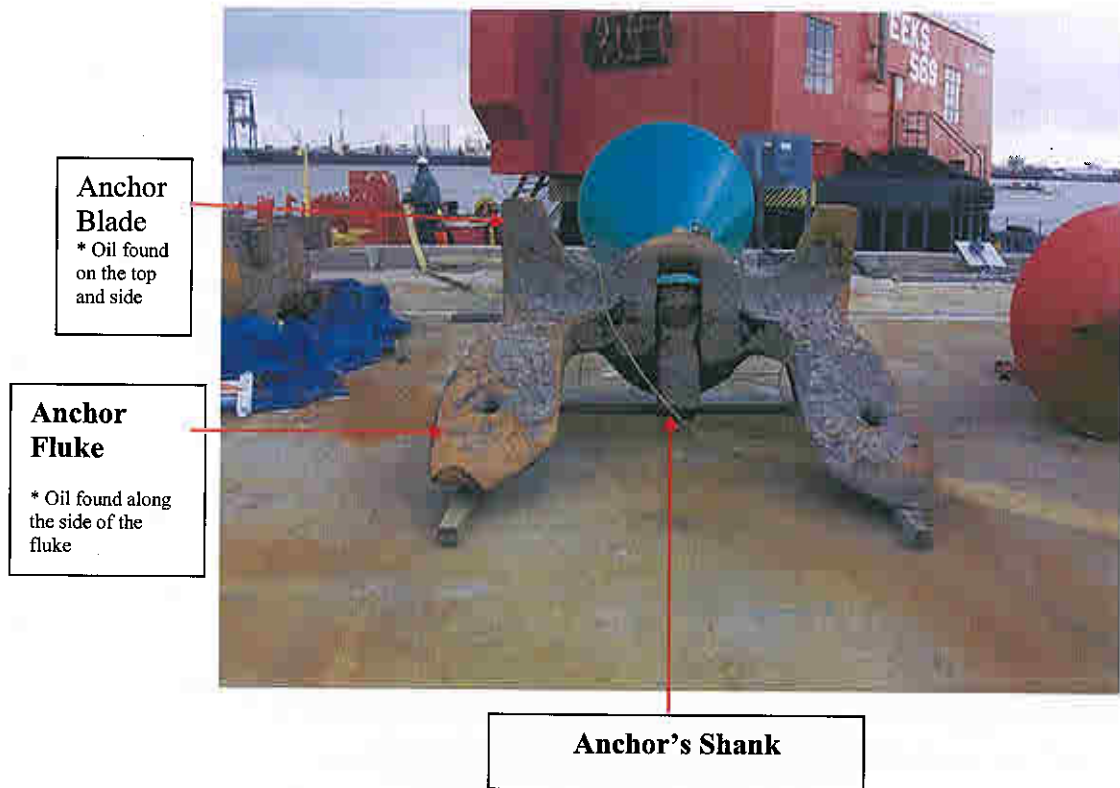
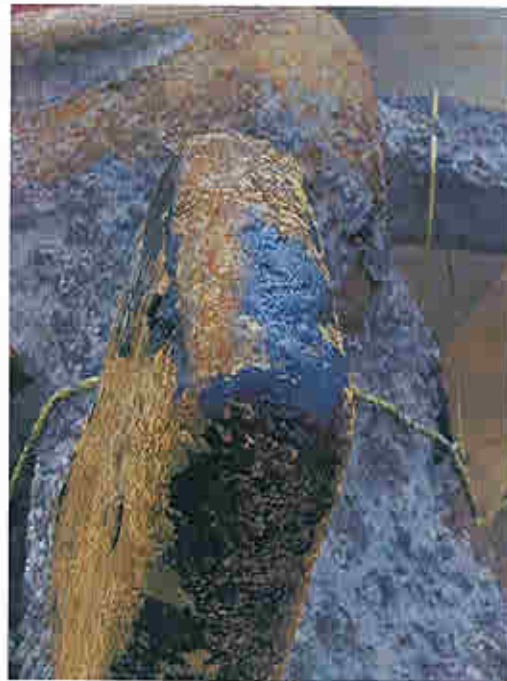
Recovered Anchor

On the 17th of January 2005, the anchor was recovered and transported to the MSO/Group Philadelphia pier. During examinations, fresh scrapings and a heavy coat of oil were found along the top and side section of one of the anchor blades (this section was later removed by MSO/Group Philadelphia personnel and sent to NTSB for analysis/comparison to other samples. Sample # ATHOS 1-006). Fresh scrapes along with heavy oil were also found on one of the anchor flukes, which was on the same side as the anchor blade with the scrapes and oil. Also at the end of the fluke the tip was bent upwards. No scrapings or oil were located on the other side of the anchor. The shank of the anchor was found to be missing; evidence suggests that a torch removed the shank.

Close-up of Anchor Blade

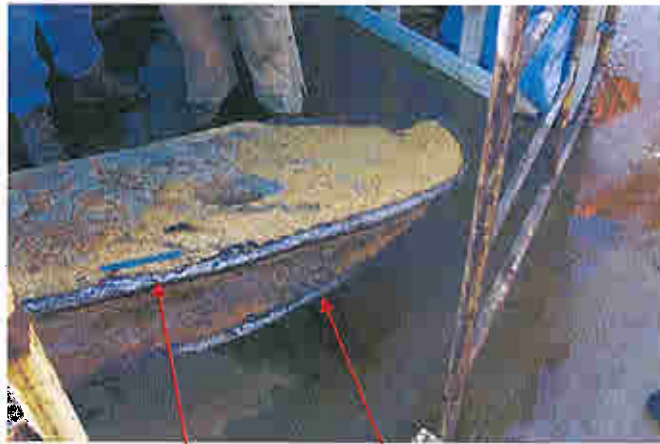
On the 2nd of March 2005, the anchor was thoroughly cleaned and the oil contamination and sediment removed. Highly visible metal scrapes on the fluke and anchor blade were found underneath the oil coating. These scrapings were found on both sides of the fluke, extending from the bull towards the anchor blade. Also found within the metal scrapings were very dense paint rub/marks that were later sampled and bagged as evidence (sample# ATHOS I-007).

Anchor Fluke – notice the metal scrapes along the sides

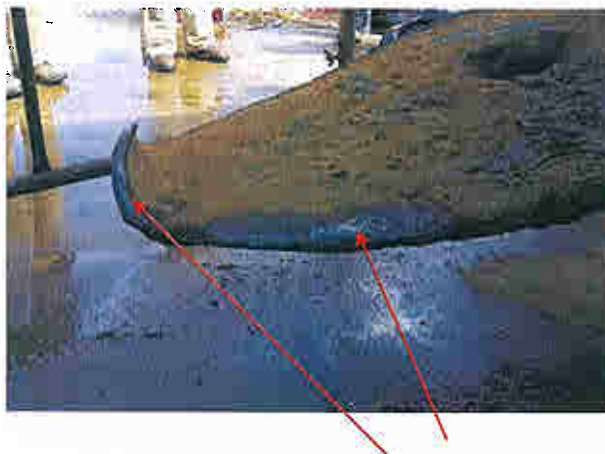
Anchor Fluke – with the bull bent upwards along with metal scrapes

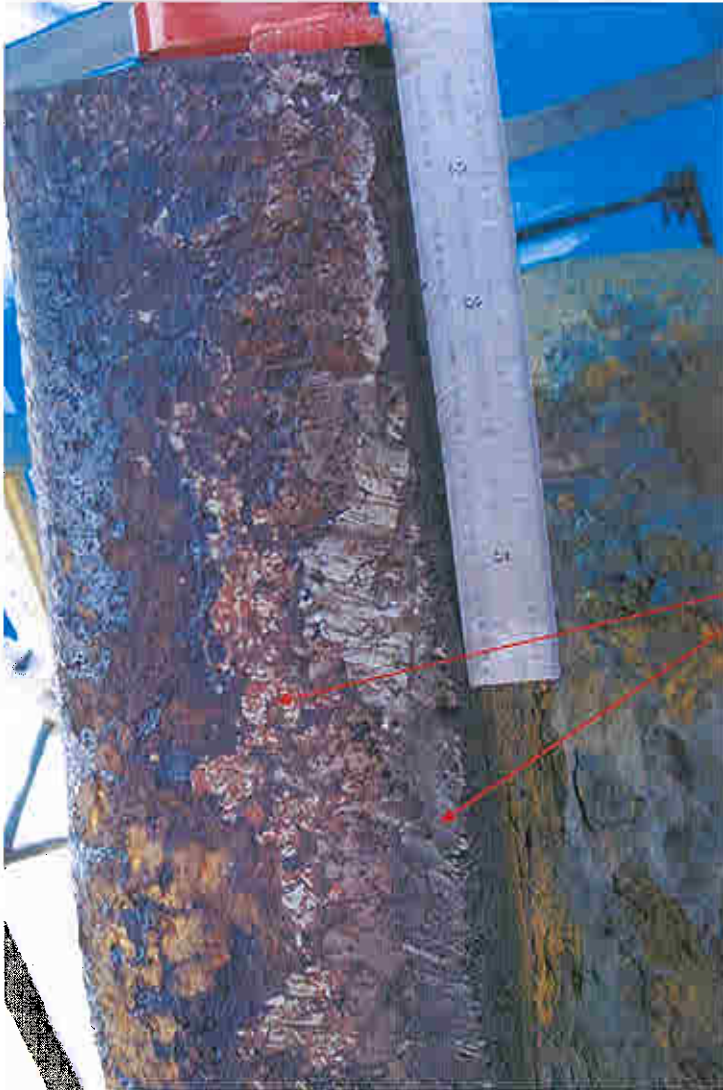
Anchor Blade –
showing the metal
scrapes and red
paint rubs.

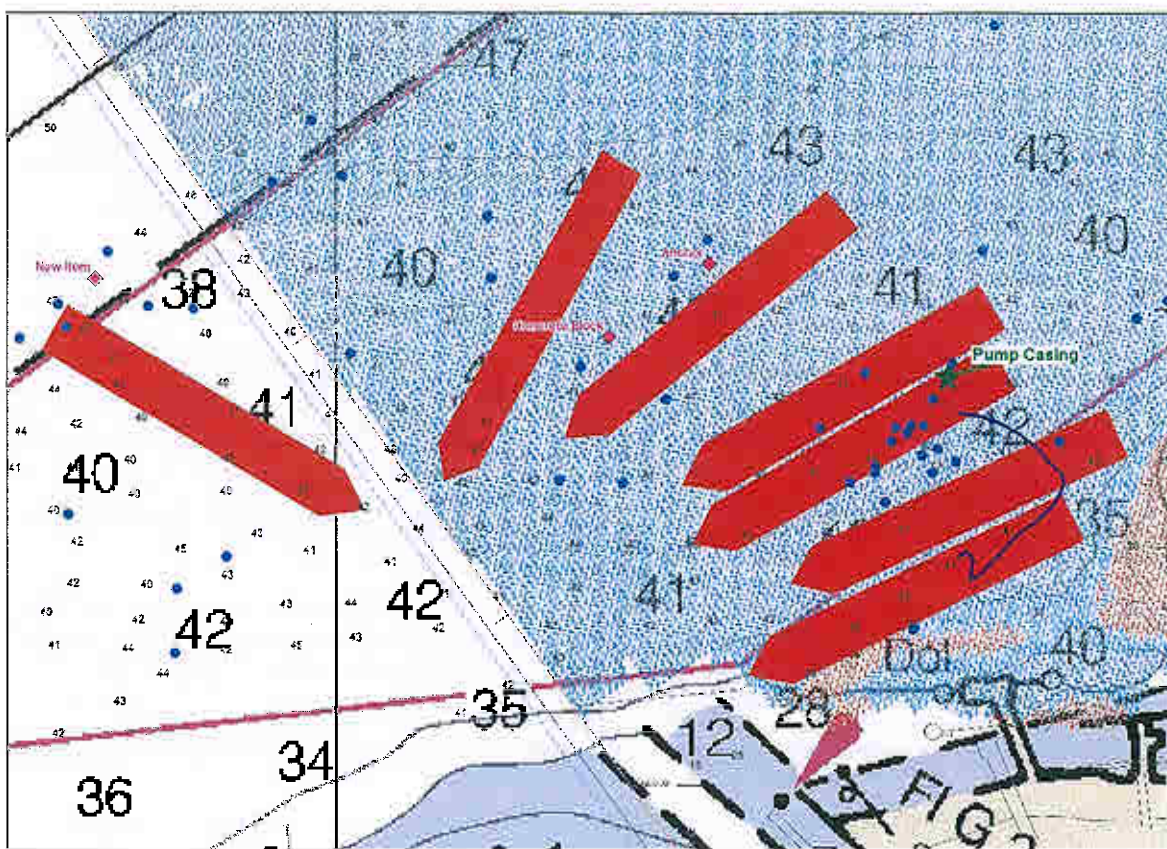
NOAA (by request of Coast Guard MSO/Group Philadelphia) created a computer generated timeline/chart showing the relationship of T/V ATHOS I's location during transit to the submerged objects in Anchorage #9. NOAA used data taken from the T/V ATHOS I's echo depth sound recorder log to plot the course of the vessel on the chart. NOAA illustrated the concrete block and anchor as purple diamonds, while the pump casing was shown as a green star. Other submerged objects that were of interest but not proven to have allided with the vessel are shown as blue circles. Also represented is a large scour mark (discovered by AUSS) identified as a blue line.

T/V ATHOS I locations related to submerged objects

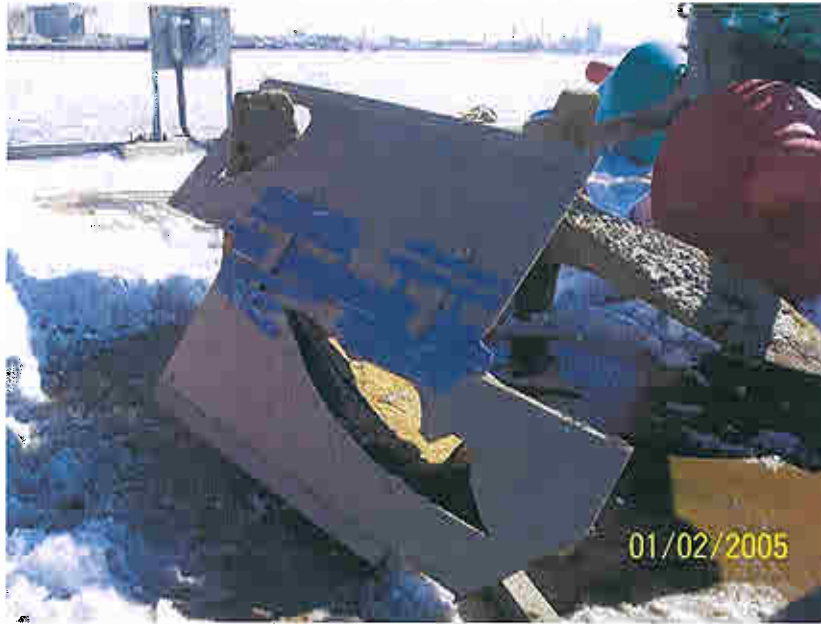
Figure 1- Cardboard Template

On the 1st of February 2005, experts hired by the owners of the ATHOS I, consisting of Mr. Tony Bowman (Naval Architect from TMC Marine Consultants) and Mr. Joseph Crosson (Metallurgist from Lucius Pitkin), along with Coast Guard Investigators examined the damaged hull section in detail and compared it to the recovered anchor's physical characteristics. Mr. Bowman and Mr. Crosson created a cardboard template of the hull damage by placing a plastic sheet against the hull and cutting an outline of the damage to the sheet. The outline on the plastic sheet was then transferred to a cardboard sheet and cutout. This cardboard template was then set to the anchor blade and fluke section (the same location of the scrapes and paint found on the anchor) for comparison. Figures 1, 2, & 3 shown below show the comparison between the template and the anchor blade. The comparison showed the anchor blade and fluke **matched identically** to the cardboard template.
