INVESTIGATION INTO THE CIRCUMSTANCES  
SURROUNDING THE

## COMMERCIAL DIVING ACCIDENT

ONBOARD THE MOBILE OFFSHORE DRILLING UNIT  
CLIFF'S DRILLING RIG NO. 12 ON MARCH 4, 1996  
WITH THE LOSS OF LIFE

FORMAL INVESTIGATION INTO THE COMMERCIAL DIVING ACCIDENT ABOARD  
THE MOBILE OFFSHORE DRILLING UNIT CLIFF'S DRILLING RIG NO. 12 ON  
4 MARCH 1996, WITH LOSS OF LIFE

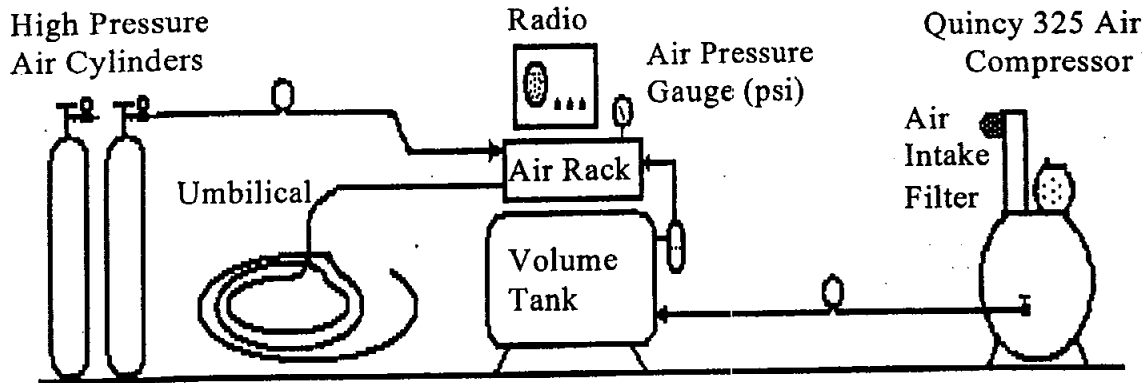
Figure 5: Schematic representation of Dive Station

35. The dive station (See Figure 5) consisted of a Quincy 325 air compressor connected by a 30-foot air hose to a 30-gallon volume tank. The volume tank was connected to an air manifold (a.k.a. air rack). Two high-pressure air bottles also were connected to the air rack to provide a secondary air supply if needed. The umbilical leading from the air rack to the diver's helmet consisted of an air hose, a communications line, a pneumofathometer, a lifeline, and the line from the NDT probe to the NDT monitor.<sup>87</sup> Next to the air rack was the communication box with batteries. Located nearby was the NDT scope used to interpret thickness readings measured by the probe operated by the diver.<sup>88</sup> The team set the compressor air intake upwind from the exhaust of the compressor's diesel engine.<sup>89</sup>

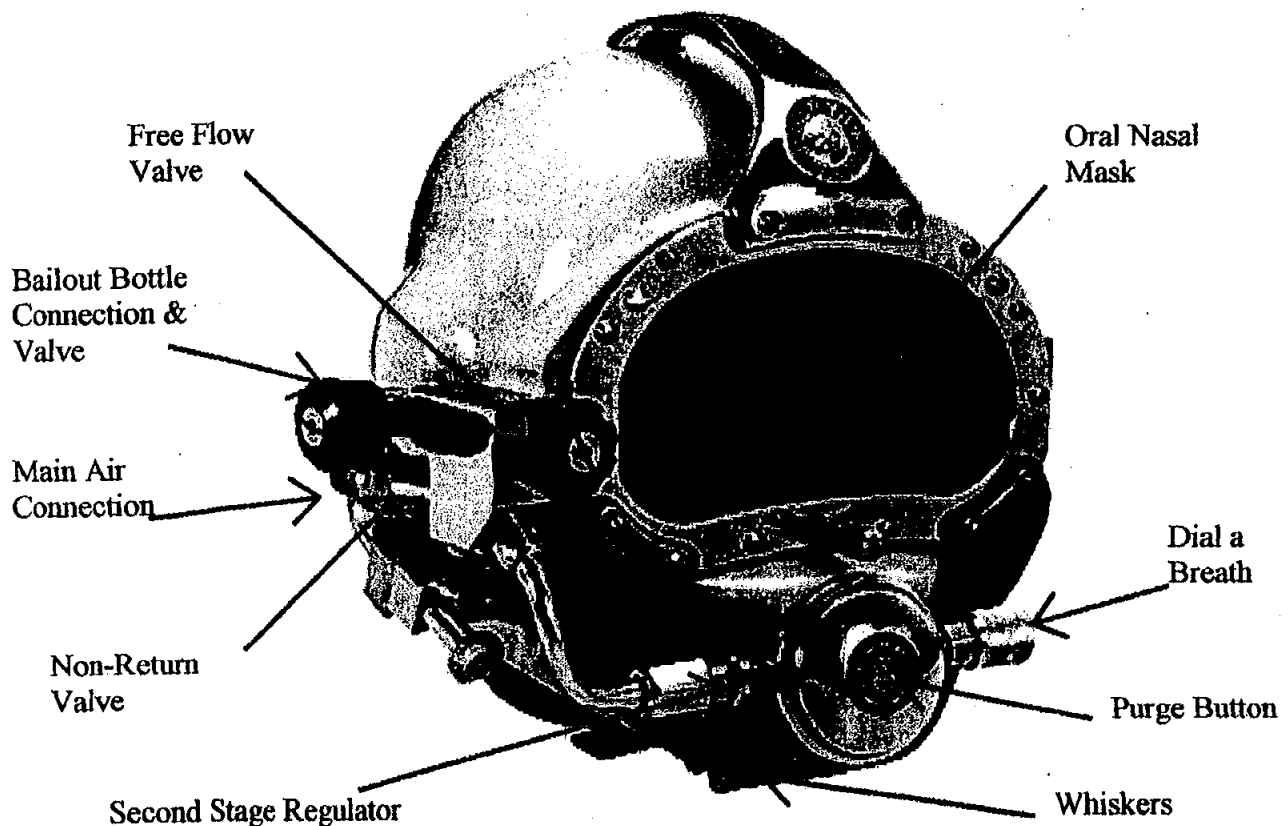
Figure 6: SuperLite 27 Dive Hat

39. At about 1330 hours, Pilkington entered the 65 to 70 degree water for the first time.<sup>95</sup> Pilkington wore a neoprene wet suit and his own Kirby, Morgan SuperLite 27 Dive Hat (See Figures 6 & 7).<sup>96</sup> He also wore Wiitala's weight belt and a harness with a quick release to which the umbilical, a knife and axe were attached. A three-foot lanyard attached the roofing axe to the diver's belt.<sup>97</sup>

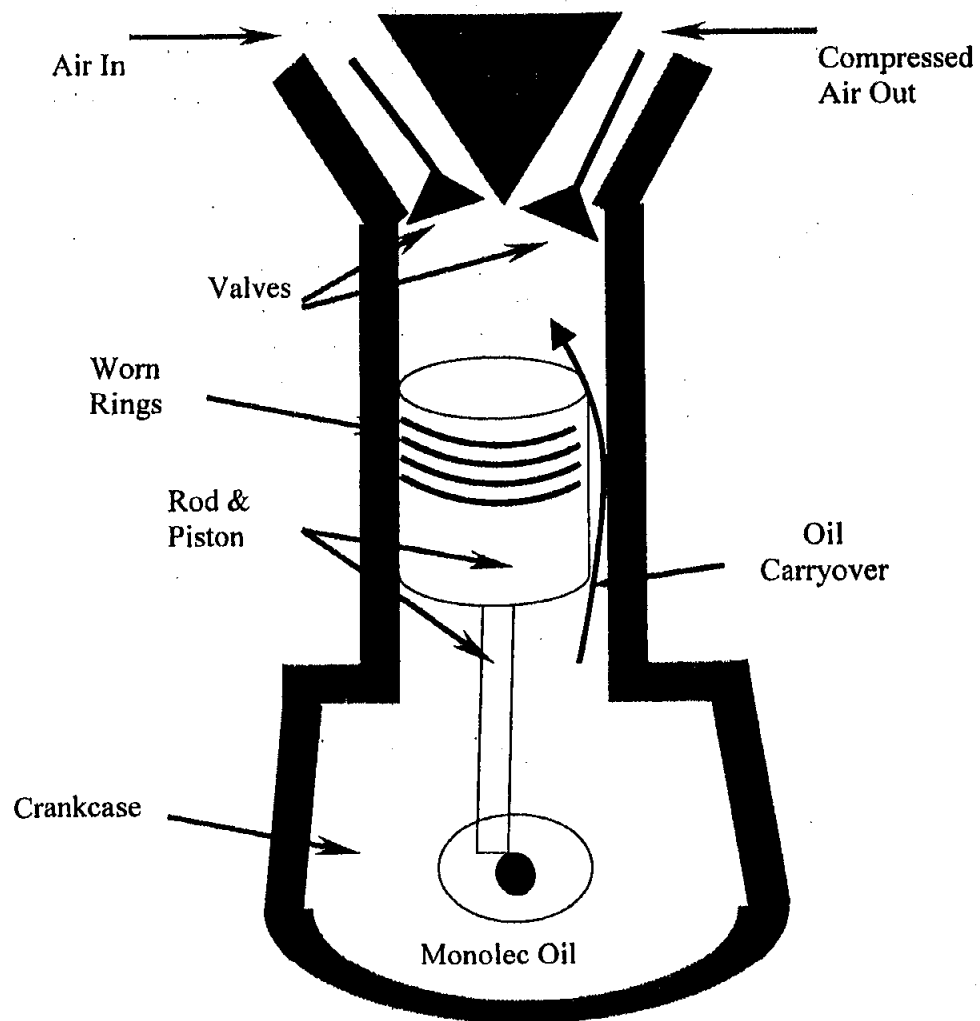
Figure 8: Representation of piston / cylinder assembly

Kirby concluded his write up by recommending Gilbert replace Compressor 2 rather than repair it.<sup>137</sup> Lawdermilk testified that when he returned to McKenzie's to pick up Compressor 2, a mechanic reported that the compressor's main problem was that a rag had been sucked through the cylinder.<sup>138</sup>
