INVESTIGATION INTO LOSS OF THE MASTER ABOARD AND
SINKING OF THE COMMERCIAL FISHING VESSEL

COSTA & CORVO

IN GEORGES SHOAL ON NOVEMBER 13, 2008

Prepared by:
U.S. Coast Guard
Sector Southeastern New England
Woods Hole, Massachusetts

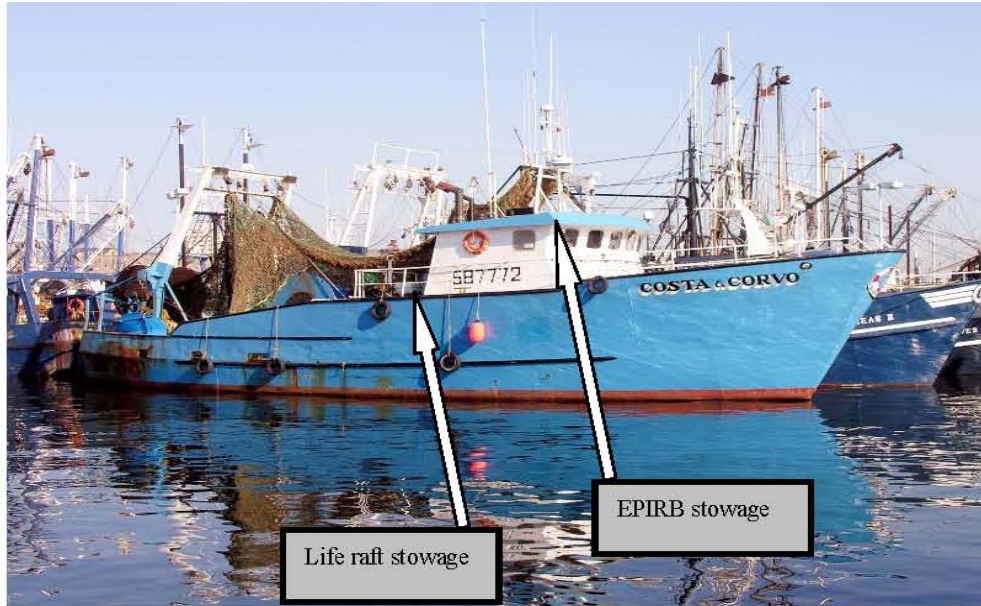
Figure 2: Storage locations of EPIRB and Life raft

The EPRIB, life raft, and life rings deployed and functioned as designed. The EPRIB was stowed on top of the pilothouse roof and deployed via a hydrostatic release when the vessel capsized. The EPRIB transmitted the Last Known Position of the COSTA & CORVO to Coast Guard District One Boston, MA indicating the vessel was in distress. Once the vessel began to sink, the life raft deployed automatically via a hydrostatic release and floated to the surface. The life raft remained secured to the COSTA & CORVO via a 100 foot sea painter line. Both items were retrieved by a Coast Guard cutter and returned to the owner of the COSTA & CORVO after they were examined by the Coast Guard Investigating Officer. Two of the vessel’s three life rings floated free as the vessel capsized. One crew member entered the water with one life ring as the vessel rolled. The three survivors were rescued clinging to two of the vessels life rings. The vessel had the required number of survival suits on board and they were inspected as satisfactory by the Commercial Fishing Vessel Examiner during the November 8, 2008 examination. However, due to the sudden and rapid roll over of the vessel, the crew members had no time to enter the inside of the vessel, retrieve, and don the survival suits.

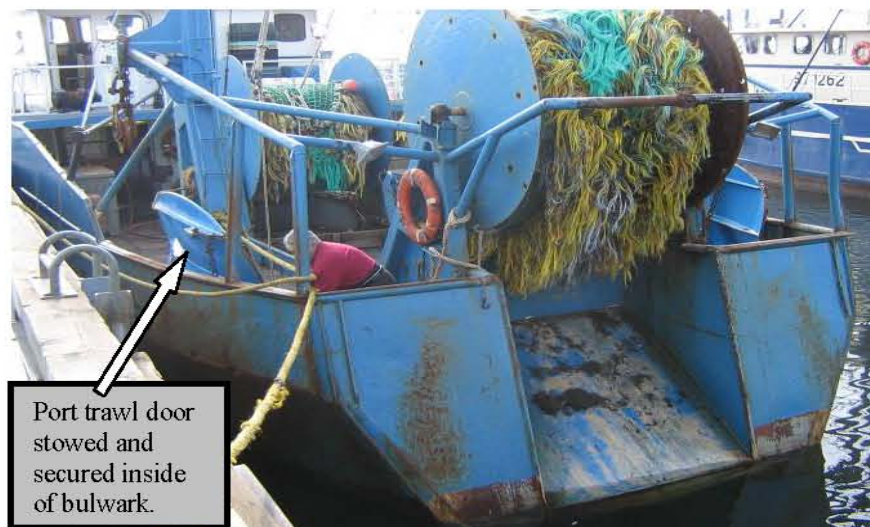
The vessel was equipped with two 1100 pound steel trawl doors stored inboard. The trawl doors are designed to flow through the water at an angle causing them to spread away from each other opening the net in a horizontal direction. The trawl doors are attached to the boat by trawl warps. During haul back operations the trawl doors were stowed outboard in preparation for the next pay-out of fishing gear.

Figure 3: Picture of the COSTA & CORVO

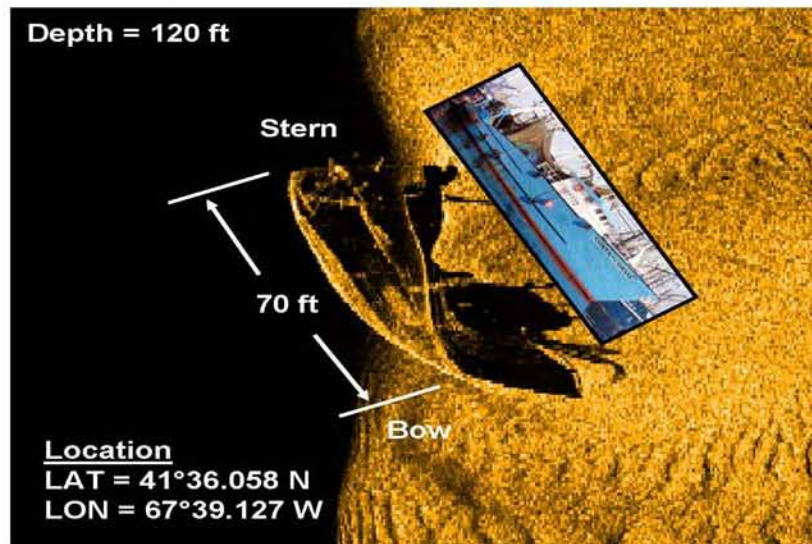
On August 11, 2009, the Naval Undersea Warfare Center conducted an underwater survey of the vessel. The information collected by the Naval Undersea Warfare Center (NUWC) was consistent with the details of the incident provided by the Investigating Officer of the U.S. Coast Guard. From the quality of the SONAR images it is clear that the vessel detected is lying on its port side. As imaged from the starboard side, the vessel hull appears to be intact and complete. It is believed the vessel slowly slid down the slope of George's Shoal and now rests in 120ft of water.

Figure 4: Sunken vessel located near last position of COSTA & CORVO (Image courtesy of Naval Undersea Warfare Center of the Naval Sea Systems Command)

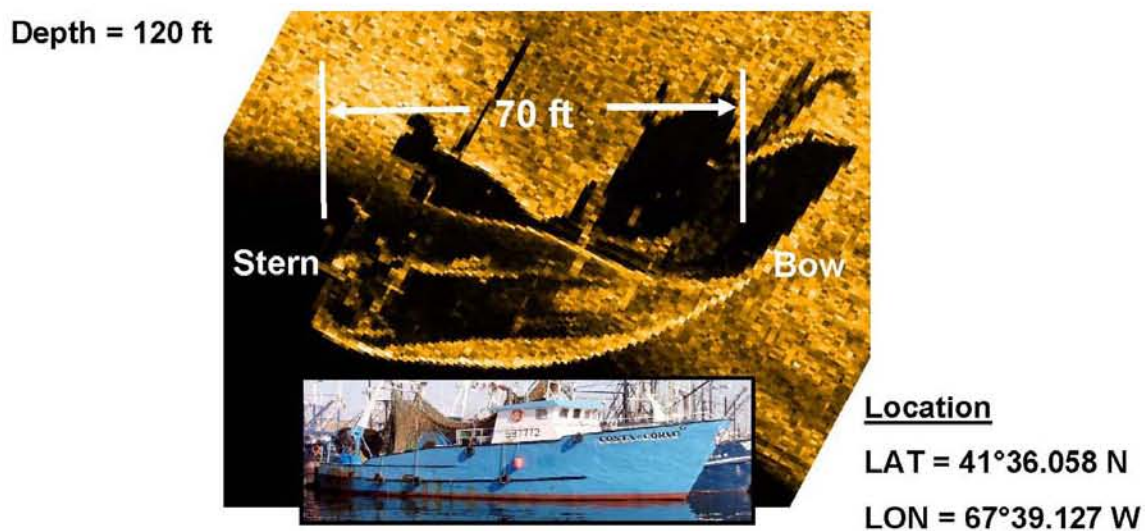
Figure 5: Sunken vessel located in last position of COSTA & CORVO (Image courtesy of Naval Undersea Warfare Center of the Naval Sea Systems Command)

The vessel found during the survey conducted by the Naval Undersea Warfare Center is near the last known position of the COSTA & CORVO and most probably is the COSTA & CORVO. The vessel and associated gear appeared to be intact with no breaches of the hull being readily apparent. The hypothetical vessel sink pattern is derived from the position of the vessel when the crew was recovered and the location that the life raft was located after the vessel sank.

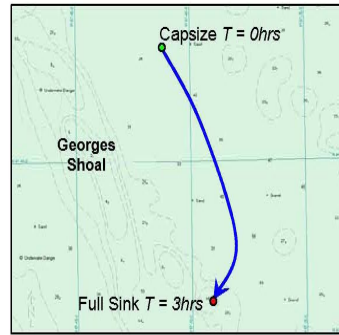
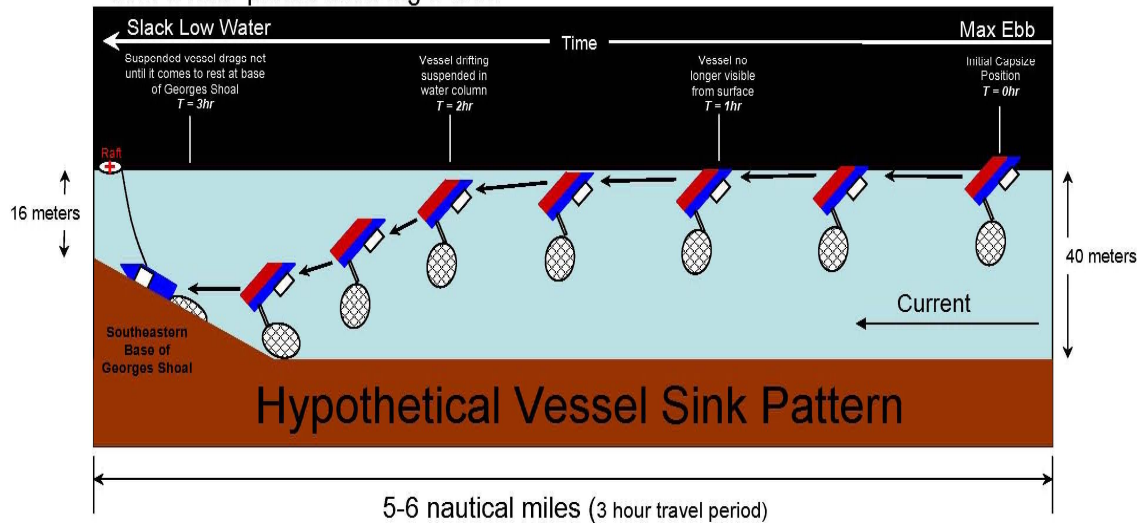
- Vessel Capsizes
- Slowly exchanges trapped air for seawater and remains on surface for about an hour
- Vessel continues to drift submerged while in suspension still releasing trapped air and towing life raft
- Life raft never breaks tether: *Boat never sinks deeper than 100ft (30m)*
- Resultant sink rate is slow and steady over 3 hour period covering 5-6nm

Figure 6: Hypothetical vessel sink pattern on November 13, 2008 (Image courtesy of Naval Undersea Warfare Center of the Naval Sea Systems Command)
