# UNITED STATES COAST GUARD

## REPORT OF INVESTIGATION INTO THE CIRCUMSTANCES OF THE EXPLOSION, FIRE, AND SINKING OF THE TANK BARGE EMC 423 WITH ONE LOSS OF LIFE

ON THE CHICAGO SANITARY AND SHIP CANAL  
ON 01/19/2005

MISLE Activity Number: 2277817

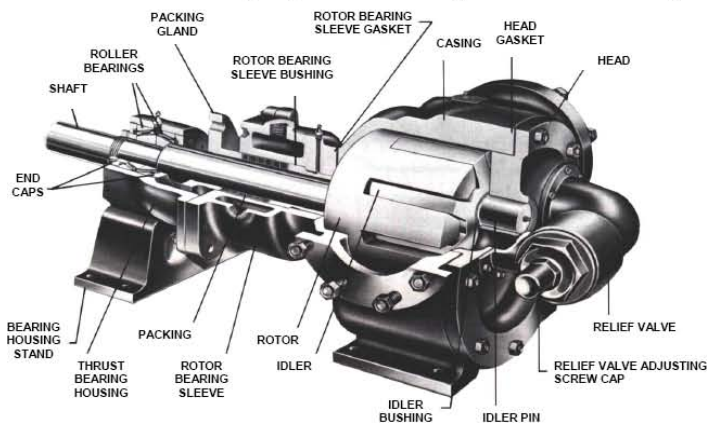
Figure 1-1: Pump Schematic (CG Exhibit 112)

Alexander Oliva was tasked with getting the cargo pump ready for the offload. Alexander Oliva "bumped the clutch" to see if the cargo pump was going to turn, and found that it would not due to the cold temperatures solidifying CSO within the pump (Figure 1-1). The heat tracing lines to the cargo

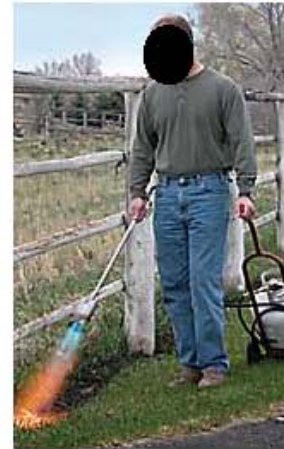
Figure 1-2: CG Exhibit 66 - Propane Torch

1. Approved, subject to the following comments.
2. For clarification; Findings of Fact 132, 133, and 134, the Investigating Officer found that on the night of the casualty the Master of the M/V LISA E stated that there was a propane torch on the barge, that the purpose of the torch was to warm up the cargo pump and that the deceased was operating the cargo pump at the time of the explosion. In Findings of Fact 142 and 143 the Investigating Officer found that on the night of the explosion a Deckhand stated that the deceased may have been using a propane torch to heat the cargo pump at the time of the explosion. The relevant conclusions to be drawn from these statements are that there was a propane torch on board the T/B EMC 423 the night of the explosion, that deceased used it to heat the cargo pump, and that the propane torch was the source of ignition for the explosion. (Conclusions 2 & 3).

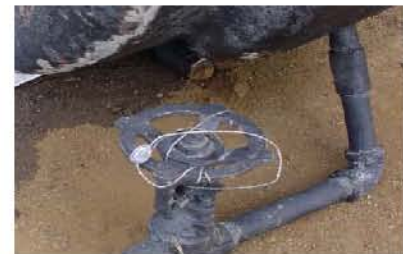
**Figure 5-14: Bleed Valve**

**Bleed Valve:** On the top of the cargo pump casing, discharge side, was a non-standard "bleed valve" mechanism (Figure 5-14). According to the manufacturer this arrangement was not necessary because the pump

was a positive displacement/self priming pump (Pg. 2444). The valve was still attached to the pump and was in the closed position when it was recovered from the CSSC after the explosion.

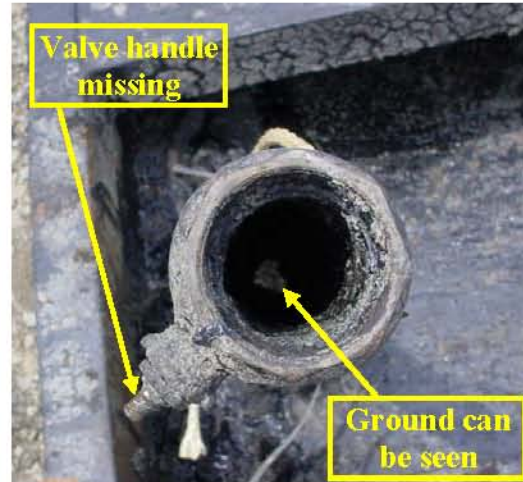
**Figure 5-16: Standpipe penetrates remnant of deck plating**

The end of the standpipe was threaded, but it did not have a closure device (cap or plug) in place when it was recovered. Employees of Egan Marine testified that the standpipe was fitted with various closure devices and/or fittings. ██████ stated that the standpipe fitted with 3" to 2" "funnel" at the top, and no additional fittings, while ██████ stated that the standpipe was fitted with a threaded cap. The owner, ██████ stated the standpipe was fitted with three additional fittings; a cap, a reducer fitting, and a nipple (Pgs. 3014-3015, 3019-3023, 3097).

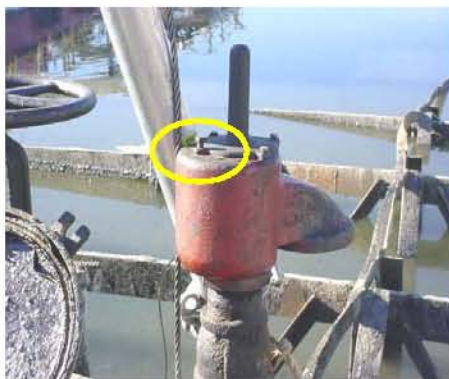
**Figure 5-17: Cargo tank #1 P/V valve**

After the explosion it was discovered that one of the bolts holding cargo tank #1 PV valve in place was partially backed out (Figure 5-17). Three additional PV valves were recovered after the explosion with similar conditions found on those also (Figure 5-18). Additionally, the flame screen was largely clogged (Figure 5-19).

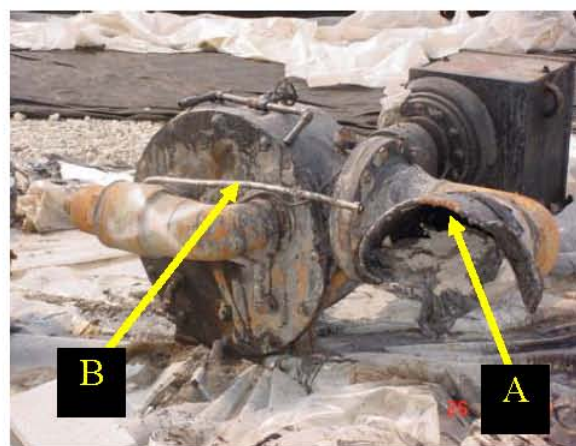
**Figure 5-27: Cargo pump heat trace tubing, post-explosion**

were later recovered from the Chicago Sanitary Ship Canal. This massive damage to the cargo pump and appurtenances significantly contrasted to apparent little to no damage incurred by the heat trace tubing on the EMC 423 cargo pump (Figure 5-27(B)) with its smooth bent shape, nearly identical to that found on the EMC 427, still intact. [REDACTED] (ATF) testified that he compared the heat trace line configuration from the EMC 472 (Figure 5-26) with that of the EMC 423 and concluded that the EMC 423 heat trace line (Figure 5-27(A)) was not bent or damaged at all during the explosion, despite the cargo pump being thrown from the barge during the explosion (Pgs. 3247-3250).

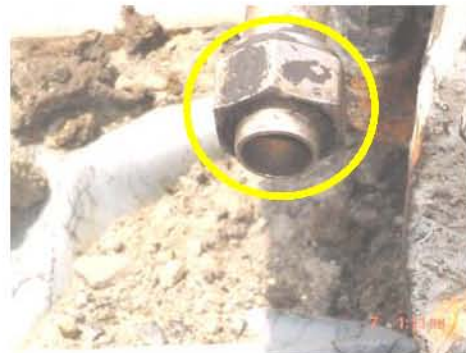
**Figure 5-29: Compression fitting on cargo pump**

examination of the compression fitting on the end of the cargo pump heat trace line (Figure 5-29) revealed that the “compression ring has necked down the tubing as it was designed to do” so that the nut was captive and would not come off. He also indicated that upon an examination of the internal threads of the nut that no “deformation of the pitch of the threads due to some mechanical forces or explosives” was observed (Pgs. 3244-3245). With regard to the compression fitting found on the section of heat trace piping that ran along the starboard end of the cargo header adjacent to the discharge
