REPORT OF THE INVESTIGATION INTO THE CIRCUMSTANCES SURROUNDING THE ENGINE ROOM FIRE ON BOARD THE

M/V SSG EDWARD A. CARTER, JR.

WHILE MOORED AT MILITARY OCEAN TERMINAL
SUNNY POINT, N.C., ON JULY 14, 2001
WITH THE LOSS OF TWO LIVES

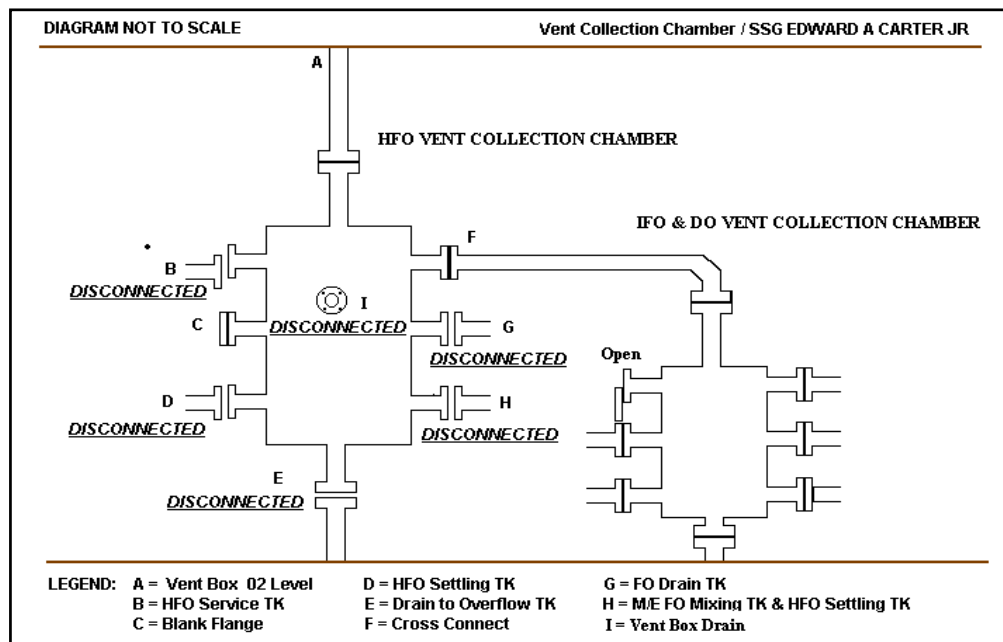
39. The second option discussed was to disconnect the HFO vent collection chamber (a.k.a. “HFO Christmas tree”) from the various vent and drain lines it serves so it could be lowered to the deck to access the vent lines for cleaning. The HFO Christmas tree is held in place by two flanged connections mounted to the starboard bulkhead on the 01 level. Once removed, the crew would have unrestricted access to the settling tank vent line so that compressed air could be used to clear the blockage. This process proved to be successful in clearing the diesel oil service tank vent in the shipyard several months earlier. With the consent of the Chief Engineer, the First Assistant Engineer ordered the Electrician, Donald Hastings, to disconnect the vent lines connected to the HFO Christmas tree on 11 July or 12 July. The Electrician worked alone to disconnect four vent line flanges and two drain line flanges that are labeled “disconnected” on Figure 2 below.

40. Also shown (on the right side of sketch) is the smaller IFO/DO vent collection chamber that was disconnected and cleaned by the crew while in the shipyard. The blank flange was found attached to the IFO/DO vent collection chamber by only one bolt. It was not determined why the crew did not secure this flange prior to the fire.

Figure 2: Schematic of HFO and IFO/DO Vent Collection Chambers

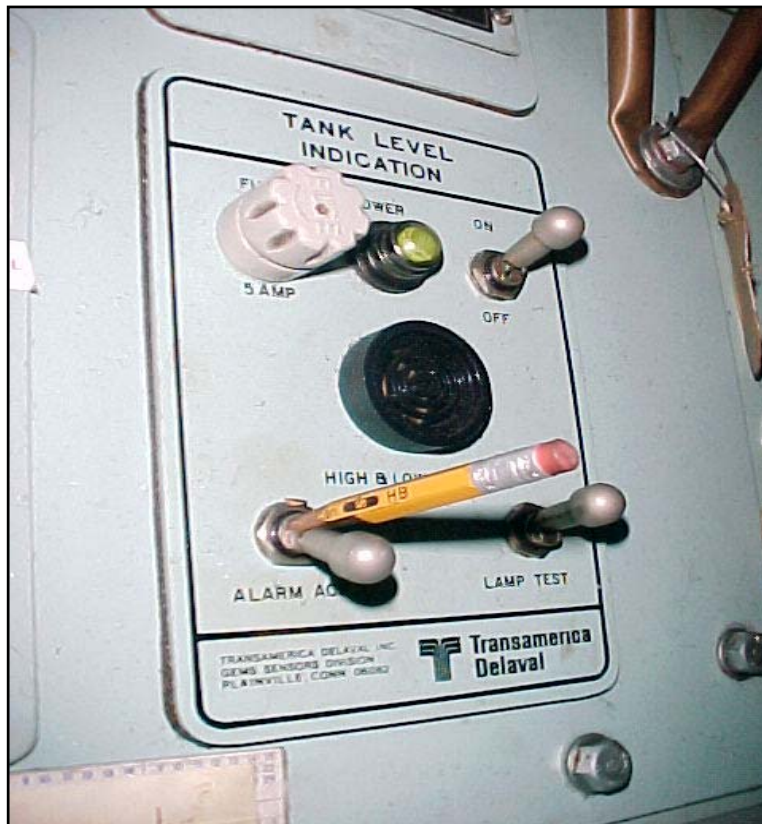
Picture 1: TLI Audible Alarm Panel in Engine Control Room
(Pencil wedged into panel to silence audible alarm)

49. The Second Assistant Engineer, Peter Donat, testified that he wedged the pencil (shown in Picture 1) in place to hold the TLI audible alarm toggle switch in the “acknowledge” position. He positioned the pencil in place several months before the fire because the TLI system was not functioning properly since the audible alarm was constantly sounding even though the tank levels were not at an alarm condition. The Second Assistant admitted that other pencils were used previously to hold the toggle switch in the “acknowledge” position. Chief Engineer Champa testified that he was not aware of any problems with the TLI system prior to the fire.

127. The Second Assistant Engineer testified that the pencil wedged into the “acknowledge” position on the TLI panel prevented the audible alarms from sounding in the engine room. Chief Engineer Gustafson testified that he temporarily wedged a pencil into the “acknowledge” position on the TLI panel to silence a continuous sounding of a high bilge level alarm while the ship was completing conversion work at Norshipco. John Sullivan testified that keeping the alarm in the “acknowledge” position prevented the display of a high tank level by the Siemens computer and the recording of the event on the sequence log. With the TLI audible alarm bypassed, the only way to identify a high level condition in any of the fuel tanks would be through a visual inspection of the bar gauge or meters on the TLI panel in the engine control room. The bar gauge changes color from yellow to red when a high tank level condition is reached. The meters are circular dials. There were no high level alarm conditions recorded in any of the computer event sequencing logs between 1-14 July. The First Assistant Engineer and Second Assistant Engineer testified that they never heard the TLI audible alarm sound on the SSG CARTER.

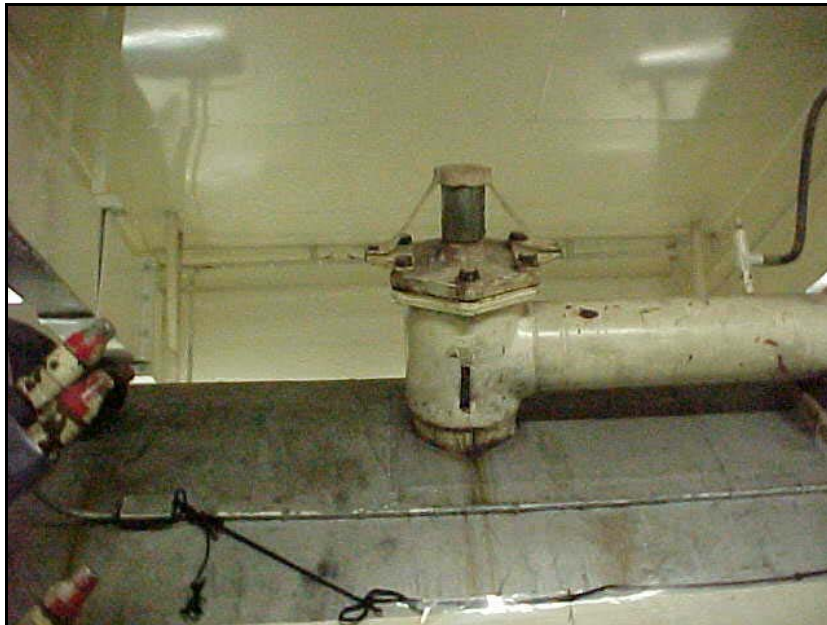
73. The low-pressure CO₂ tank was refilled on 10 June. FPS was ordered by Norshipco representatives to keep the main stop valve “locked” in a closed position to prevent an accidental discharge. This “lock closed” program was in accordance with Norshipco’s safety procedures for ships fitted with low-pressure CO₂ tanks while moored at their facility. Picture 2 is the main stop valve with the locking cap properly installed. One cannot tell whether the valve is in the open or closed position because it does not have a rising stem nor does it have a position indicator. The only way to check if this valve is opened is to remove the locking cap and turn the valve handle with a wrench.

Picture 2: CO₂ Tank Main Stop Valve (from sister vessel, SEALAND QUALITY)

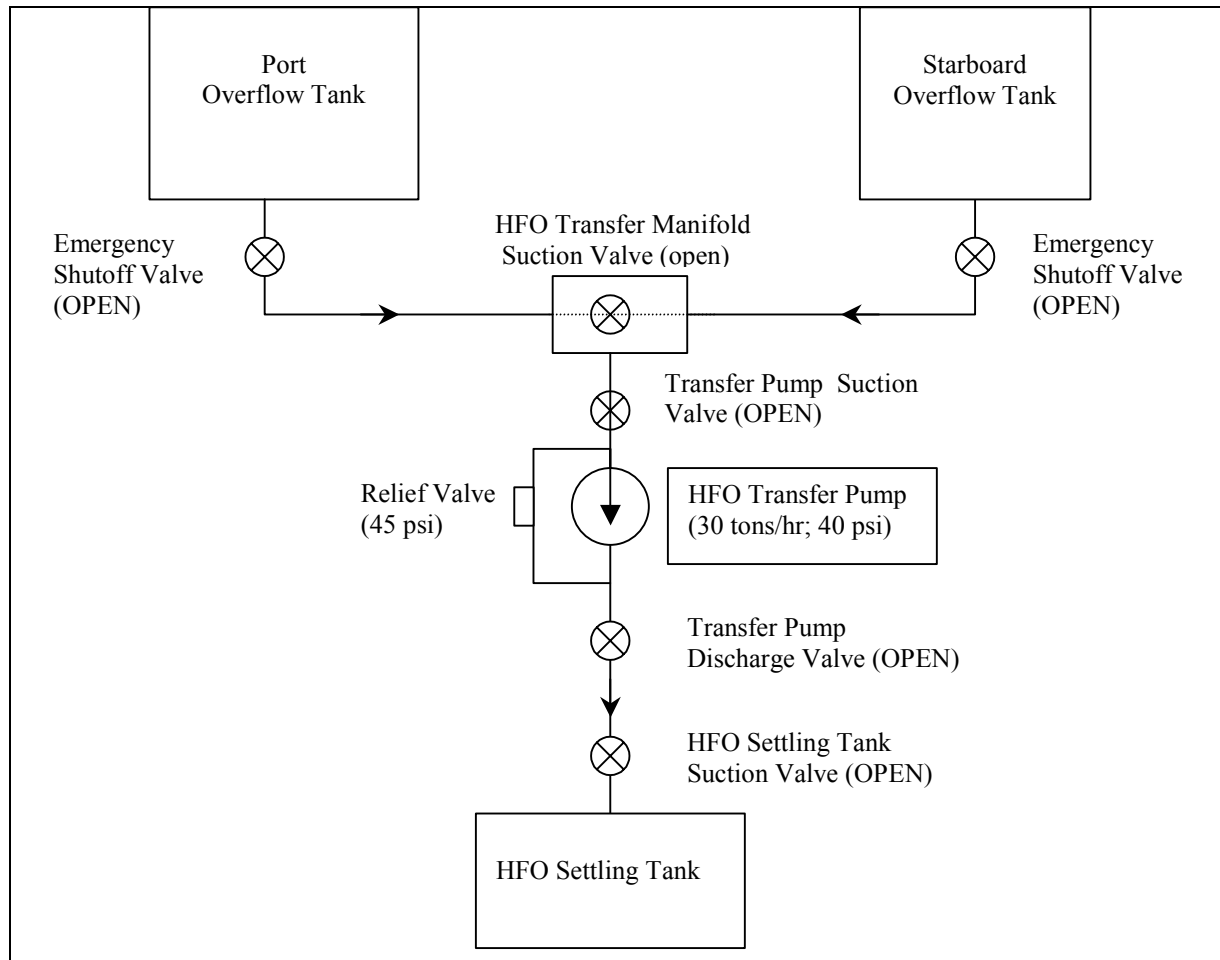
123. On 20 July, the CWO Gonzales and Mr. Sullivan discovered valves opened in the HFO transfer system which would allow fuel to be transferred from the port and starboard overflow tanks into the HFO settling tank. The "open" position of all the valves was confirmed by cycling the valve hand wheels. The overflow tank suction valve, which serves both overflow tanks, was the only valve opened on the HFO transfer manifold (total of five valves). The team did not confirm the position of the diesel oil transfer system valves.

Figure 4 – Post-Fire Fuel Piping Arrangement for HFO Transfer from Overflow Tanks to the HFO Settling Tank (taken from F.O. Filling and Transfer System Drawing)

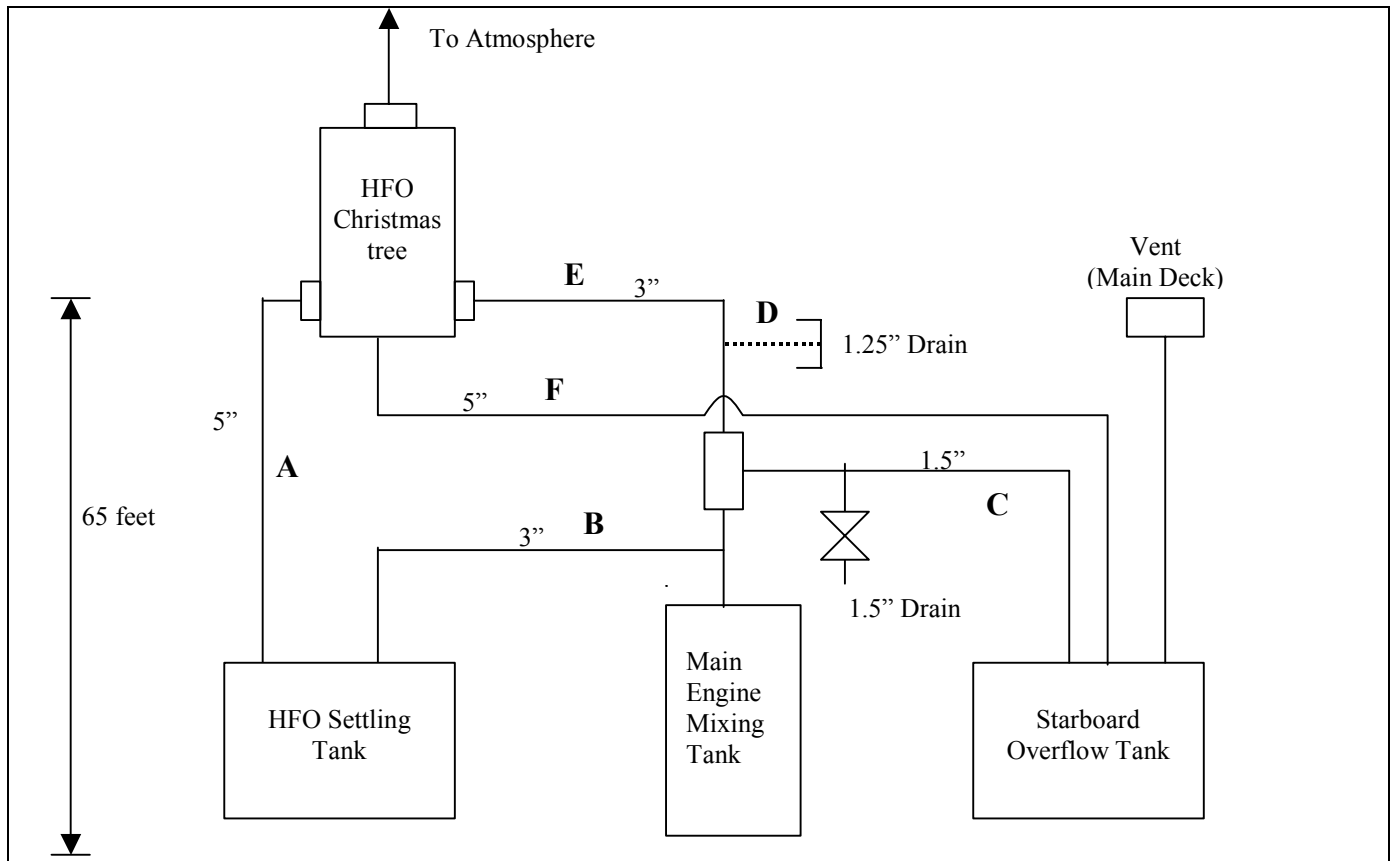
Figure 5: HFO Settling Tank and Main Engine Mixing Tank Vent System
(from F. O. Service System Piping Diagram)

128. Figure 5 is the HFO settling tank and main engine mixing tank vent collection piping

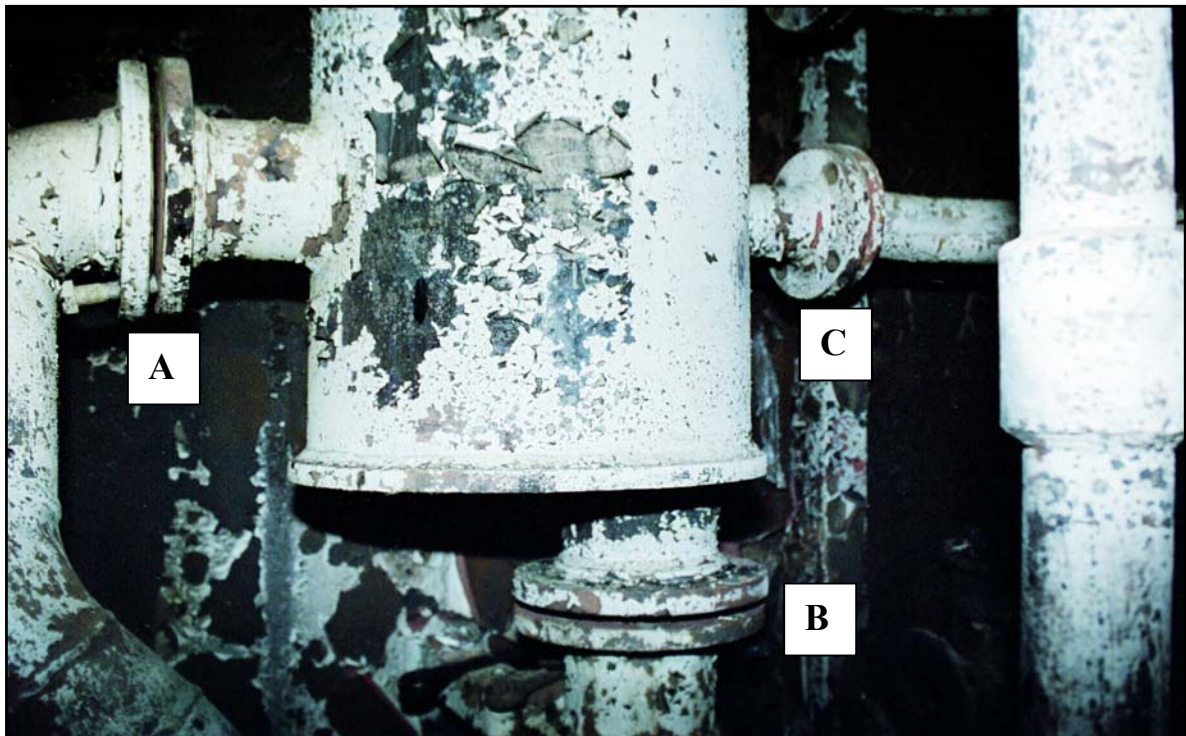
Picture 5: Lower Section of the HFO Christmas tree on 01 Level (Post-Fire)

141. Picture 5 is the lower section of the HFO Christmas tree taken after the fire. The vent pipe on the left (depicted by label A) is the 5" vent line from the HFO settling tank to the HFO Christmas tree. All but one of the bolts were completely removed from the flanged connection. The one bolt remained because the bolt length was too long to back out all the way. The vertical pipe at the bottom of the picture (label B) is the 5" drain line from the HFO Christmas tree to the starboard overflow tank. The gap in between the disconnected flange was measured to be 0.75". The 3" vent pipe on the right of picture (label C) is from the main

171. The incinerator exhaust stack is located four feet from the HFO Christmas tree. As depicted in Picture 5, an expansion joint on the incinerator exhaust stack was removed on the 01 level to examine the internal condition of the stack. The interior of the stack looked clean and undamaged with no indications that fire started inside the stack. Sections of the incinerator exhaust stack insulation were removed between the main deck and 01 level. There was no sign that fuel had contaminated any of the insulation on the incinerator exhaust stack.

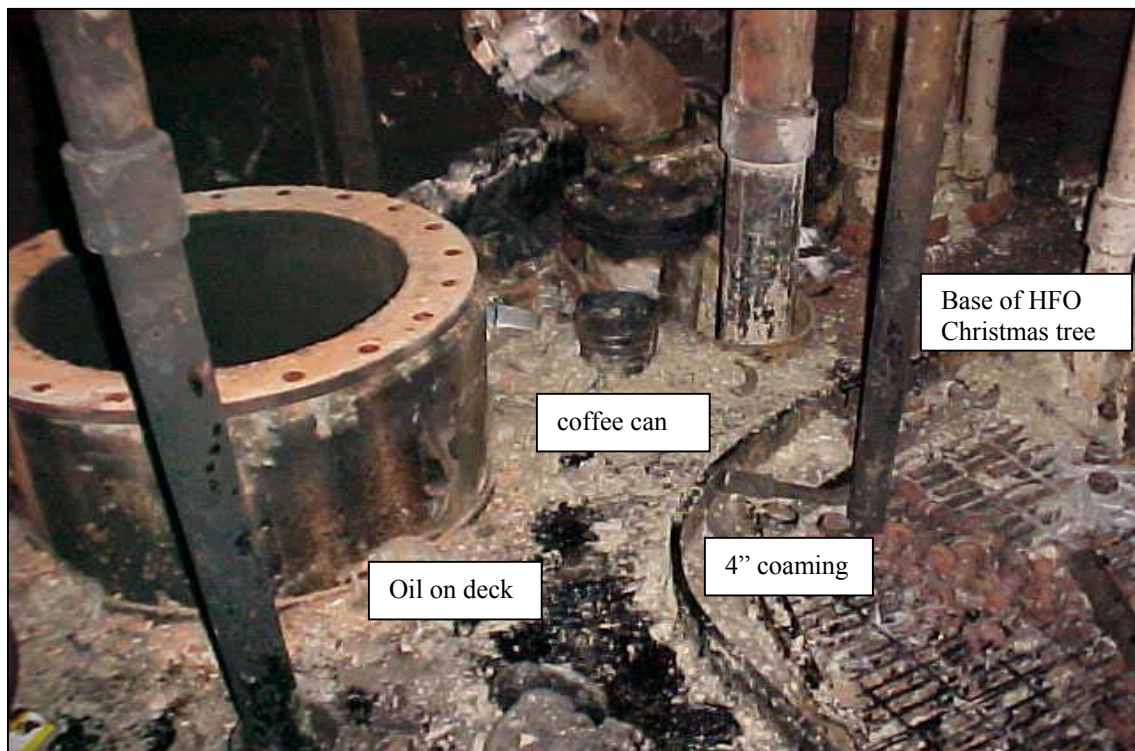
Picture 6: 01 Deck Level in Vicinity of the HFO Christmas Tree After the Fire

144. Picture 6 was taken several days following the fire in the vicinity of the HFO Christmas tree. In the foreground is the HFO that was found on the majority of the solid deck plating on the 01 level. Separating the solid deck plating from the grating (foreground, right) is 4" high deck coaming. The bolts and nuts on top of the grating were from the expansion joint removed from the incinerator exhaust stack (left side of picture) which was accessed during the investigation. The small coffee can contained the nuts and bolts removed by the Electrician from the HFO Christmas tree flanges several days before the fire. CWO Gonzales testified that there was oil trapped beneath the can once it was removed from the deck. The vertical pipe pictured to the right of the coffee can is the 5" vent line from the HFO settling tank. The upper right corner of the picture is the base of the HFO Christmas tree. The white material in the picture is the part of the insulation material removed from the incinerator exhaust stack.

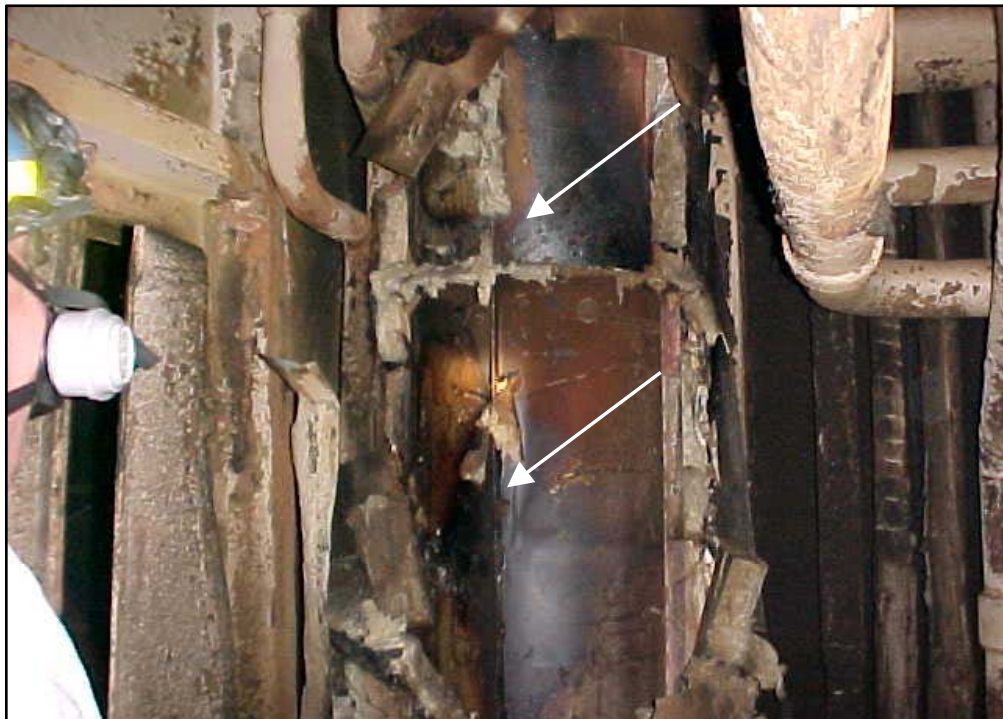
172. The investigative team completed an external exam of the auxiliary boiler exhaust stack by removing the sheathing and rock wool insulation (fiberglass) from the stack between the main deck and 01 level. This area was selected due to the discovery of melted rivets used to hold the sheathing together. Along the upper portion of the exhaust stack near the 01 level, there were two black stains found which were not present on any other portion of the stack. Picture 7 below shows the two black stains found by the team. ATF agent, John Golder, testified that these stains were consistent with markings left behind from fuel combustion. Upon closer examination, Mr. Golder identified residue from burned oil evident on the insulation adjacent to the exhaust stack where the stains were located. Mr. Golder described the insulation showed signs of a “wicking effect” where the fuel moved through the fiberglass layers from the outside toward the inside before making contact with the hot auxiliary boiler stack.

Picture 7: Auxiliary Boiler Exhaust Stack (between Main Deck and 01 Level)
[Arrows depict location of black stains]

173. A small part of the fiberglass insulation had become hardened from heat exposure. Portions of the oil-saturated insulation were sent to the Dr. Graham (Coast Guard Marine Safety Lab) to compare it with the fuel samples collected from the two deck levels, the main engine mixing tank, and the HFO tanks. Dr. Graham concluded that the heavier hydrocarbon compounds from the main engine mixing tank and the HFO tanks were similar to those found on the insulation indicating that these samples are related. He could not conclusively state that the oil on the insulation matched any of the other samples because the dissimilarities were not consistent with weathering, including any evaporation losses from heat exposure. Dr. Graham testified that there were no signs of combustion on the insulation sample due to the lack of pyrogenic compounds.

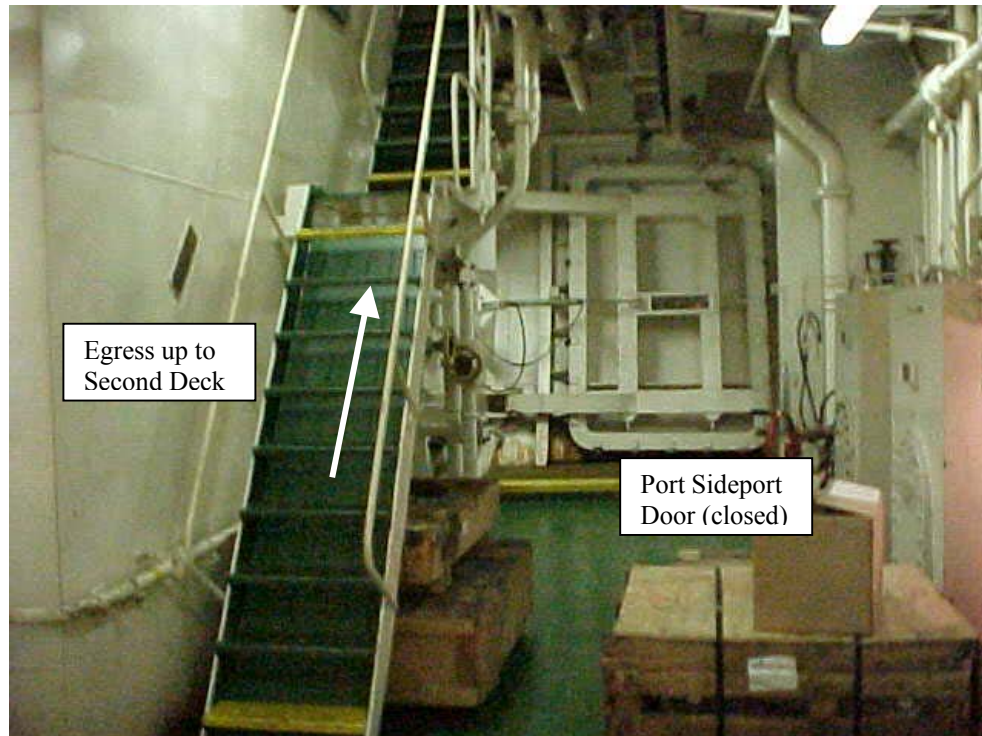
Picture 8: Third Platform Level looking toward Port Sideport Door (Frame 46)

201. On the day after the fire, a Coast Guard investigator spotted a yellow line tied off to a metal ladder rung in the vicinity of the port sideport door on the third platform level. The other end of the line was seen in the Cape Fear River directly below the sideport door. Chief Engineer Gustafson testified that this yellow line was normally tied to a bucket used for bunkering operations. A pair of earplugs that matched those used by the Wiper were recovered in the vicinity of the port sideport door. No one saw the Wiper jump into the water from the ship. The height of the sideport door opening above the Cape Fear River at the time of the fire was approximately 15 feet.
