# Report of Investigation

Sinking of the M/V ELIZABTH M (Official Number # 262962) and Six  
Barges with Four Fatalities on January 09, 2005 at the Montgomery  
Locks and Dam on the Ohio River at Mile Marker 31.7

USCG MISLE Incident Investigation Activity Number 2271812

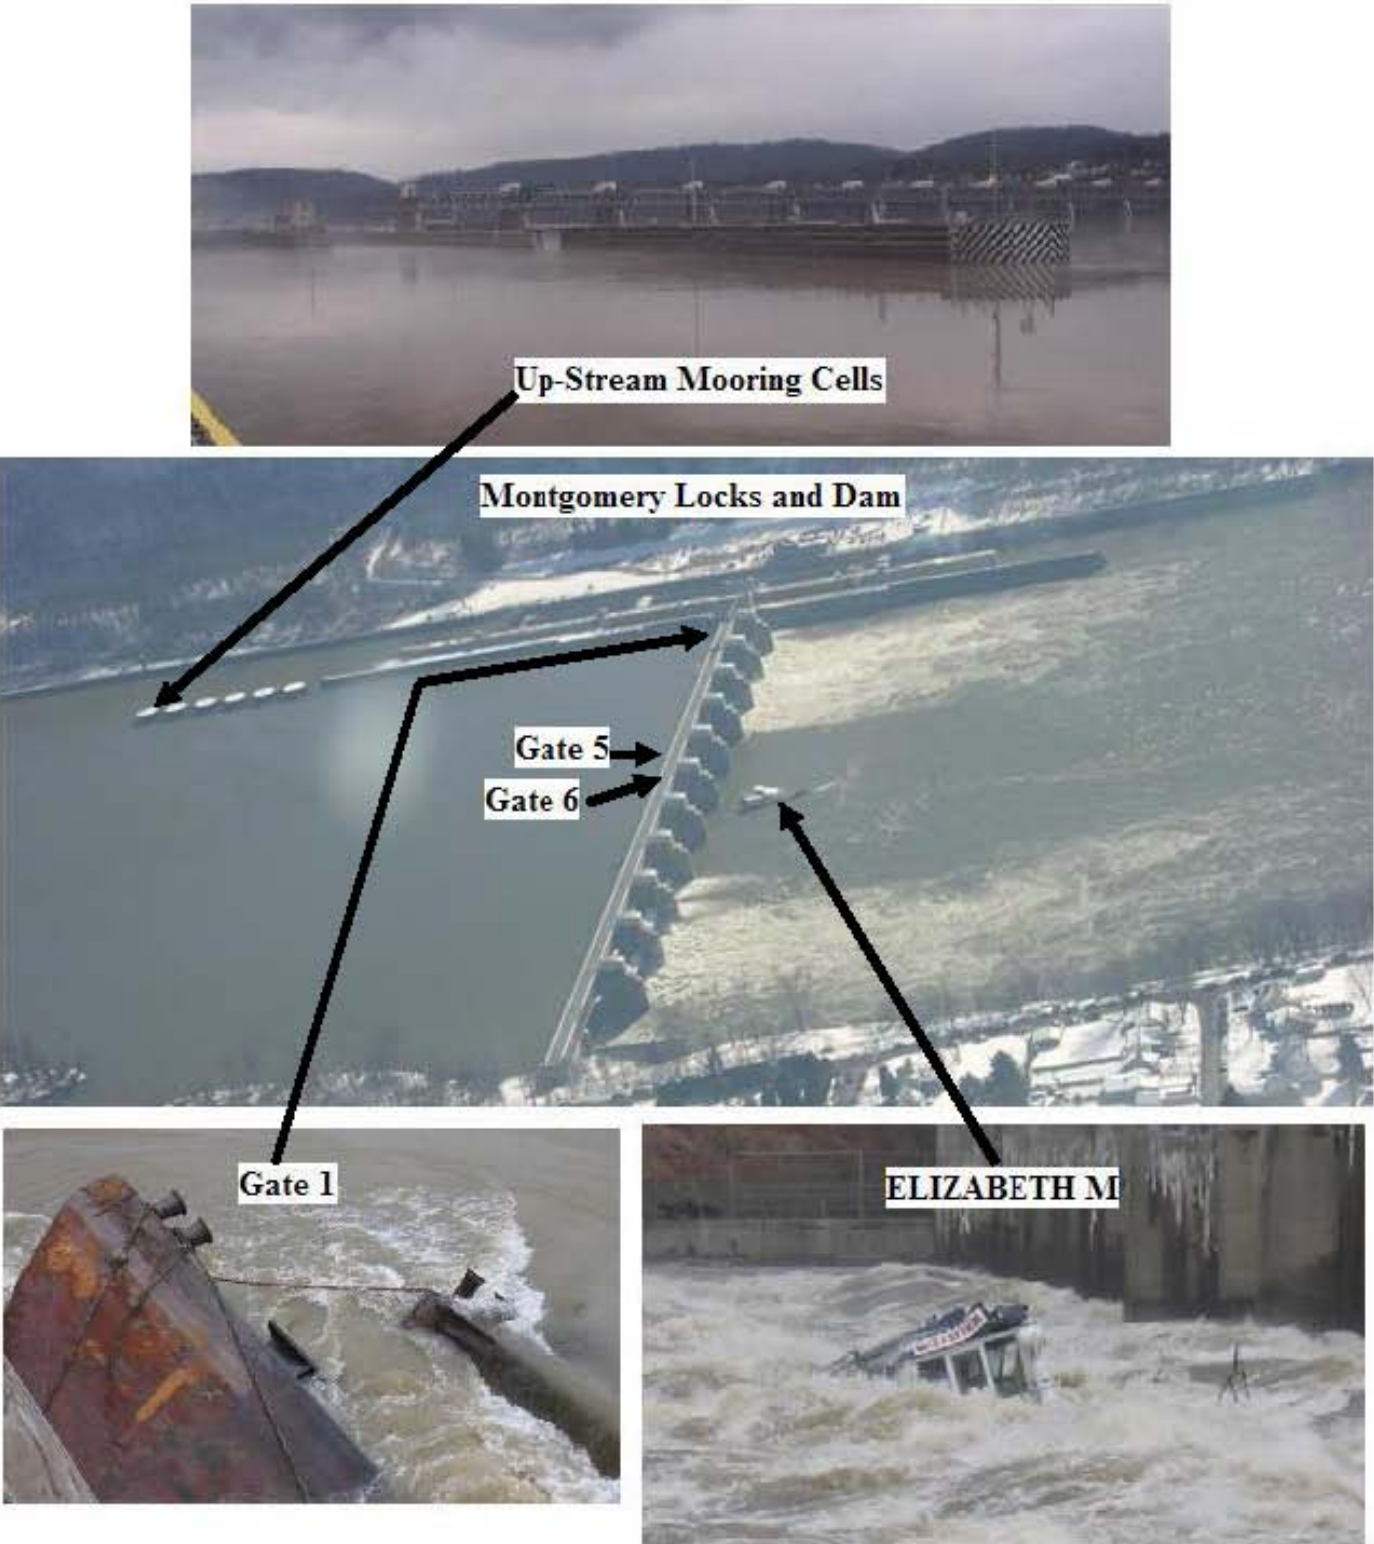
Figure 1: Overview of casualty scene.

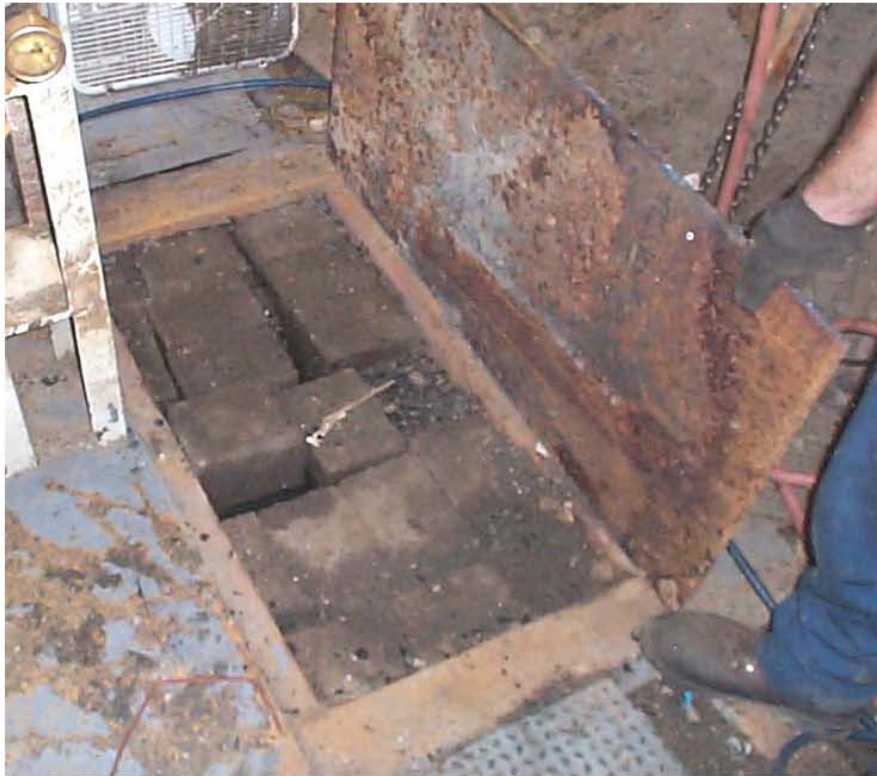
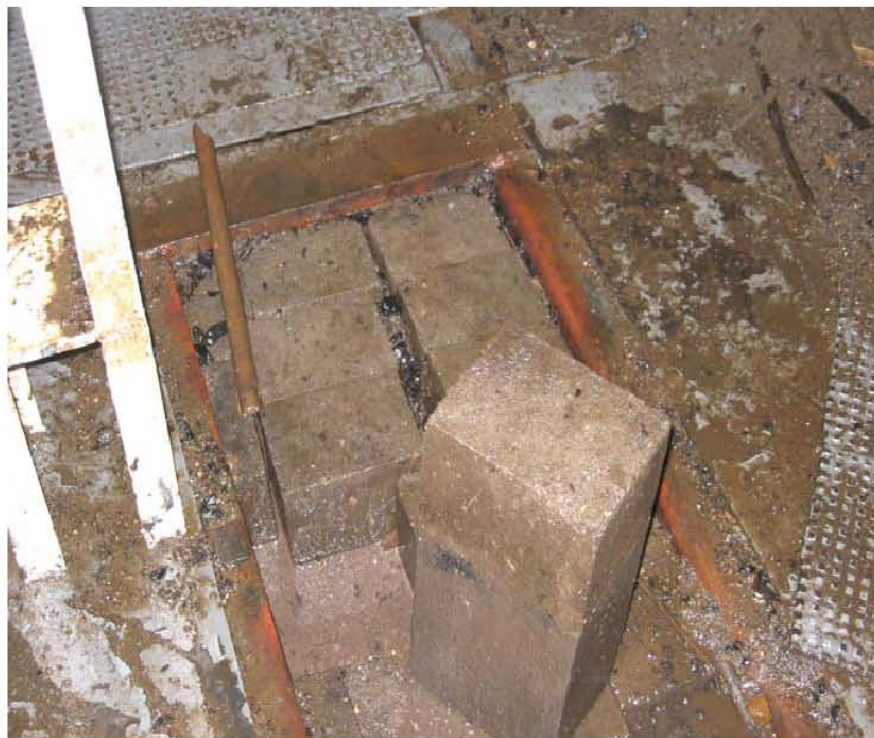
2. In April 1997, 35 tons of ballast (cement blocks) was installed on the ELIZABETH M in an attempt to trim the vessel to the original waterline after replacement of the vessel's main propulsion engines. The vessel was not ballasted prior to this installation. Vessel plans indicate the original waterline was 6'6". Pre-casualty photographs of the vessel (see figure 2), taken approximately three months before the casualty, show the vessel drafting approximately 7'6". The original main propulsion engines were White Superior Model 405 with Falk gears. The vessel was repowered with lighter Caterpillar 3512 engines and gears. When the ballast was installed it was divided equally, port and starboard, by placing an equal numbers of blocks on each side of the vessel in approximately the same relative position and distance outward from the centerline in the following locations: 7 tons in the forward void, 14 tons below the deck plates in the engineroom and 14 tons in the lower aft void. Although an accurate determination could not be made regarding the exact weight of the original engines and gears, post casualty analysis indicated, "It is likely that the 35 tons is significantly more ballast than the weight difference between the original and final engines & drive trains." Post casualty analysis completed by the U.S. Coast Guard Marine Safety Center (MSC) indicated the approximate 1' increase in draft over the original waterline would have negatively impacted the vessel's survivability during a sinking scenario by increasing the vessel's susceptibility to downflooding through non-watertight doors. Although the post-casualty analysis only captured the vessel's static response in calm water, environmental conditions (such as current) and the vessel's dynamic response (such as pitch, roll, free surface effects, etc.) on the night of the casualty would have further reduced the vessel's survivability as outlined in the analysis. (IO Exhibit 144, 145, 146, 147)

Figure 4: Post-casualty photographs of ballast installed in the engineroom on the ELIZABETH M in April 1997.

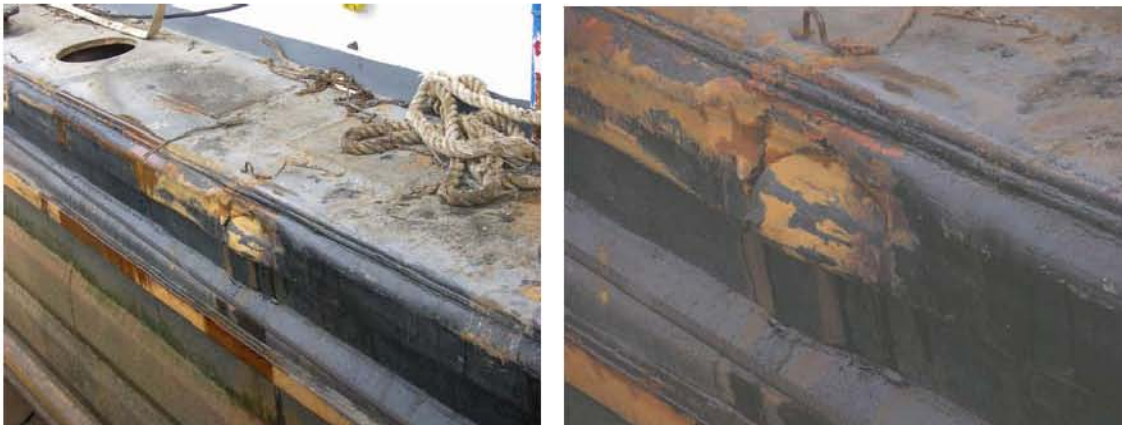
18. On 31DEC04, at approximately 1230, the ELIZABETH M allided with the barge CBL 7711 (O.N. 583351) while building a tow at the Colona loading facility located at approximately mile 23 on the Ohio River. The ELIZABETH M sustained damage to her starboard rub rail approximately amidships. Damage consisted of fractures covering roughly a 6 inch x 8 inch area contained totally within the rub rail. The damaged area was located approximately 1.5 to 2 feet above the waterline. The damage did not permeate into the vessel's hull. (IO Exhibit 013, 095, Trans Vol I pg 38 ln 1, Vol II pg 86 ln 5, Vol III pg 134 ln 8, Vol III pg 268 ln 1)

Figure 5: Post-casualty photographs of ELIZABETH M rub rail damage sustained on 31DEC04.

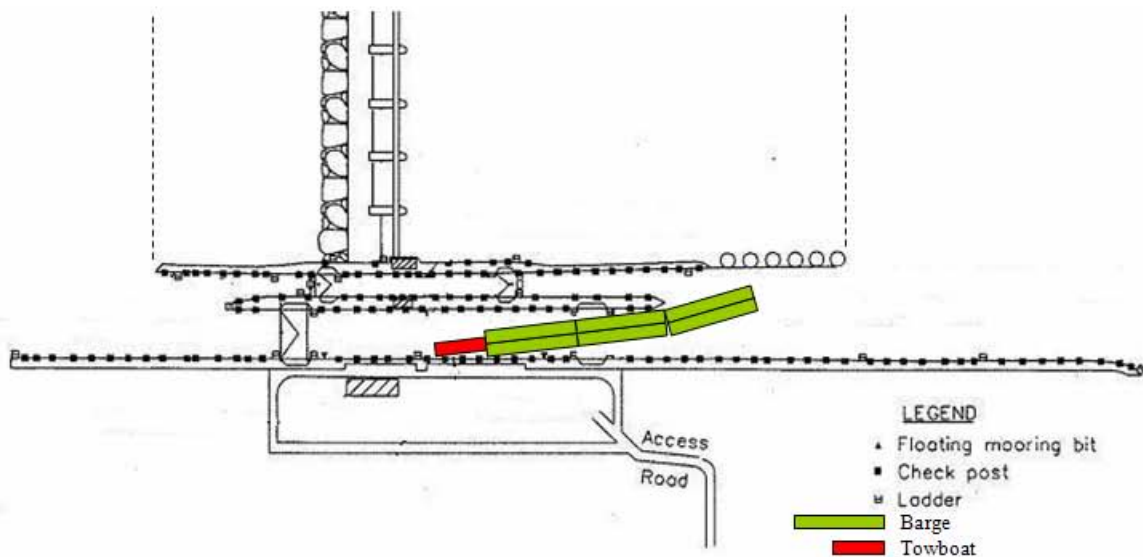
66. On 09JAN05, at approximately 0202, the tow of the ELIZABETH M allided with the upstream bull nose at the end of the middle lock wall. The allision caused all the wires at the coupling between the lead and center barges in both the port and starboard strings to separate with the exception of the wires on the port string between the port stern of the lead barge and the port bow of the center barge. [REDACTED] placed a line between the starboard stern of the lead barge and the starboard bow of the center barge in the starboard string to keep the barges at the head of the tow from rounding to. After the allision the towboat and tow continued making headway, in an upstream direction, angling out towards the center of the river. This was the approximate time that [REDACTED] (Locksman) observed the ELIZABETH M was going "...out toward the center river a little quicker than what I seen other people do..." and "...accelerated..." [REDACTED]

Figure 13: Approximate location and configuration of the ELIZABETH M and tow after the allision with the bull nose of the middle lock wall.

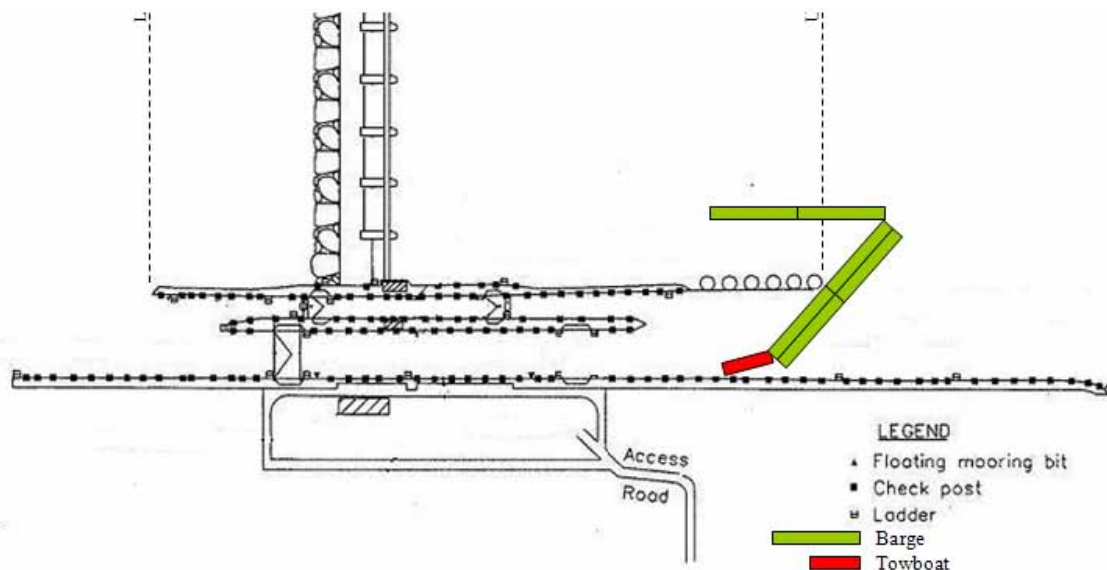
71. Shortly after telling Stewart to "Fan your rudders" the towboat's starboard quarter allided with the landside lock wall. The allision tore the starboard chock off the towboat and caused all of the facing wires between the ELIZABETH M and the tow to separate with the exception of the port facing wires. The tow continued to rotate around the end of the river side lock wall heading towards the dam. At this time [REDACTED] relieved Stewart as operator of the ELIZABETH M. After being relieved Stewart started calling for assistance over the marine radio. [REDACTED] maneuvered the ELIZABETH M to the port stern corner of the stern barge in the port string and used a line to secure the bow of the towboat to the tow to try to push the tow upstream out of the locks and towards the mooring cells located above the upper end of the landside lock wall. (Trans Vol II pg 51 ln 16, Vol II pg 51 ln 21, Vol II pg 52 ln 2, Vol II pg 58 ln 17, Vol II pg 60 ln 4, Trans Vol II pg 63 ln 10, Vol II pg 123 ln 9, Vol II pg 123 ln 15, Vol II pg 124 ln 4, Vol II pg 124 ln 11, Vol III pg 277 ln 4)

Figure 15: Approximate location and configuration of the ELIZABETH M and tow after the allision with landside lock wall.

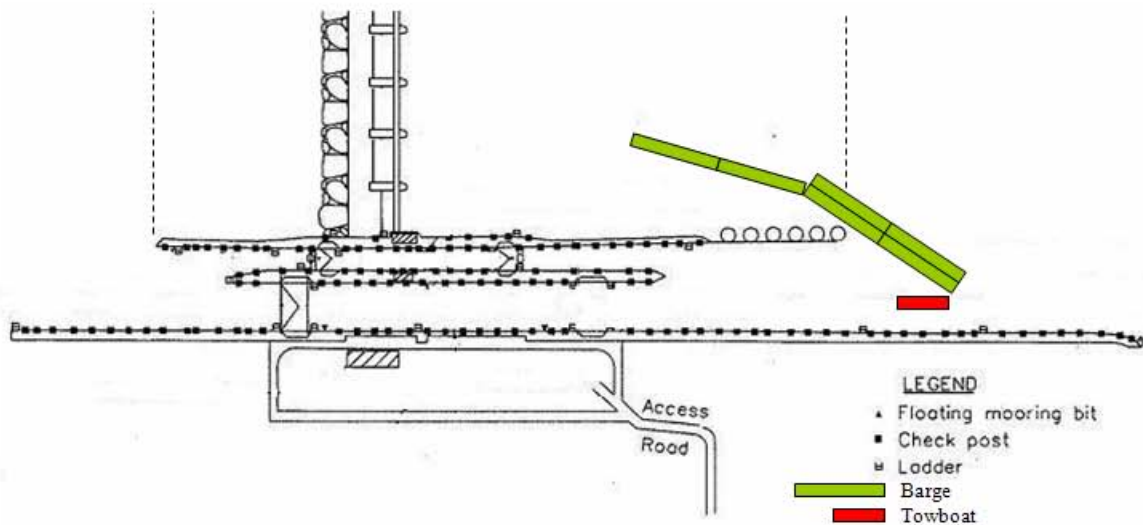
74. On 09JAN05, at approximately 0214, the ELIZABETH M succeeded in pushing the tow up to approximately the 800 foot marker on the landside lock wall. At this time [REDACTED] made a report to the pilothouse that the stern barge in the port string was sinking. Fearing the sinking barge might cause other barges in the tow and/or the towboat to sink; [REDACTED] ordered the deckhands to release the sinking barge from the tow. The wires securing the sinking barge in the tow had tightened up as the barge lost freeboard and the deckhands were not successful in releasing the barge. (IO Exhibit 050, Trans Vol II pg 52 ln 9, Vol II pg 52 ln 23, Vol II pg 53 ln 3, Vol II pg 61 ln 13, Vol II pg 61 ln 17, Vol II pg 64 ln 2, Vol II pg 125 ln 19, Vol II pg 126 ln 4, Vol II pg 129 ln 1, Vol III pg 158 ln 16, Vol III pg 277 ln 18, Vol III pg 316 ln 1, Vol III pg 318 ln 14)

Figure 16: Approximate location and configuration of the ELIZABETH M and tow after being pushed up to the 800 foot mark on the landside lock wall.

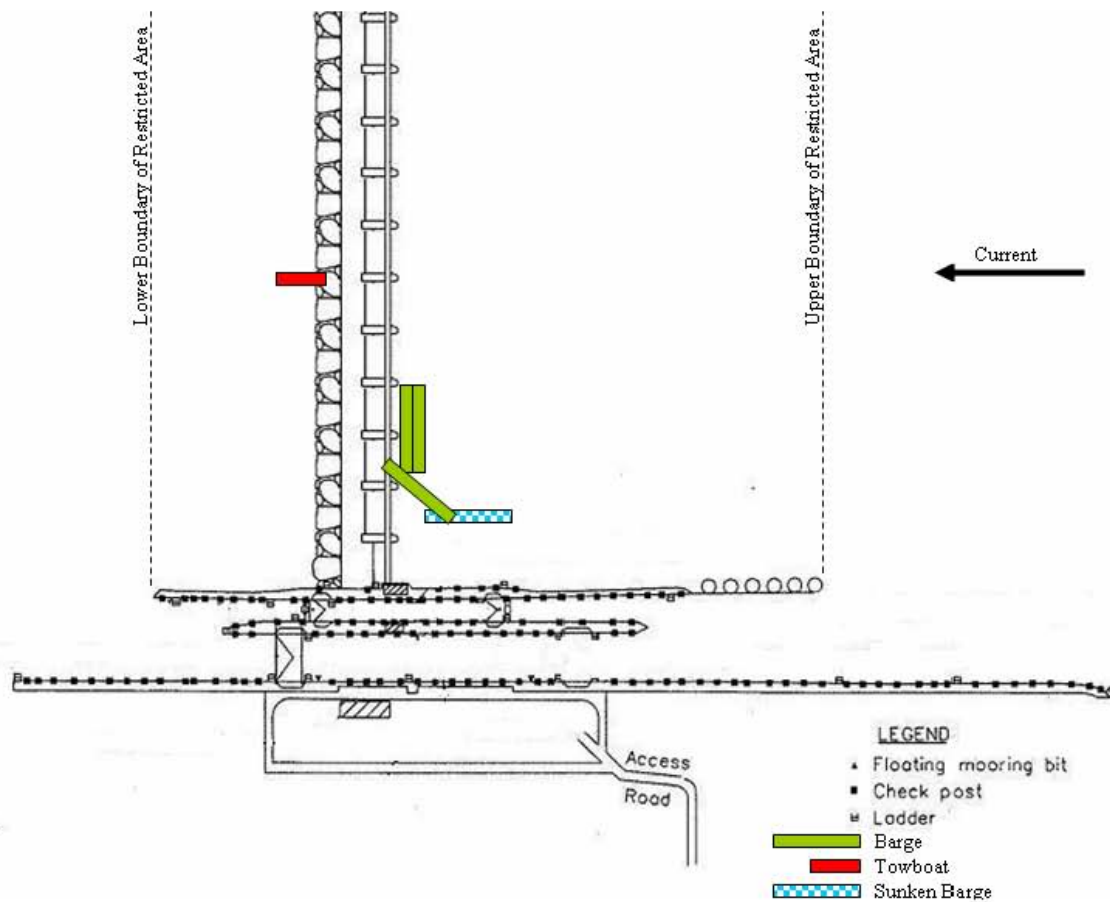
81. On 09JAN05, at approximately 0220, the ELIZABETH M went over the Montgomery Dam. Just prior to the time the ELIZABETH M went over the dam one of the Locksmen ([REDACTED]) heard two distinct and separate "thumps" that were 10 to 15 seconds apart. The other Locksman ([REDACTED]), having completed opening dam gate 9, was walking towards gate 1 when "there was a loud bang, a real big -- a crash..." which caused him to lose his balance. [REDACTED] who was standing on the dam in the vicinity of gate 6, saw two barges start to get jammed in gate 6 but they quickly dislodged and went over the dam. The ELIZABETH M went over the dam shortly after the barges. [REDACTED] testimony regarding what he witnessed as the ELIZABETH M approached, allided with and went over the dam was "...before it started going over the rollers, the whole stern was completely submerged, and the rest of the quarter deck and so forth went very fast, and the only part I could physically see was the wheelhouse..." and "...the tow knees on the bow of the towboat on both sides. I could only see maybe a foot of that." The ELIZABETH M initially struck the dam "sideways" at a 45 degree angle on the starboard side of the vessel, then spun and went over the dam stern first through the spillway at dam gate 6. After going over the dam, the stern of the vessel submerged then resurfaced and drove the bow of the vessel into the outflow coming through the spillway. The bow then resurfaced, the stern re-submerged and the ELIZABETH M sank almost immediately. The vessel came to rest between dam gates 5 and 6. The four barges (the CTC 7712, CTC 962, CTC 8205 and CTC 8412) that remained in the pool above the dam eventually sank and came to rest in the vicinity of dam gates 1, 2, 3 and 4. The CTC 7616 came to rest near the Lower Approach Cells to the Montgomery Locks. The CTC 7638 came to rest near the right descending bank near mile marker 33.5 on the Ohio River. (IO Exhibits 003, 65, 70, 72, 77, 149, Trans Vol I pg 38 ln 12, Vol II pg 54 ln 13, Vol III pg 163 ln 12, Vol IV pg 198 ln 8, Vol IV pg 211 ln 21, Vol IV pg 254 ln 3, Vol IV pg 273 ln 7, Vol V pg 17 ln 10, Vol V pg 35 ln 3, Vol V pg 137 ln 5, Vol V pg 138 ln 4, Vol V pg 138 ln 21, Vol V pg 164 ln 22, Vol V pg 207 ln 12)

Figure 18: Approximate location of the ELIZABETH M and barges after striking the dam. The two barges not shown in the illustration are the barges that went over the dam before the ELIZABETH M and sank further downstream.

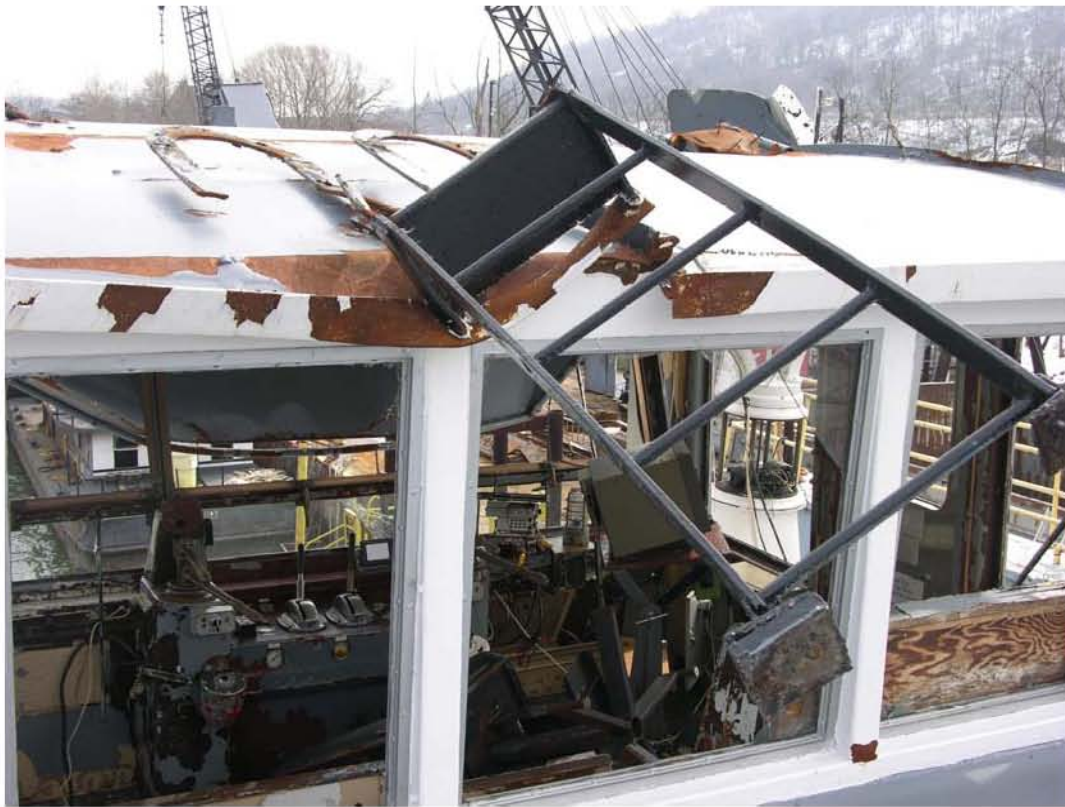
vertical position when the top of the pilothouse struck the dam gate. The ladder was still attached to the top of the pilothouse but, the damage to the ladder made it impossible for him to proceed any higher on the vessel so he held onto the ladder waiting for assistance. (IO Exhibit 123, Trans Vol III pg 280 ln 4, Vol III pg 280 ln 14, Vol III pg 281 ln 8, Vol III pg 282 ln 4, Vol III pg 282 ln 22, Vol III pg 339 ln 2)

Figure 19: Post-casualty photograph of the ladder on the ELIZABETH M leading to the top of the pilothouse used by [REDACTED] to secure himself and [REDACTED] until they were rescued.

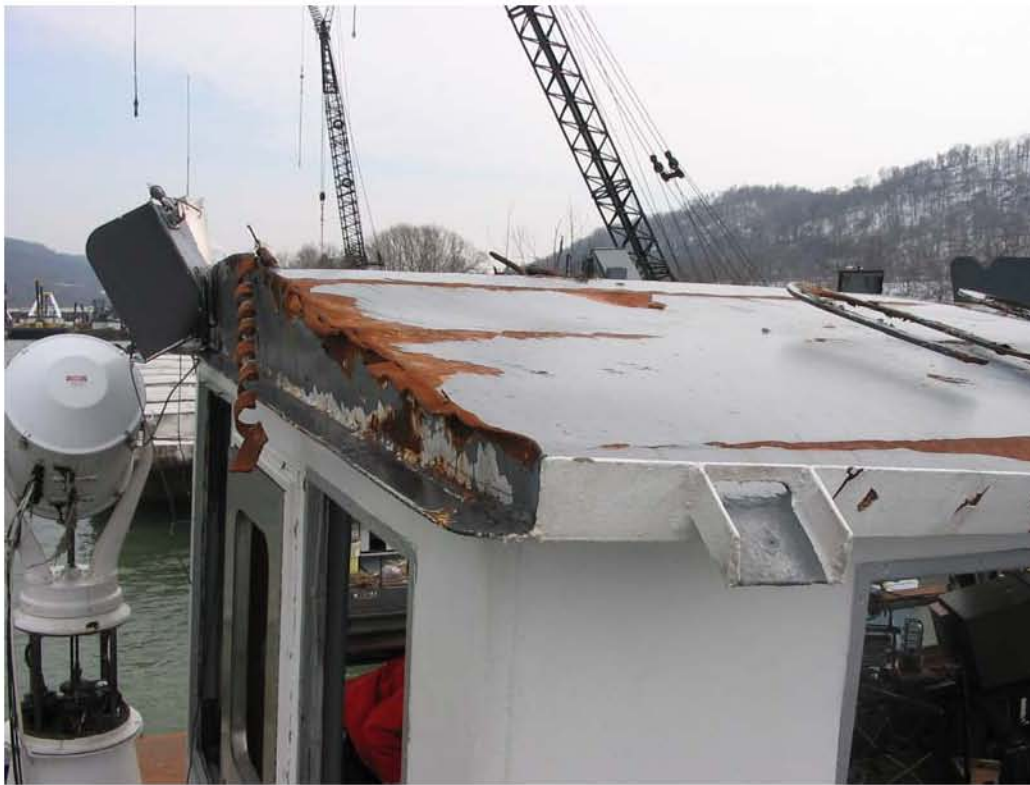
Figure 20: Post-casualty photograph of the top of the pilothouse. Also pictured is the drain [REDACTED] attempted to hold onto while waiting to be rescued.

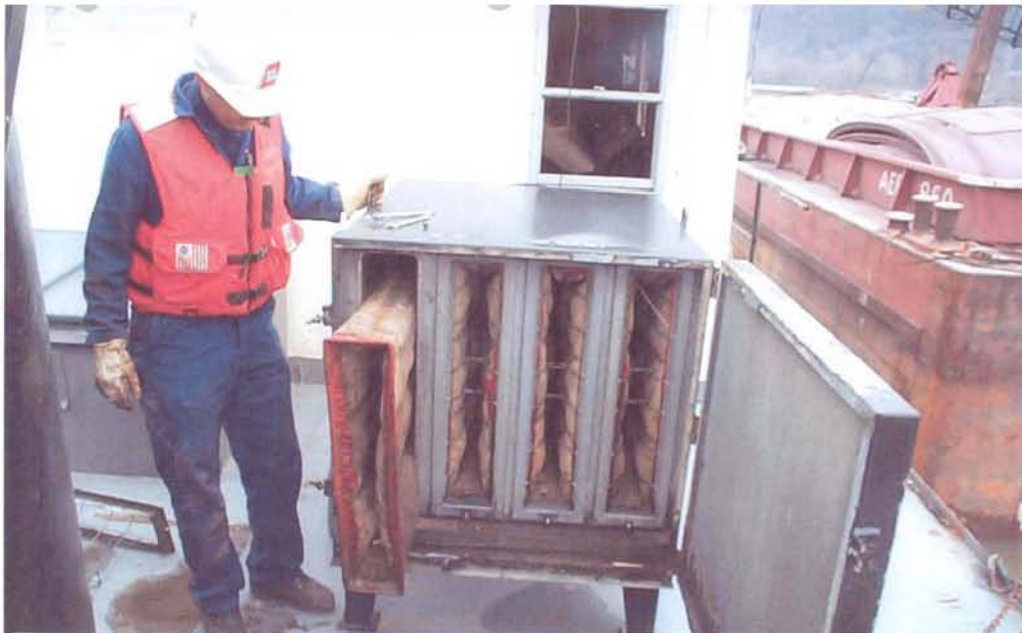
Air filter housing

Figure 22: Post-casualty photographs of air filter housing on the 01 deck and collapsed flexible PVC duct hoses in MDE air intake system.

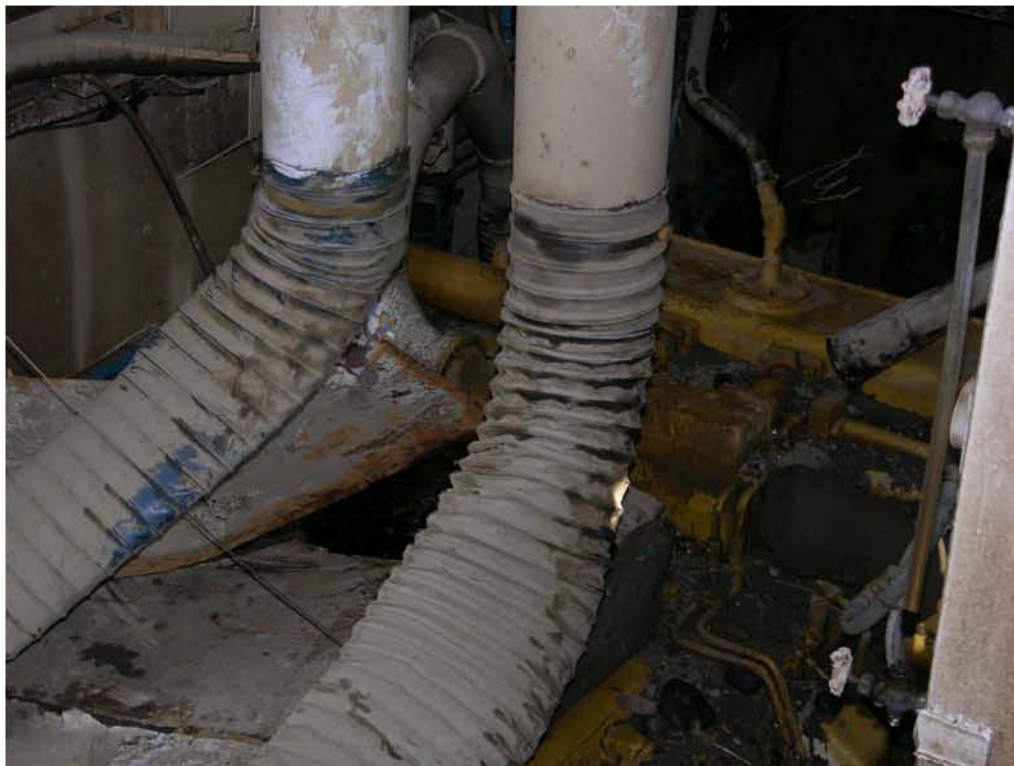
Collapsed PVC hoses at the steel piping connection from air filter housing.

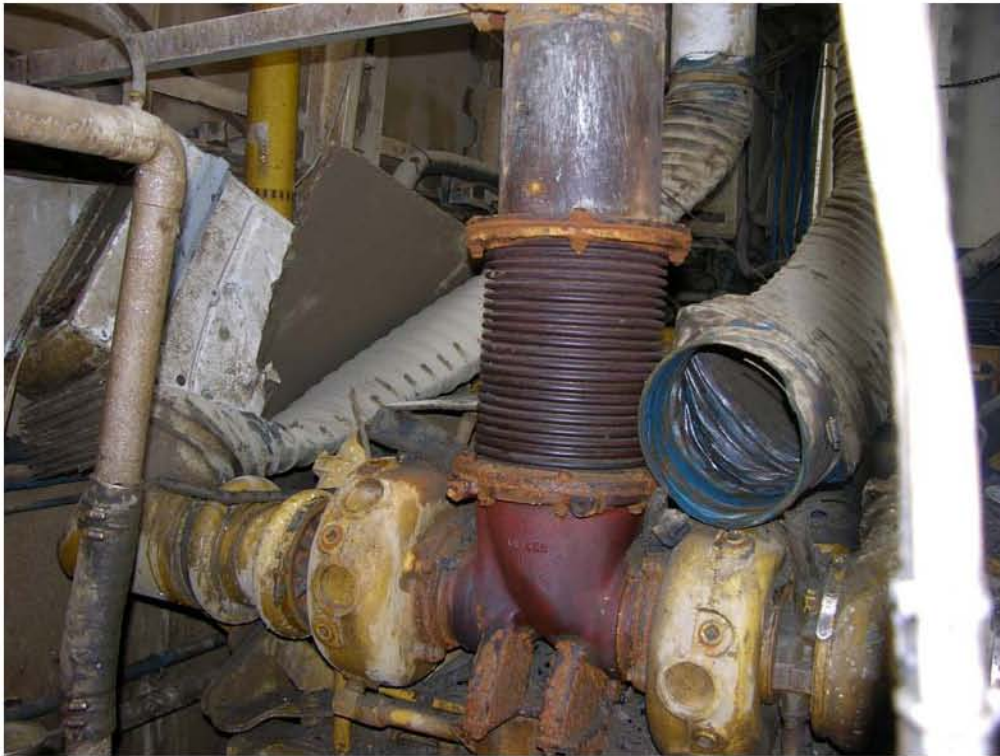
Collapsed PVC hoses at MDE turbochargers inlets.

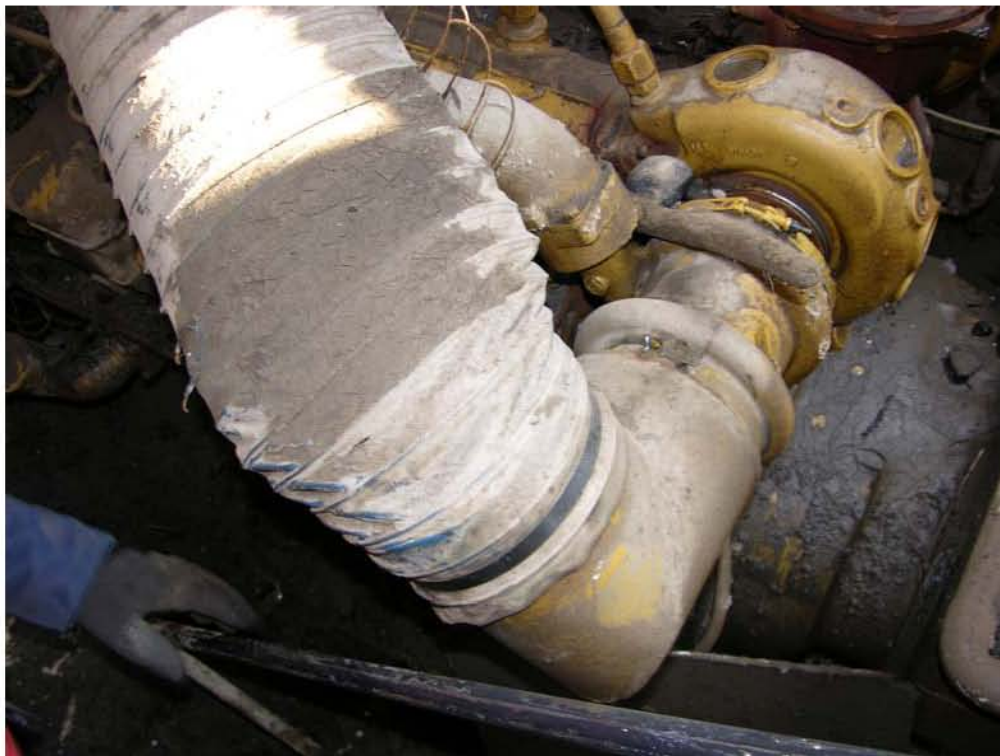
Collapsed PVC hoses at a MDE turbocharger inlet.

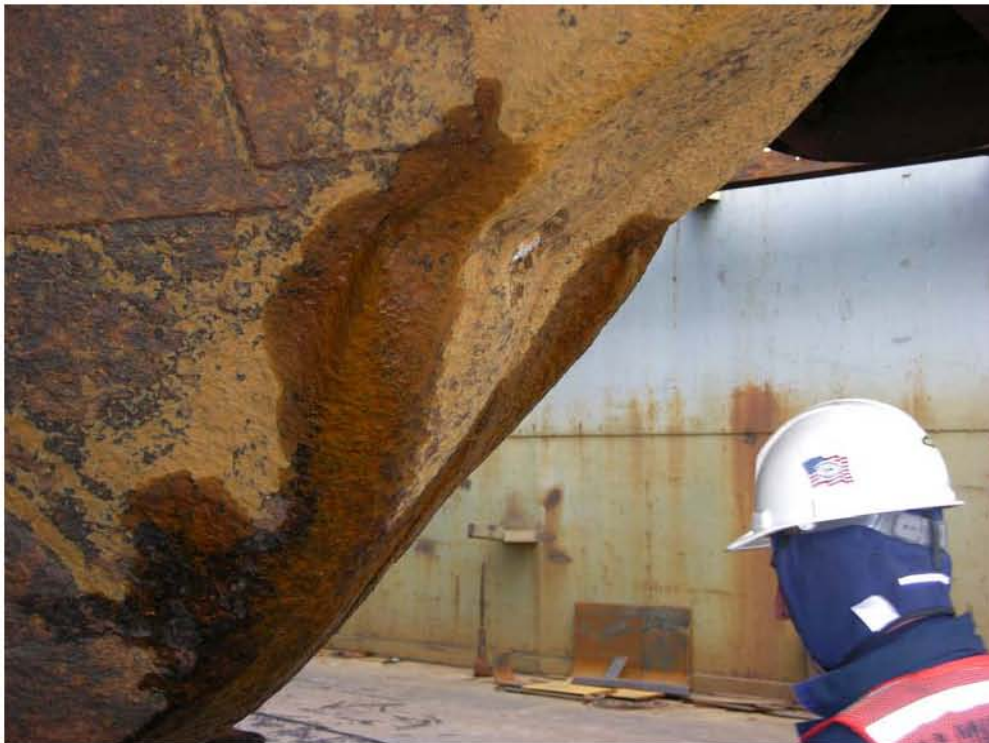
Figure 23: Post-casualty photograph of pinholes and fractures in The ELIZABETH M forepeak.

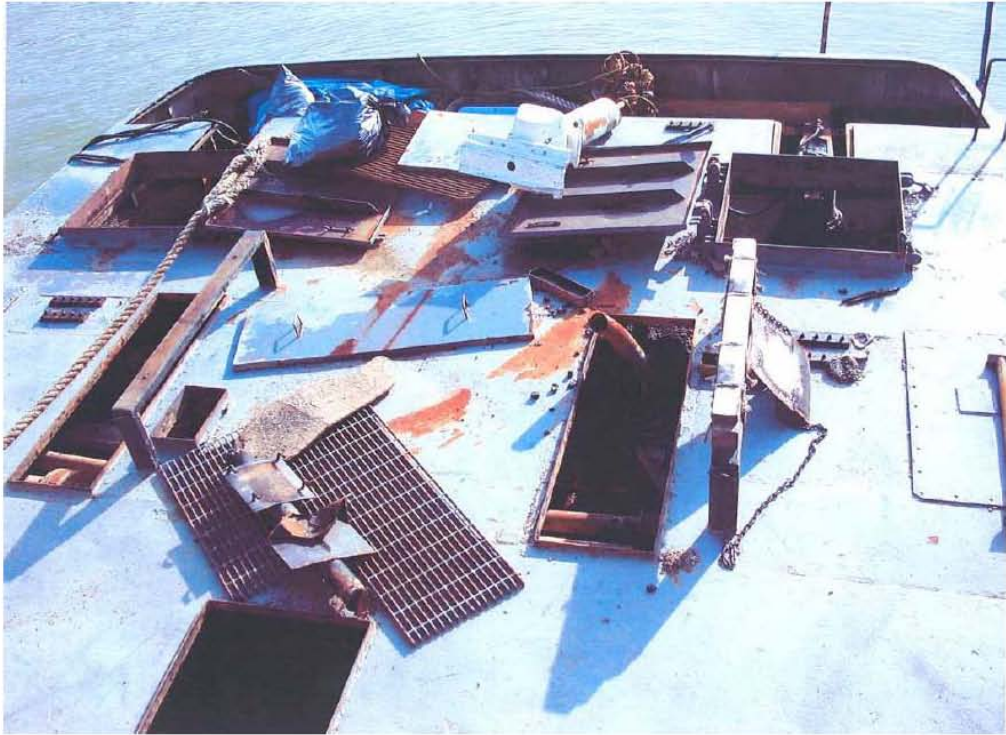
Figure 24: Post-casualty photograph of ELIZABETH M raised poop deck. Grating pictured on poop deck was used over the opening at the stern (top of photograph).

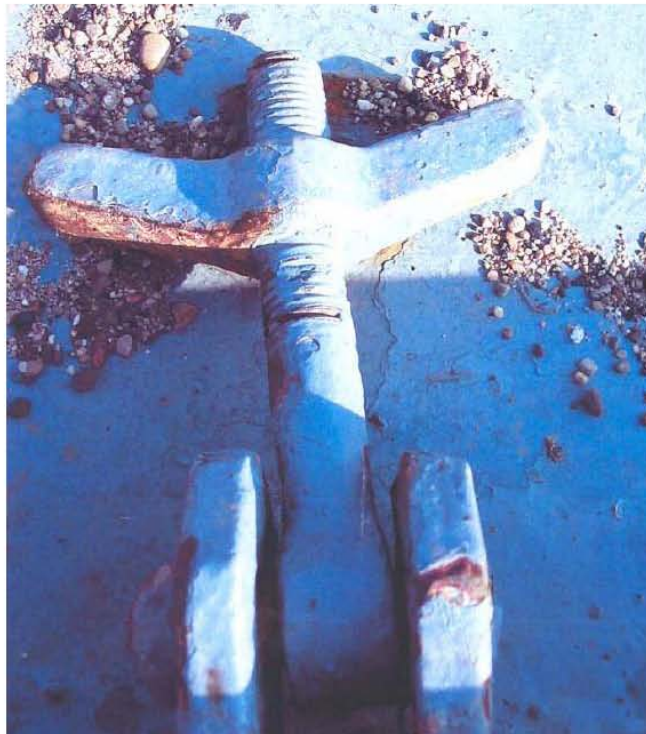
Figure 25: Example of unserviceable hatch dogs found on the ELIZABETH M. Heavy paint would make it impossible to properly secure a hatch.

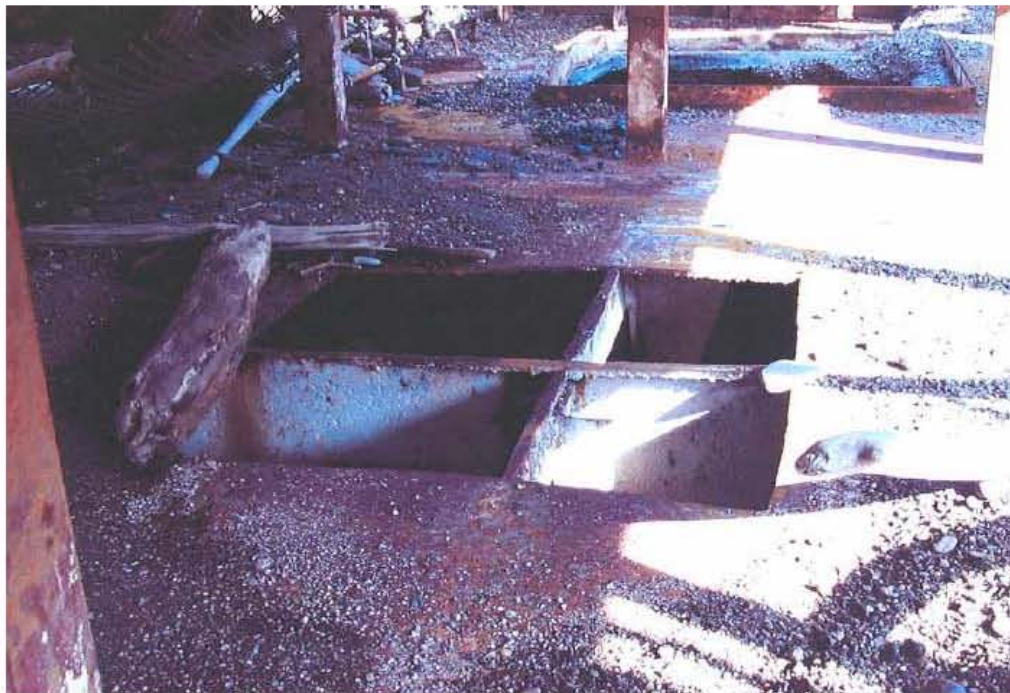
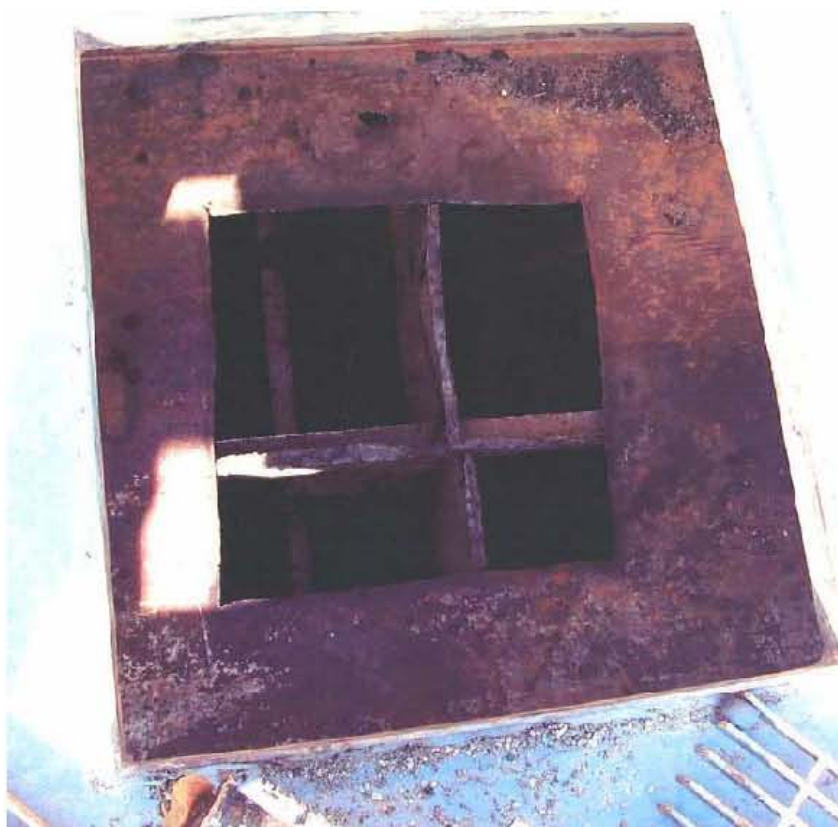
Figure 26: Post-casualty photographs of the two 25" x 25" cutouts in ELIZABETH M's main deck.

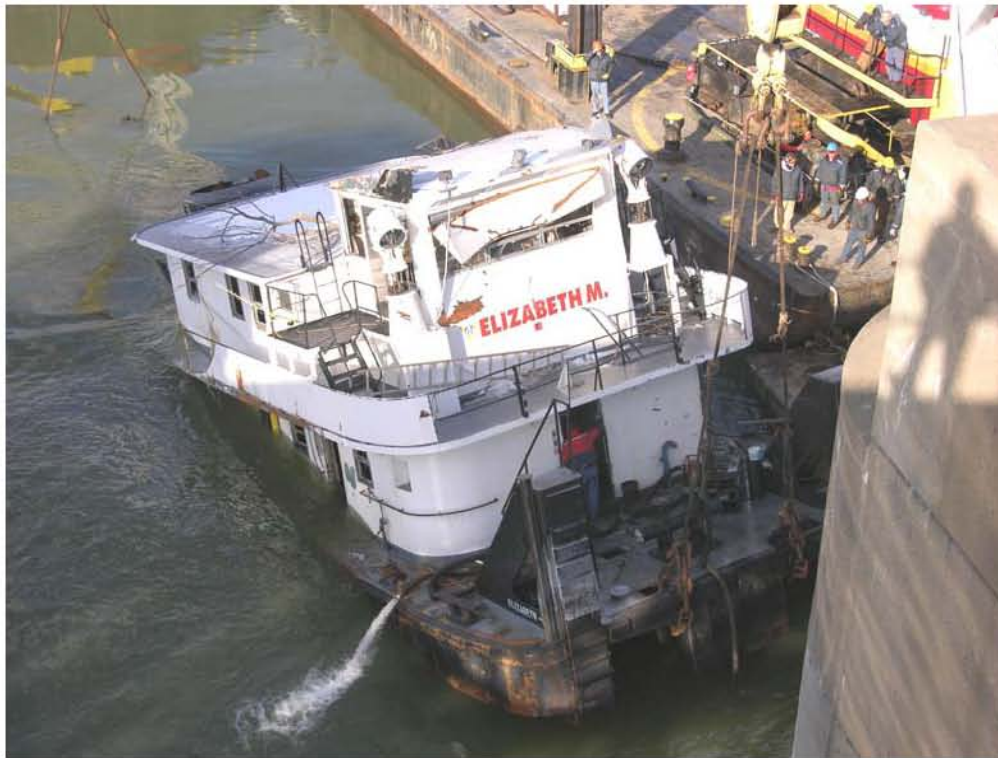
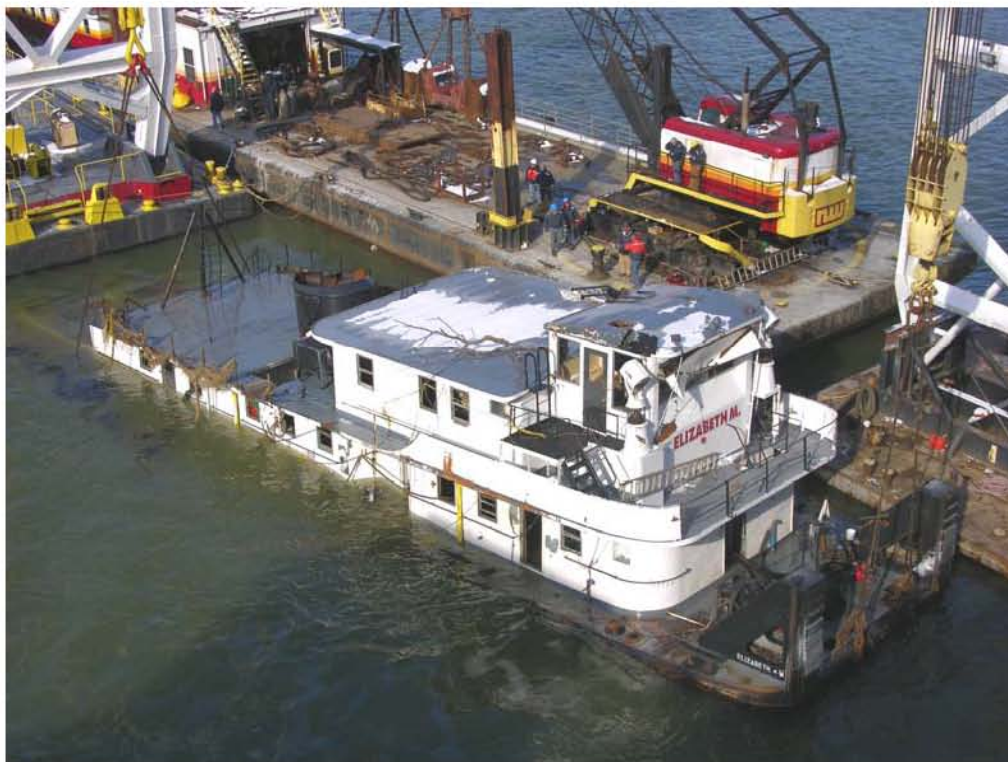
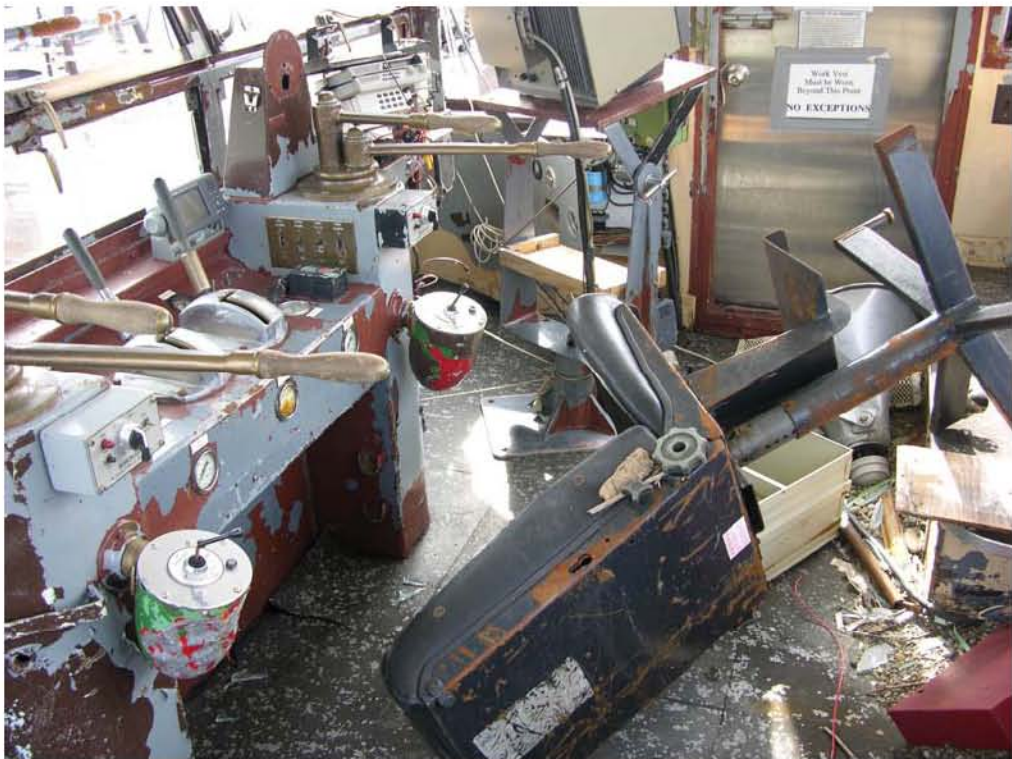
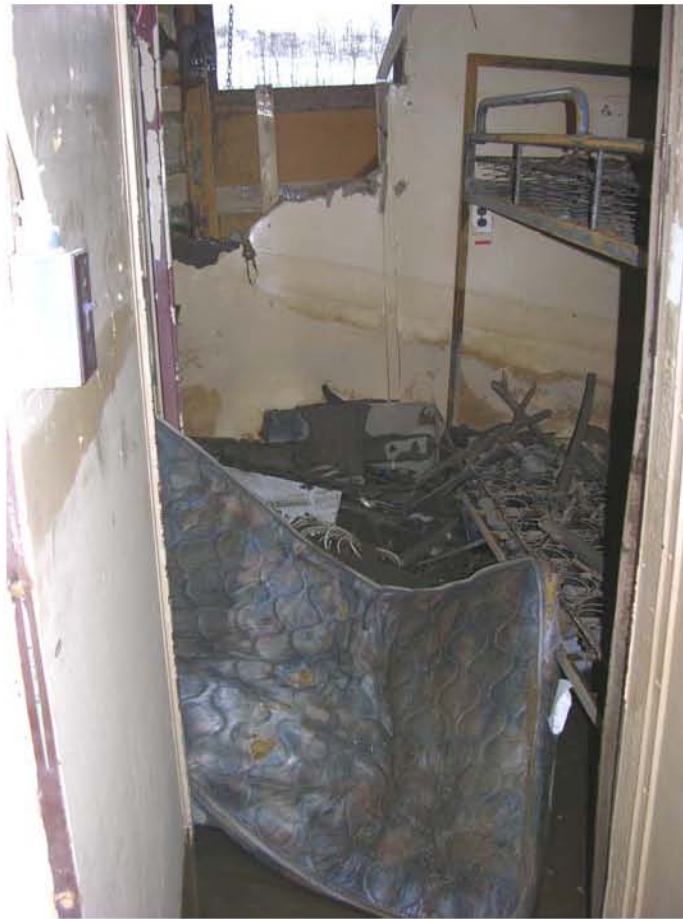
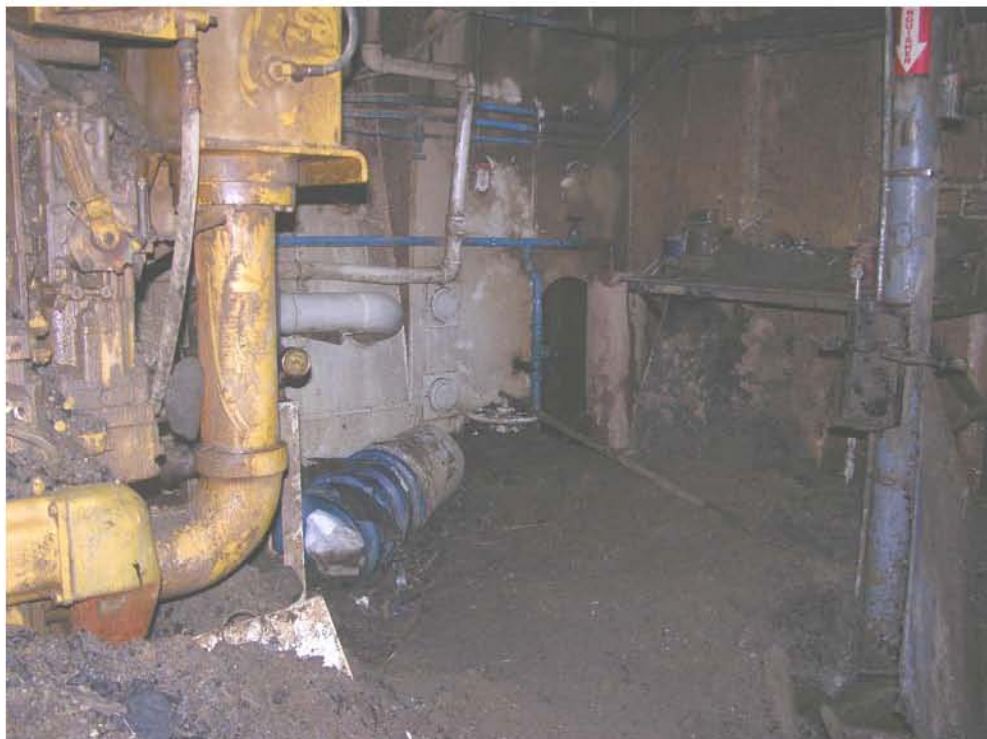
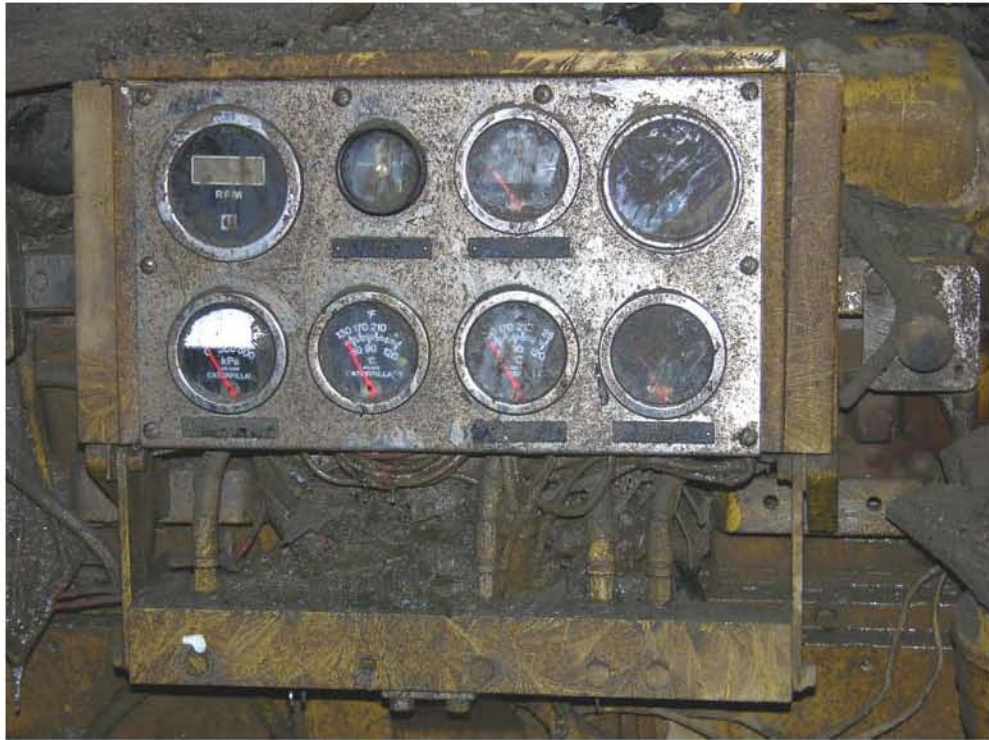
Figure 27: Post-casualty photographs of the ELIZABETH M taken during salvage operations and vessel survey.

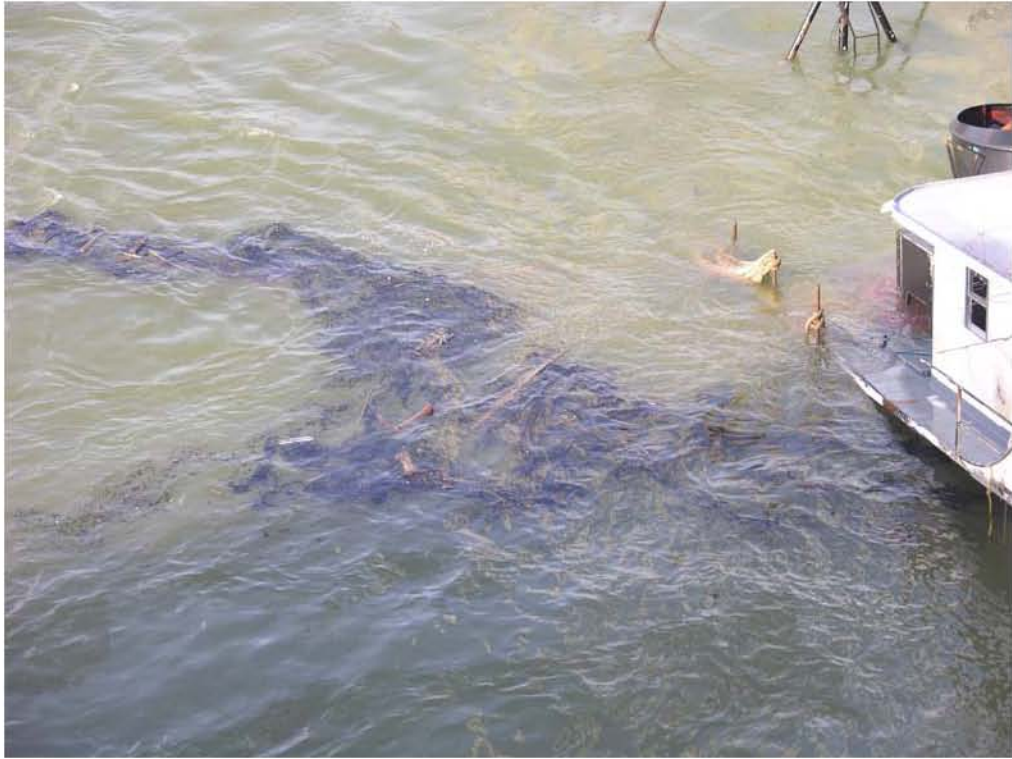
Oil emanating from the ELIZABETH M during salvage operations.
