UNITED STATES COAST GUARD

REVIEW OF MEXICO'S SECRETARY OF COMMUNICATIONS AND TRANSPORTATION INVESTIGATION OF THE CIRCUMSTANCES SURROUNDING THE SINKING OF THE PASSENGER VESSEL

ERIK

IN THE SEA OF CORTEZ ON JULY 3RD, 2011
WITH ONE DEATH AND SEVEN
PERSONS MISSING AND PRESUMED DEAD

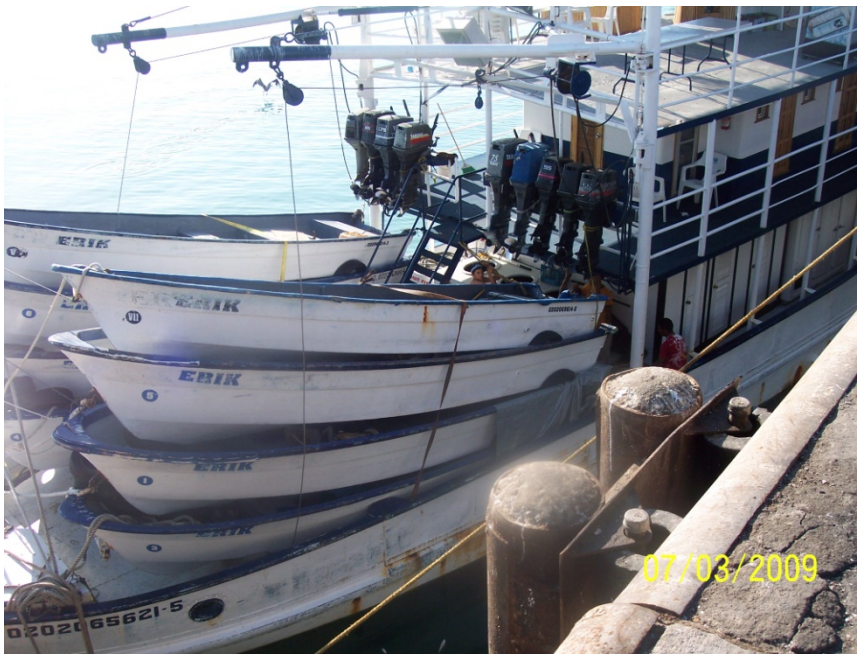
Figure 4: Picture dated 7/3/2009 showing two stacks of “pangas” on the stern of the vessel. This picture was taken before the modifications to enlarge the main deck to accommodate a higher number of “pangas”, and the placement of a fuel tank for their engines.

Passenger Statements: The "Pangas" did not have covers and water went in them freely and collected there throughout the storm.
