REPORT OF THE INVESTIGATION INTO THE

FLOATING OCS FACILITY - TENSION LEG PLATFORM

FPS AUGER

LIFEBOAT FALL WITH LOSS OF LIFE ON JUNE 30, 2019

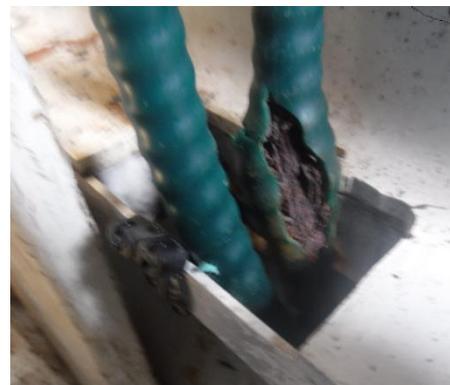
On the day of the casualty, the crew cycled the hooks (open to closed position) two times while in the water. If a cable conduit is already damaged, the act of cycling exposes the conduit layers to additional stresses, including compression and tension (stretching). It is probable⁴ that during the second cycling event, the

Image 6: Photograph of damage to Lifeboat No. 6 aft control cable dated June 6, 2019. Credit: Palfinger.

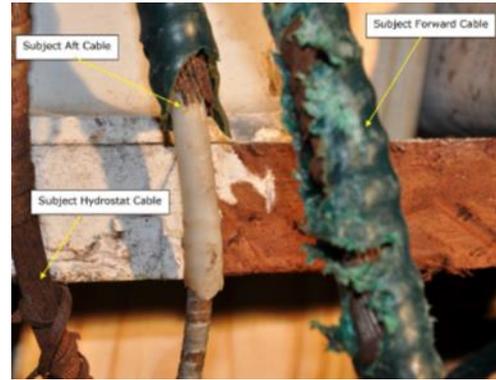
conduit, already weakened and damaged, separated during the closing action (see Image 7). As a result, when the system was reset, the locking shaft on the aft hook did not return to the fully closed position, but rather, came to rest at an “almost open” position. In this position, the hook could support the weight of the lifeboat and its occupants as the lifeboat was hoisted from the water to the davit. However, at the davit, additional forces applied to the hook and the lifeboat, as a result of the winch pulling the boat against the bumpers, caused the locking shaft to rotate from the “almost open” to the open position. Under load, the aft hook was free to open and release from the lift ring (a ring attached to the end of the fall cable (wire rope); often called the “D” ring). The forward hook, not designed to bear the entire load of the lifeboat or operate outside of specified angles, was unable to sustain the weight of the lifeboat, separated from the hull and eventually opened.

Image 7: Photograph of aft control cable after casualty. Photograph documents separation of three layers of the conduit: the green plastic cover; a steel wire; and a white polyethylene liner. Credit: DNV-GL.

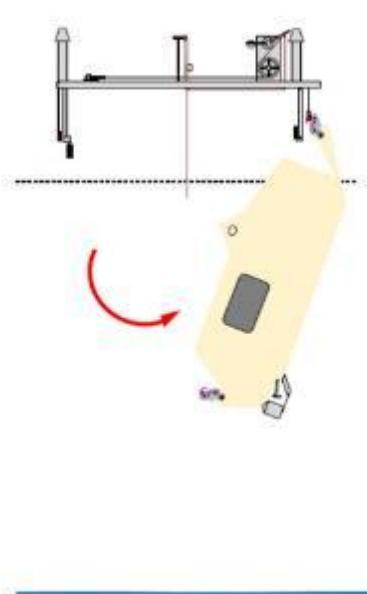
Figure 11: The aft hook releases and the lifeboat swings placing all the weight onto the forward hook.

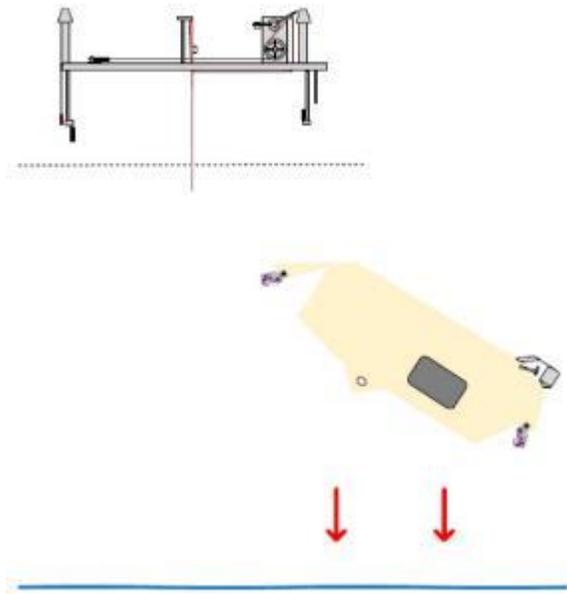
Figure 12: The forward hook, not designed to bear the entire load of the lifeboat or operate outside of specified angles, was unable to sustain the weight of the lifeboat, separated from the hull and eventually opened. The lifeboat fell and landed inverted in the water.

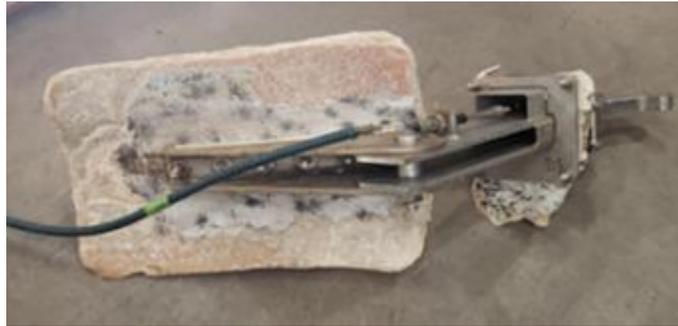
4.2.4.2.1. The bow end of the hull split, and the bow hook was torn free of the hull (see Figures 21). The bow split arrested approximately halfway along the length of the boat.¹⁵ The patch that pulled out is consistent in shape with a previous repair made to the FRP around the bow hook (see Figure 21).

Figure 21: Bow hook and surrounding FRP post-casualty. Credit: CG.

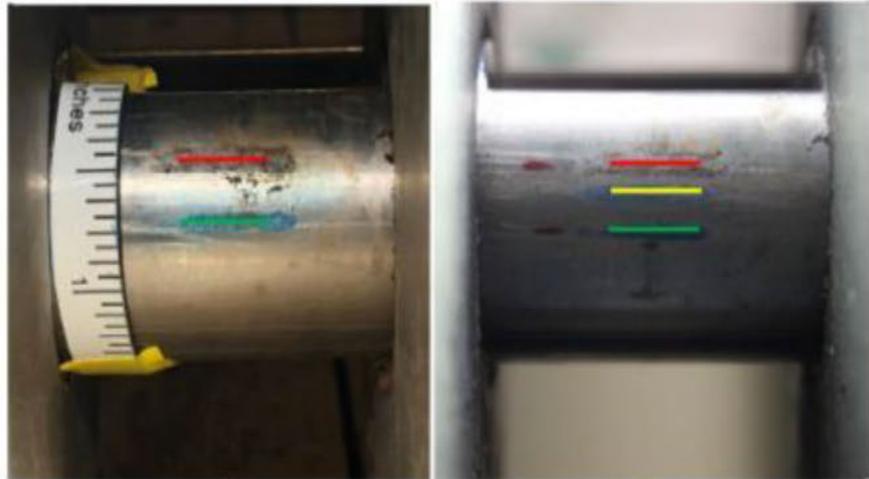
“The position of the red line relative to the green and yellow line may have been created in two possible ways: (1) under load, the location of contact between the hook roller and the locking shaft rotates to a more open position or (2) the failure in the Subject Aft Cable.”¹⁸

Figure 25a (left) and 25b (right): Lifeboat No. 6 locking shaft. Credit: DNV-GL.

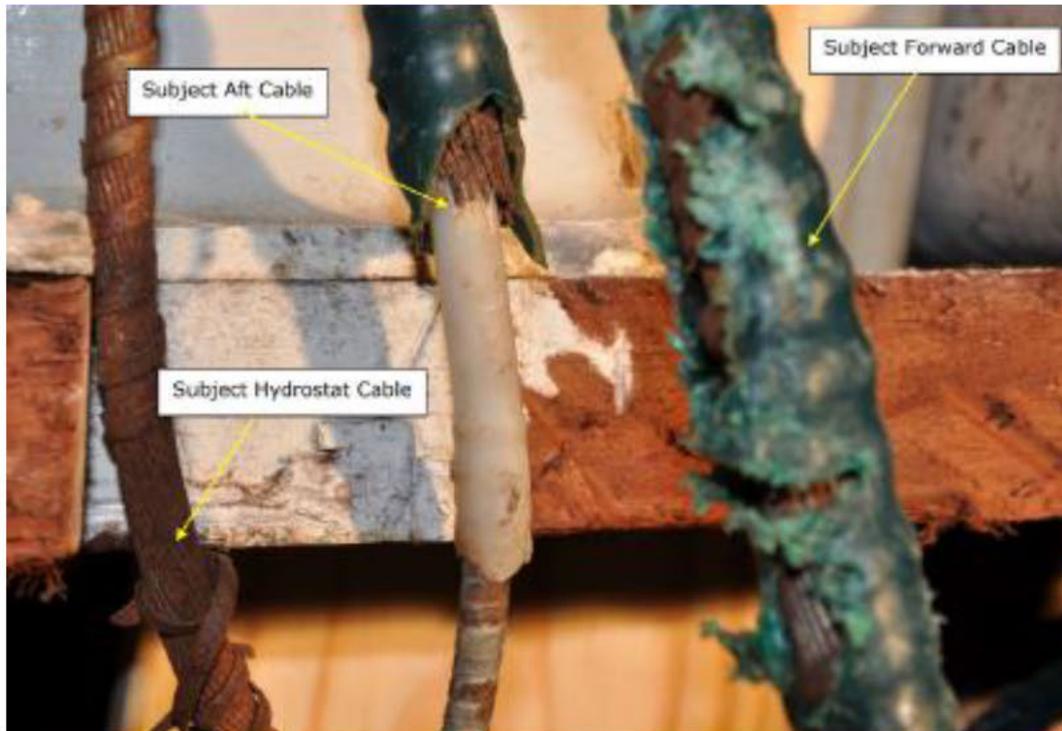
4.2.4.4.2. Significant damage to the aft control cable was found approximately .72 to 1.34 feet from the hook release station conduit cap. The outer green conduit cover, steel strands and polyethylene liner were totally separated. Only the inner member remained intact (see Figure 27).

Figure 27: As-found condition of Lifeboat No. 6 control cables after reassembly at DNV-GL facility. Credit: DNV-GL.

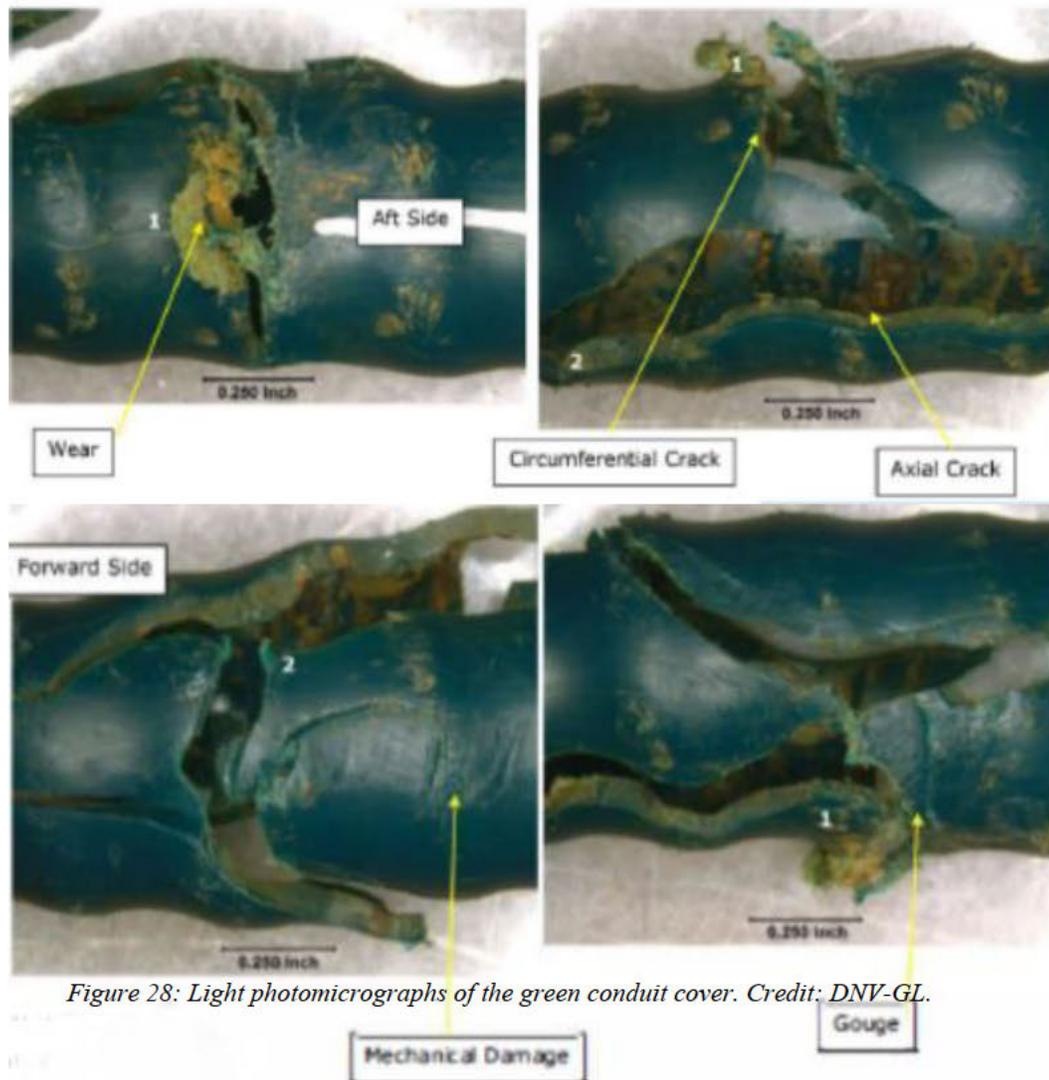
Figure 28: Light photomicrographs of the green conduit cover. Credit: DNV-GL.

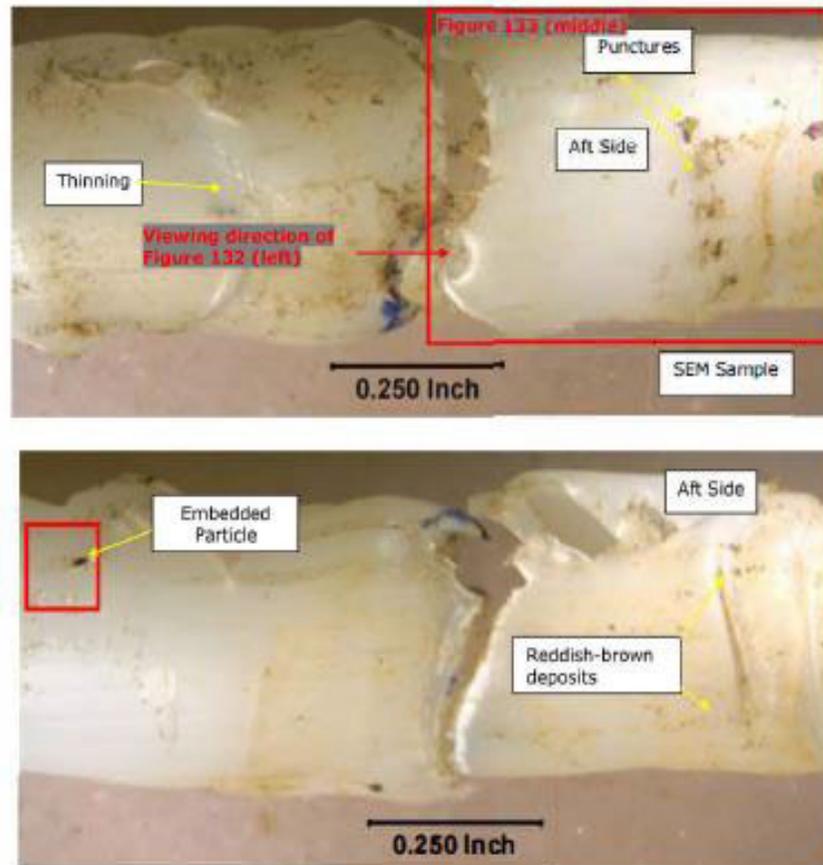
“Fracture paths are primarily circumferential in nature. The previously noted tearing and buckling are visible in the micrographs. The buckling suggests that the liner layer had been compressed; however, the morphology of the fracture surfaces indicate that the tube failed in tension. Additionally, a thinned area on the aft side of the Subject Hook Release side of the failure is visible. A reddish-brown, embedded particle, as well as reddish brown deposits, are visible near the failure on the external surface of the liner. Punctures are visible on the aft side of the Subject Aft Hook side of the failure, and correlate with the size and spacing of the individual wires that make up the conduit.”²³

Figure 29: Light photomicrographs of the white polyethylene liner. Credit: DNV-GL.

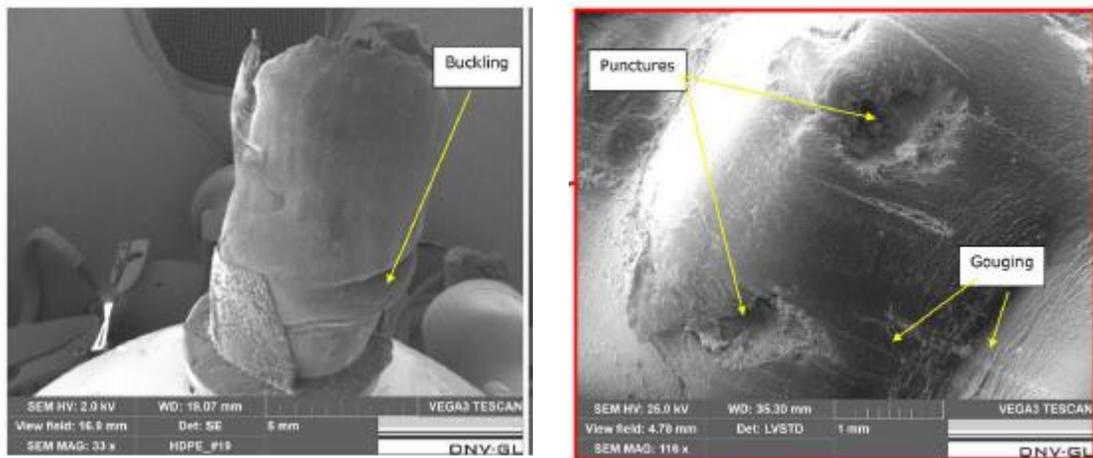
found the punctures spaced 35 to 45 mils from one another, which is similar to the spacing identified between the tips of the corroded conduit wires.²⁴

Figure 30: SEM images of white polyethylene liner. Credit: DNV-GL.

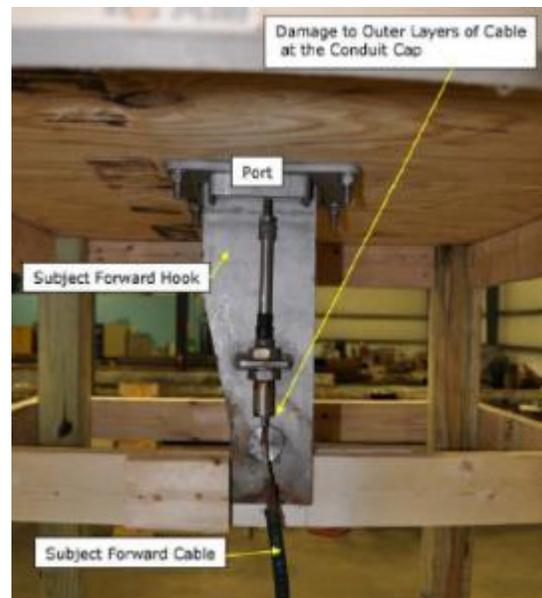
4.2.4.6.1. The forward hook was found in the open position²⁵, dangling from the lifeboat, attached to the boat by the control cable. The forward hook control cable showed damage at the conduit cap, exposing the inner member (see Figure 31). The outer green cover, wire, and white polyethylene liner did not show significant mechanical damage.

Figure 31: Forward control cable at hook conduit cap. Credit: DNV-GL.

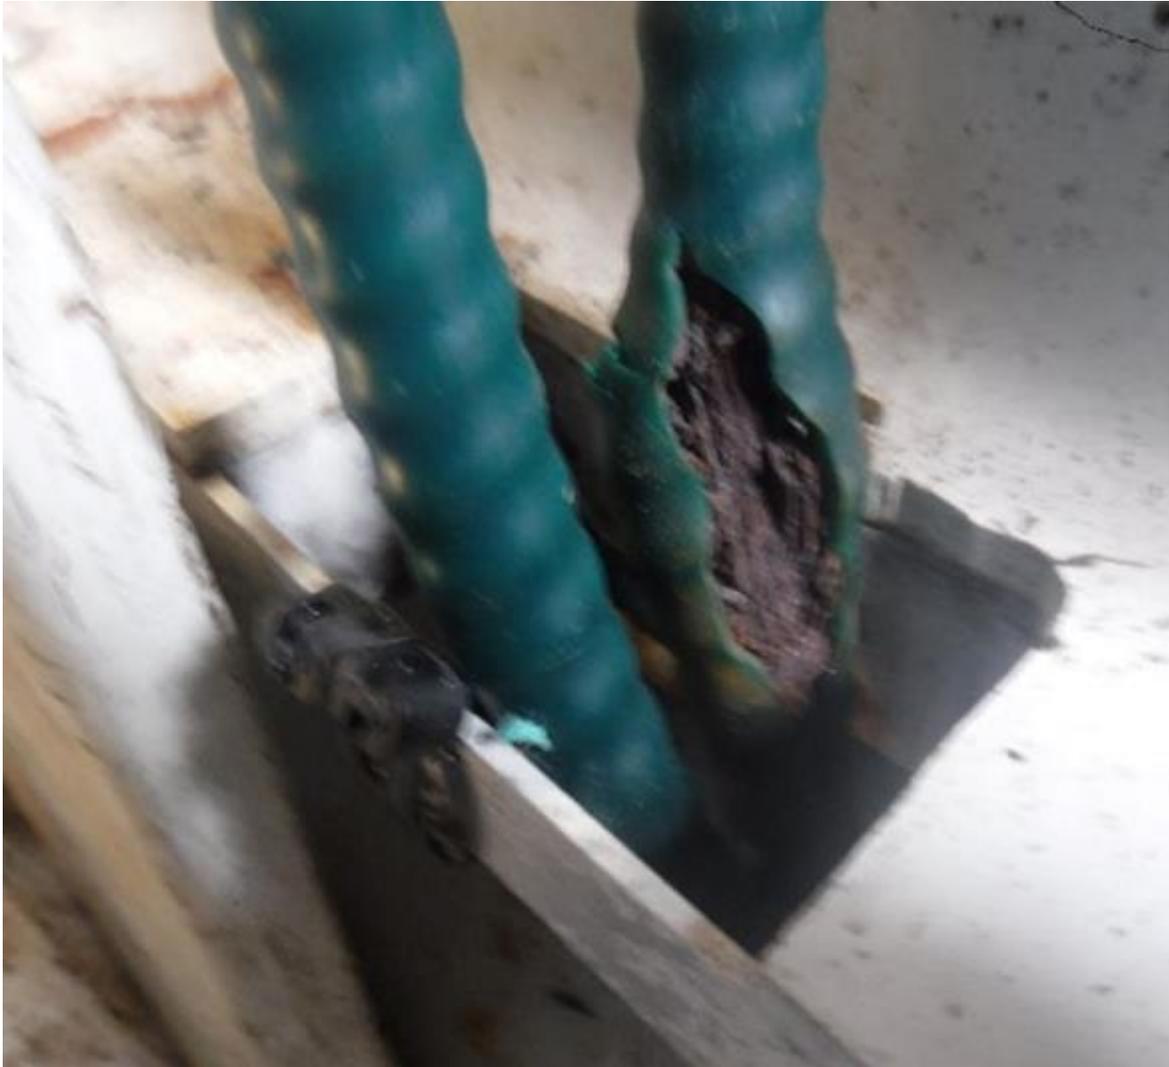
Figure 35: Photo of Lifeboat No. 6 aft control cable. Taken on June 6, 2019. Credit: Palfinger.

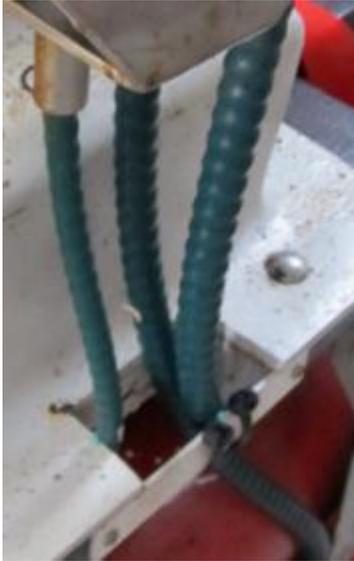
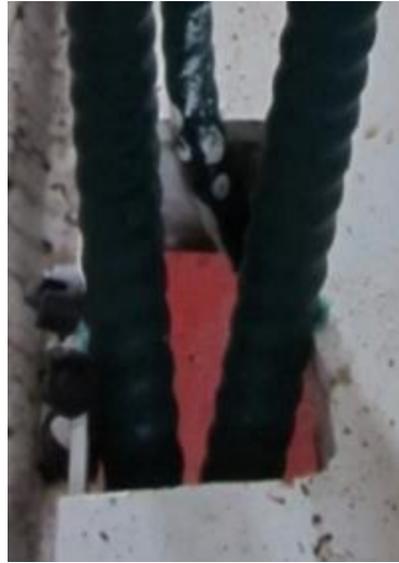
Figures 38 (left) and 39 (right): Photos of aft control cables in or around 2014. Credit: Shell.

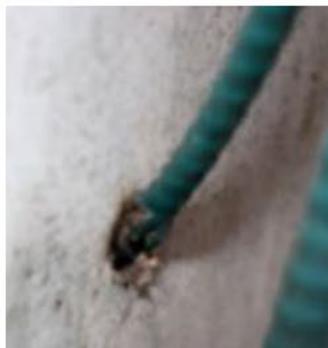
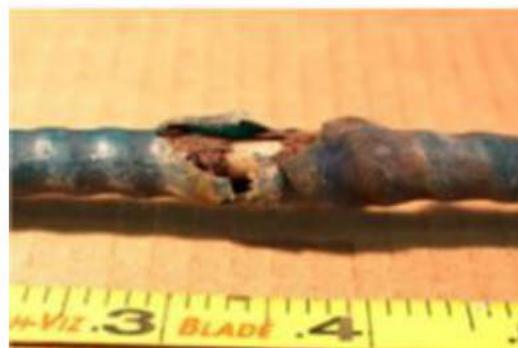
Figures 40 (left) and 41 (right): Photos of Lifeboat No. 7 hydrostat control cable. Credit: CG and DNV-GL.

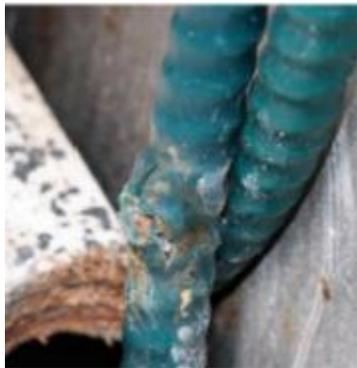
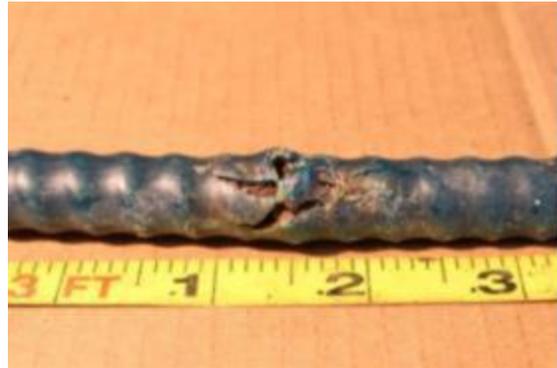
Figures 42 (left) and 43 (right): Photos of Lifeboat No. 8 forward control cable. Credit: CG and DNV-GL.

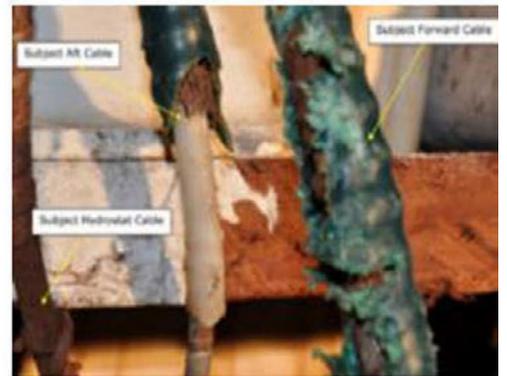
Figure 49: Lifeboat No. 6's aft hook control cable after the casualty. The aft cable is in the center of the picture. Credit: CG.

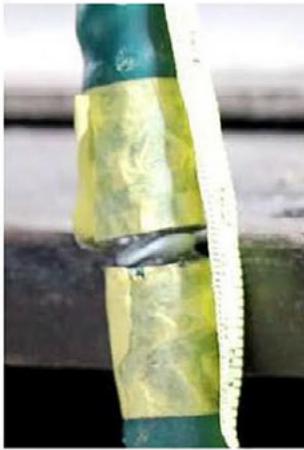
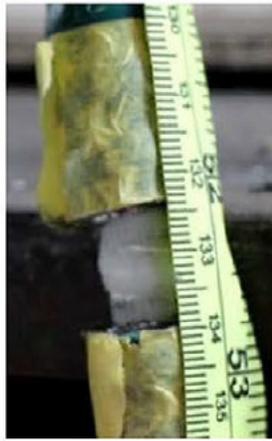
Figure 60 (far left) and 61 (right): The white polyethylene liner evidencing forces of compression and stretching after the wire layer is fully compromised. These photos were taken during the Coast Guard's experiment at MSTC. Credit: CG.

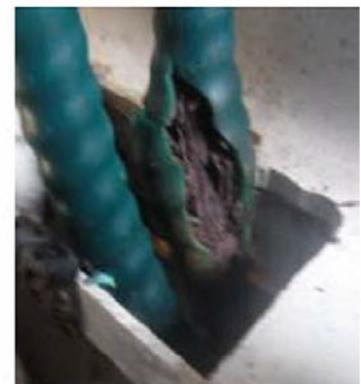
Figure 63: Lifeboat No. 6's aft control cable on June 6, 2019. Credit: Palfinger.
