UNITED STATES COAST GUARD

**MARINE BOARD OF INVESTIGATION INTO THE
CIRCUMSTANCES SURROUNDING THE SINKING OF THE**

F/V KATMAI

**IN THE AMCHITKA PASS, NORTH PACIFIC OCEAN
ON OCTOBER 22, 2008, WITH MULTIPLE LOSS OF LIFE**

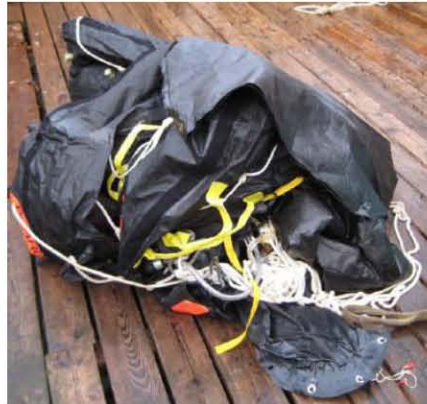
chambers and the canopy was missing. The servicing manual for the 10 person Crewsaver liferaft required that the valve assembly on the compressed gas cylinder be attached to the 90 degree elbow on the inflation hose with 30 ft-lbs of torque. The checklist used by the liferaft servicing facility to service this liferaft did not indicate that the ballast bags were inspected or that the compressed gas cylinder was verified to be attached in accordance with manufacturer's specifications. See Analysis section for more information regarding the F/V KATMAI liferafts.

Recovered F/V KATMAI Liferaft

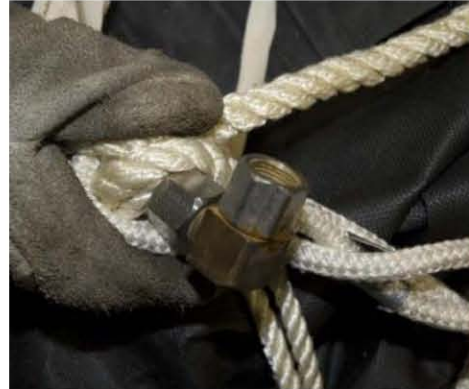
Inflation Hose Bottle Connection

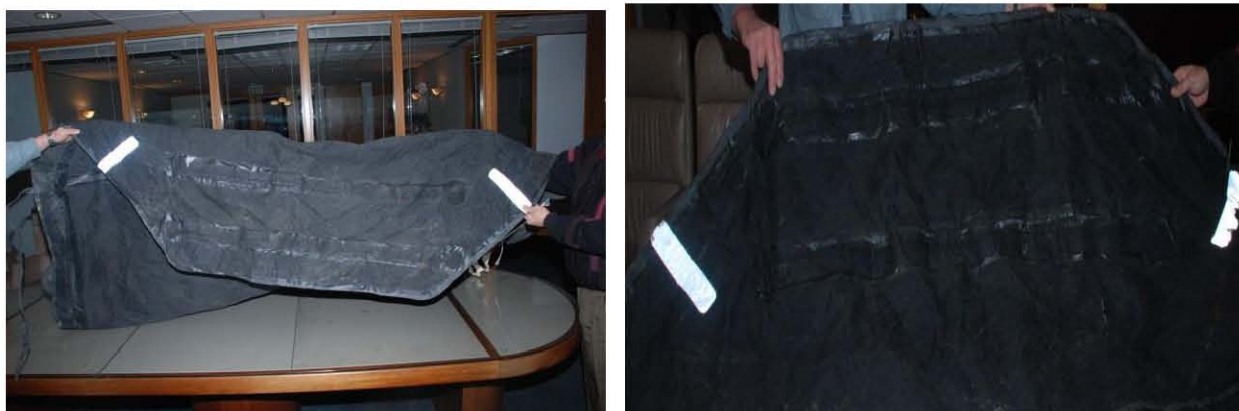
Ballast bags should have been attached to the floor of this liferaft. 46 CFR 160.051-4 (1994 Edition) required that "water pockets to improve stability and reduce drifting" be fitted on the underside of the liferaft floor. This liferaft was manufactured in 1994 and would have been required to comply with this regulation. An examination of the underside of the liferaft floor indicated that the ballast bags were missing from the liferaft floor. The two pictures below show where the two ballast bags should have been attached to the liferaft floor. Based on an analysis of the pictures below, the liferaft manufacturer stated the ballast bag on each side would have been approximately 48" long with each holding approximately 3.5 cubic meters of water.

Missing Ballast Bags on Bottom of Liferaft Floor

The high seas experienced on October 22, 2008 may have pulled the ballast bags off of the floor of the liferaft but there are minimal indications of tearing. The following picture shows the stitching that connects the ballast bag to the liferaft floor. The stitching was intact but an examination of the remaining ballast bag material was inconclusive as to whether the ballast bags were torn off of the liferaft from exposure to the high seas or if they were manually cut/ripped off from the liferaft. Both ballast bags were completely removed from the liferaft making it difficult to determine if the ballast bags were properly attached prior to the casualty. Based on a review of the checklist used to service this liferaft in 2007, there is no indication that the servicing technician inspected or verified the proper installation of ballast bags on this liferaft.

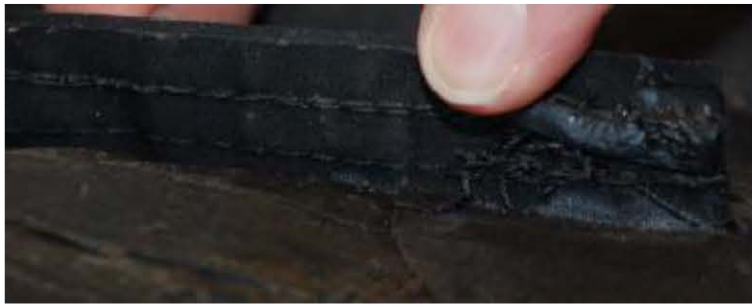
Ballast Bag Connection to Lifteraft Floor

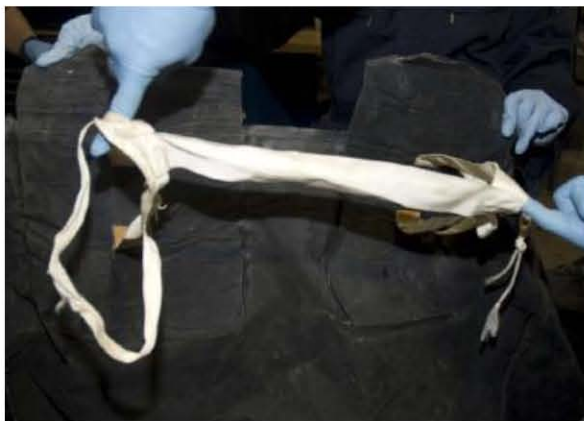
The compressed gas cylinder should have been attached to the liferaft in the cylinder harness. The compressed gas cylinder was missing when the liferaft was recovered by the crew of the FPV COURAGEOUS on October 22, 2008. The following pictures show the cylinder harness on the recovered liferaft and also a picture of a similar harness with a compressed cylinder inserted into the harness.

Recovered Lifteraft Gas Cylinder Harness

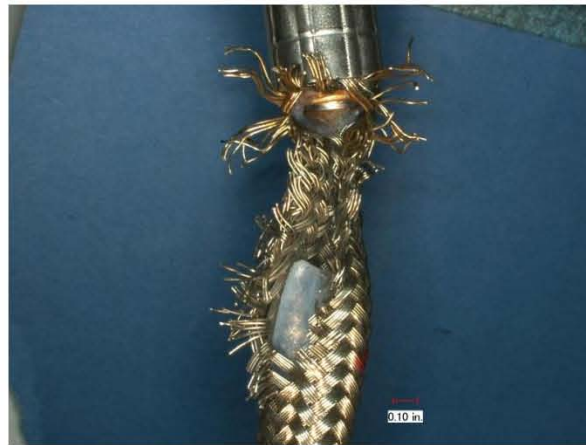
damage and elongation discovered on the inflation hose. The following picture shows that the elongation of the inflation hose caused the Teflon liner to rip at the end that was crushed causing a hole in the hose.

Torn Teflon Liner of Inflation Hose

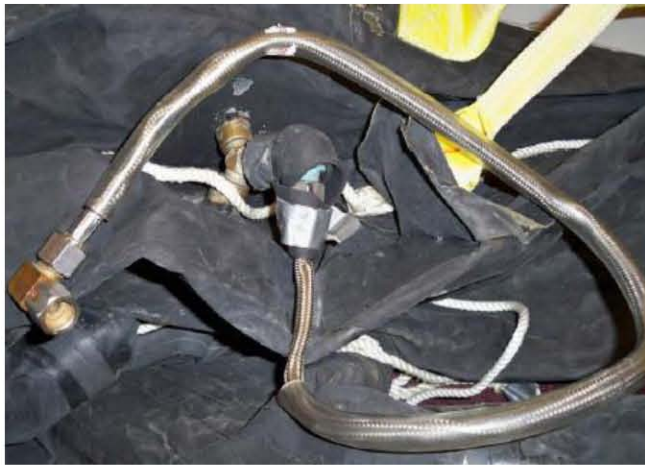
The presence of these particles does not indicate whether or not the 90 degree swivel elbow was properly attached to the inflation valve assembly on the compressed gas cylinder following the servicing of the liferaft in December 2007. The 90 degree swivel elbow should have been attached to the inflation valve assembly with 30 foot-pounds of torque. This fitting was either not installed properly by the servicing facility or it was forcibly removed following the deployment of the liferaft either by hand or by the force of the seas. There is no evidence or testimony from the crew or vessel owner to indicate that either Crewsaver liferaft had been tampered with by the vessel owner or crew of the F/V KATMAI prior to being deployed on October 22, 2008.

Liferaft Inflation Hose

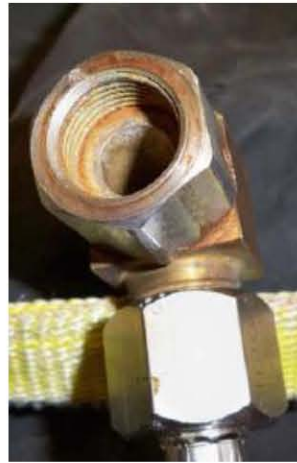
90 Degree Swivel Elbow

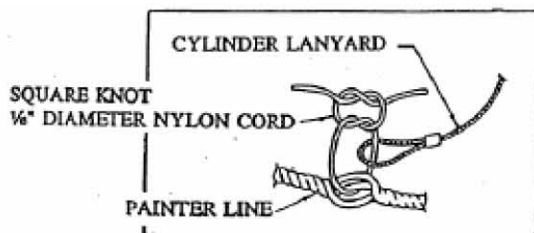
The painter of the liferaft was examined and the nylon cord that would have attached to the cylinder lanyard as shown in Figure 16 was missing.

Figure 16: Cylinder Lanyard Attachment

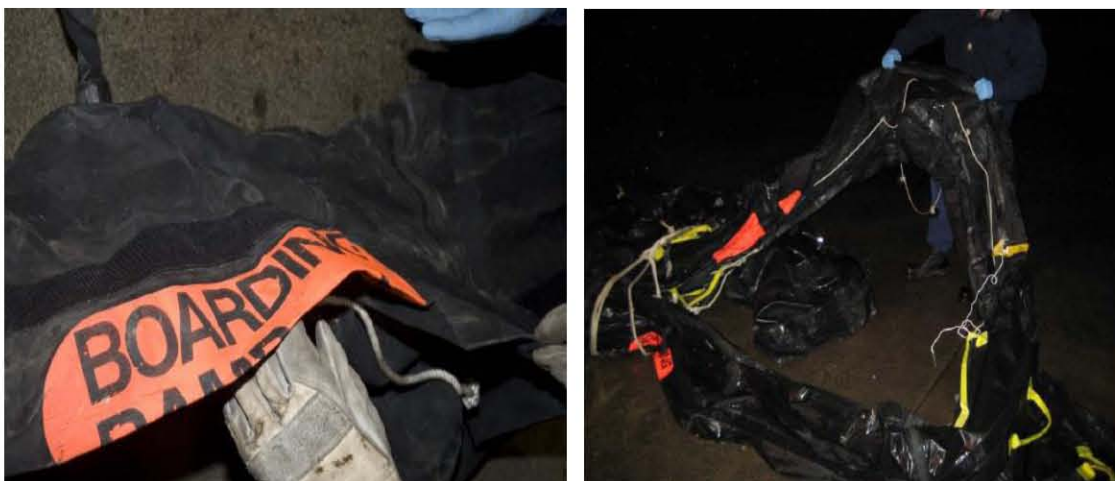
The liferaft hull was examined and did not appear initially to have inflated when it was deployed from the F/V KATMAI. The picture below shows the hull of the recovered liferaft in which the hull appears to be vacuumed similar to a liferaft stored in its container. However, a review of video footage from a Coast Guard search and rescue helicopter showed that both hull chambers of the liferaft had at least partially inflated when it was deployed from the F/V KATMAI. The condition of the liferaft hull when it was recovered was most likely a result from being tossed around in the rough seas.

Recovered Crewsaver Liferaft Hull

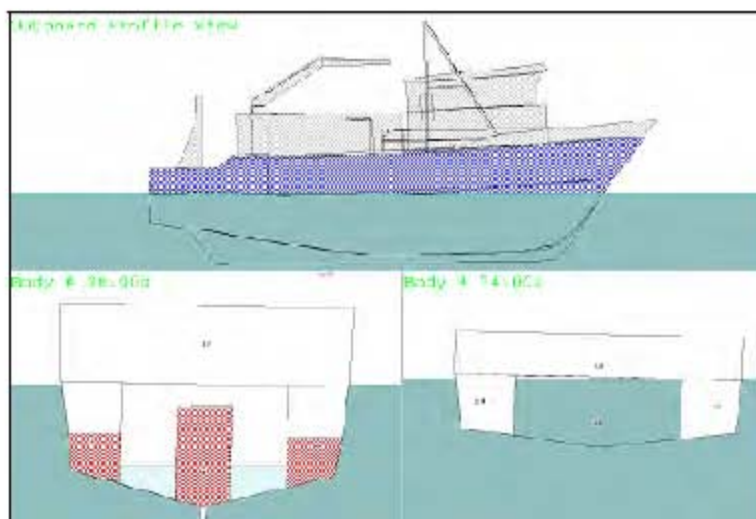
Figure (10). Step C in 1st flooding scenario

Step C is graphically shown in Figure (10). The model remained afloat with flooding of the lazarette space and water 2 feet above the deck plates in the engine room

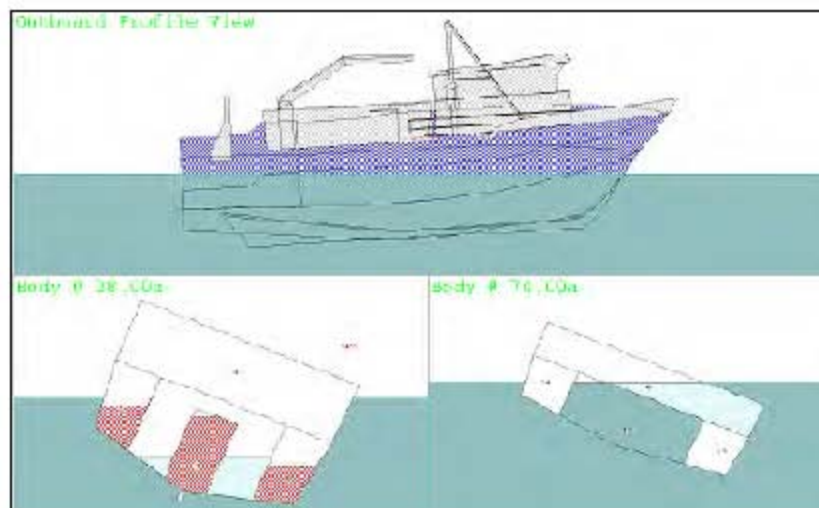
Figure (11). Step E in 1st Flooding Scenario

enough to enter these spaces through the downflooding locations. Figure (11) shows the model in this condition, which corresponds to Step E in Table (4).

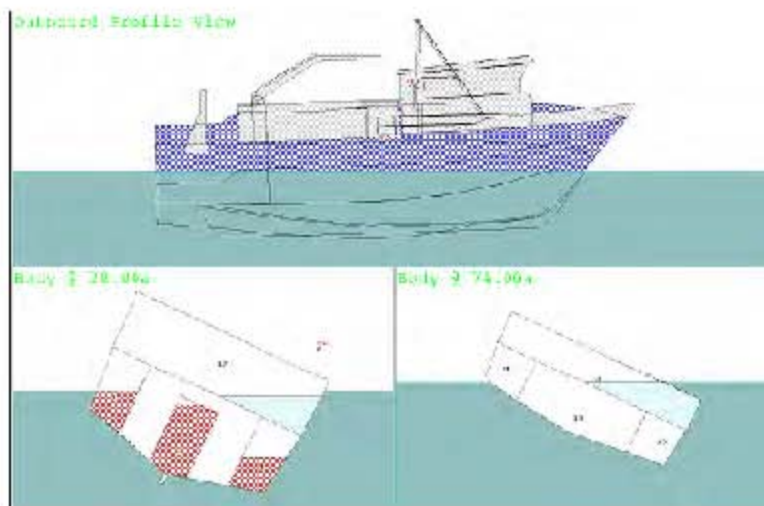
Figure (12). Step D in 2nd Flooding Scenario

Reference (a) indicated that the Chief Engineer reported that the flooding in the lazarette space and engine room was under control and going down. The flooding scenario in Table (5) examines the situation where the lazarette space and engine room have been pumped dry, but water was unable to drain from the aft bulwarks and water was starting to enter into the processing space through the reportedly open aft door into the space. As can be seen, even if the engine room and lazarette space were pumped dry and their buoyant volume restored, uncontrolled water entering the processing space led to the sinking of the model. Figure (12) shows Step D in the second flooding scenario with 6 inches of water in the processing space.

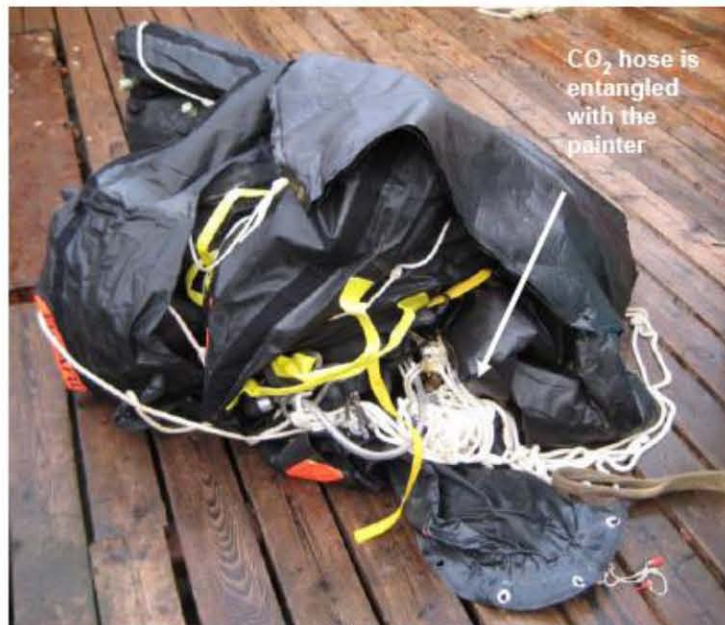
Figure 1. The un-inflated *Katmai* life raft as recovered on fishing vessel *Courageous*. The painter is a rope line that attaches the raft to the vessel and when pulled, it activates the inflation mechanism.

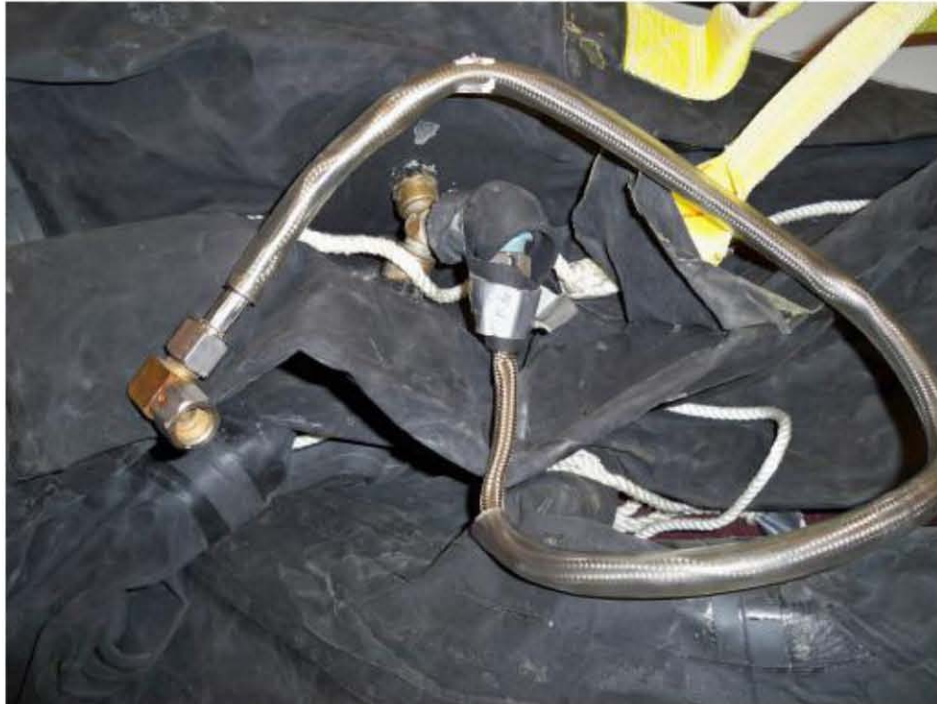
Figure 3. Image of the CO₂ inflation hose attached to the life raft fitting (painter is removed). No CO₂ tank was found with the life raft.

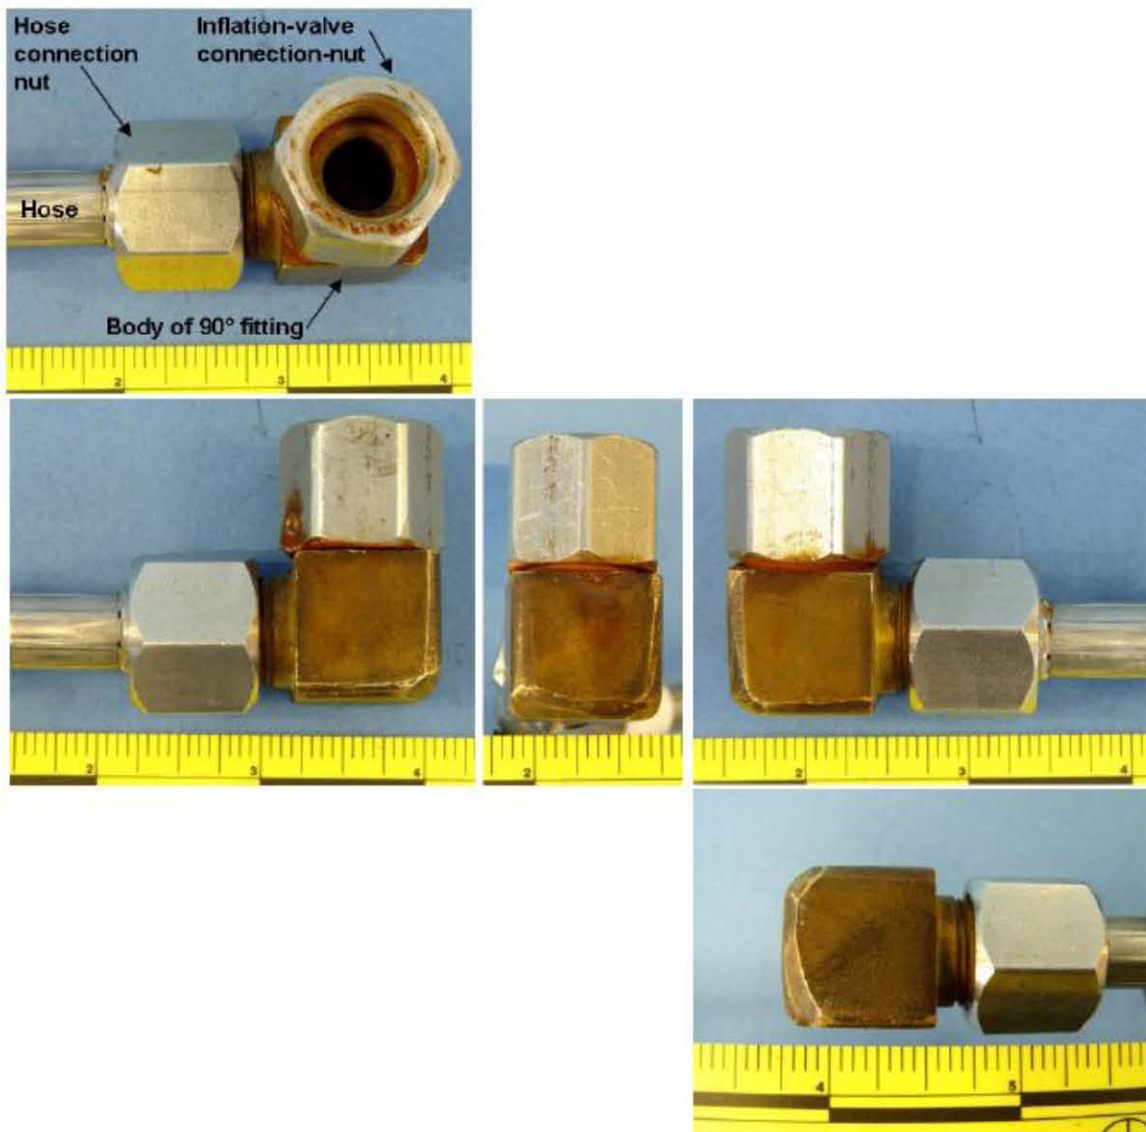
Figure 5. Photomacrographic details of the 90° fitting. Note the brownish-orange deposits at the interface surfaces between the inflation-valve connection-nut and the body of the 90° fitting.

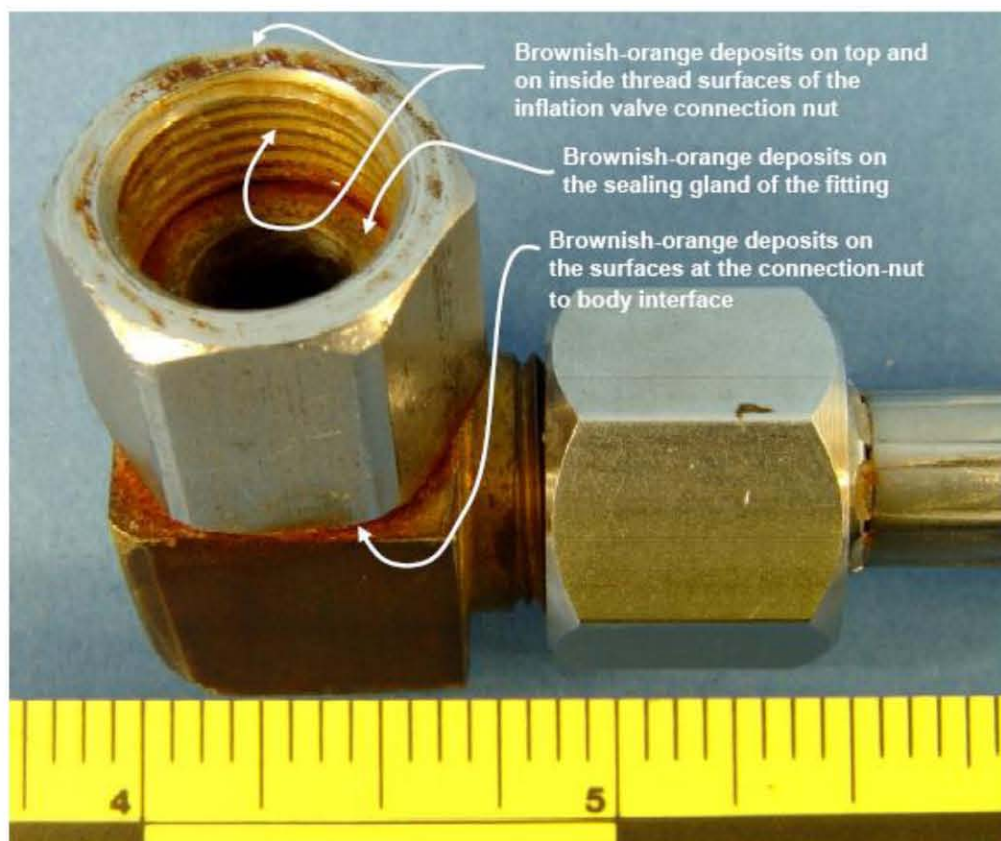
Figure 6. Close-up view of the 90° fitting. Note the brownish-orange deposits on the top and internal thread surfaces of the connection-nut and at the interface between the connection-nut and the body of the fitting.

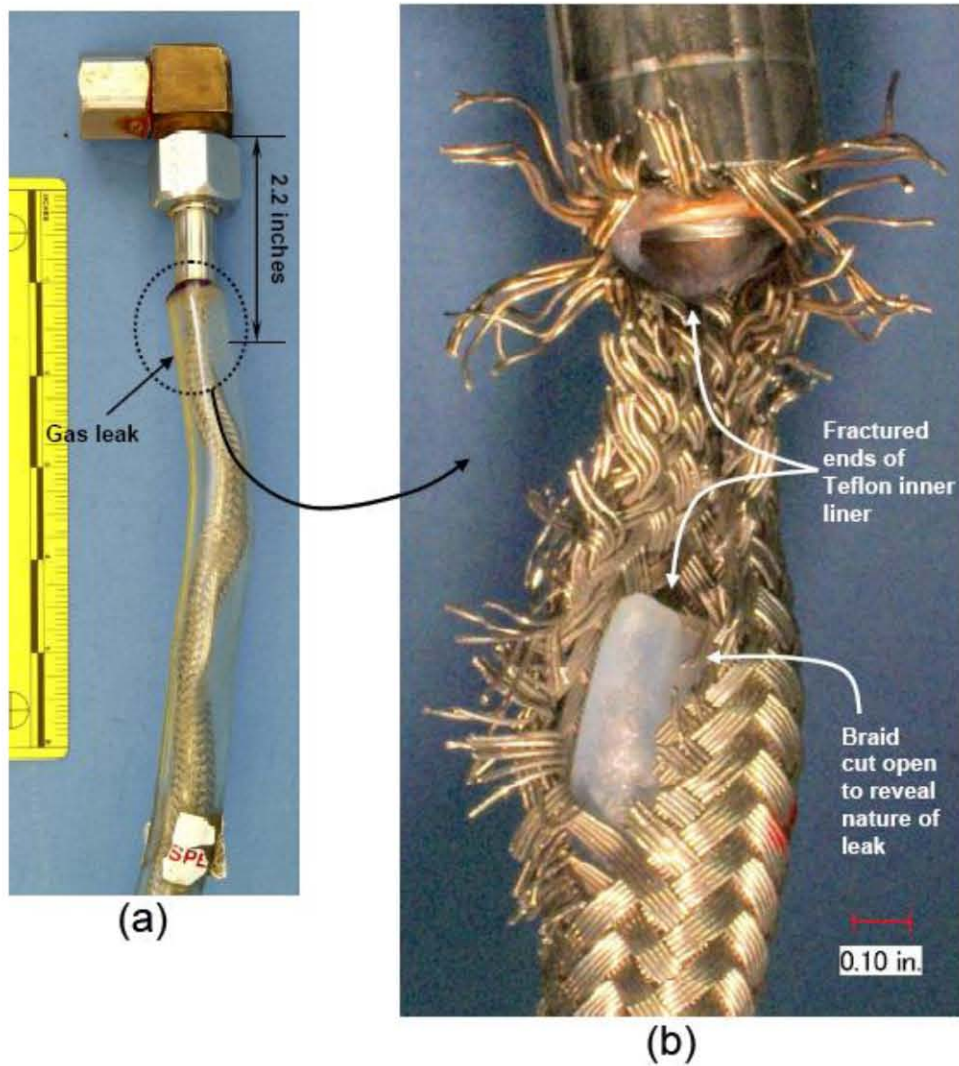
Figure 8. a) External location of the leak in the hose assembly. b) Rupture in the Teflon liner adjacent to the hose connector at the inflation-valve end of the hose.

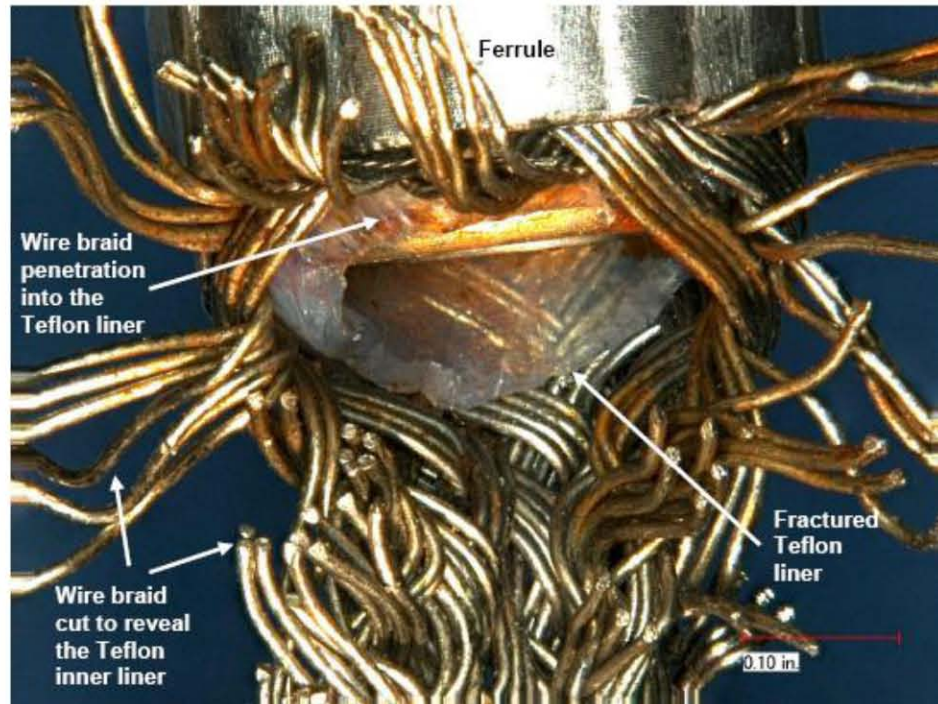
Figure 9. Higher magnification image of the Teflon liner fracture.
