**REPORT OF INVESTIGATION
INTO THE
COMMERCIAL FISHING VESSEL MARY B II
(O.N. 274604)
SINKING AND LOSS OF THE VESSEL WITH MULTIPLE
LOSS OF LIFE AT THE YAQUINA BAY BAR ENTRANCE,
NEWPORT, OREGON
ON JANUARY 8, 2019**

MISLE ACTIVITY NUMBER: 6607968

CAPSIZING AND LOSS OF LIFE OCCURRING ON THE COMMERCIAL FISHING VESSEL MARY B II (O.N. 274604) AT THE YAQUINA BAY BAR ENTRANCE NEWPORT, OREGON ON JANUARY 8, 2019

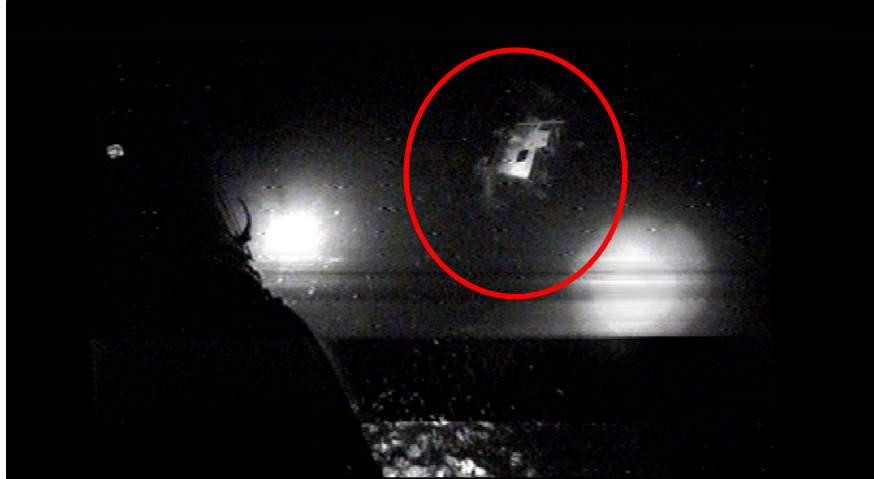
Figure 19. Screen capture from the CG Helo 6527 camera system showing the MARY B II's cabin (circled in red) partially submerged while it was floating north of the North Jetty. (Source – Coast Guard)

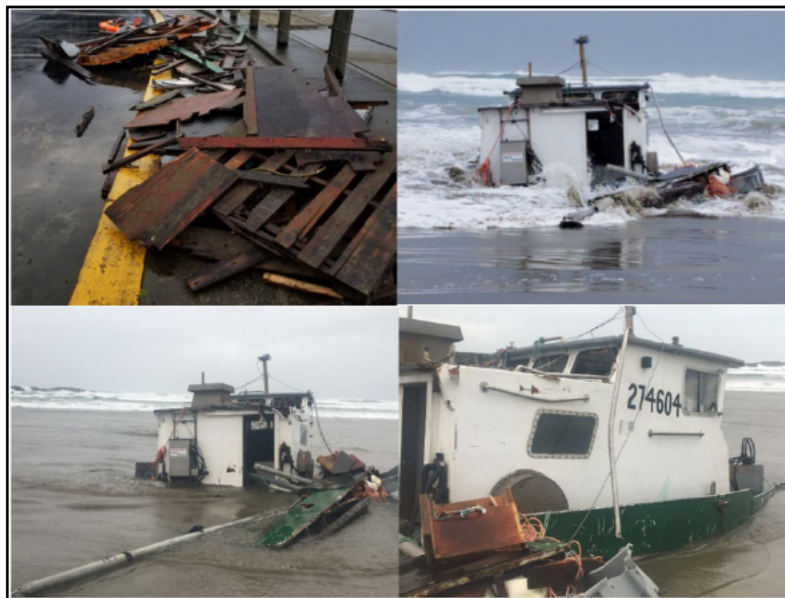
Figure 21. Composite of pictures of the wreckage of the MARY B II taken January 9, 2019. Bottom left image, on the extreme left of the image, you can see the rocks of the North Jetty at Yaquina Bay Bar in the distance. (Source – Oregon State Parks, Mr. [REDACTED] CG Exhibit 007)

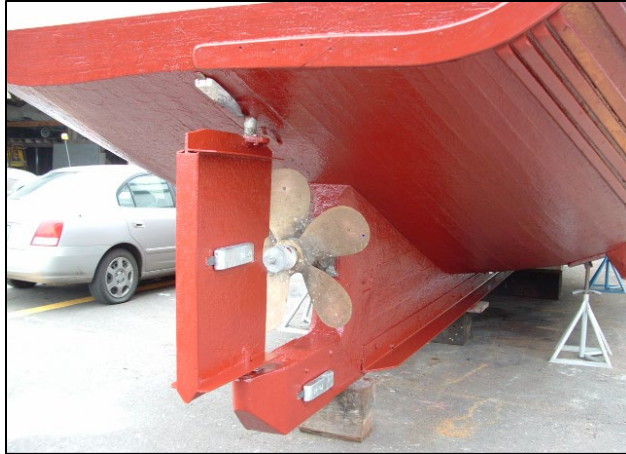
Figure 47. Photo of the BESS CHET (later known as MARY B II)'s propeller, provided by the marine surveyor. (Source – Mr. [REDACTED])

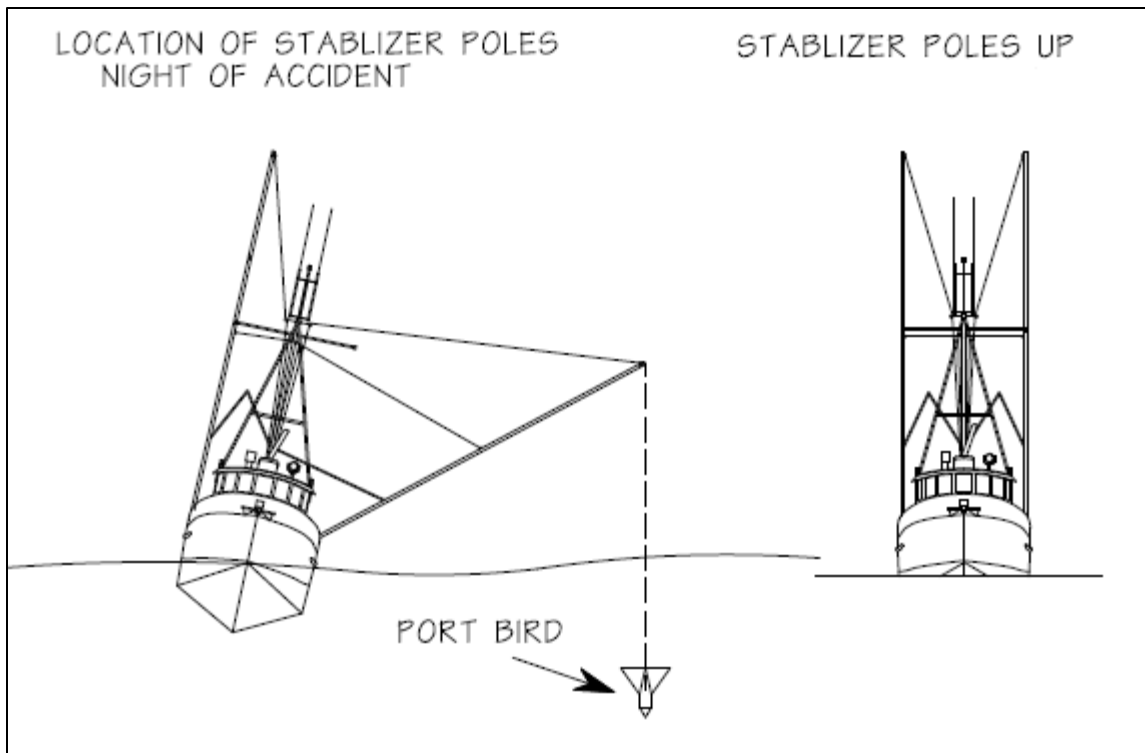
Figure 55. Line drawing of a fishing vessel with the port outrigger out while looking at the bow of the vessel. Left, during the final moments of the MARY B II inbound transit the VICTORY crew noticed the port outrigger partially out with no evidence of a stabilizer or “bird” in the water. It is unknown what the angle of the outrigger was. Dashed line is a visualization of the setup if a port “bird” or stabilizer was in the water. Right, is the stowed position of the outriggers in the upper rigging of the vessel (Source – [REDACTED] ©)

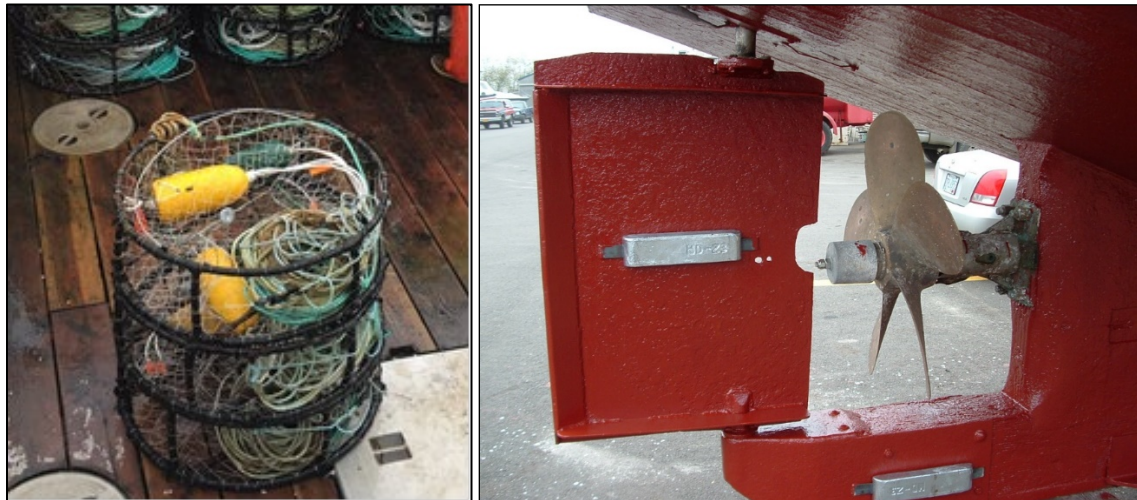
Figure 56. (Left) Image of crab pots and lines associated with the use of these pots, showing the general type of line that may have fouled the propeller, rudder or propeller shaft of the MARY B II to an unknown degree. (Source – Coast Guard). (Right) Underwater aft section of the

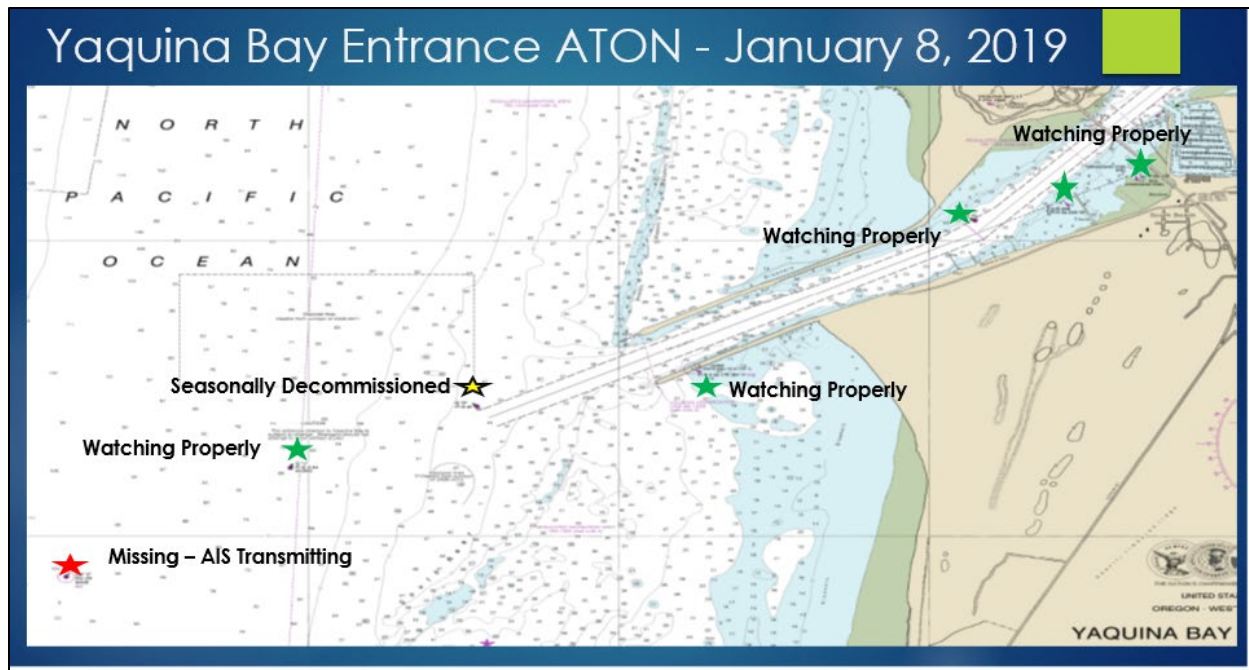
Figure 60. The status of ATON on the accident night. Note, lighted channel buoy 3 although listed as “seasonally decommissioned” the buoy had sunk and was reported missing in August 2018 and could not be recovered as of the accident date. Buoy “Y” was also sunk. (Source – Coast Guard, CG Exhibit 052)

Administrative Recommendation 7: Recommend that the Commandant of the Coast Guard commission a workgroup to study the need for replacement of the navigation buoys placed at the entrance of hazardous bars and similar waterways that are subjected to extreme sea conditions. Recommend the findings of this work group drive the design, construction and implementation of a buoy type that can withstand extreme sea, current and mooring challenges.

Action: I concur with this recommendation. The Coast Guard is already taking actions that comply with the above recommendation.

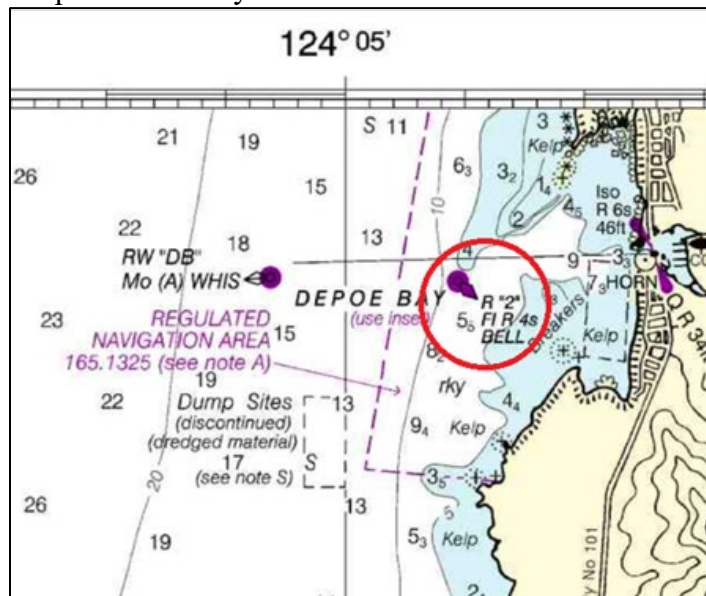
Figure 61. Depoe Bay approach buoys, the lighted buoy circled in red sank on January 4, 2019. Note the navigation ranges as magenta tear drop shapes in the right side of the image in the light yellow landmass. (Source – NOAA Chart 18561)
