UNITED STATES COAST GUARD

REPORT OF INVESTIGATION

SINKING OF THE F/V MAJESTIC BLUE IN THE SOUTH PACIFIC OCEAN ON JUNE 14, 2010 WITH Loss of Two Crewmembers

MISLE ACTIVITY NUMBER: 3766101

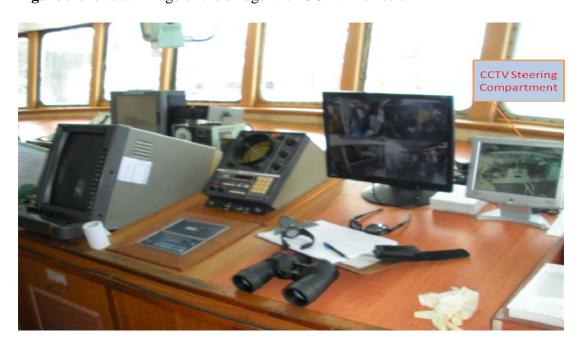
Figure 5 shows an image of the bridge with CCTV monitors

1335 - The 2nd Engineer departed the rudder compartment, but did not close the watertight door upon leaving the space. The Captain (and Fish Master (arrived on the bridge and observed the flooding through the CCTV.

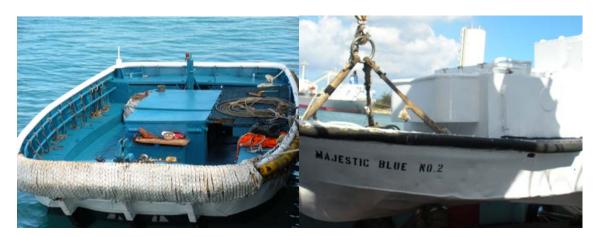
1345 - The skiff (Figure 6) and net boat (Figure 7) were launched by the crew and placed along the starboard side of the vessel.

Figure 6 skiff

Figure 7 net boat

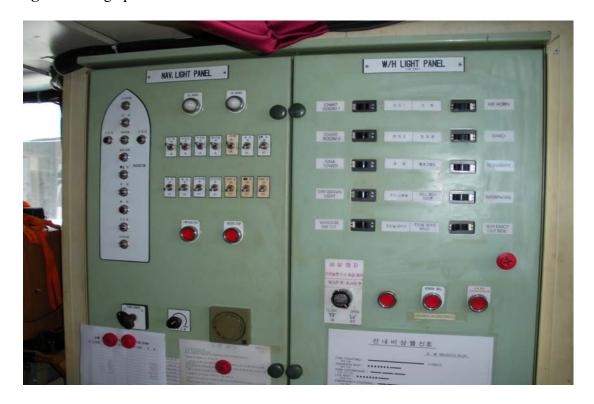
1.10.2 Instructions - The written language on board the ship varied between English and Korean. Figure 8 shows a light panel on the bridge with an emergency signal chart with both languages on display. Electronic copies of other emergency procedures such as abandon ship, man overboard, fire, damage control and distress signaling were obtained from a previous Captain and were only written in English.

<u>Recommendation 1</u>: The Coast Guard should develop regulations within 46 CFR Part 28 requiring an "Open" and "Closed" indicator panel on the bridge for each watertight door.

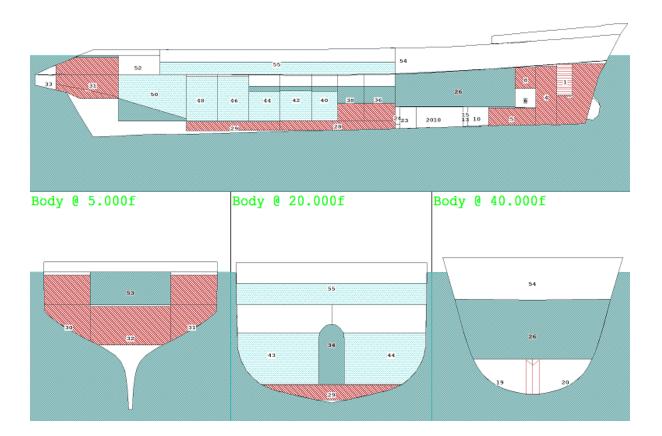
2.1.2 Crew actions - Upon discovery of the flooding the ships general alarm was energized in a timely manner. Damage control efforts consisted of an attempt by four members of the engineering department to close the watertight door leading into the rudder compartment. The attempt was unsuccessful. There were no other damage control measures taken or dewatering actions performed by the crew. During the flooding emergency the 2nd Engineer left the rudder compartment after initially investigating the flooding without closing the watertight door, as he did on each of his hourly rounds during his watch. Further, following the unsuccessful attempt by the crew to close the rudder compartment door, the crew departed the shaft tunnel compartment in order to abandon ship without closing the shaft alley/engine room watertight door. The analysis shows that if either of the doors was closed and the flooding isolated to only the rudder compartment and or the shaft tunnel compartment the vessel would have maintained its intact stability. It is only after all three compartments (rudder, shaft tunnel, engine room) flood, that the vessel rapidly loses its intact stability and further allowed the flooding water to migrate onto the main deck area through the engine room stairway access. With 50% of the vessels main deck flooded the vessel is at immediate risk of capsizing and shown below in Figure 11.

The Engineering department was responsible for performing hourly rounds in the machinery spaces below the main deck to inspect systems and general safety. They followed a poor rule in that each watertight door was left in the open position at all times and held open with a hook or line.

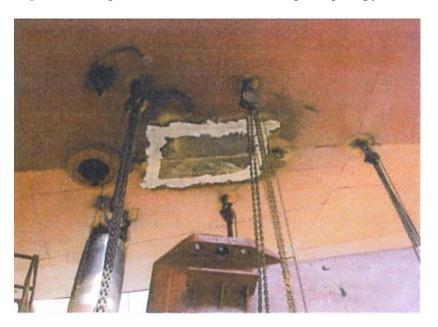
Figure 12 image taken of hull while in Longsheng Shipyard, China

the hull repairs made at the shipyard. The only evidence or data regarding the repairs in the aft region was an image of an insert taken by the vessel manager (Figure 12) and the work order for hull repairs while at the shipyard. There was no USCG oversight at the shipyard regarding survey of the hull or examination of repairs. The image also shows that the rudder was removed. The rudder and steering system was, according to records, disassembled, cleaned, inspected and repaired while in the shipyard.

The proximate cause of this sinking was the rapid intrusion of sea water into the steering compartment through an unknown breach or breaches in the hull envelope of approximately 106-176 square inches. The vessel sank in the South Pacific in waters 3 miles deep, some 2,100 NM southwest of Hawaii and 625 NM northwest of Fiji. As such neither the examination nor recovery of the vessel is feasible and the actual cause and exact location of the flooding is unknown and unknowable. The recent shipyard repair work and hull survey was not under CG oversight therefore no documentary evidence is available regarding the outer structural integrity of the hull and or quality of repairs.
