**COLLISION BETWEEN THE T/V TINTOMARA AND BARGE DM932 BEING  
PUSHED BY THE MEL OLIVER AT MILE MARKER 99 OF THE LOWER  
MISSISSIPPI RIVER ON JULY 23, 2008**

**ACTION BY THE COMMANDANT**

## REPORT OF INVESTIGATION INTO THE CIRCUMSTANCES SURROUNDING THE **THE COLLISION BETWEEN THE T/V TINTOMARA AND THE BARGE DM932**

ON 07/23/2008

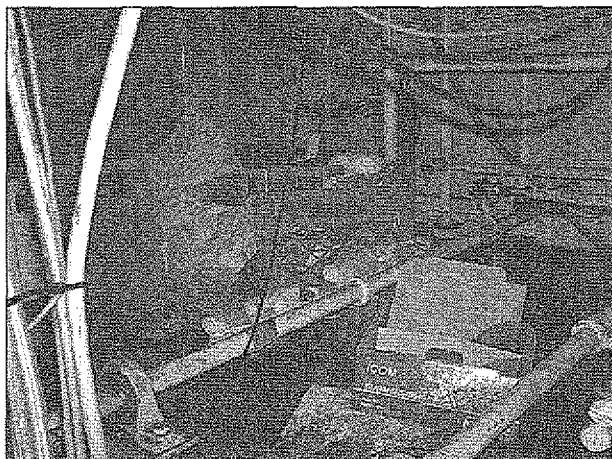
*Photo 1 - IO Exhibit 139-3*

- (d) The void space under the wheelhouse on the MEL OLIVER was also used as a storage area for discarded parts, excess equipment and various supplies. Immediately following the collision, the DMI found this area to be cluttered and unkempt. In addition to a tremendous number of loose items, there was a substantial amount of oily liquid residue on the deck plating. (See photos below) (also reference generally [REDACTED] 2).

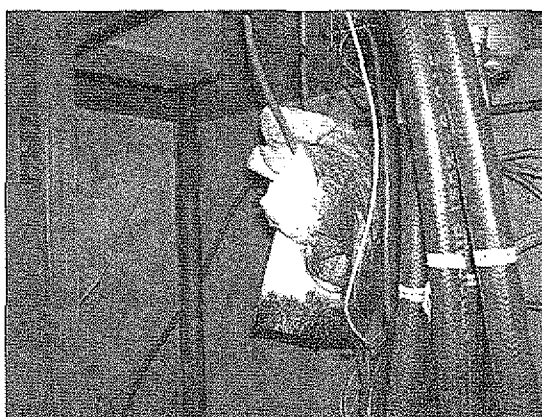
*Photo 3 - IO Exhibit 139-9*

- (e) The fluid appeared to be coming from a leaking hose that extended into the wheelhouse, which was wrapped in an oily rag (see photo below). According to the DMI, it appeared to have been an ongoing problem because the entire starboard side of the area was oily and covered with absorbent cloth. ([REDACTED] 2 pgs 32- 34) (see also, IO Exhibit 94, pg 2 line item 8).

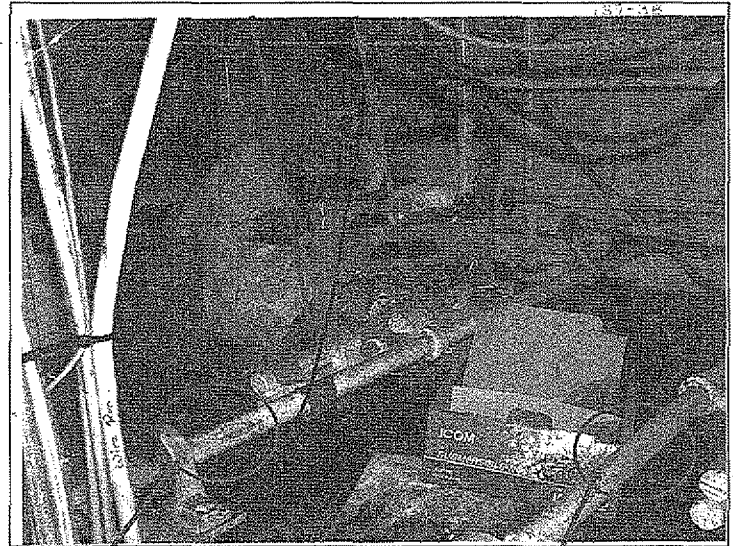
Photo 4: IO Exhibit # 139-3B

- (f) As seen in the photo to the right, the steering linkage is exposed:
- (g) Each steering rod has a set of counter weights welded along the side to assist with movement when the steering-stick in the wheelhouse is manipulated or moved from side-to-side (steering from port to starboard and vice versa). (2 pg 25 line18 – pg 27 line 22).

The steering system seen on the left side of the photo is for the main, or primary, steering system.

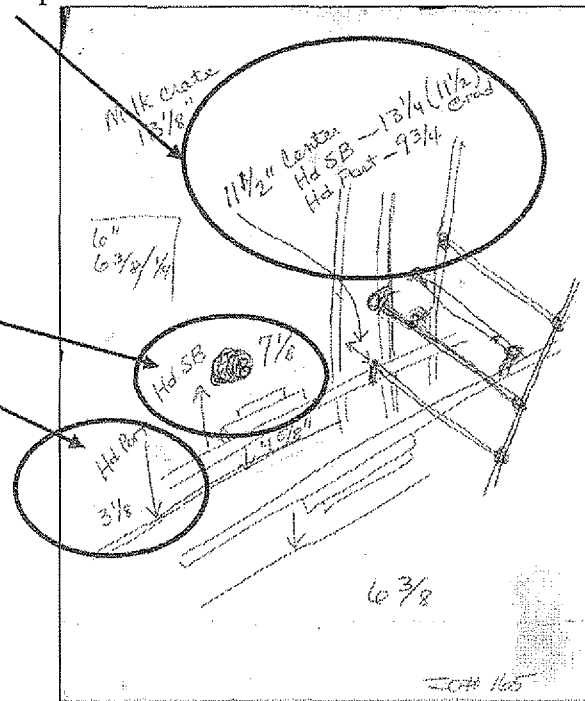
Figure 3: IO Exhibit # 165, MEL OLIVER Mechanical Linkage – hand-drawn depiction w/ measurements

- (h) The system was roughly sketched to record various measurements such as distances and rotational movement. Clearance measurements were noted such as the distance at the rod ends when the steering-sticks were pushed from port to starboard.

The rotational movement of the linkage counter weights measured at  $7\frac{1}{8}$  inches to Hard Starboard and  $3\frac{1}{8}$  inches Hard Port.

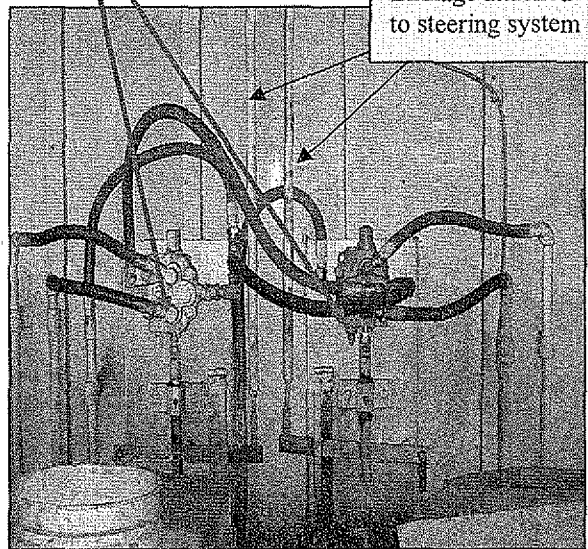
Photo 5: IO Exhibit # 156

The yoke pivots up and down to manipulate the arms on the hydraulic pump(s) below the deck. (2 pg 30 lines 13-17)

MEL OLIVER Mechanical Linkage (without witness markings)

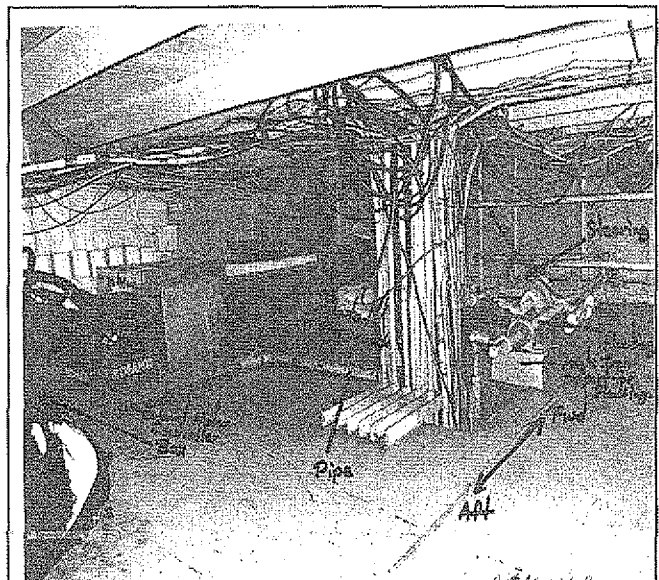
Photo 7: ACL Exhibit R  
(annotated by CWO during testimony)

(k) The area was cleaned at some point following the collision and prior to this visit. All items were stacked neatly along the sides of the bulkhead, the deckplate (floor) was wiped clean and the dripping line had been repaired. (see ACL photo to right).

(l) Comparing the photos of this space from the day of the collision, an inventory was done and all but two items were located (a small metal wire rack on the far right side and an empty box). The items on the left side of the space as seen in the original photos remained on the left side and visa versa. (2 pg 38 line 16 – pg 39 line 20).

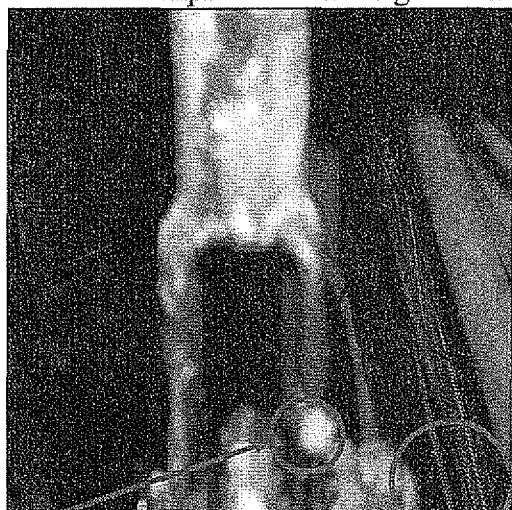
Photo 8: IO Exhibit 164  
steering yoke with chips

(n) The examination then continued down the linkage rod and like testing was done around the counter weights. Again, no jamming occurred. Finally, the examination led to the end of the rod and the yoke. (see photo 5, previous page). This yoke is the "elbow" of the rod between the horizontal section in the void space and the vertical section passing through the deckplate into the engine room where it attaches to the hydraulic pump.

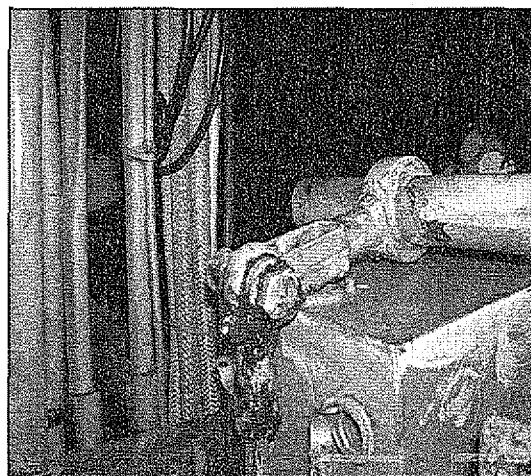
Photo 9: IO Exhibit #160

(p) Looking around the area near the yoke, a loose metal electrical box was found<sup>32</sup>. Along the edge of the box was a cream-colored paint that appeared to be the same color as the chips found under the yoke. The box was located on the same side of the "room" as the yoke and was of a size that it was reasonable to believe that it would fit under the yoke.

(q) The box was slid under the yoke. The box moved easily under the yoke and the area on the box painted with the cream-colored paint met up exactly with the spot under the yoke where the paint chips were found. (see photo right).

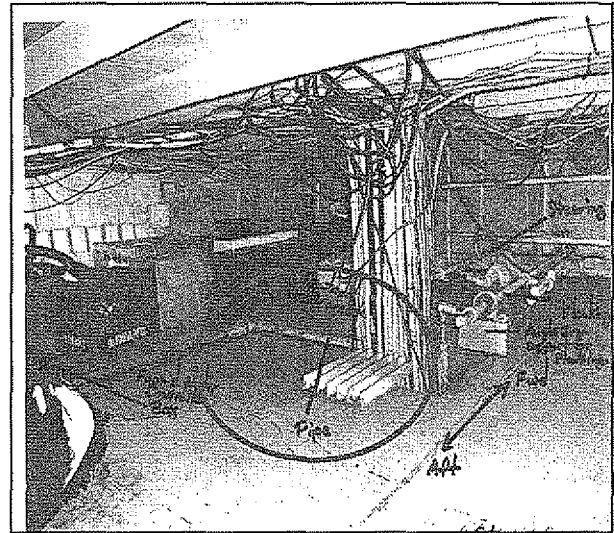
(Duplicate Photo 8): ACL Exhibit R  
(annotated by CWO [REDACTED] during testimony)

- (f) In an attempt to determine how the box could have worked its way under the yoke, a survey of the layout surrounding the yoke was done. Note again ACL Exhibit R (right).

In addition to the angle iron support for the steering rod on one side (as seen in photo 5, page 50, photo 9, previous page and photo 10 below), a pipe runs across the deckplate. The position of the pipe and the position of the angle iron created a "channel" leading directly to the yoke; the angle iron on one side, the pipe on the other and the yoke at the end. Notice how far the pipe extends toward the side wall where all the loose materials are stored.

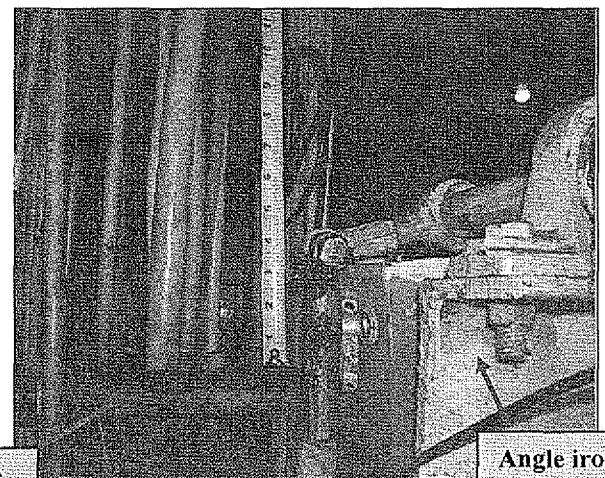
Photo 10: IO Exhibit # 162

Considering the oily nature of the deckplate, coupled with the natural vibration of the towboat, it is possible that the loose box worked its way into the "channel" leading to the yoke and eventually under the yoke. (see placement of box between pipe and angle iron in photo 10 below).

- (s) Several tests were conducted on the steering linkage. An IO was in the wheel house of the MEL OLIVER and asked to turn the stick to starboard. Measurements were taken with the box under the yoke and without the box; the difference in the travel distance was roughly  $\frac{7}{8}$  of an inch ( $4\frac{3}{8}$  vs  $3\frac{1}{2}$ ). ([REDACTED] 2 pg 53 line 16 – pg 57 line 17). This test was conducted numerous times with the IO using both hands in an attempt to get the sticks to move to starboard; all without success. Additional tests were conducted turning the steering-sticks to port. The box did not impede the rotation of the steering to the port.

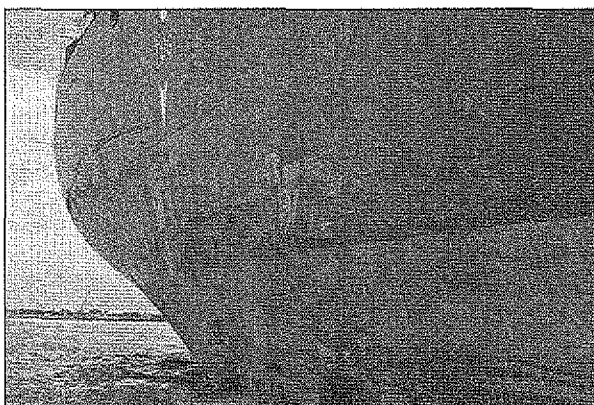
*Photo 11: Port side TINTOMARA  
(post casualty)*

The TINTOMARA sustained cosmetic damage only. Paint scrapings were noted on both the port and starboard sides of the vessel.

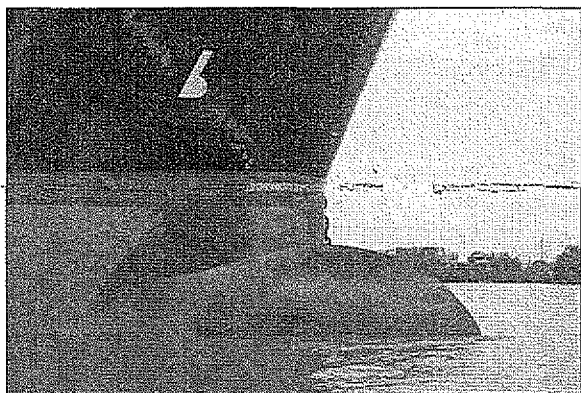
*Photo 13: Bulbous Bow TINTOMARA (side view)  
(post casualty)*

In addition, the TINTOMARA had a sufficient residual amount of oil remaining on her bulbous bow as shown in the following photo. Of significant note, the bulbous bow is of a unique shape. Unlike the common rounded tip, the tip here has a sharp, almost knife-like edge. This edge cut into the tank barge (DM932) nearly severing it in half. (see Photos 17 & 18 page 55 below).

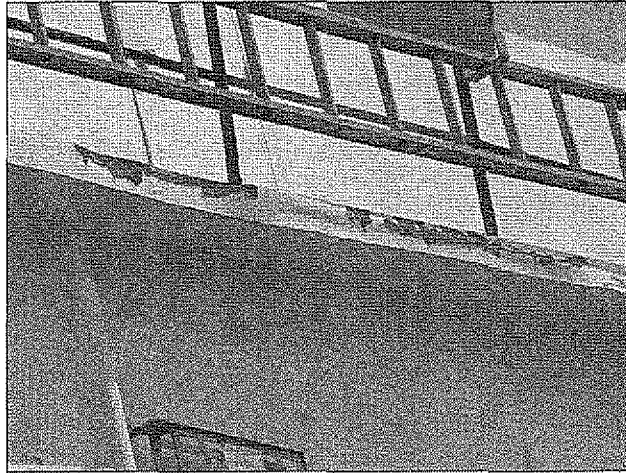
*Photo 15: Port side MEL OLIVER 2d deck railing(post casualty)*

The MEL OLIVER sustained minimal damage, mainly to surface areas (such as lighting and railings) resulting from the back-lash of the face wires.

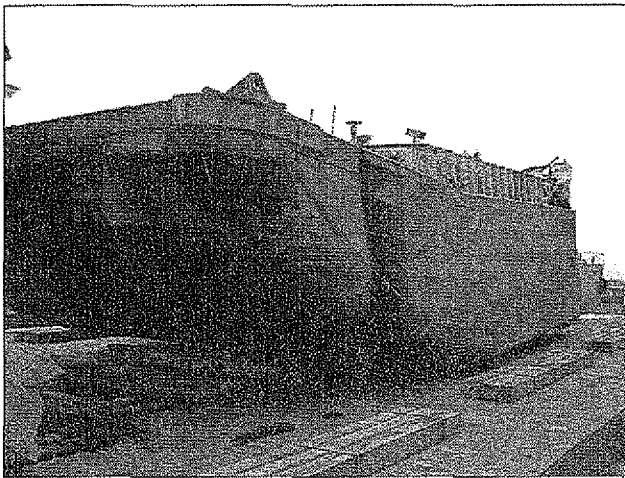
*Photo 16.: Bow rake, forward half of salvaged barge DM932; about 70' in length (post casualty)*

The DM932 was severed nearly in half roughly 70' behind the bow rake.
